Irradiation aging of the electronics of the ATLAS Transition Radiation Tracker

Bijan Haney, on behalf of the TRT Group
Radiation Effects Workshop - April 23, 2018

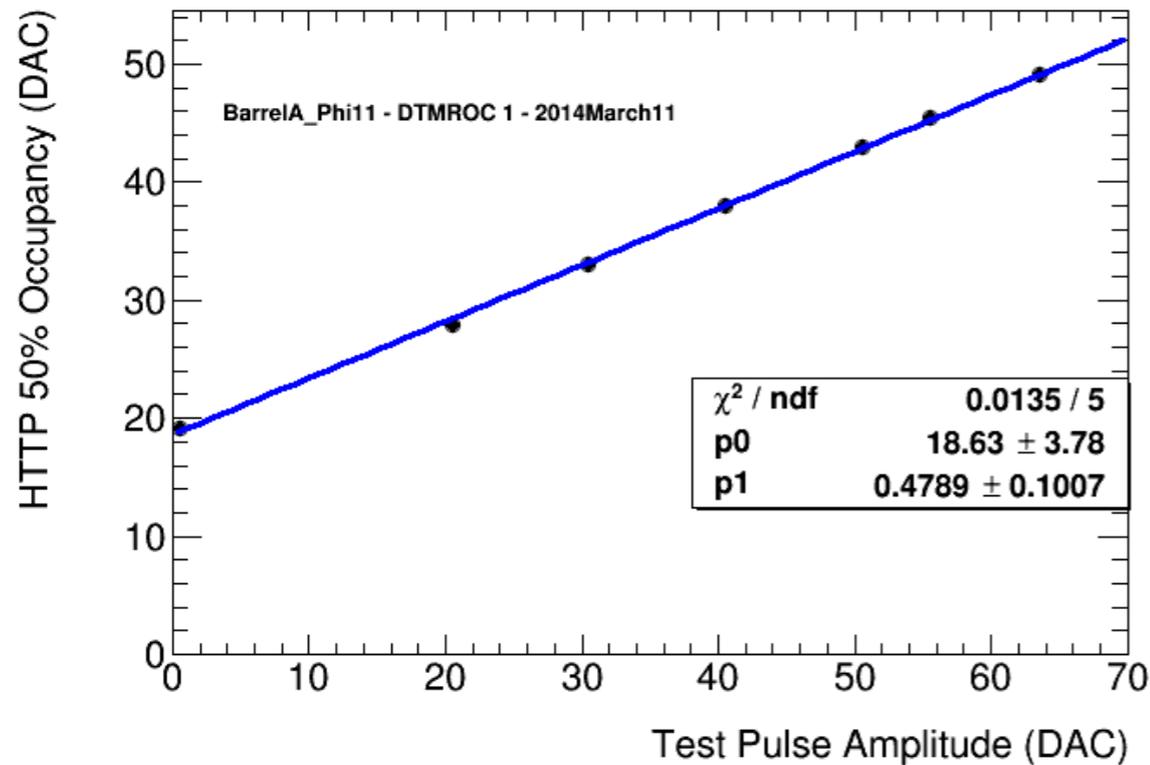
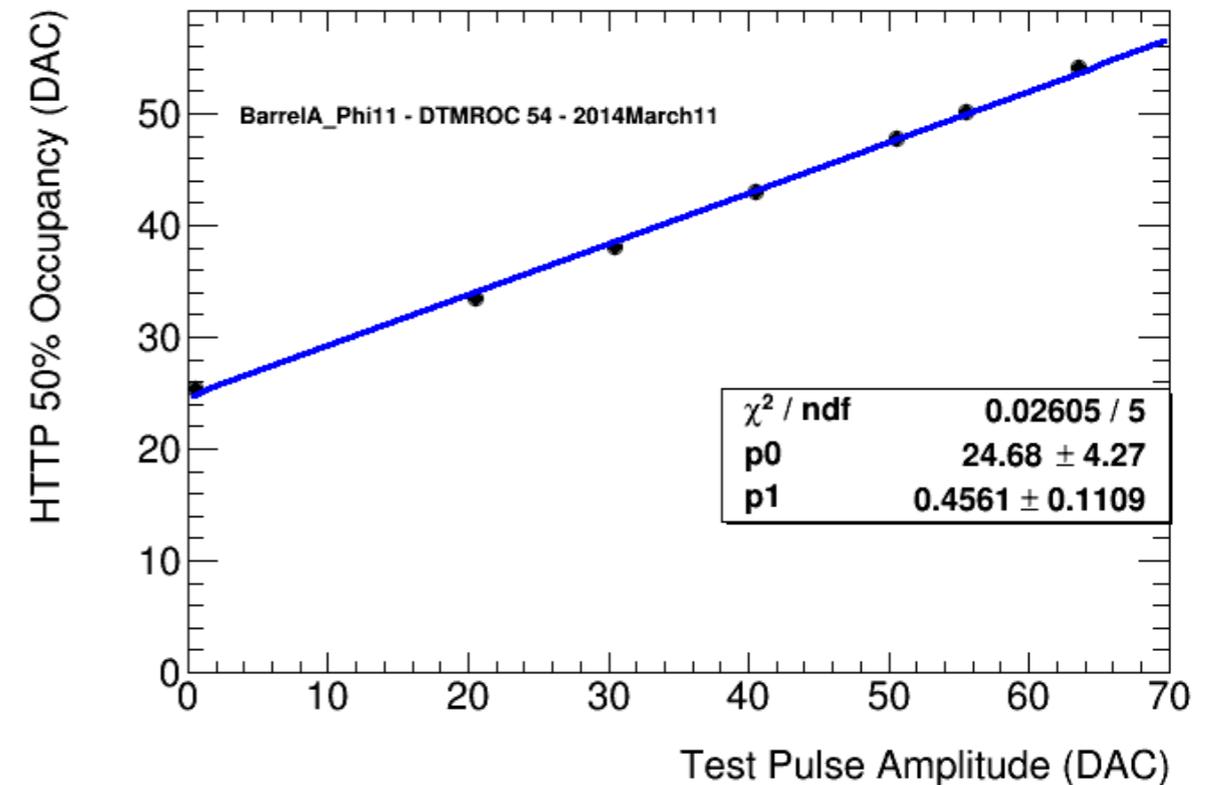
Linearity of gain of the test pulse

- The gain is linear from close to 0 DAC injected charge all the way to the maximum of 63 DAC for all DTMR0Cs.
- Above are two representative chips from Barrel A.
