Measurement with SEM

T. Asada

2018/05/29 in Capri

Purpose

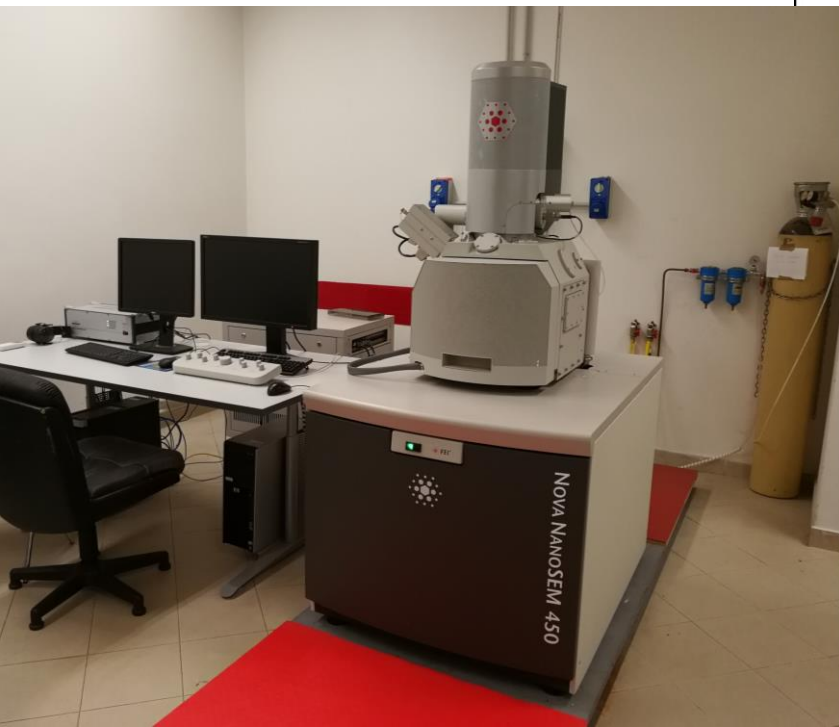
Scanning Electron Microscope

- depth of focus is very high, but penetration depth is several hundred nm
- the resolution depends on the width of electron beam and its diffusion

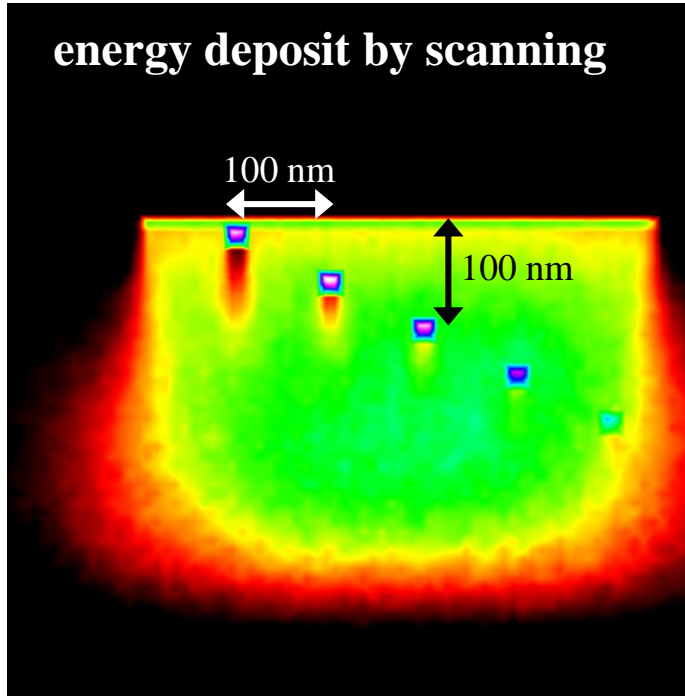
SEM simulation by CASINO v3

SEM Vacc = 5 keV

energy deposit by scanning

electron incident

geometry

C coat (10 nm)

↓ gelatin layer
+ 20 nm Ag cylinder

detected electrons / 1000 ev in sensor position

Ag filament which depth is up to 200 nm is detectable, however 100~200 nm positions are worse contrast and resolution.

The contrast effect may be not so strong in our target; Carbon, energy < 100 keV (see nextpage)

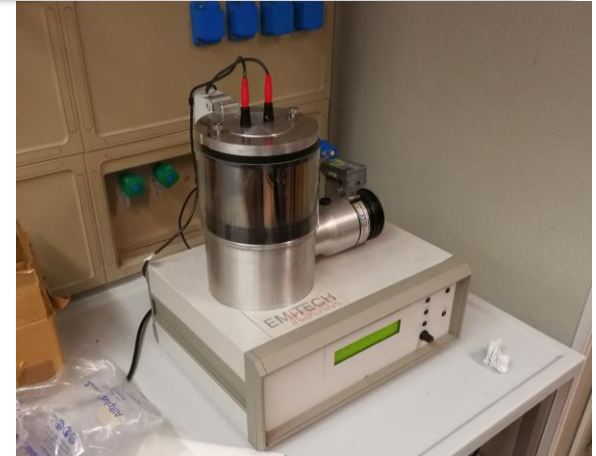
Carbon sputter

- Surface coating layer is need for electron conduction
 - minimum coating is required to keep good contrast
 - Carbon: transparent material, however thicker coating (20 nm) didn't contribute to film protection performance while resolution becomes worse
 - Au/Pd: reflective material, however, very thin layer (4 nm) gives enough conductivity, and gives better contrast
- Au/Pd 4 nm is best

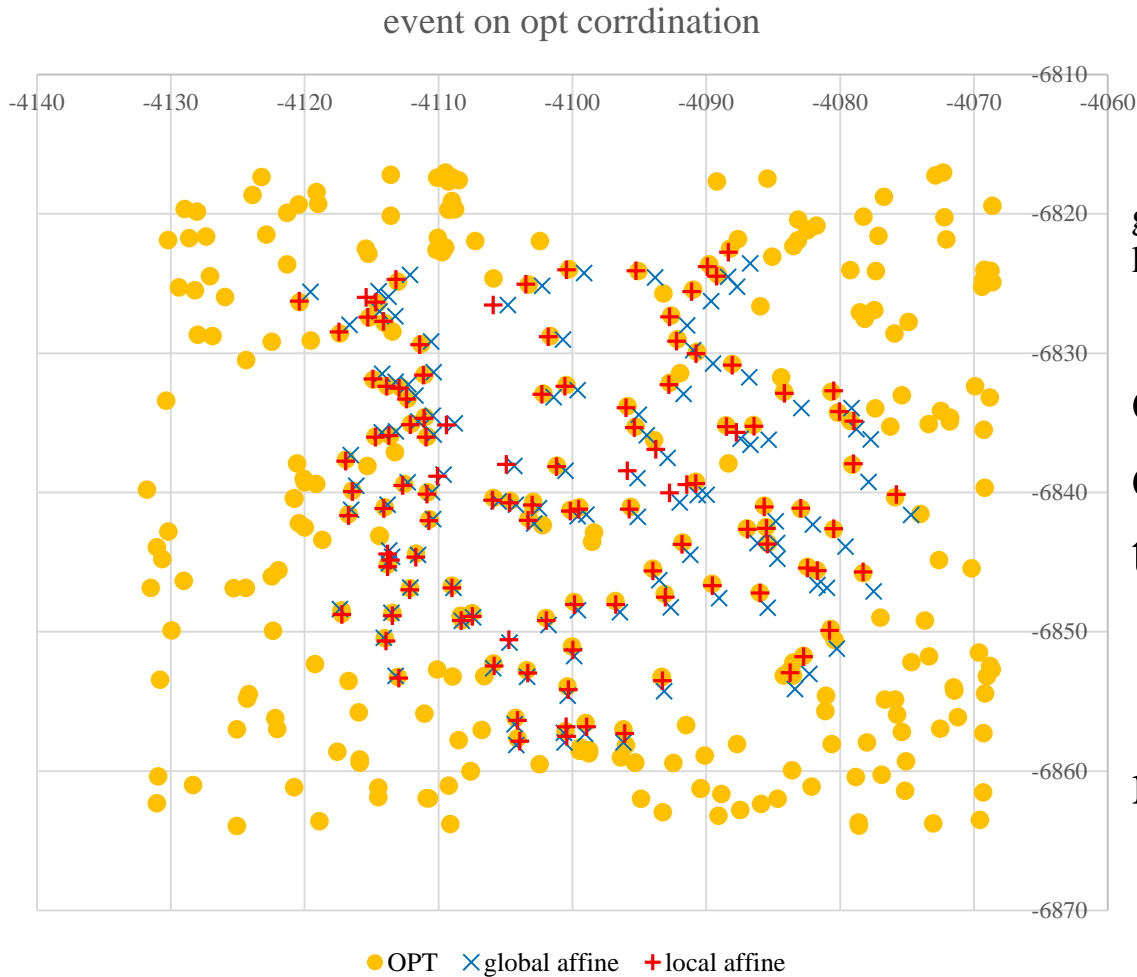
position matching

global affine: corner optical marks
local affine: event matching inside view

currently local affine
conversion needs manual
treatment for view by view

→ pattern matching is
needed for large statistics

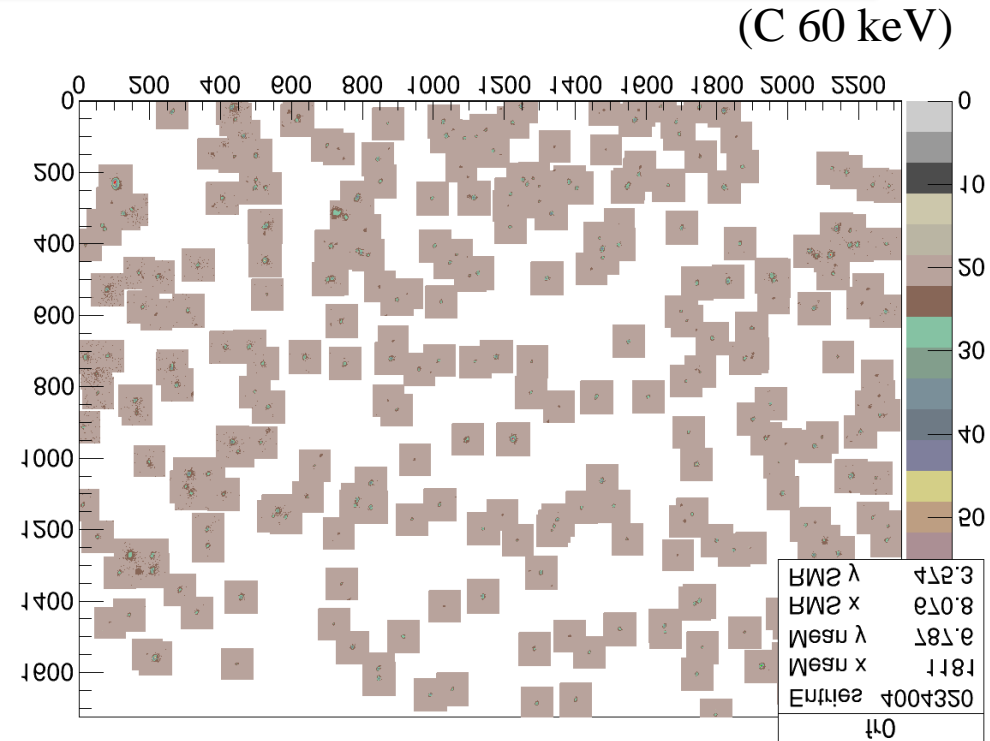
Napoli view 60 x 45 um

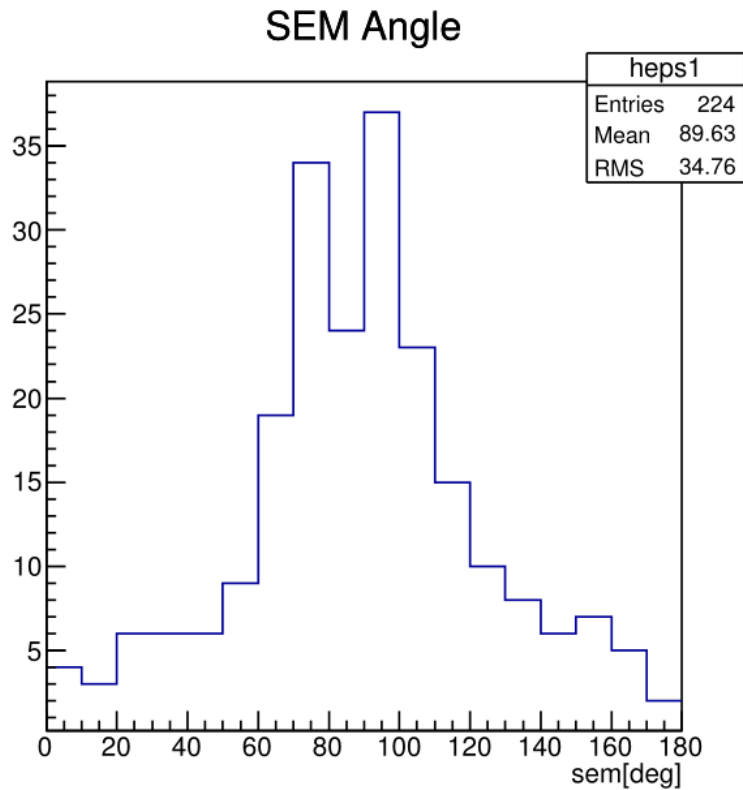
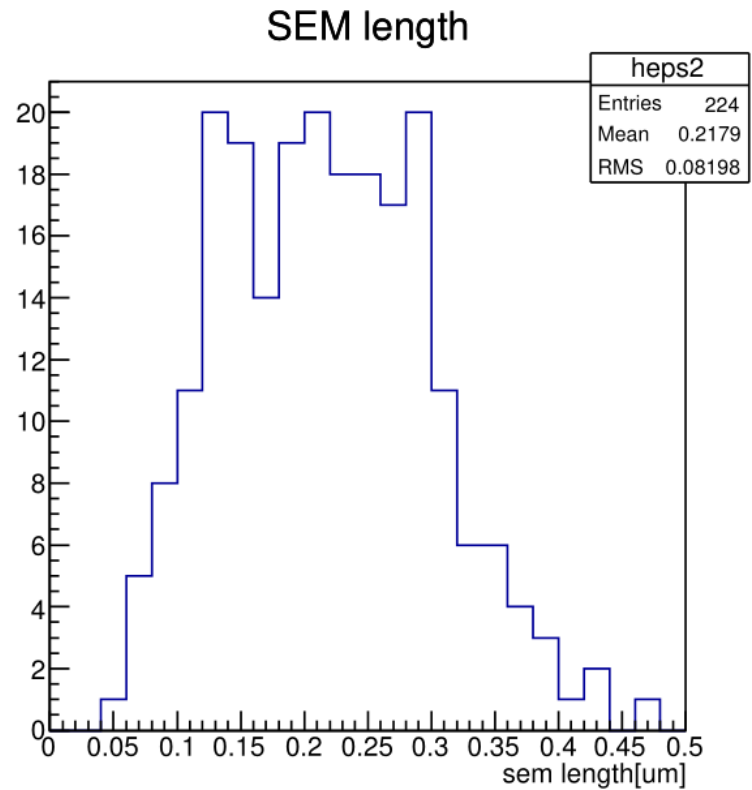
manual check result (C 100 keV)

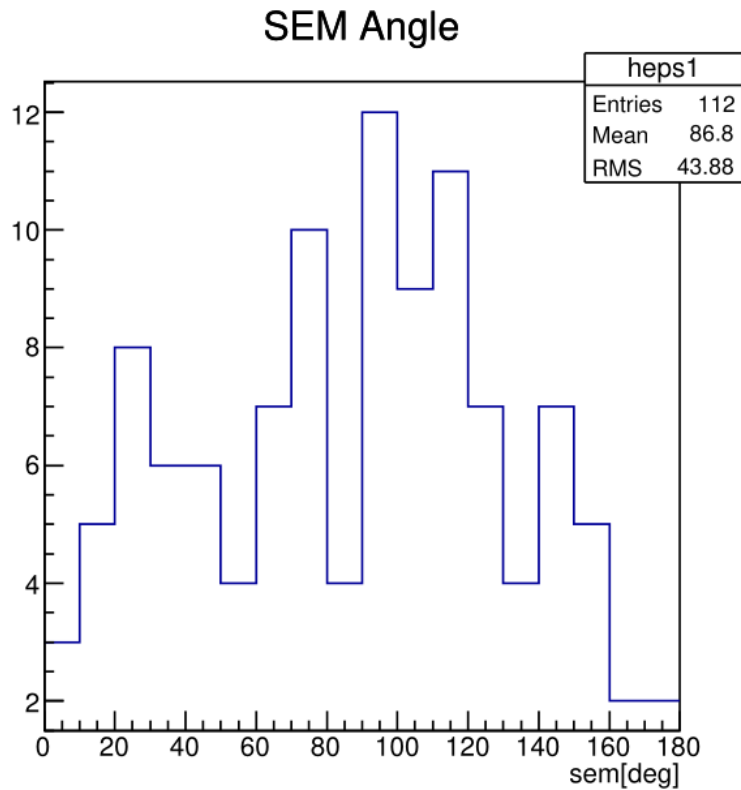
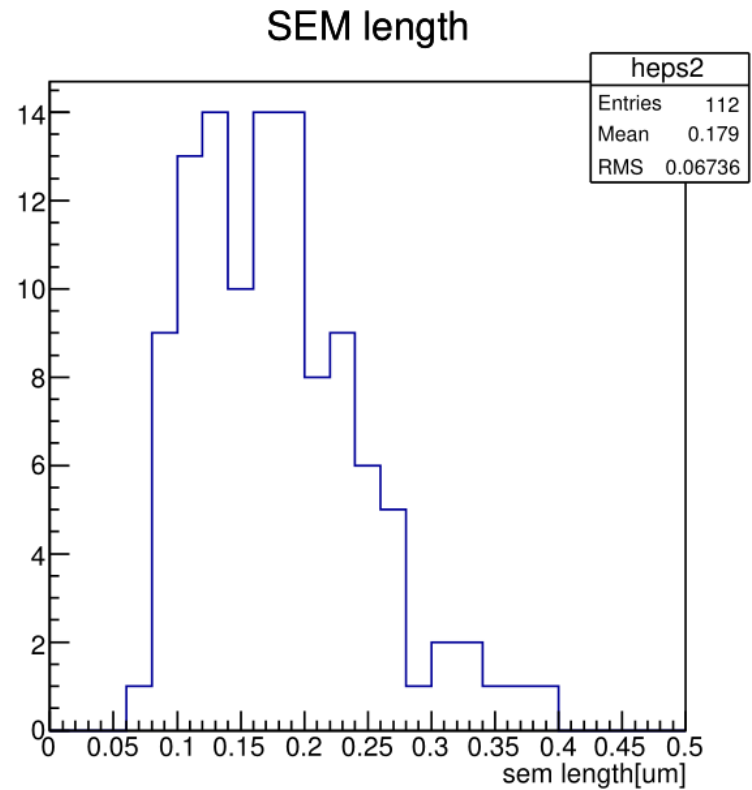
manual check result (C 60 keV)

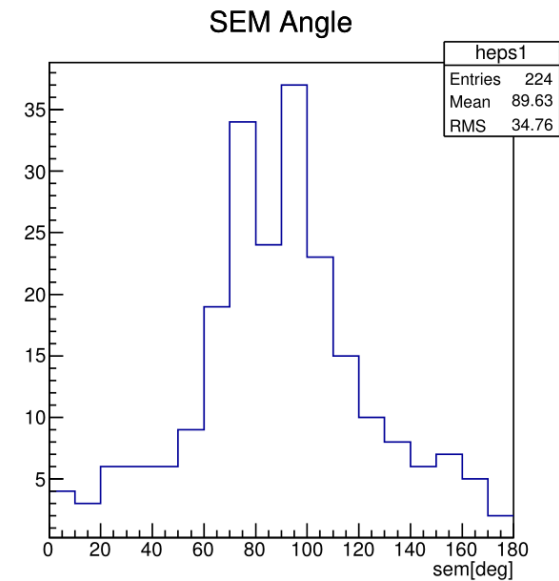
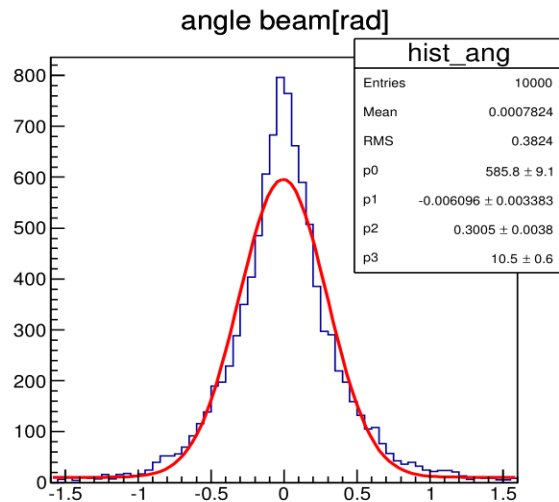
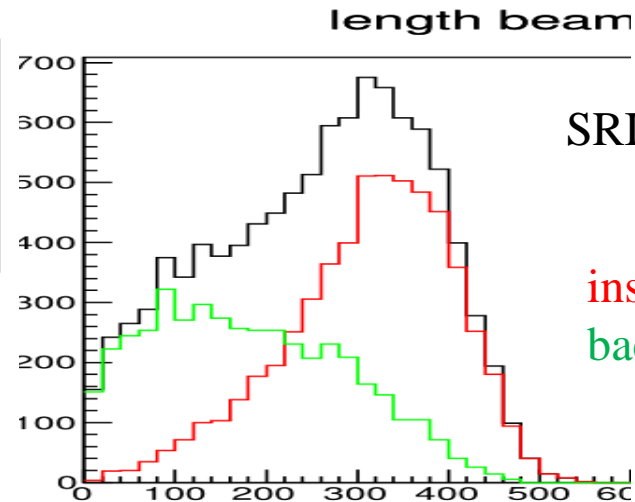
comparison to SRIM simulation (100 keV)

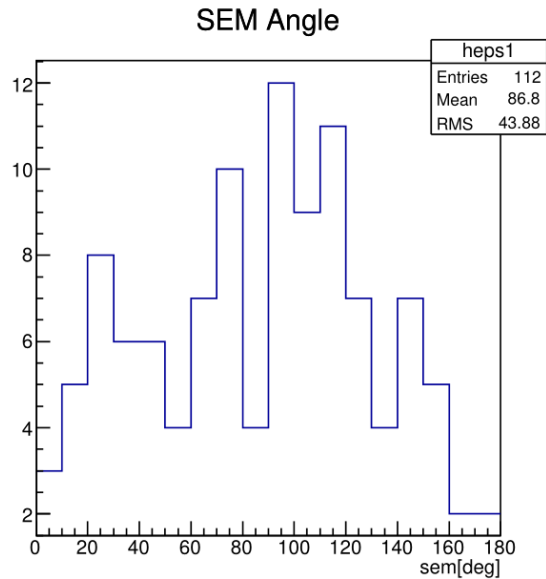
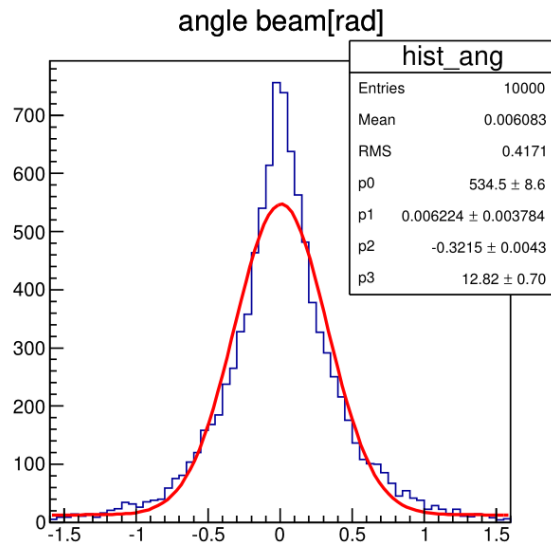
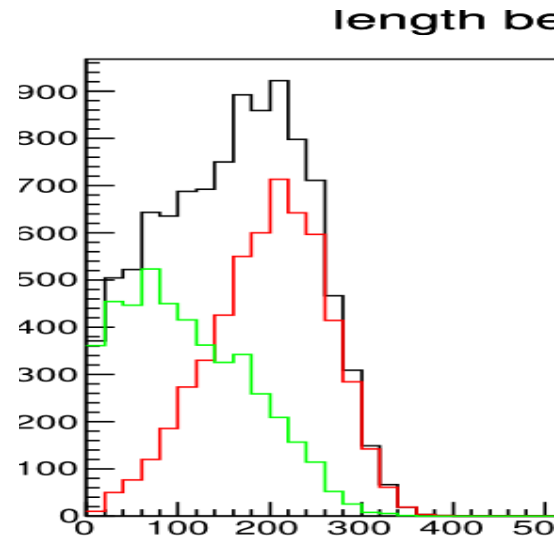
comparison to SRIM simulation (C 60 keV)

SRIM simulation

inside event

backscatter event

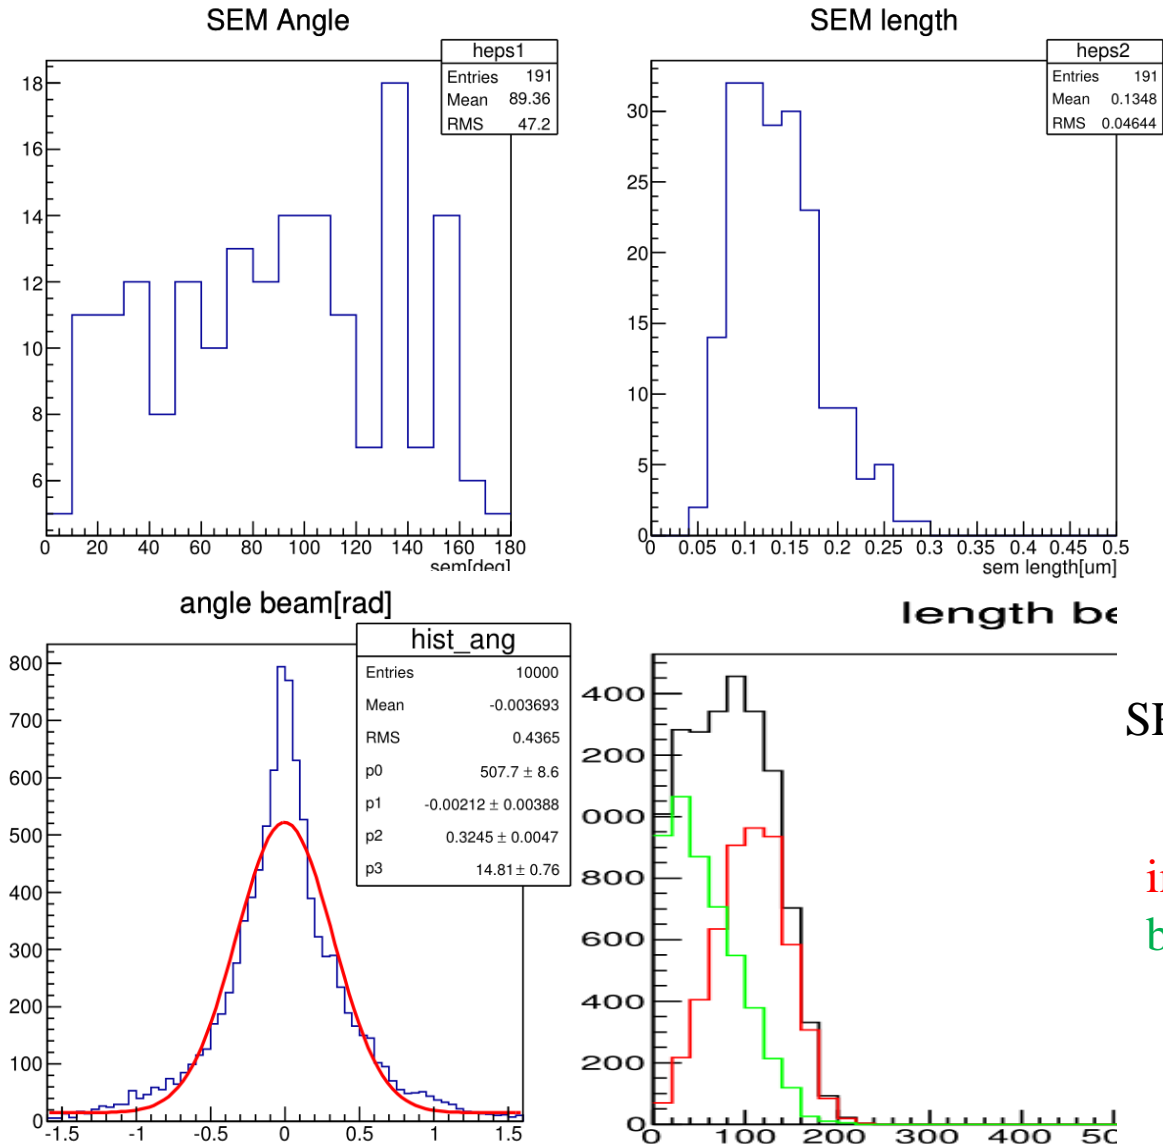
comparison to SRIM simulation (C 30 keV)

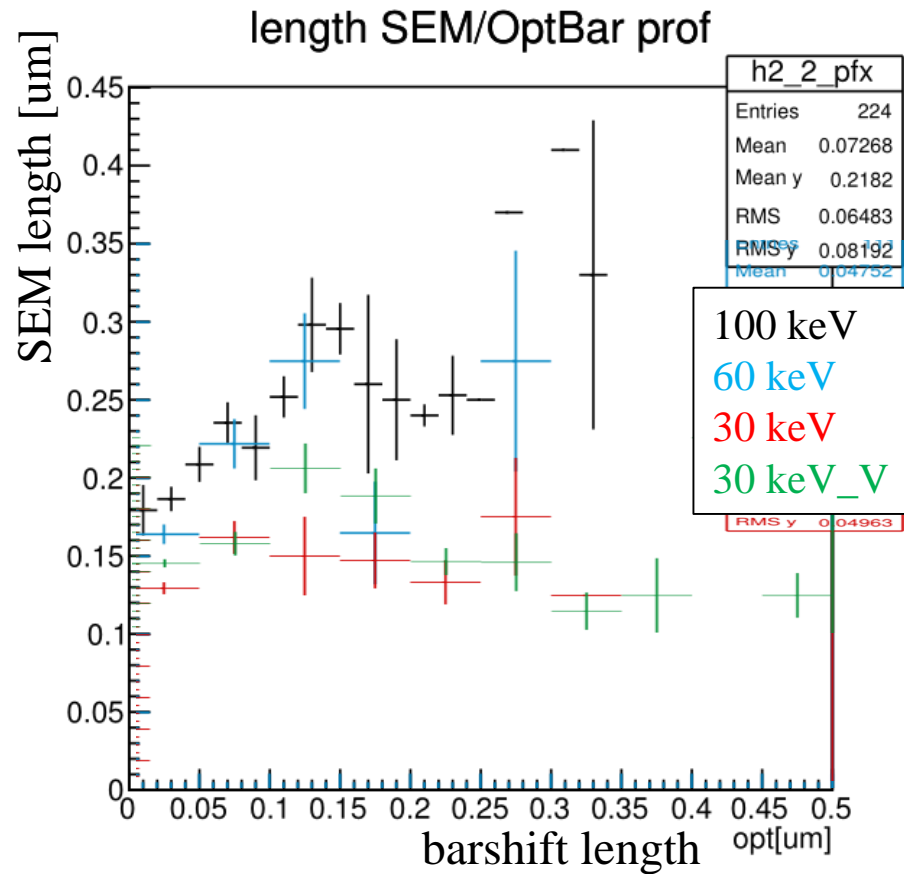
correlation between bar-shift and SEM measurement

- longer tracks length than 150 nm is less correlated to bar-shift
- 30 keV (expected 1.6 grains) samples seem to have another behavior of bar-shift?

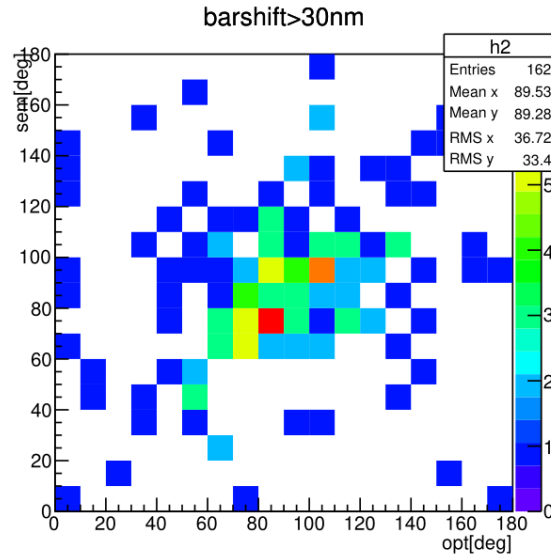
angle dependency of SEM / optical bar-phi

angles both have peak around 90 deg, but not linearly
Stronger bar-shift still not have good correlation to SEM

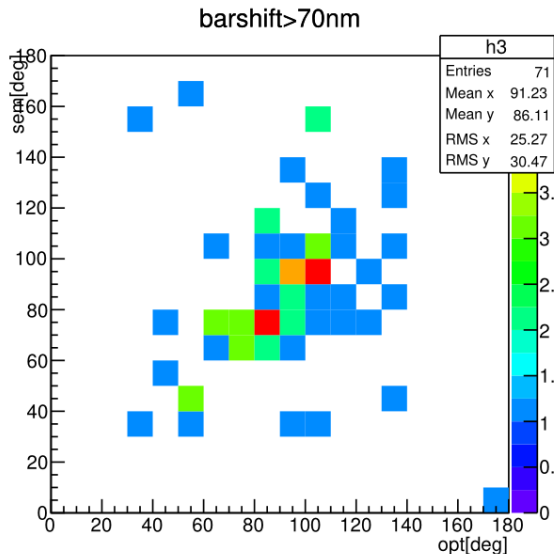
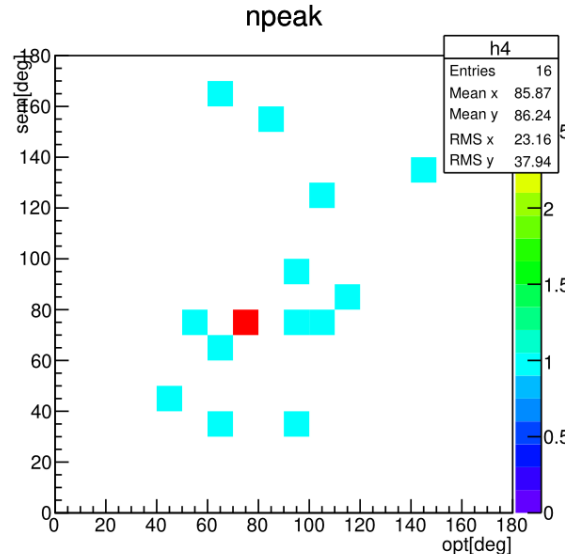
One possible reason is definition of SEM manual measurement (effect of filament tail)

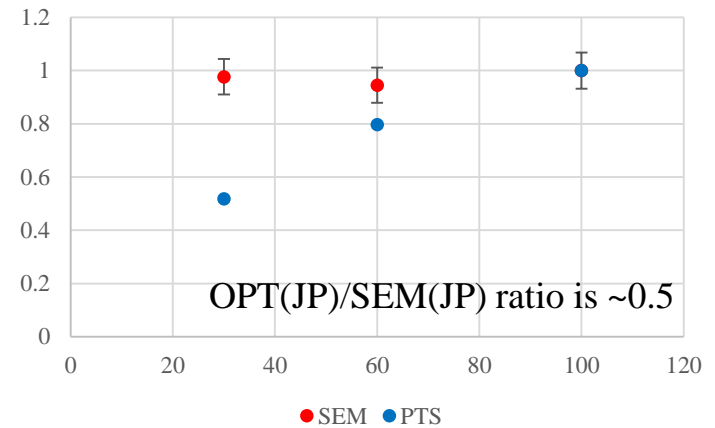
Old measurement in Japan-PTS

detected event density ratio
respect to 100 keV sample

Absolute value is not good due to dust, cluster event, etc.
Japan has low contrast at lower energy tracks

P: detection efficiency of 1 crystal
 $1 - \Sigma(P^n)$: possibility of no crystal detected
