# ILC E-driven e<sup>+</sup> source

## Rotation Target design and R&D

**T. Omori, 4-Sep-2018**

**POSIPOL 2018, Sep 3rd - 5th, 2018  
CERN, Geneva, Switzerland**

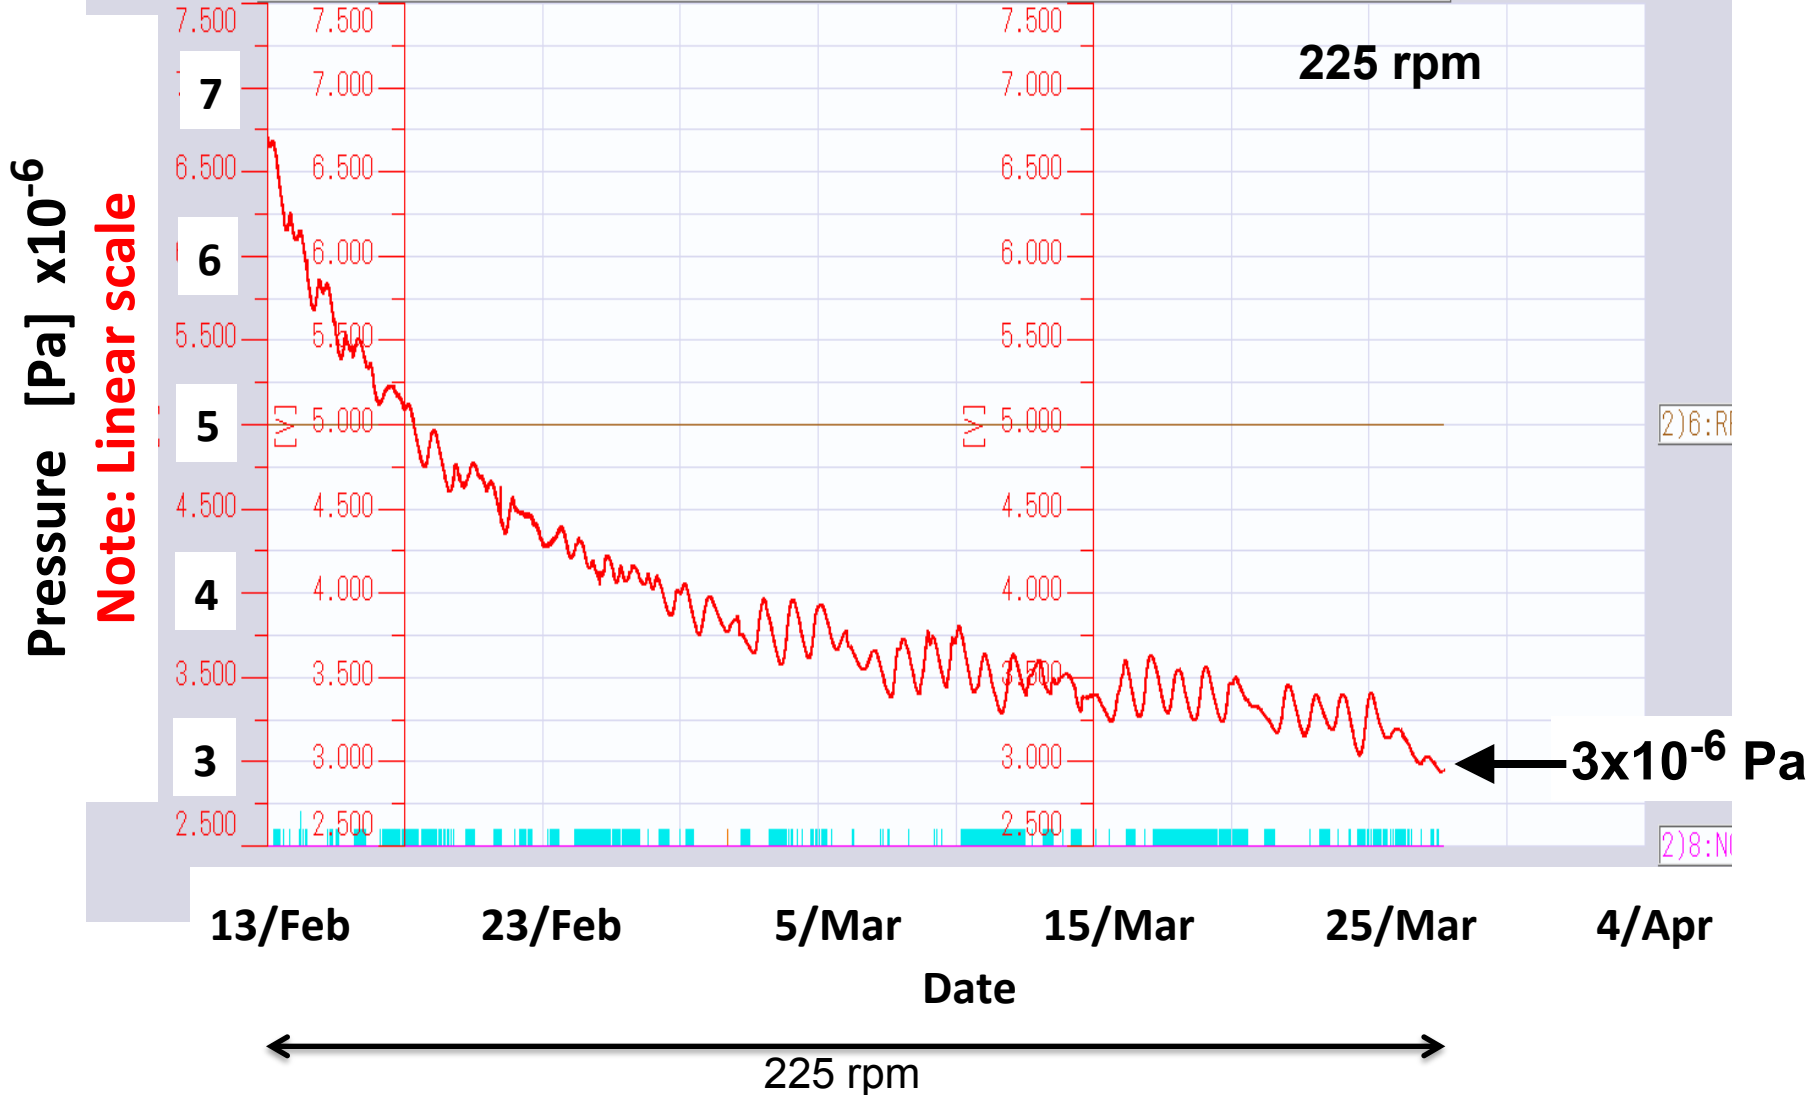
# Central Part Prototype Vacuum Test

February/13 – March/28, 2017

- Ion pump 100 liter/sec.
- Rotation at 225 rpm (value).
- We started the experiment on February 9<sup>th</sup>, 2017.
- Vacuum level went good monotonically.
- And reached  $\sim 3 \times 10^{-6}$  Pa at the end of March.
- Vacuum level was stable at  $\sim 3 \times 10^{-6}$  until April 10th.
- **Then, we observed small spikes.**
  - Height of a spike  $\sim \times 1.5$ .

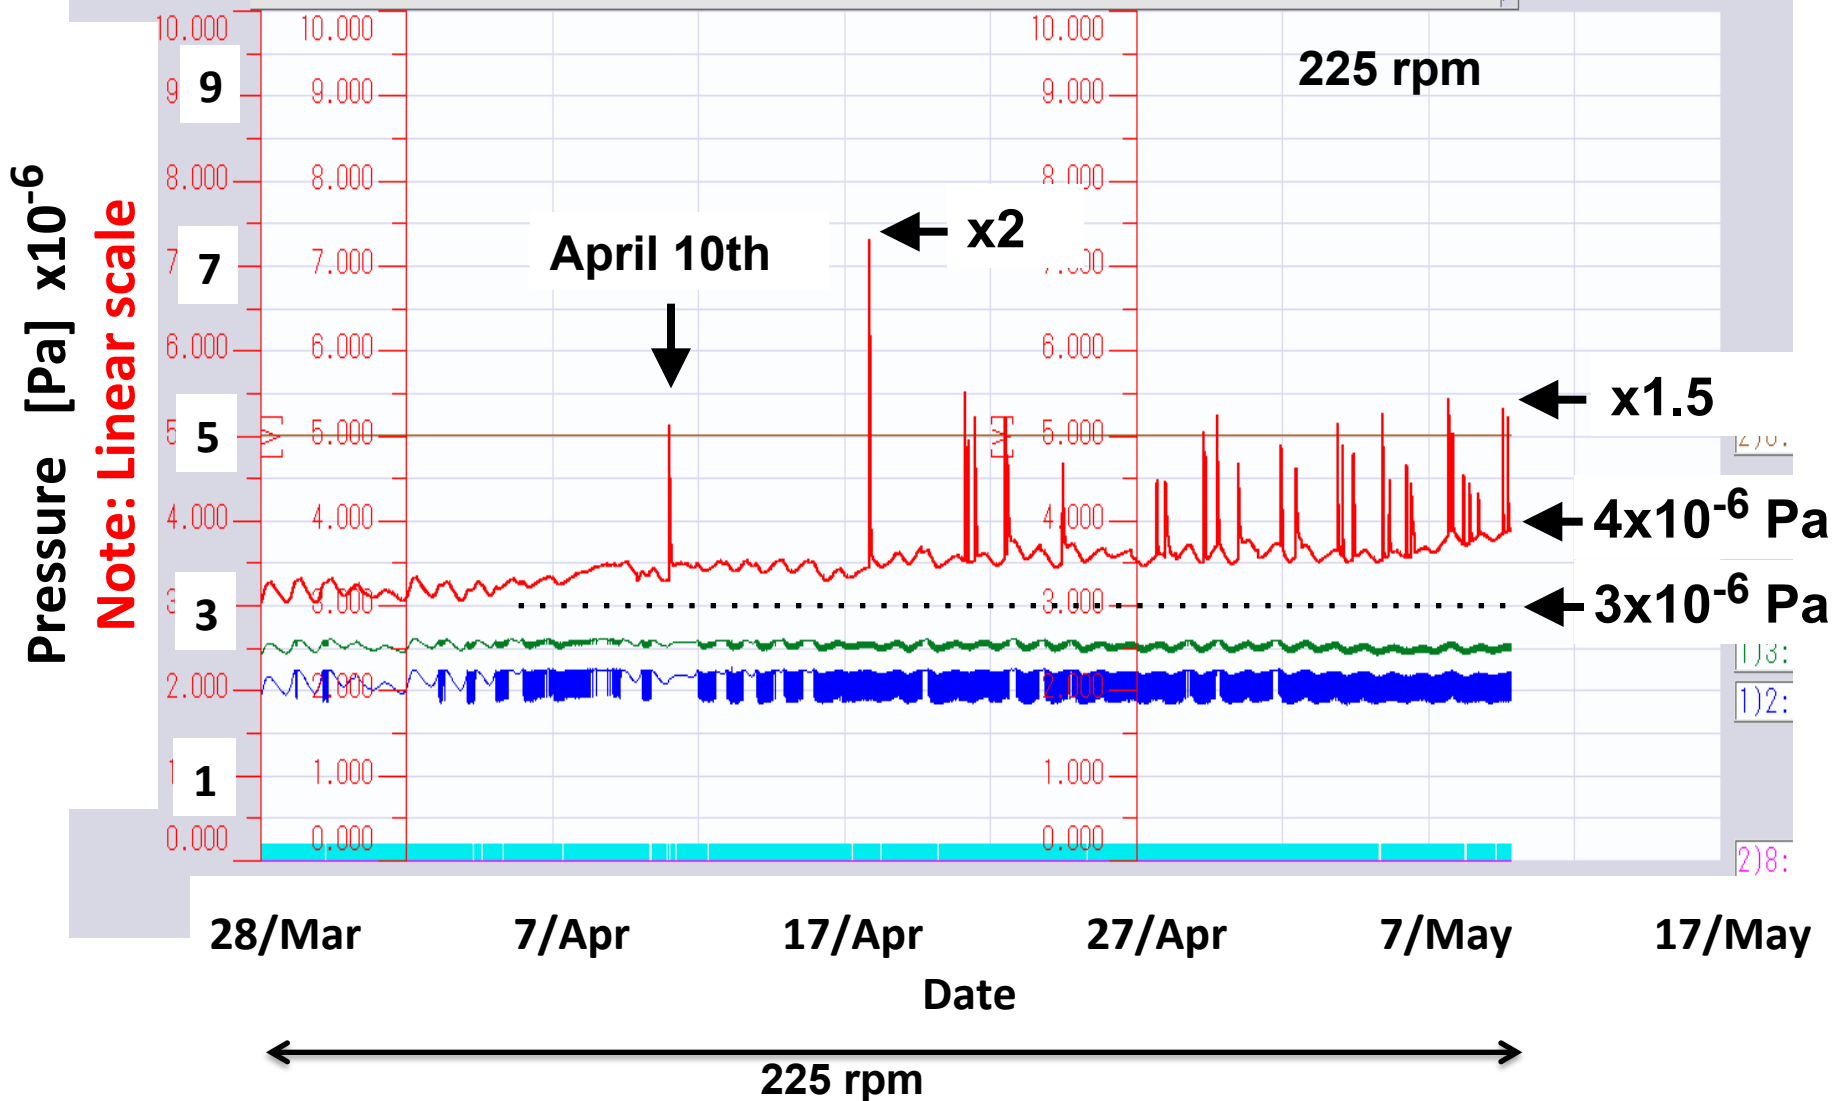
# Central Part Prototype Vacuum Test

Small spikes (x1.5 – x 2) were observed

March/28 – May/09, 2017

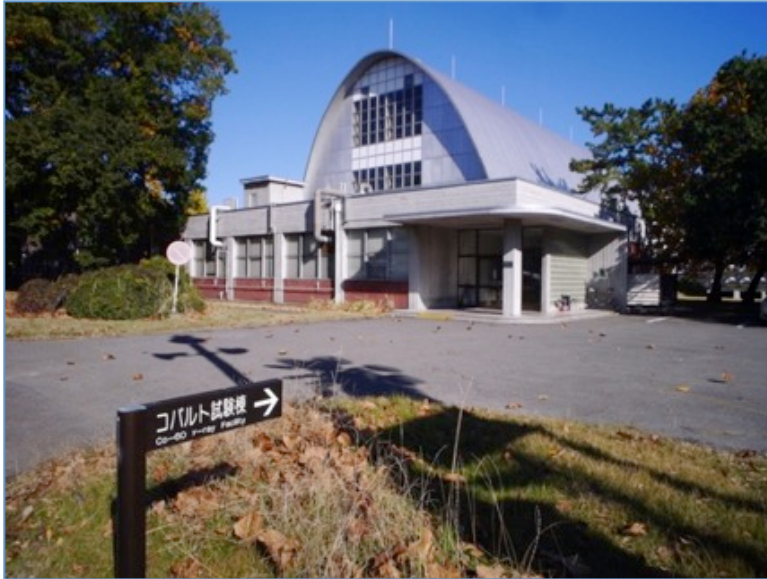
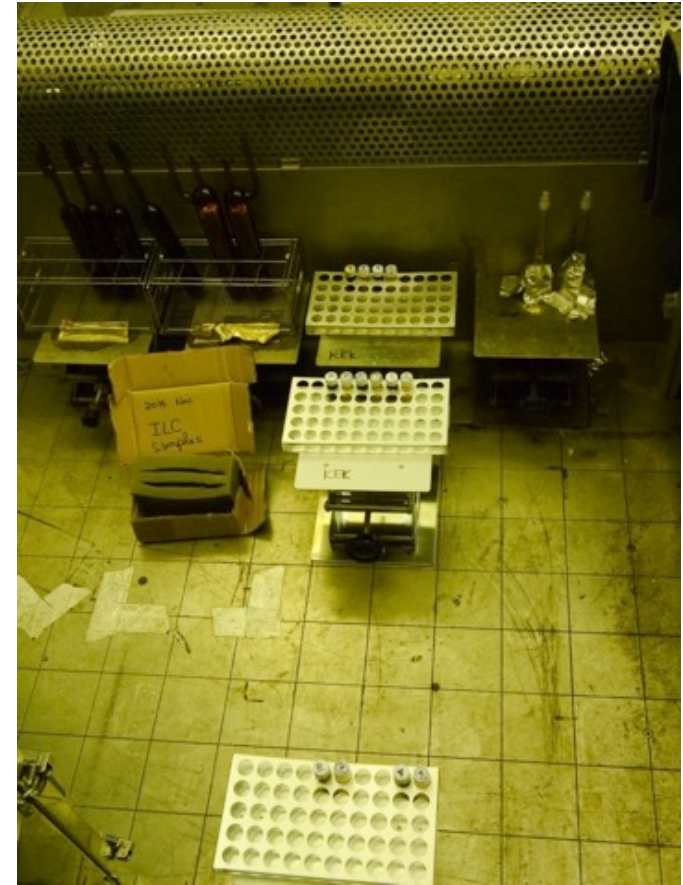
- The seal dosed up to 4.7 MGy (3 ILC year , 2600 bunch) is examined.
- Rotation : 0-600 rpm.
- **No leak was found. GOOD!**
- **But, viscosity increased.**

## (1) The ferrofluid dosed 4.7 MGy (3 ILC year, 2600b)

We used the ferrofluid in a small target. Rotation : 0-600rpm.

**No leak was found. GOOD!**

But, viscosity increased, and we need to know the cause.

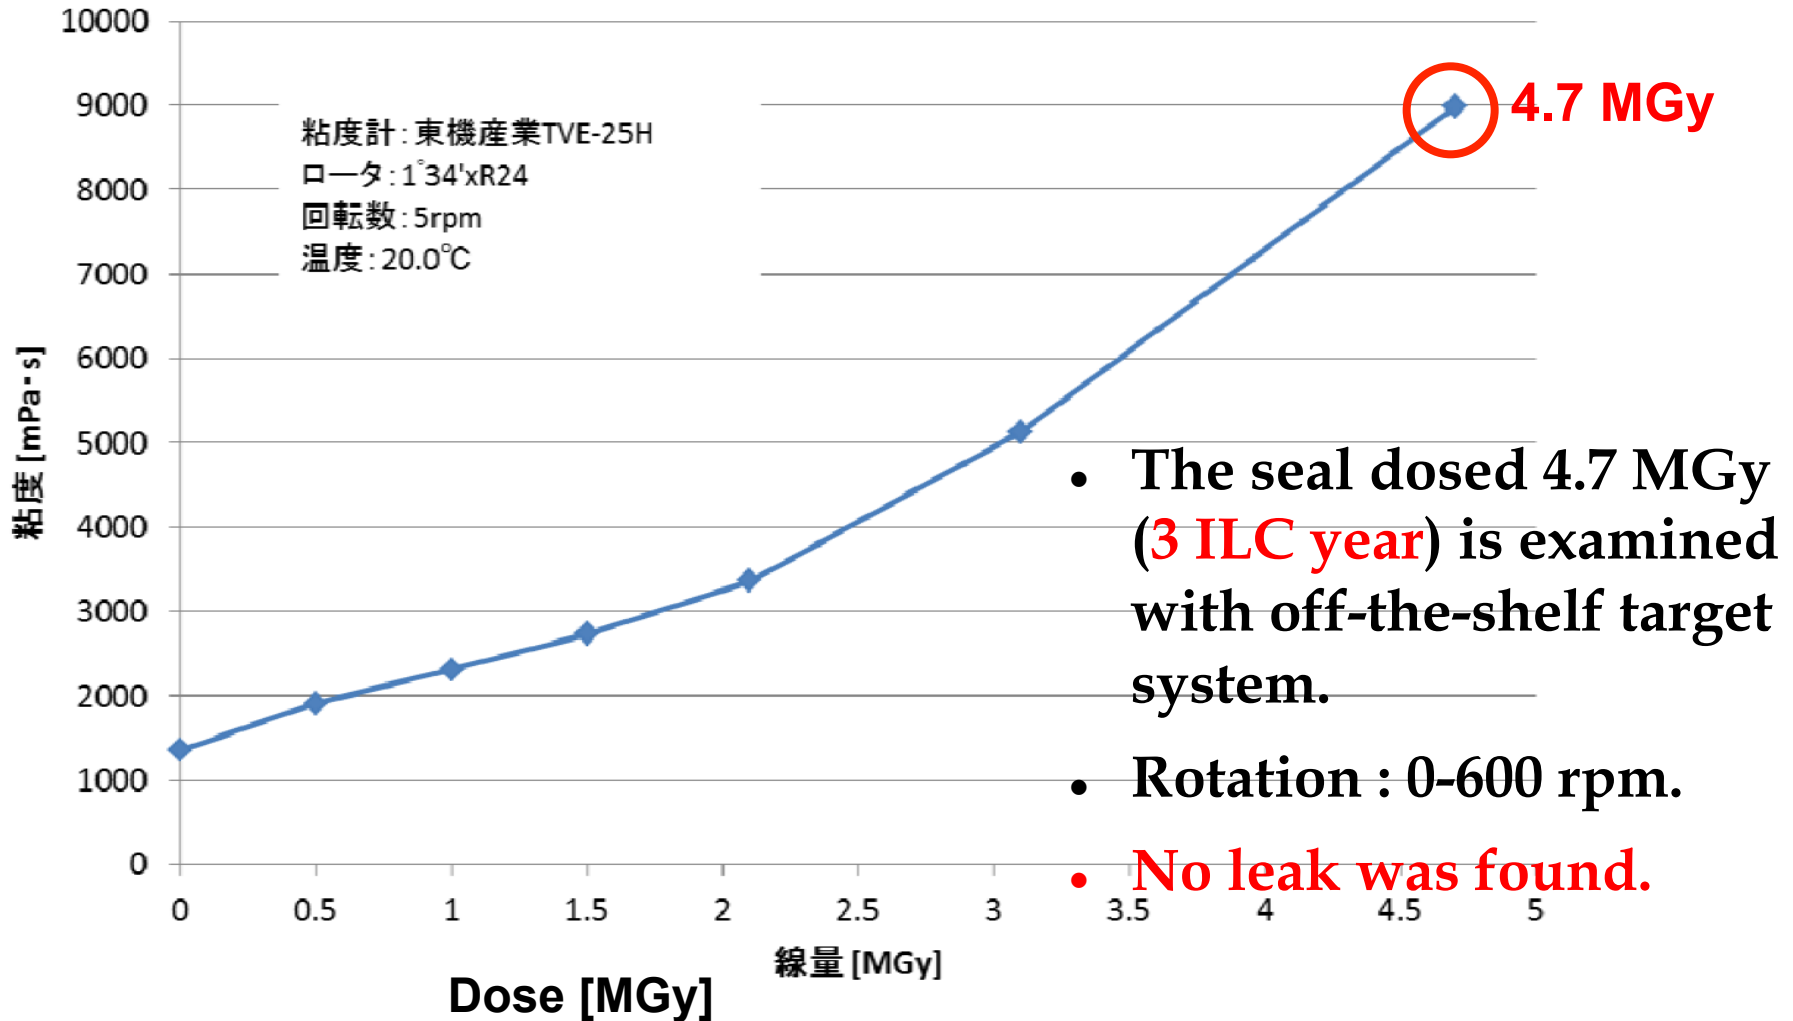
### Viscosity as a function of dose

## More systematic study for CN oil

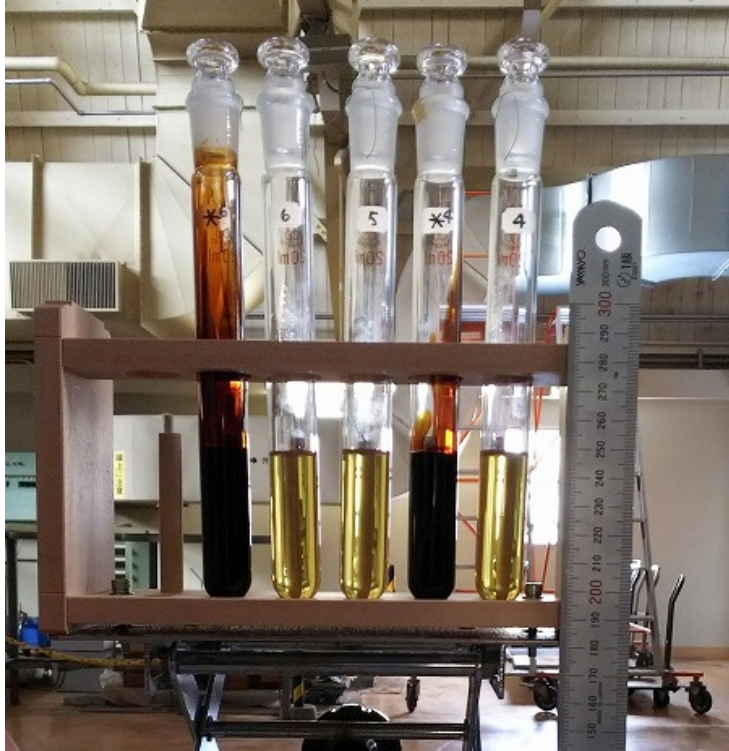
# New Radiation Test: Feb 2018 and Summer 2018

**Radiation tests with monocular structure analysis  
by GPC and UV-Vis methods are on going.**

**GPC: Gel Permeation Chromatography**

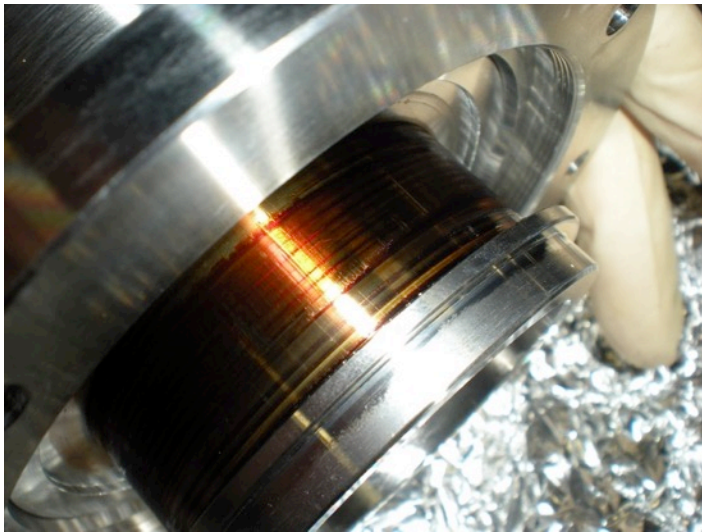
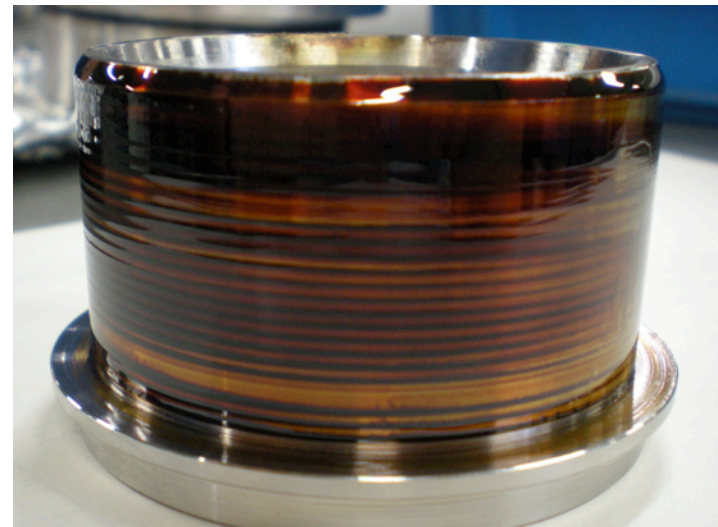
- We opened the chamber of the prototype on 19<sup>th</sup> July.  
And observed inside by eyes.
- No damage of the fluid was observed by eyes.  
Even small amount of disappearance of the fluid was observed.

If there is evaporation, we will see powders of dried fluid.

- Before the opening, we expected to see the powders at some stages of the seal (seal has 20 stages in total) near the vacuum.  
But we observed healthy fluid even at the inner most stage.
