# Higher power couplers at Helmholtz-Zentrum Berlin

## BESSY VSR and bERLin Pro

Emmy Sharples  
05.06.2018

World Wide Fundamental Power Coupler  
meeting #4, CERN, June 5-6, 2018.

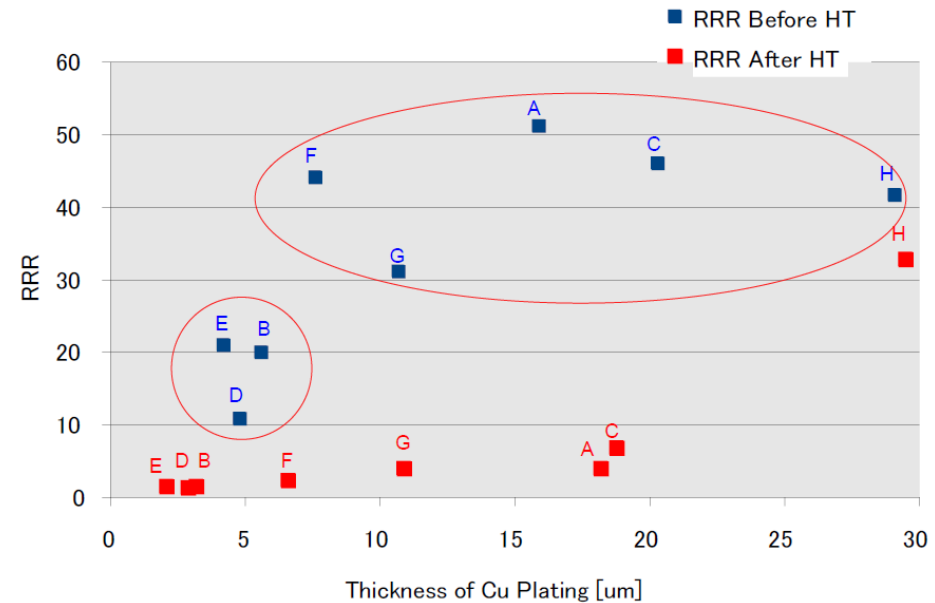
Sample 1	After Brazing (780°C)
RRR (Steel + Cu):	2.3
RRR (Steel):	1.43
RRR (Cu):	7.4 (calculated)

Sample 2	Before Brazing
RRR (Steel + Cu):	8.6
RRR (Steel):	1.43
RRR (Cu):	36.4 (calculated)

- Samples consistent with work from E. Kako
- Scotch tape samples taken from the sample.
- No separation of the coating was seen

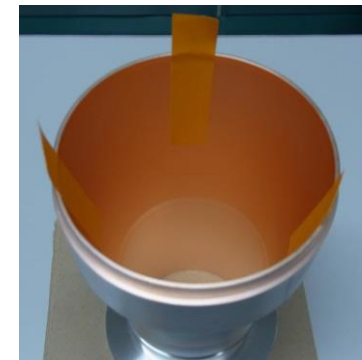
# Coating analysis

- Samples were cut from the test assembly to verify the braze and copper coating.
- Braze between parts fully wets the join and appears to have no inclusions

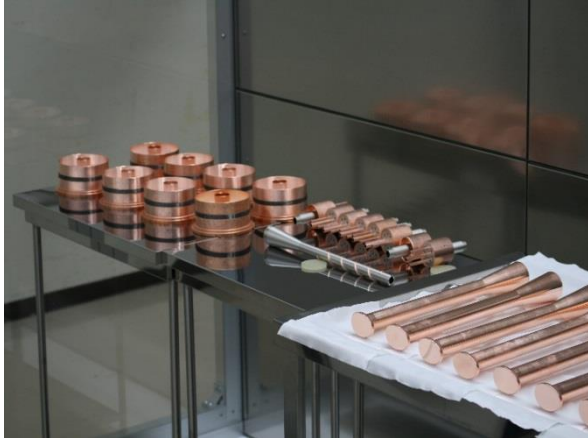
Coupler tips outer

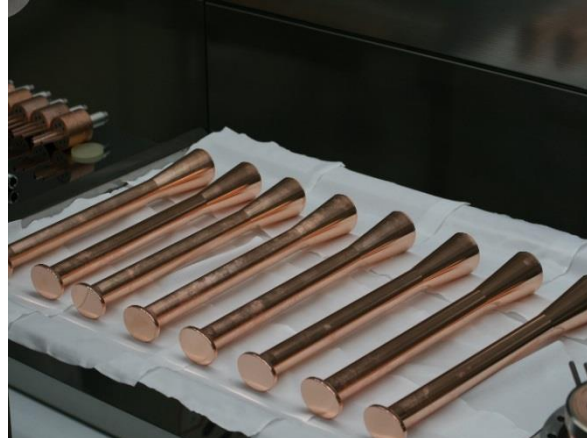
Warm to cold transition flange

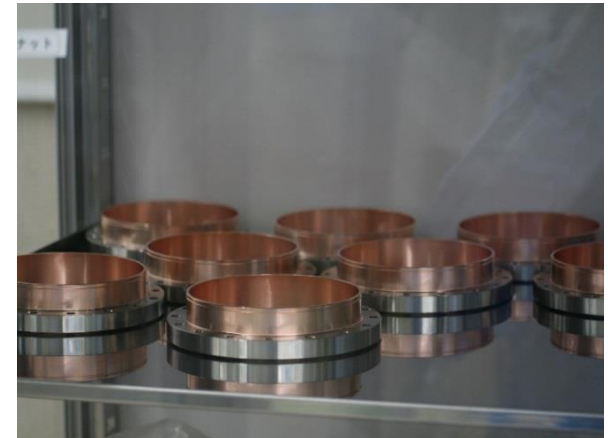
All parts of cold part manufactured and awaiting final braze.

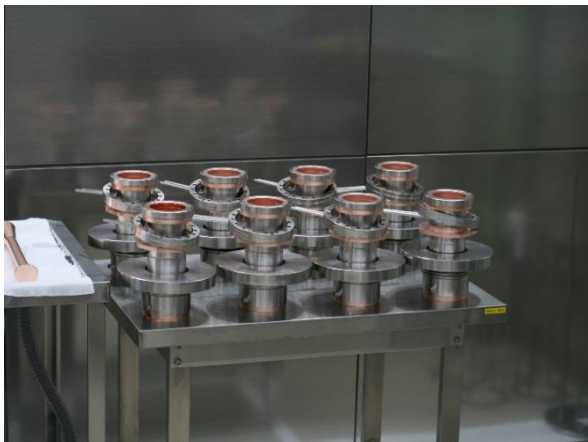
Outer conductor including cavity flange (including cooling)

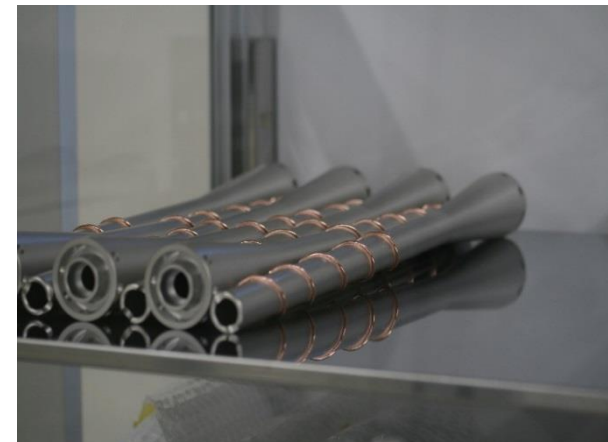
Coupler tips inner part showing cooling channels
