Status of MQYYM

Helene Felice for the MQYYM team

History of MQYY development

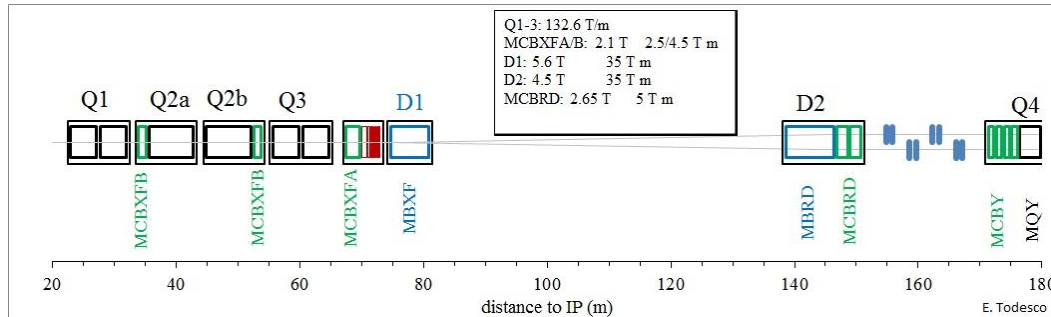
Q4 is the LHC MQY, double aperture quadrupole with 70 mm aperture

Layout of the magnets close to the interaction point

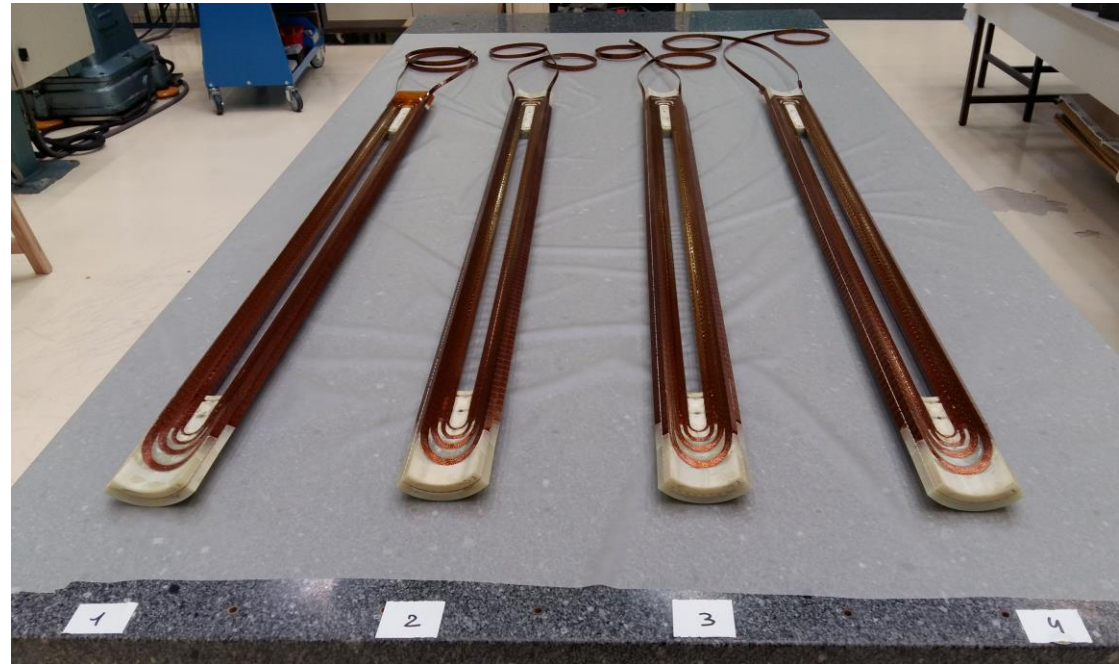
Coil Fabrication status as of Nov 2017

Fabrication dates
Coil 0	22/03-27/04/2017
Coil 1	17-31/07/2017
Coil 2	4-14/09/2017
Coil 3	15-29/09/2017
Coil 4	23-31/10/2017

- Initial plan in agreement: 10 coils
- Cable at CEA for 10 coils
- End parts manufactured for 8 coils (coils 0 to 7)
- 5 coils made: coil 0 + coils 1 to 4

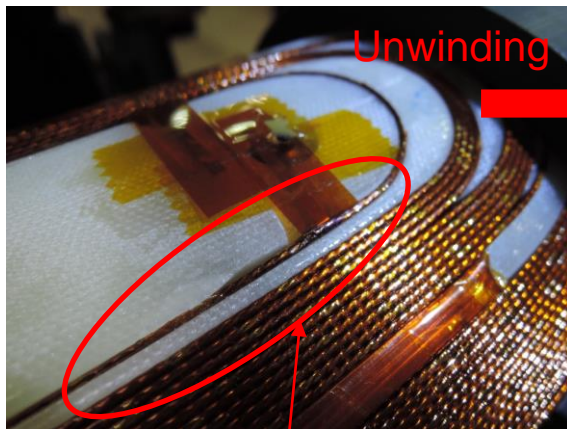
Layer jump is mispositionned
G11 seems weakened locally

- At QA step: notice an issue with the layer jump
- Decision to unwind layer 2
- Damaged insulation repaired and layer rewound

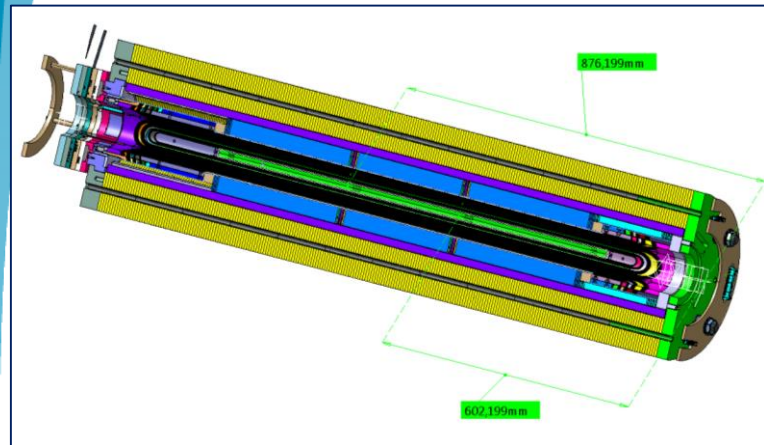
- Wiring diagram for pigtailed in preparation
- Agreement that
 - CERN is taking care of everything from SG to instrumentation plate
 - CEA takes care of everything from Instrumentation plate to HBM DAQ

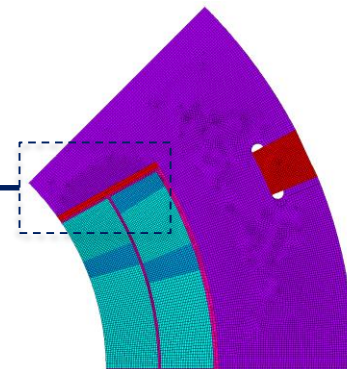
Introduction of slits (thank you N. Bourcey)

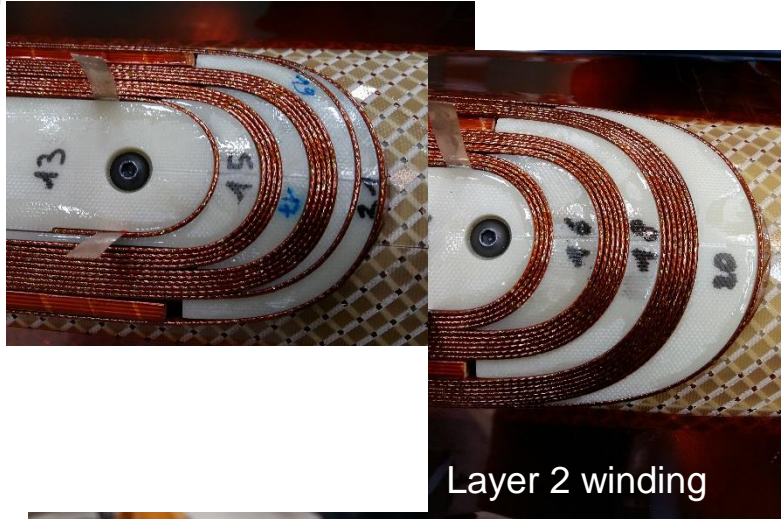
Layer 2 winding

- Good matching of the coil parts with the winding
- **CuBe Broken flags** after polymerization
=> Require smoothing of the sharp edges to avoid damaging the flags
- Impulse test showing change of frequency as V increases
=> Turn to turn weakness?
=> likely due to the weld of the vtaps using Tin Indium solder (fusion T < polymerization T!)

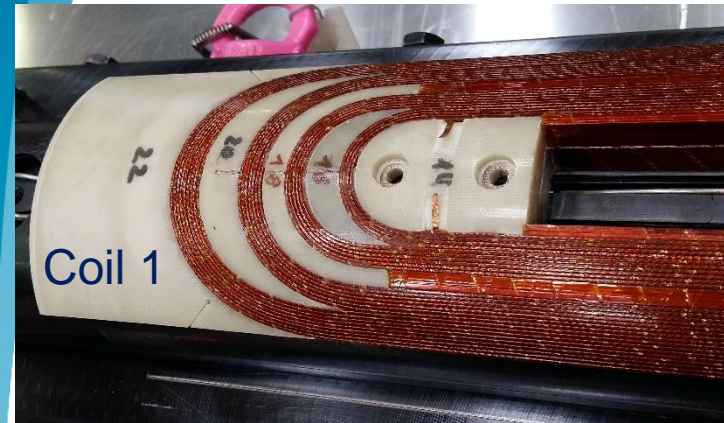
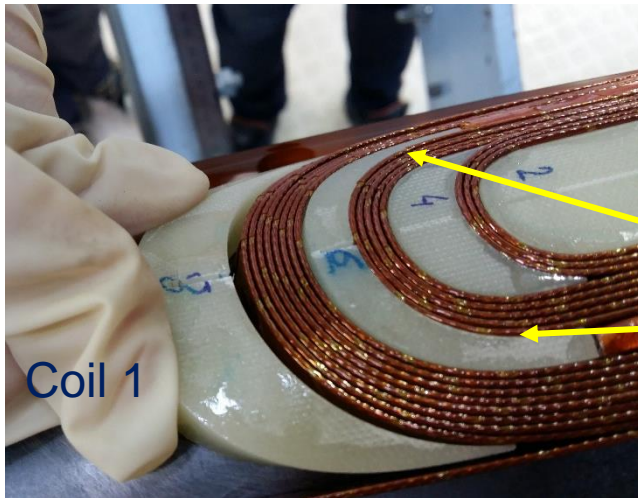
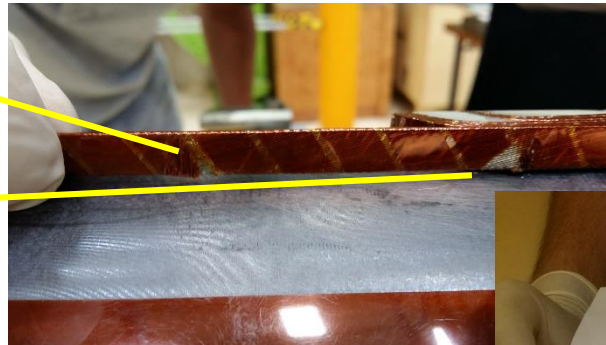
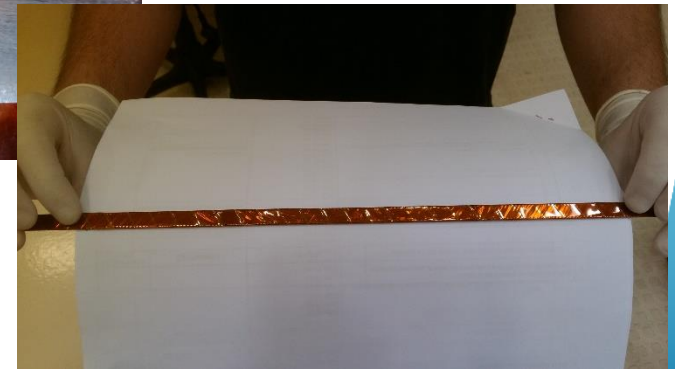
Coil 1

- Vtaps:
 - narrower CuSn_6 flags and SnAg solder
 - Grooves added in the end part
- **Slit** in some of the spacers, filled with G10 pieces before polymerization
- Finalization of procedures for insulation of angular wedges

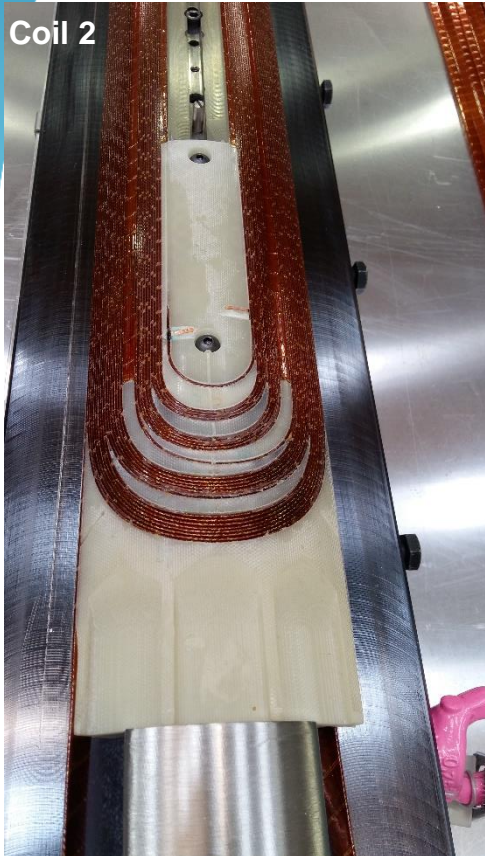
Coil 2 to 3

- No major issue during coil fabrication of coil 2 and 3
- Concern on vtap flags: grooves are not deep enough => some compression of the taps

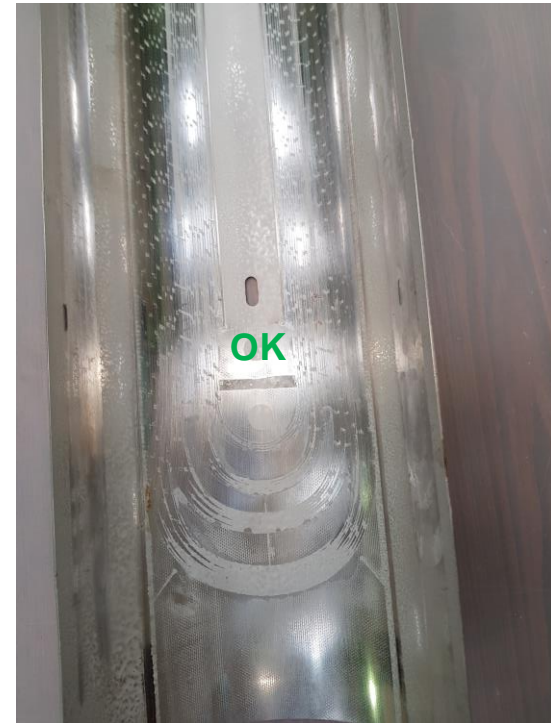
Coil 4

- Vtaps/endpart groove problem solved
- But :
- Unglued turn on the outer layer => adhesive missing? Unexpected cleaning?
- gap in the last but one turn in the RE IL: investigation ongoing. Last turn winding tension relaxation after lead cutting is suspected

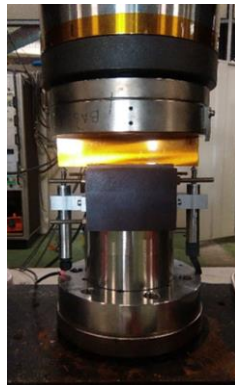
Stack size	Avg Rigidity (GPa)
NS - 0.1 mm	7.3
NS	7
NS + 0.1 mm	6.9

Cross-check ongoing at CERN
+ at cold
+ creep (change of dimension under constant compression)
+ stress relaxation (change of compression under constant dimension)

Stack of 18 conductors cured at:

- Nominal size
- NS - 0.1 mm
- NS + 0.1 mm
