Status of Laser Cleaning and Polishing, Sample Characterisation

Arturs Medvids, Pavels Onufrijevs,
Jevgenijs Kaupuzs

31.08.2018

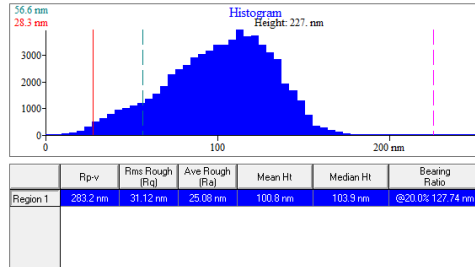
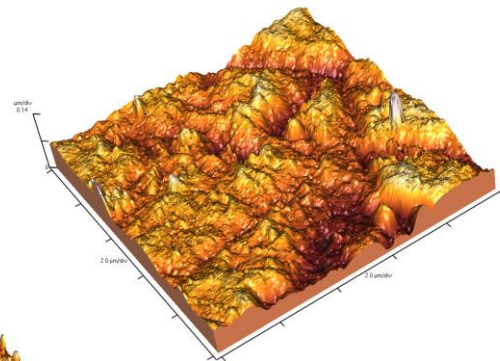
L8

(255,254) x: 9.96 μm y: 9.922 μm z: 0.1364 μm

Sample	Ra	Ra by AFM in RTU
SUBU5 CERN (C10)	126 ± 15 nm	9 nm
SUBU5 INFN (L20)	197 ± 98 nm	9 nm
EP (L21)	233 ± 66 nm	12 nm
EP+SUBU5 (L16)	192 ± 64 nm	13 nm
Tumbling (L8)	207 ± 53 nm	25 nm

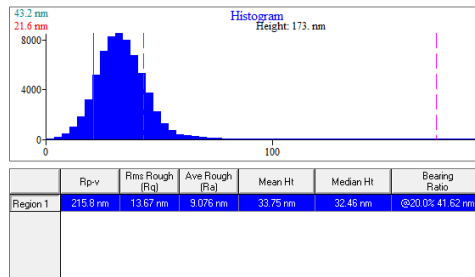
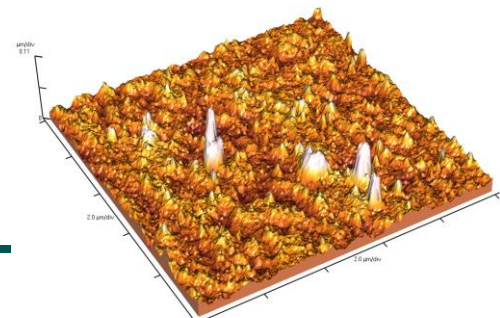
C10

(252,256) x: 9.84 μm y: 10.00 μm z: 0.5623 μm

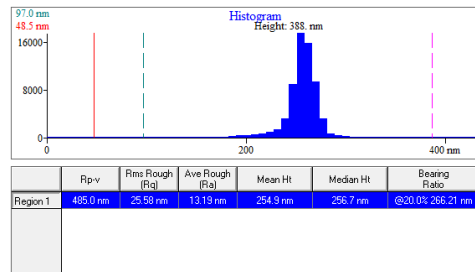
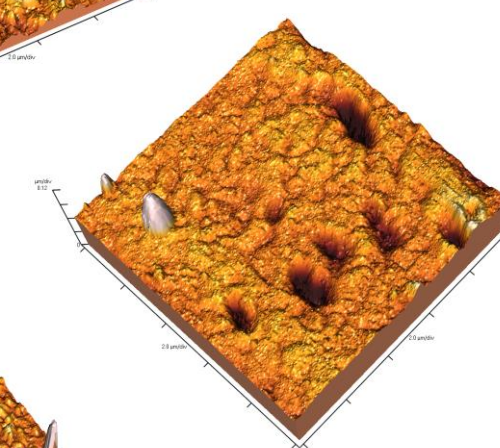
L16

(253,254) x: 9.88 μm y: 9.922 μm z: 0.2427 μm

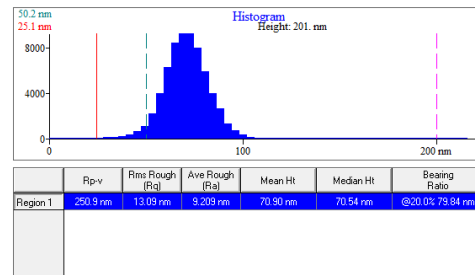
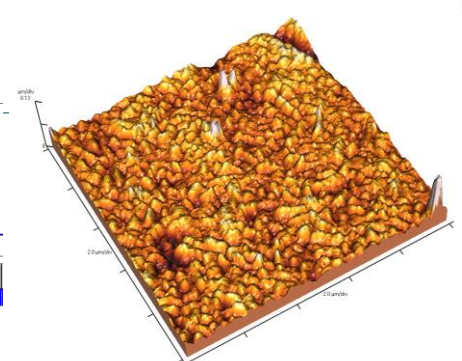
L20

(254,2) x: 9.92 μm y: 0.07813 μm z: 0.07094 μm

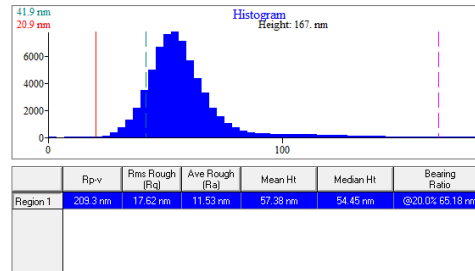
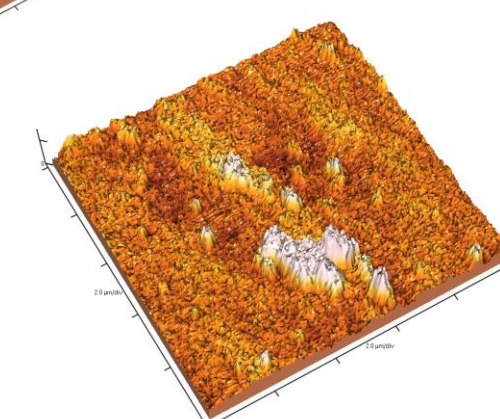
L21

(252,256) x: 9.84 μm y: 10.00 μm z: 0.7158 μm

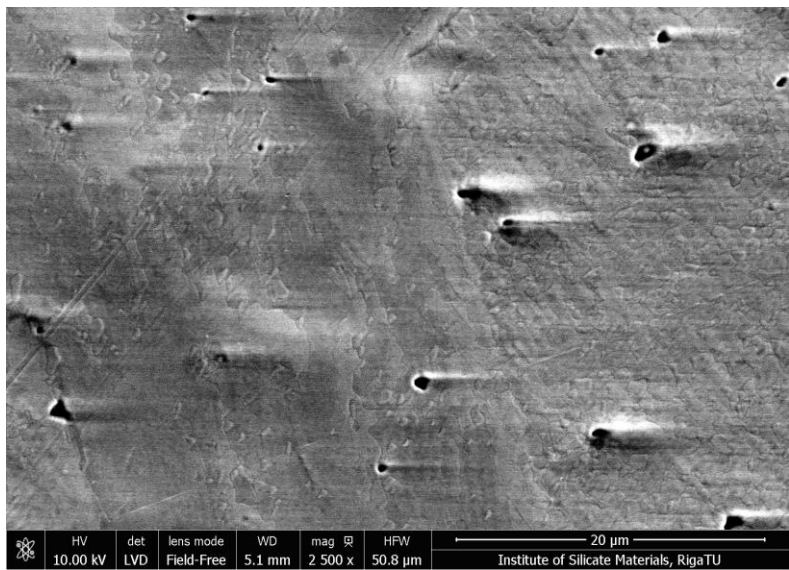
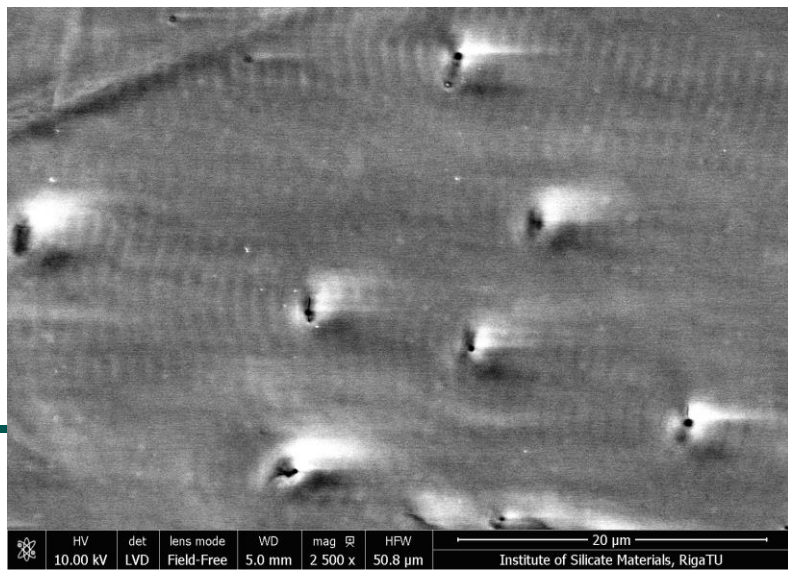
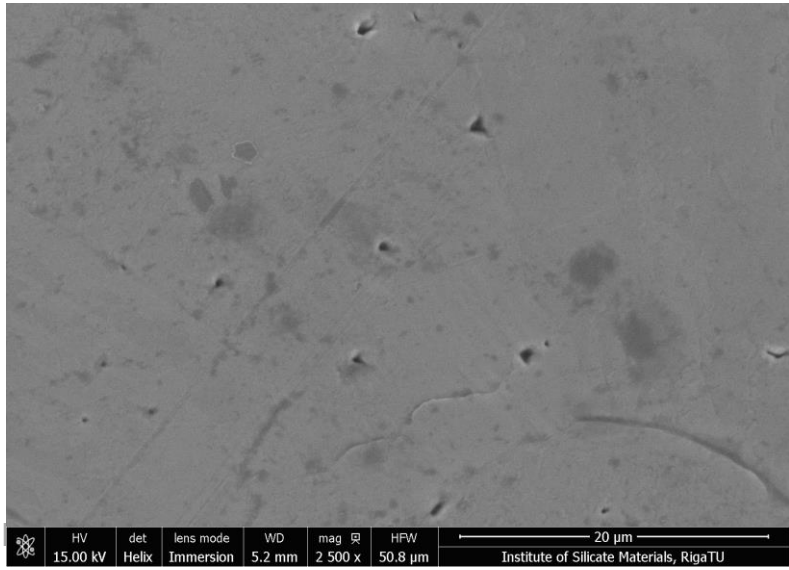
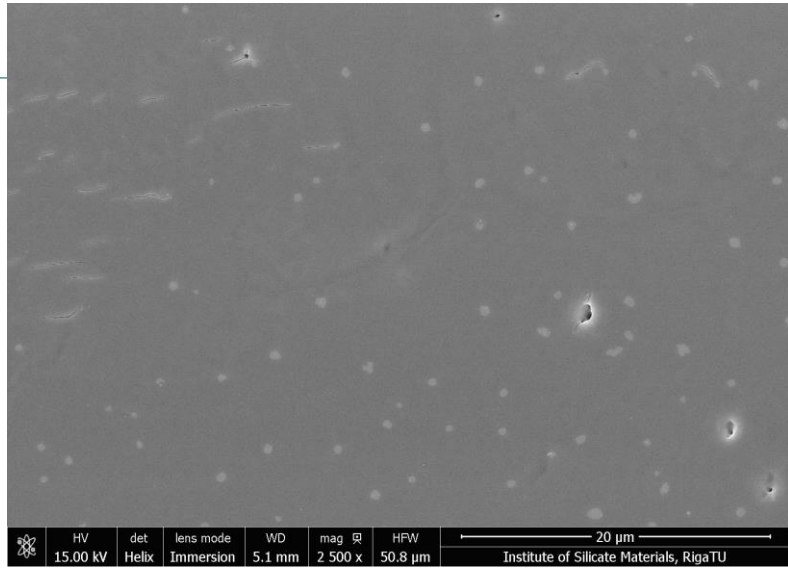
Lens mode: Field-Free

Lens mode: Immersion

Non-irradiated

Irradiated by Nd:YAG laser

1. Typical for Nb/Cu samples (C10, L16) is the presence of pinholes with size up to 500 nm.
2. Only for the sample L8 the surface is characterized by chaotically distributed scratches with length up to 10 μm .
3. For the sample L21 the pinholes are longitudinal and orientated with length up to 5 μm .
4. After irradiation by pulsed Nd:YAG laser ($\lambda = 1.064 \mu\text{m}$, $\tau = 6 \text{ ns}$ and intensity up to $I = 200 \text{ MW/cm}^2$) in scanning mode with step $5 \mu\text{m}$ in Ar atmosphere for the samples C10, L8, L16, L20, L21 longitudinal pinholes fully disappeared and appeared periodical structure - Laser-Induced Periodic Surface Structures (LIPSS) with period 1 μm and amplitude up to 5 nm.
5. After irradiation by laser, the surfaces became smoother, but with cracks up to 5 μm length. Pinholes and cracks in the sample L21 fully disappeared.

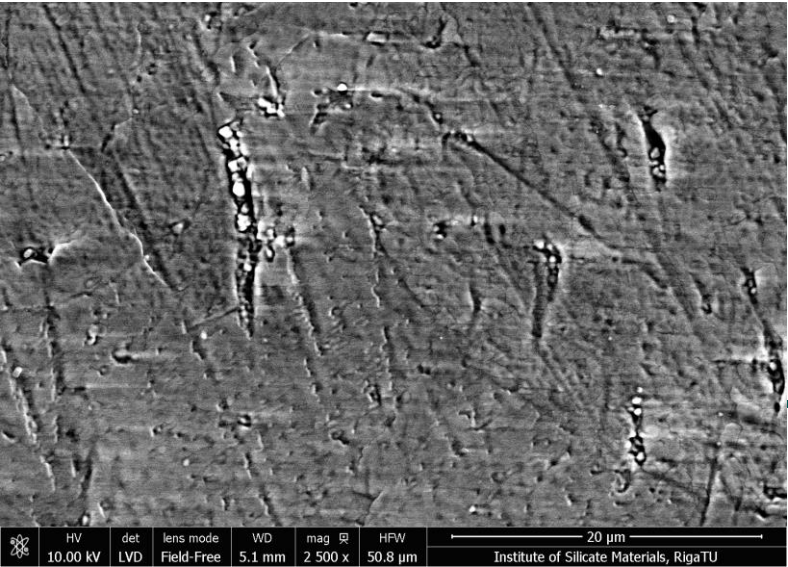
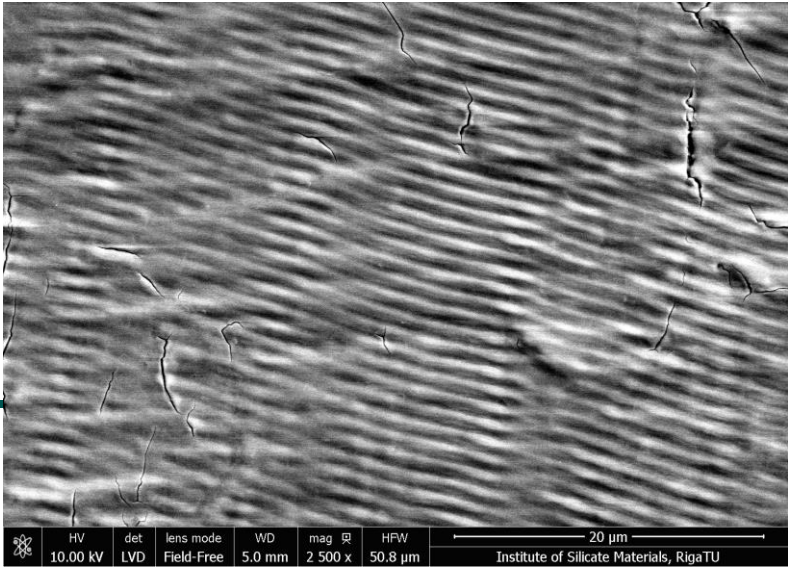
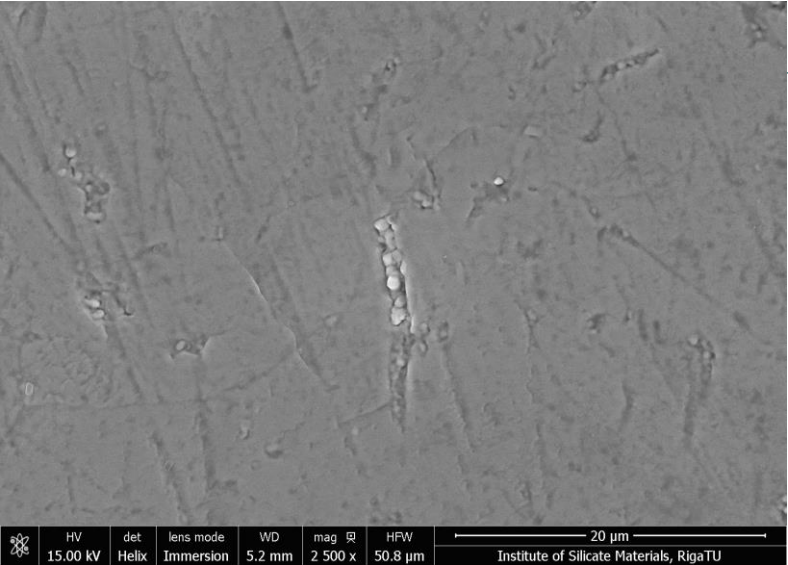
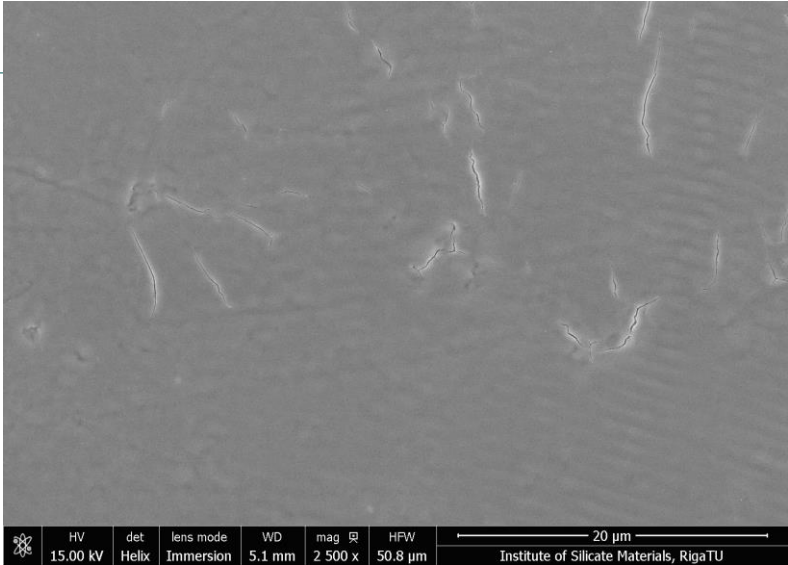
Lens mode: Field-Free

Lens mode: Immersion

Non-irradiated

Irradiated by Nd:YAG laser

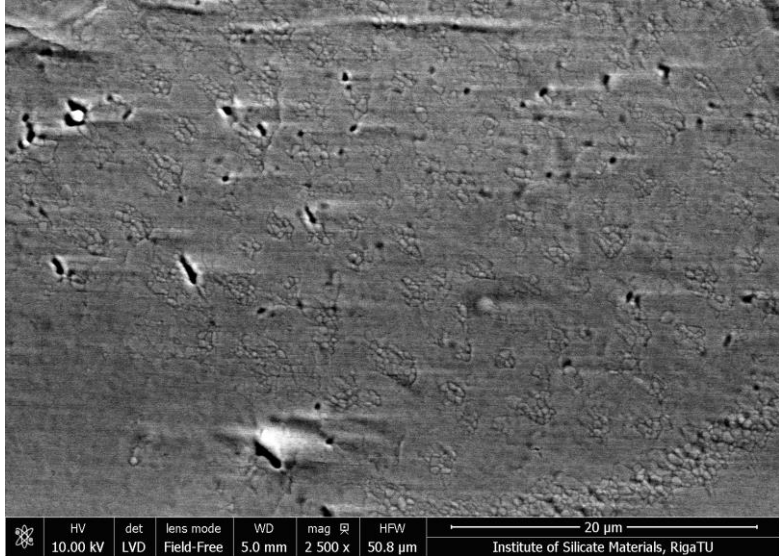
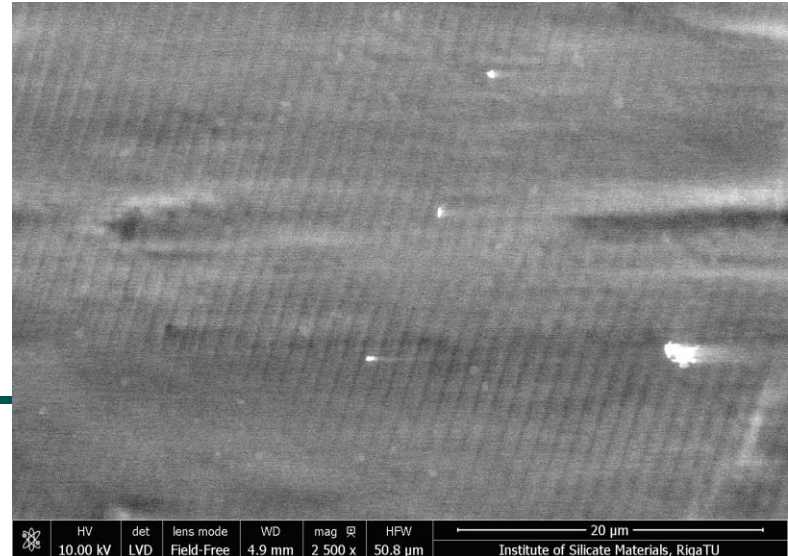
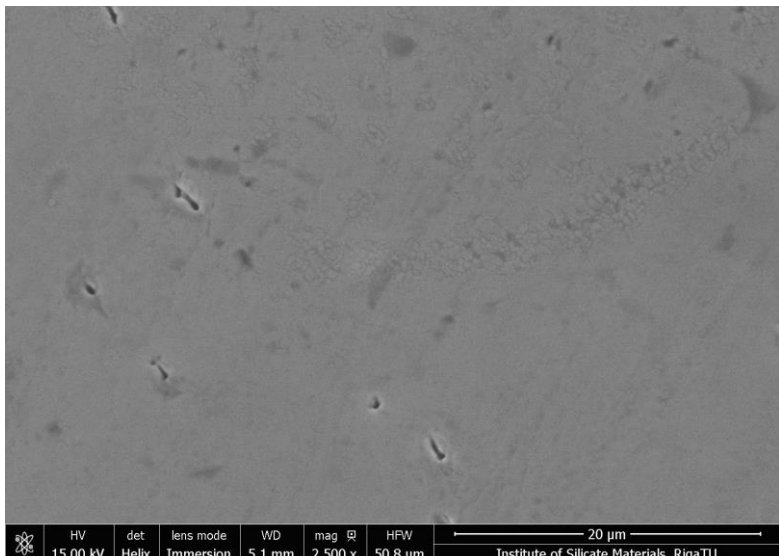
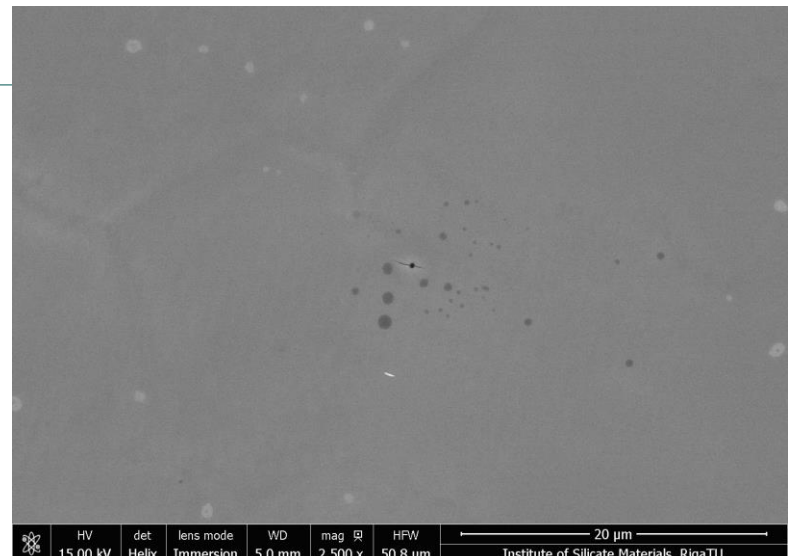
Lens mode: Field-Free

Lens mode: Immersion

Non-irradiated

Irradiated by Nd:YAG laser

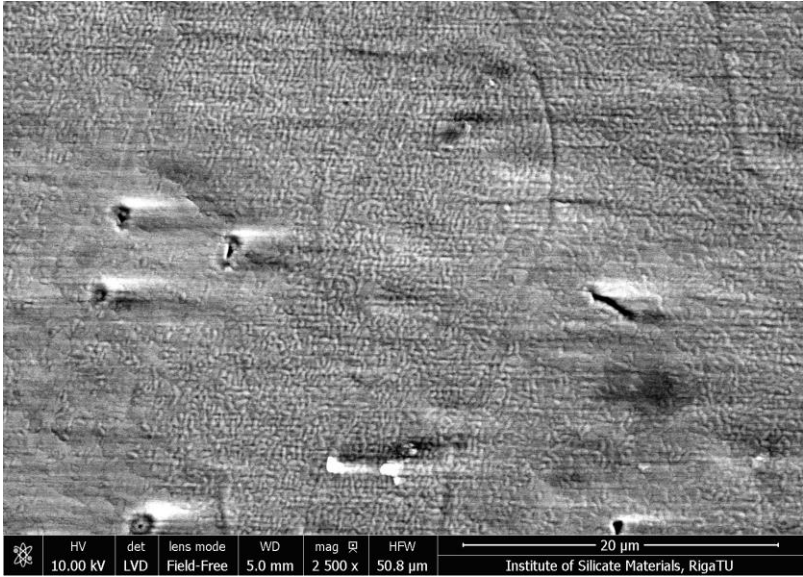
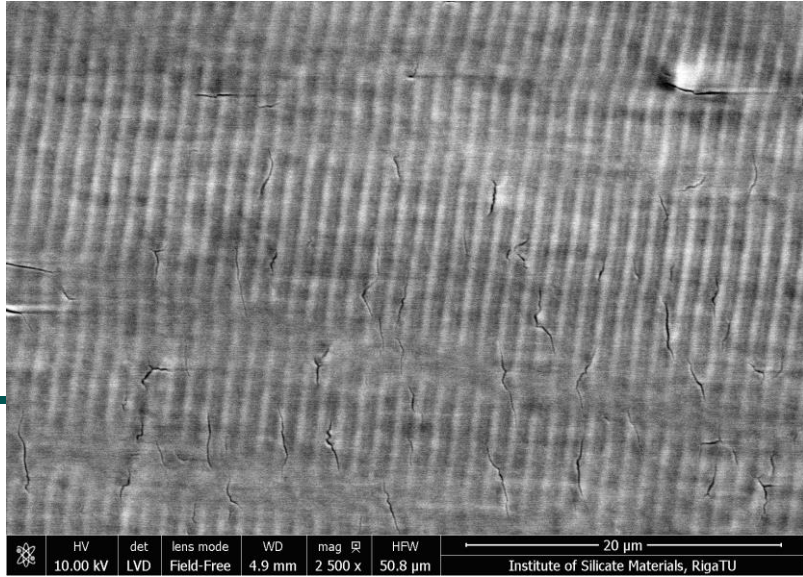
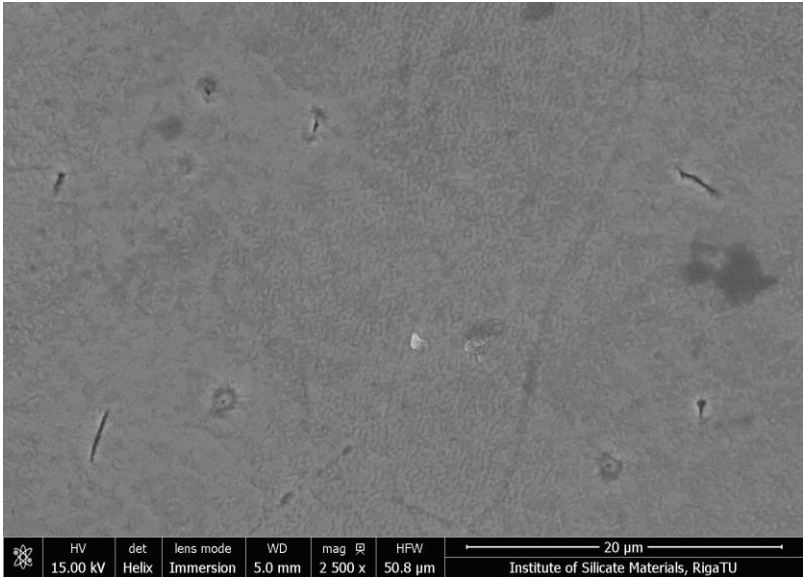
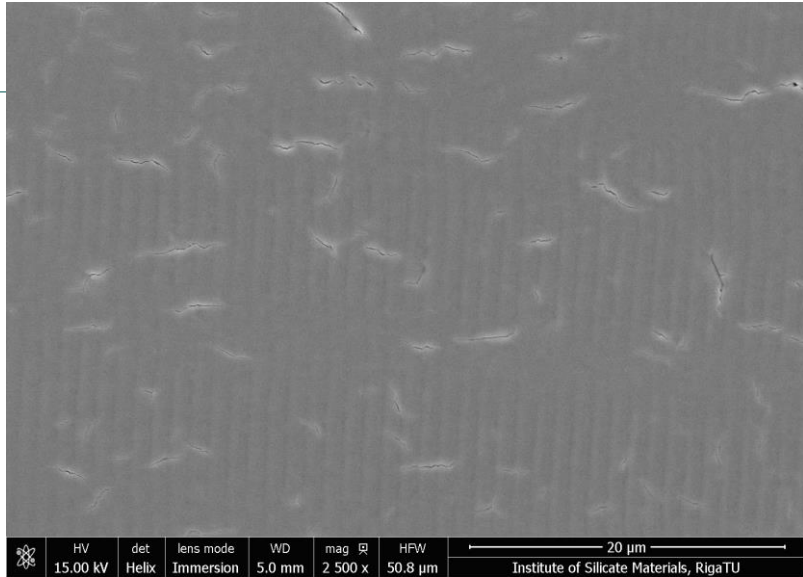
Lens mode: Field-Free

Lens mode: Immersion

Non-irradiated

Irradiated by Nd:YAG laser
