Status of RF characterisation facilities: The HZB quadrupole resonator

Oliver Kugeler 6th WP15 ARIES meeting 31.08.2018

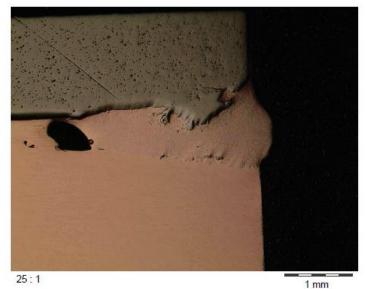
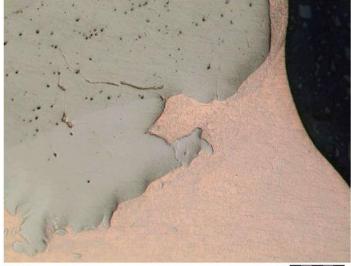
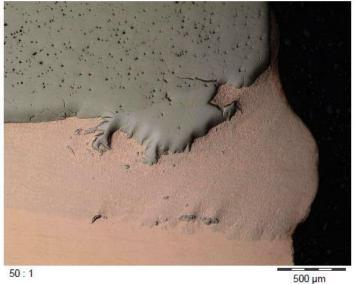
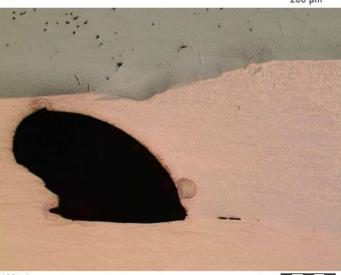
Test welds Nb to Cu before etching, welding performed at RI

100:1

50:1
