# SLAC Status in Accelerator Structures Production and Analysis of Structure Changes after High Power Tests

Juwen Wang

4<sup>th</sup> X-Band Structure Collaboration Meeting

March 5, 2010

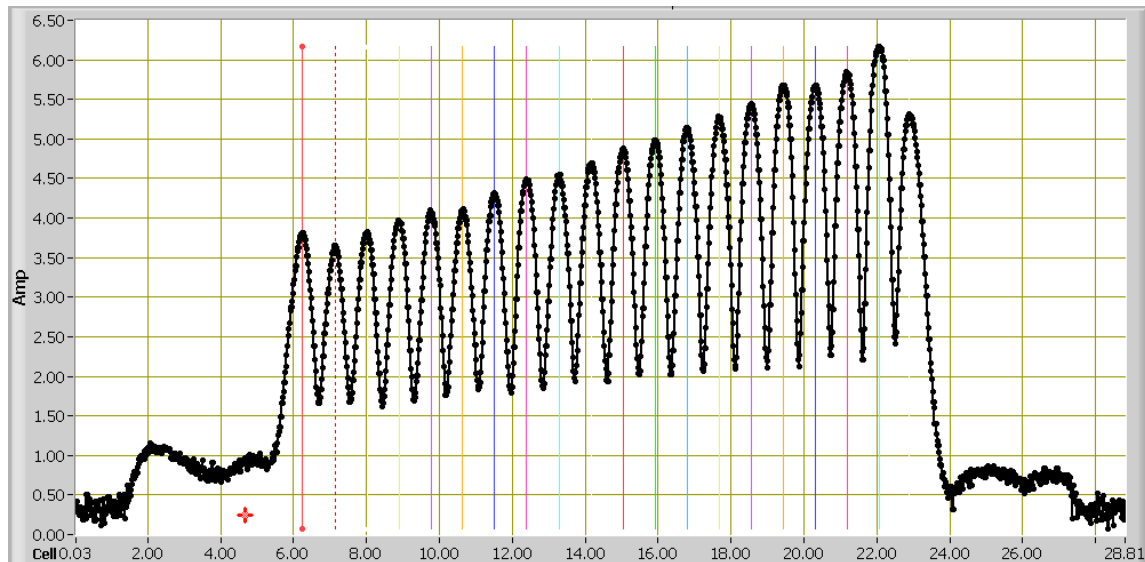
11421.7 MHz at 21.1 C, N2  
Before high Power test at SLAC

- From the Standing wave pattern, the output part and some cells were “damaged”.
- In general, there was a 1MHz frequency increase of  $2\pi/3$  mode at similar operation conditions. In another words, the cumulated phase drift was about 15 at frequency at similar operation conditions
- The total high power test time was 4000 hours, is it a reason to cause more “damage” in comparison with T18-SLAC?

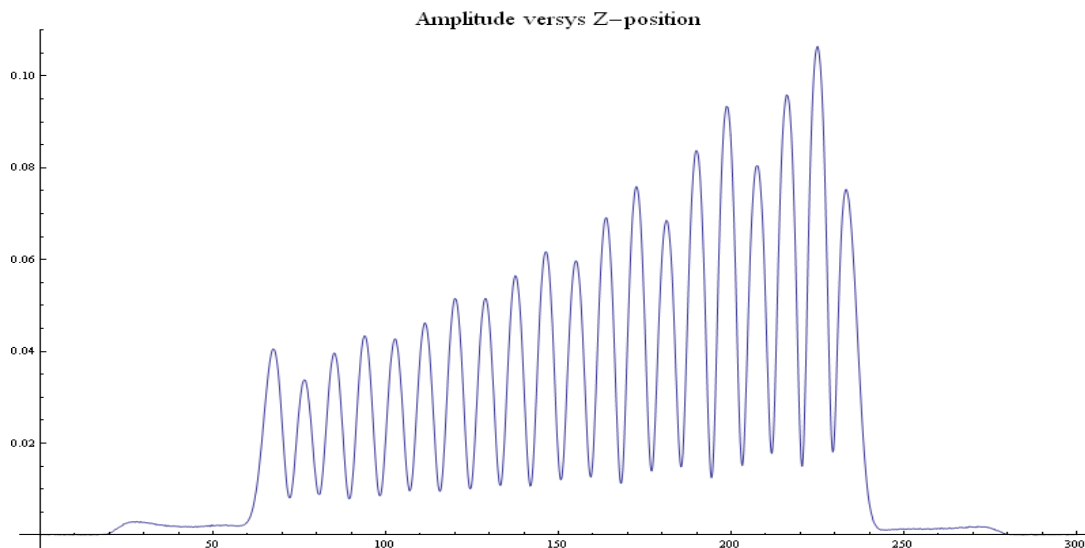
11422 MHz at 21.1 C, N2  
After high power test at KEK  
by Toshi

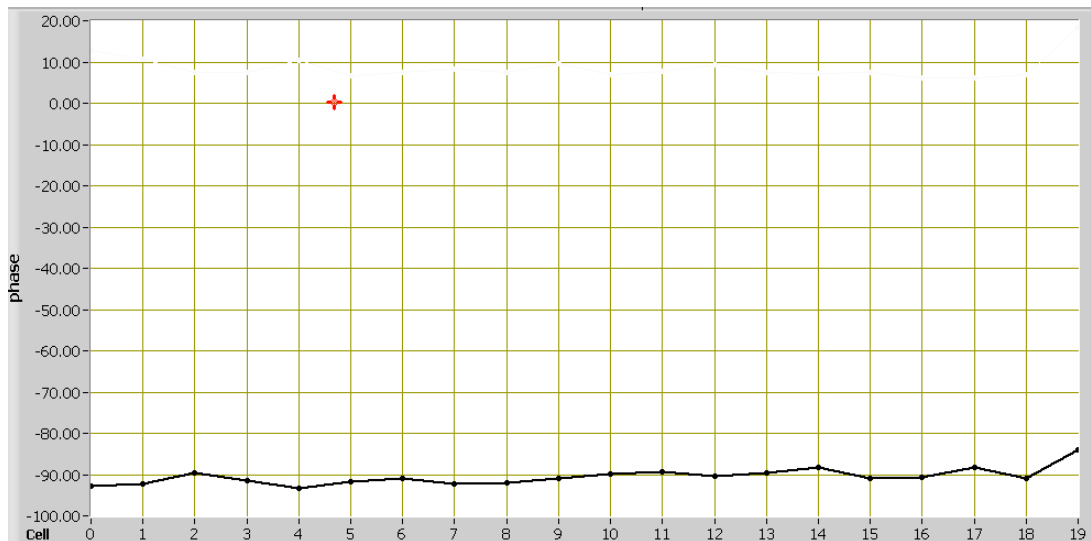
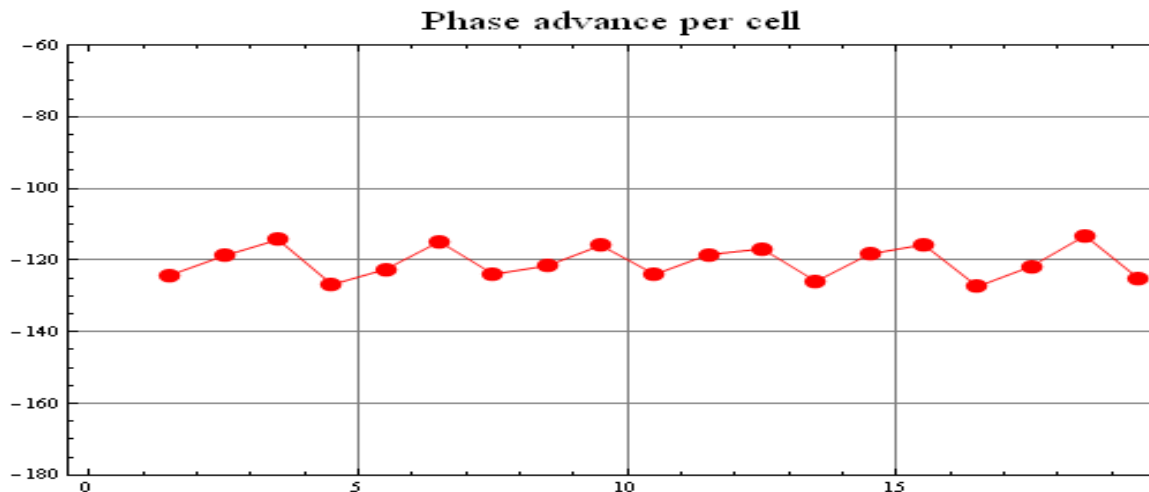
# Phase Measurement of T18-KEK Before and After High Power Test

11421.7 MHz at 21.1 C, N2  
Before high Power test at SLAC

Considering the string  
perturbation and  
temperature correction, the  
frequency was increased by  
1.2 MHz (Toshi calculated  
1.1 MHz).

11423.2MHz at 22.7deg C in N2  
After high power test at KEK by  
Toshi

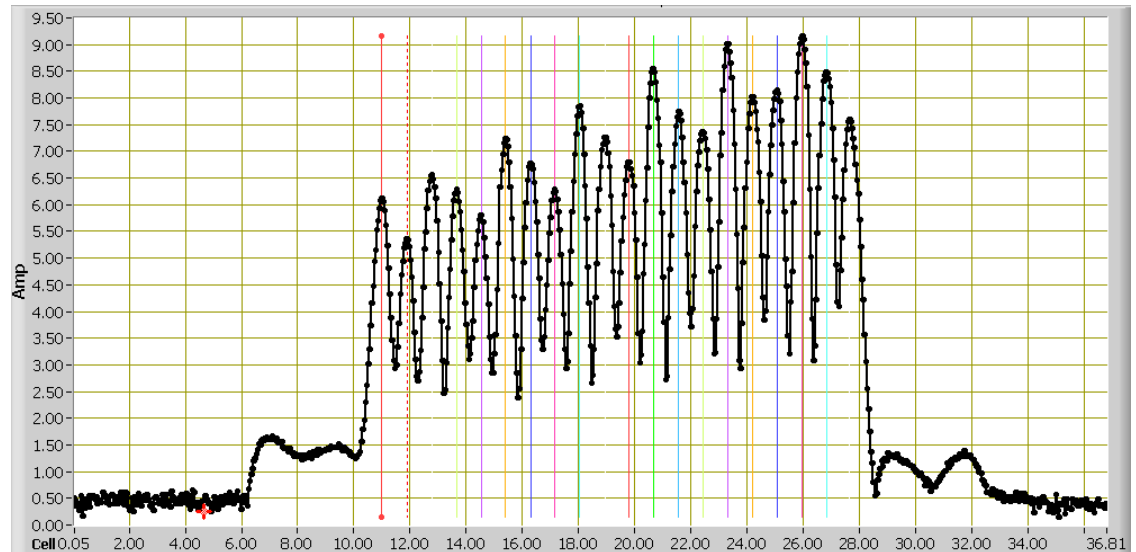
11424.56 MHz at 21.1 C, N2  
After high power test

- From the standing wave pattern, the output part and some cells were “damaged”.
- In general, there was a 1MHz frequency increase of  $2\pi/3$  mode at similar operation conditions. In another words, the cumulated phase drift was about  $16^\circ$  at frequency at similar operation conditions
- The pulse heating for TD18 structure is higher, but it is believed that the “damages” were still on the disc irises.
- The total breakdown event recorded was more than 4000 – only twice higher than T18 SLAC #1, but the TD18 breakdown rate measured after 700 hours was higher than T18 SLAC #1 by factor of 100. The “damage” can be caused at higher power and full pulse width in stead of the process beginning with lower power and short pulse width?

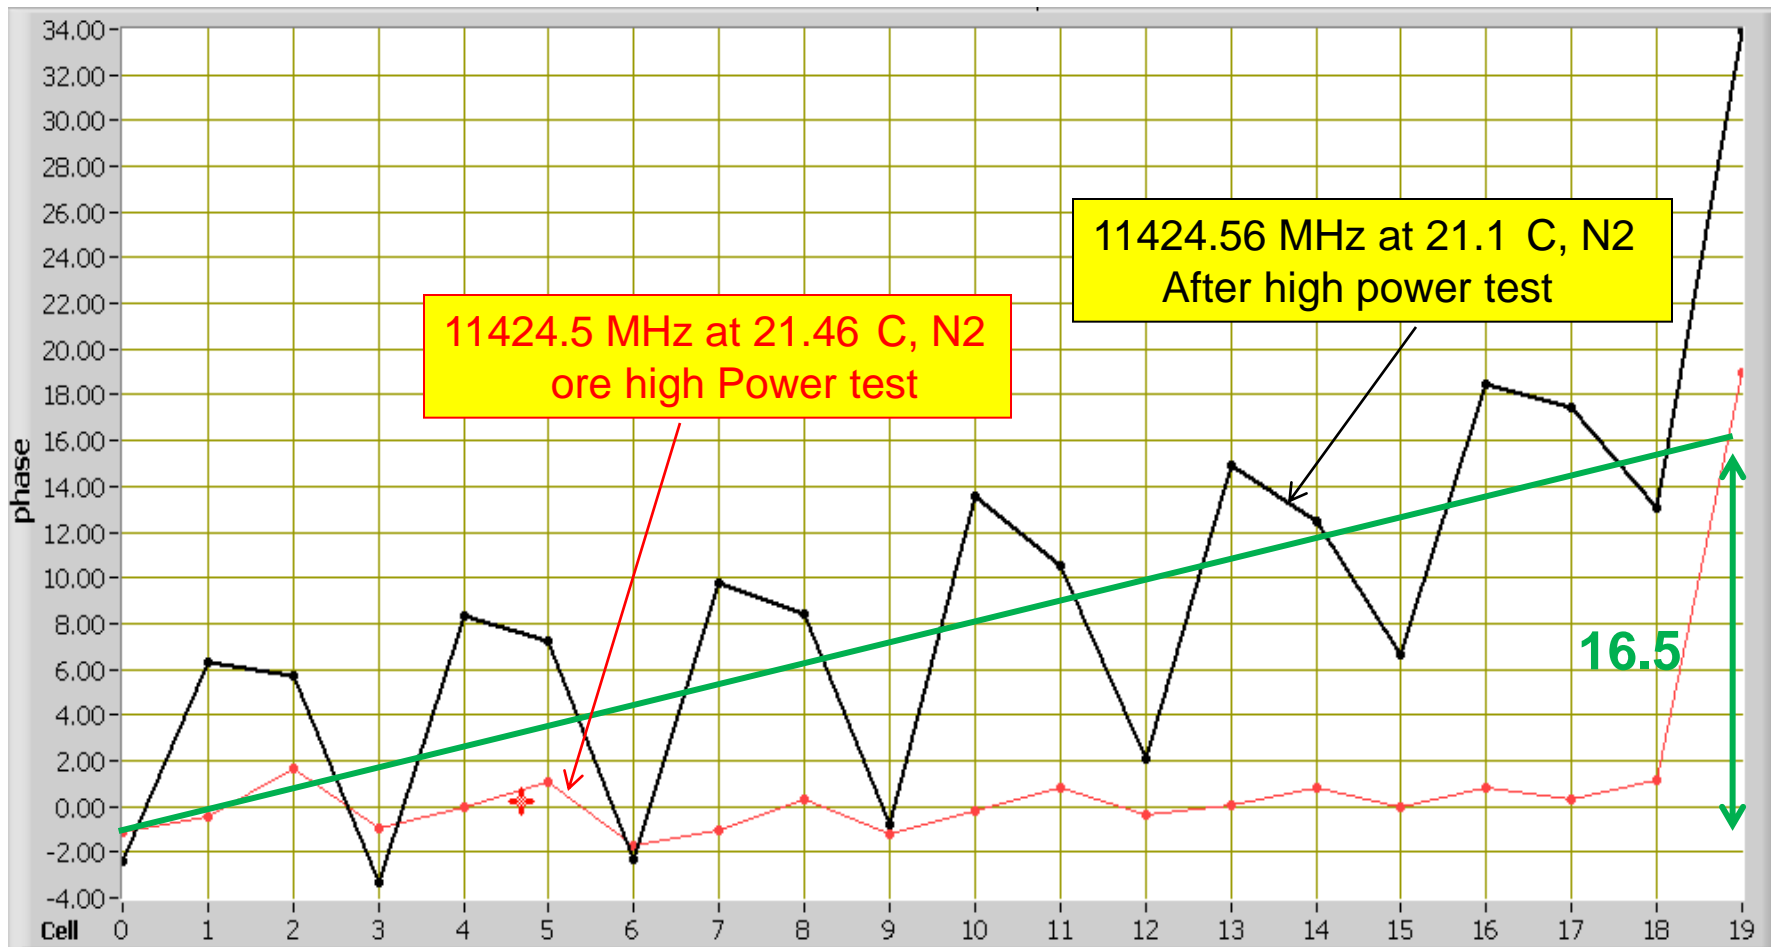
# Phase Measurement of T18-KEK Before and After High Power Test

Select bead pulling frequencies based on the same measurement condition for both before and after high power test

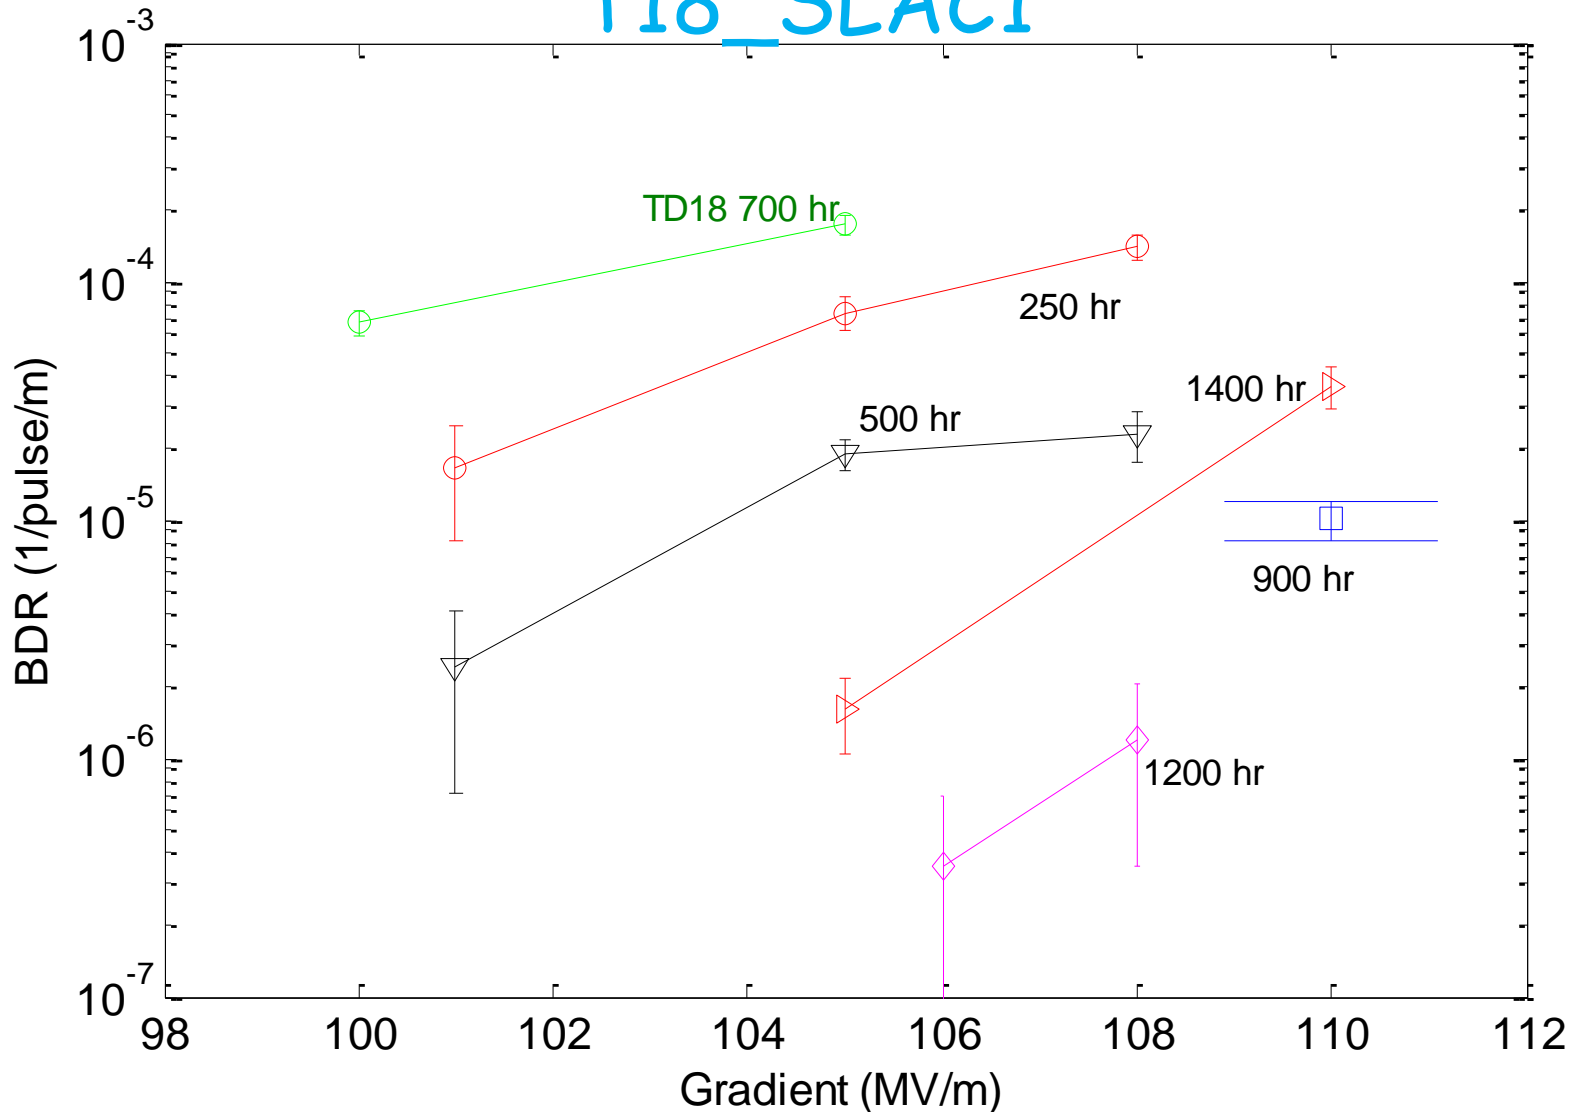
# RF Process Results Comparison with T18\_SLAC1

Pulse width 230ns, Green line for TD18, Others for T18

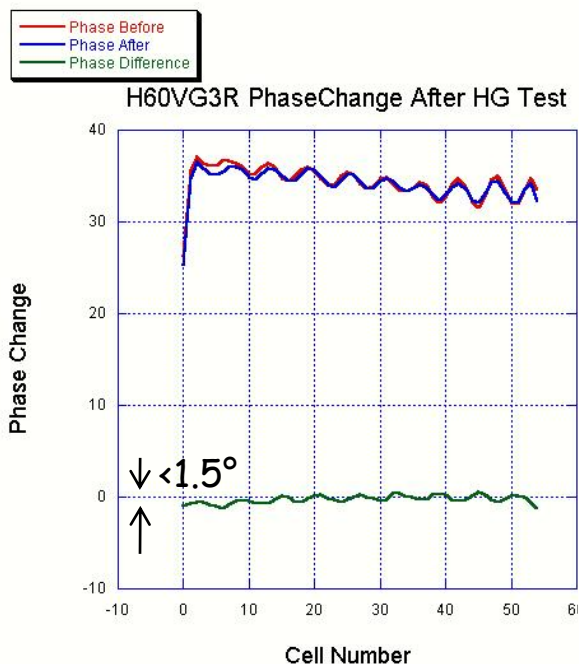
**H60VG3R**  
1000 Hours RF on (65MV/m, 400ns)  
8000 Body Breakdown

- There was no much increased standing wave pattern, the phase plots in output parts could be used to fit together in order to compare the phase change before and after high power tests.
- In general, there was no frequency change for designed mode  $2\pi/3$  or  $5\pi/6$  at similar operation conditions. In another words, the cumulated phase drifts for those long structures were very few degrees at frequency at similar operation conditions

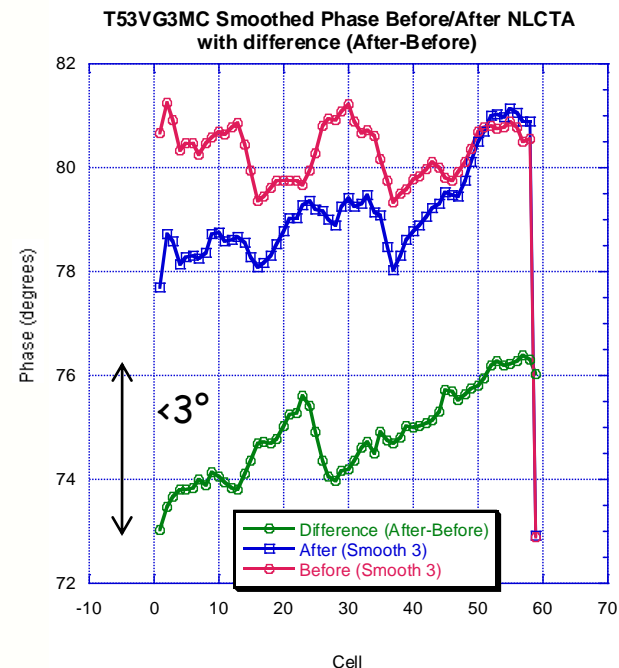
**T53VG3MC**  
900 Hours RF on (92MV/m., 400ns)  
1600 Body Breakdown

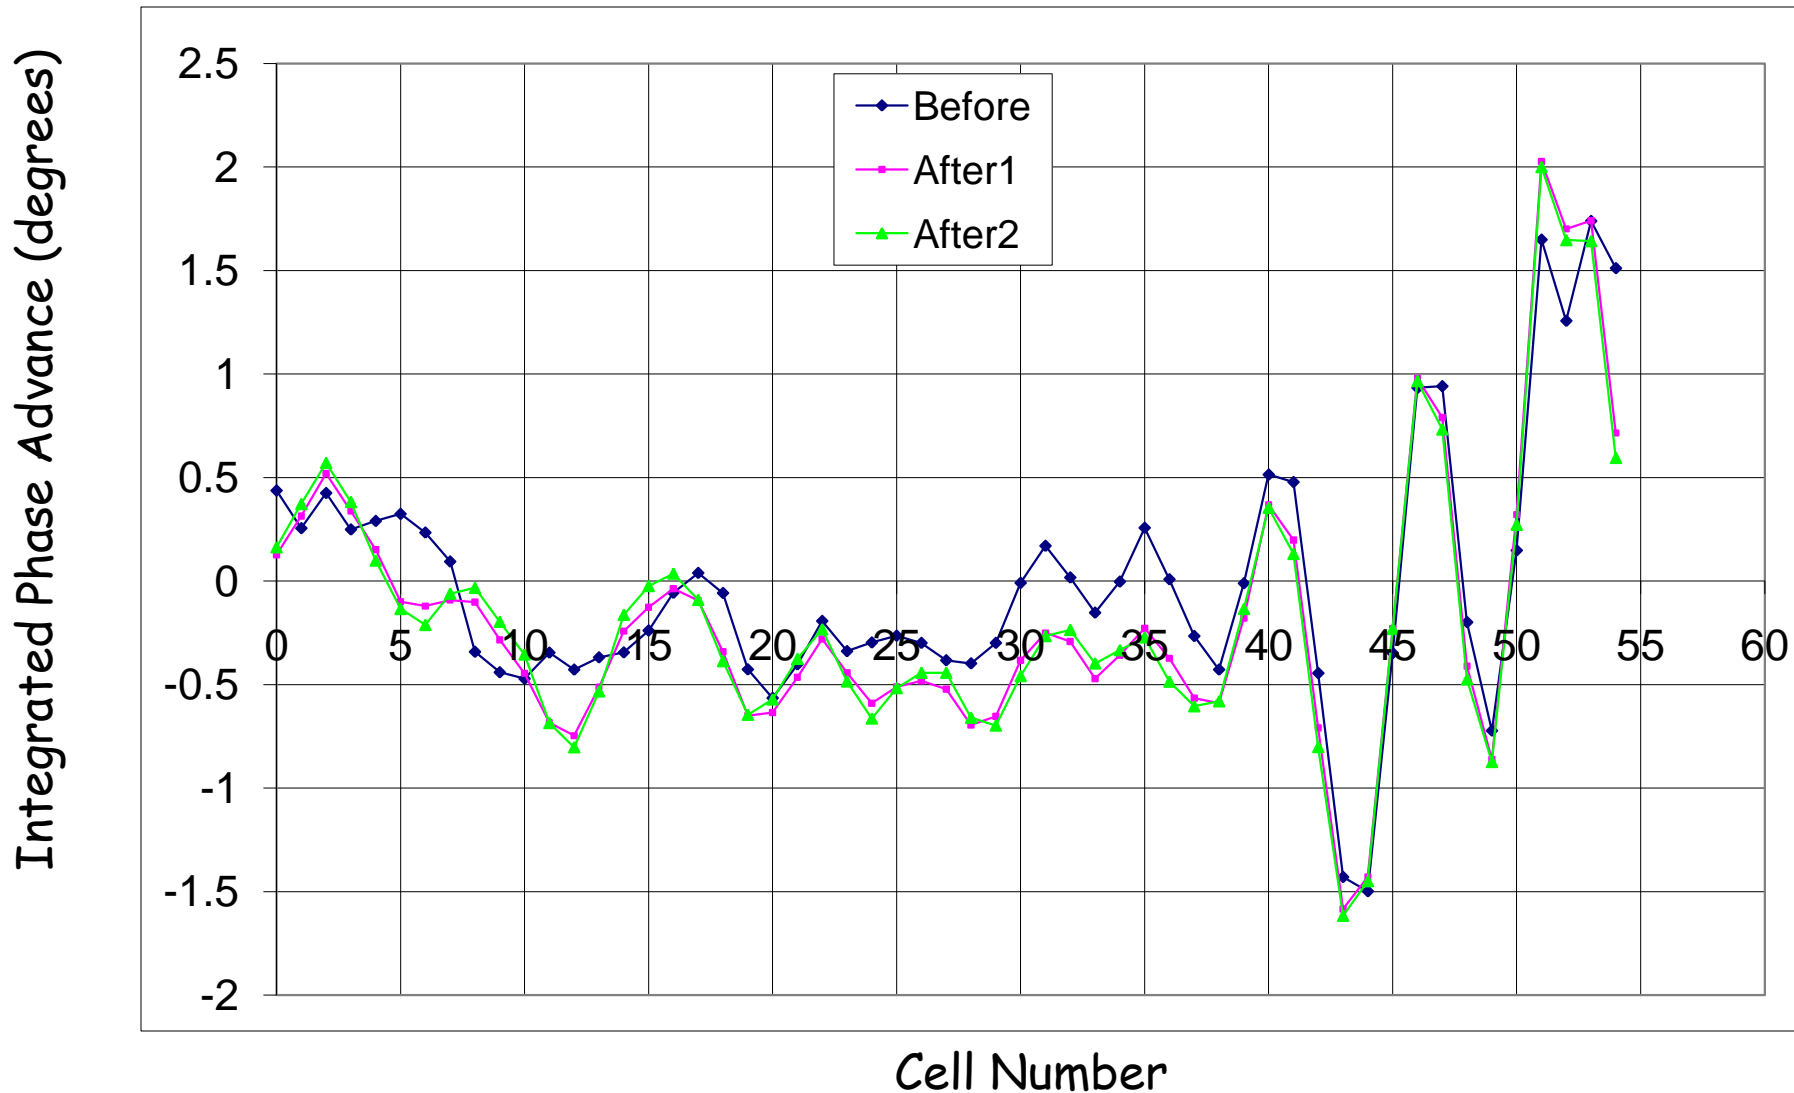
Bead-Pull Phase Advance Measurements of H60VG3 (FXB2)  
Before and After 300 Hours of Processing to 70 MV/m  
(7000 Breakdowns, 300 Hours RF On)
