12th ALICE ITS upgrade, MFT, and O2 Asian workshop
INHA University
November 19-20, 2018

OB HIC QA at CERN

Petra Riedler, CERN

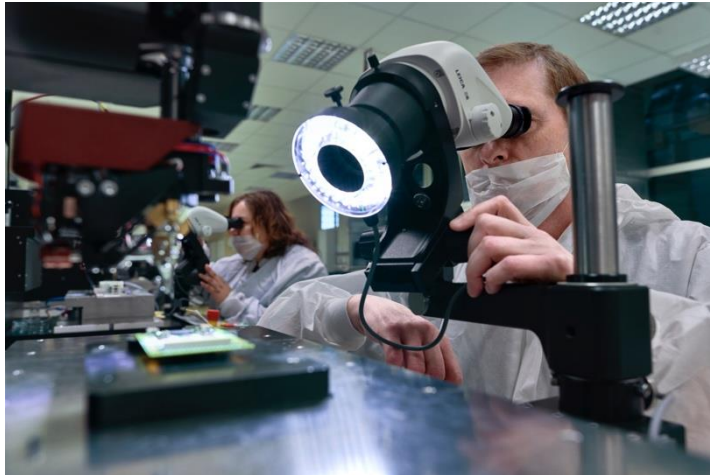
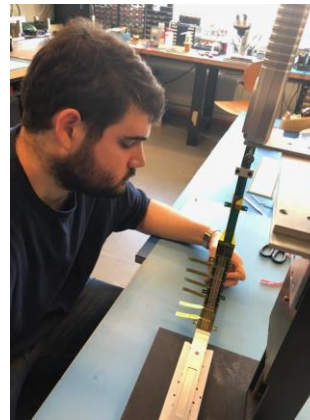
1. **Reception:** inspect for any damages on the package, sealing of the wrapping or transport plate, contamination
2. **Inspection:** with a digital microscope of the FPC, bonding connections, glue spots, possible contaminations,...
3. **Bondlab inspection:** visual inspection with a high performance optical microscope (Leica), wire bonding pull tests
4. **Peel test:** glue adhesion strength between FPC and chips, followed by high magnification microscope inspection
5. **Cycling test:** thermal cycling of the HIC, including pull tests before, during and after cycling, followed by peel tests

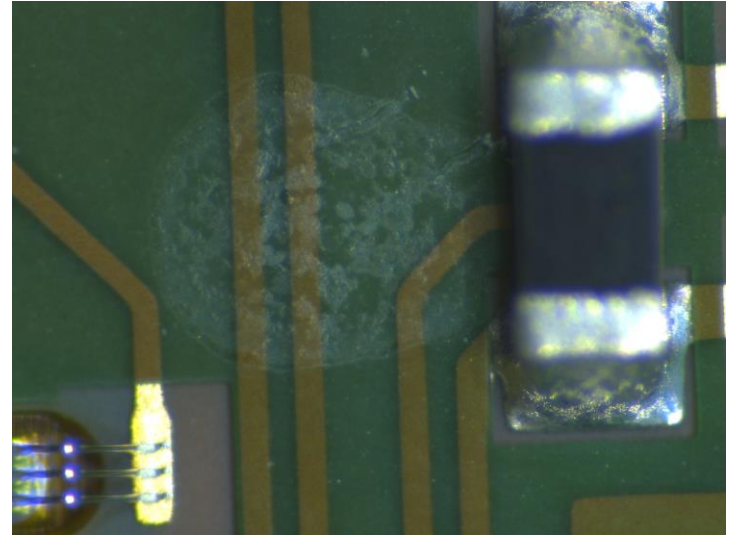
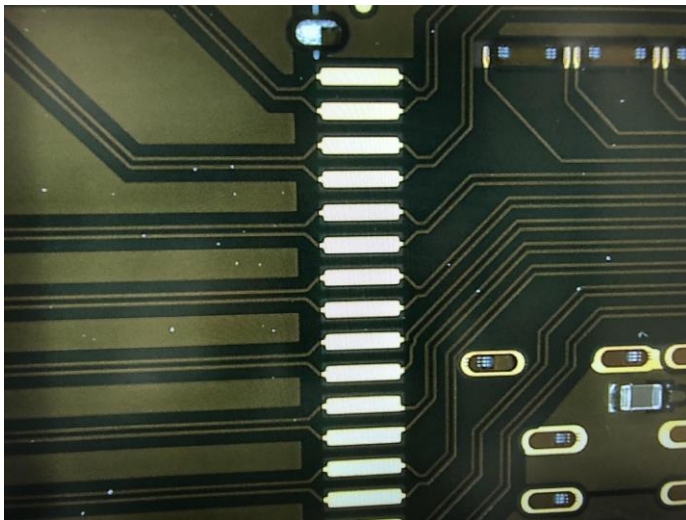
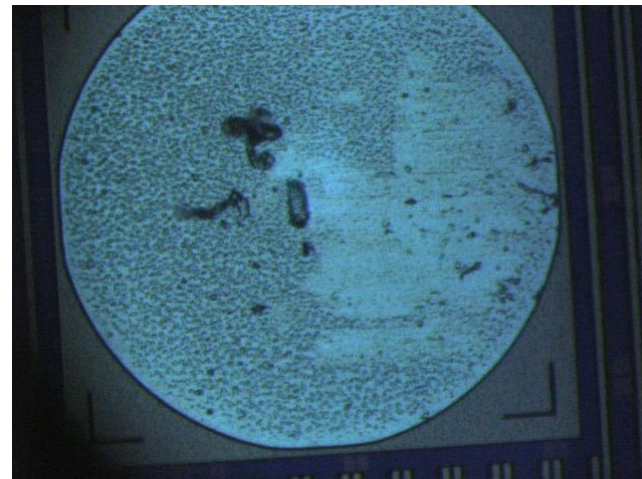
Examples – visual inspection

Issues flagged:

- Contamination of the carrier plate
- Contamination/patterns on FPCs
- Chip pad contamination
- Particle contamination in general

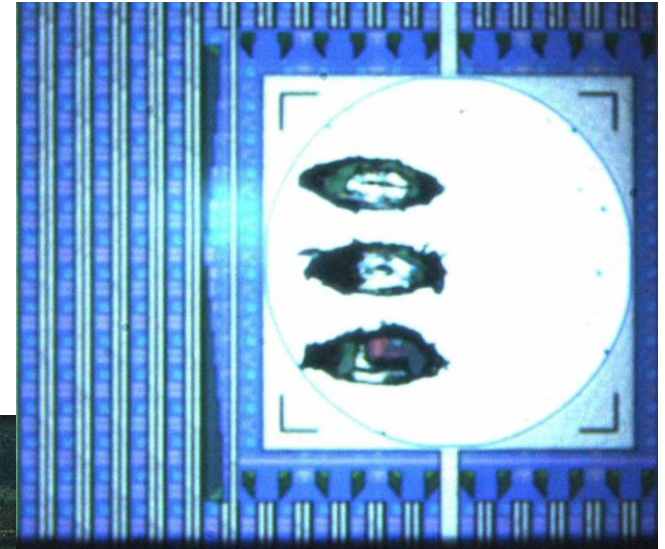
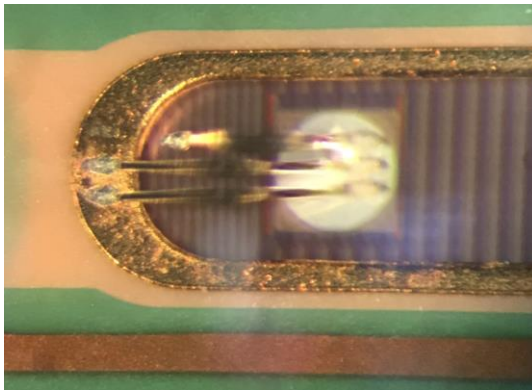
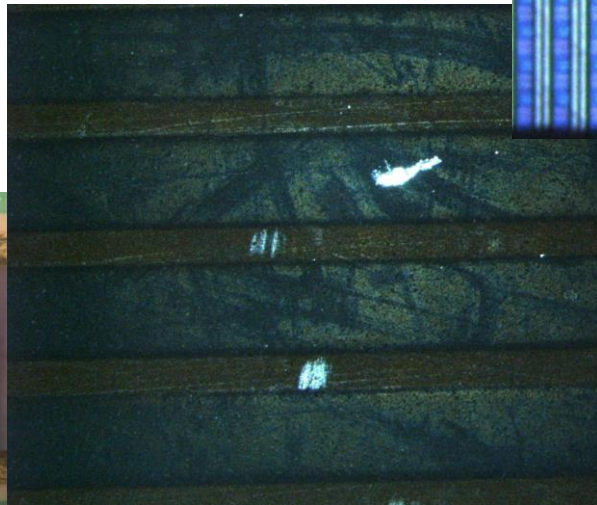
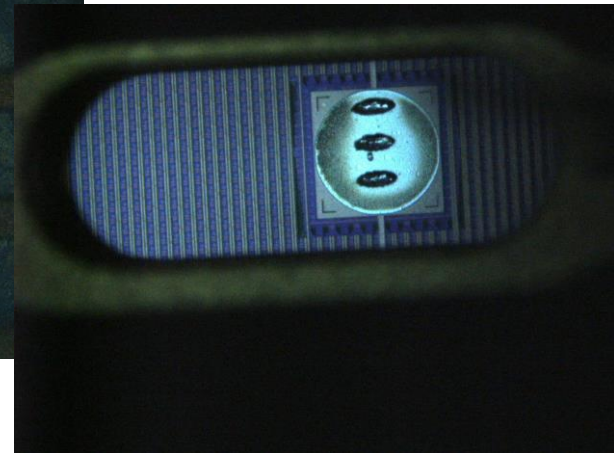
Examples – bond inspection

Pull test and visual inspection carried out by the CERN bondlab

Issues flagged include:

- Too low pull test values
- Contaminations on chip pad or FPC
- Deformed or irregular bond feet
- Cratering
- Bond foot lift

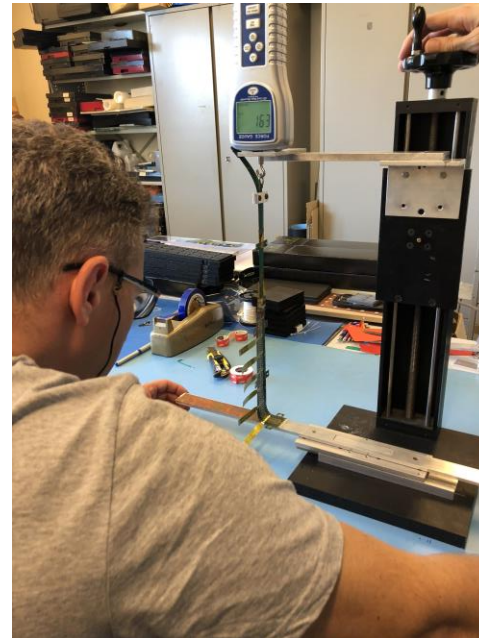
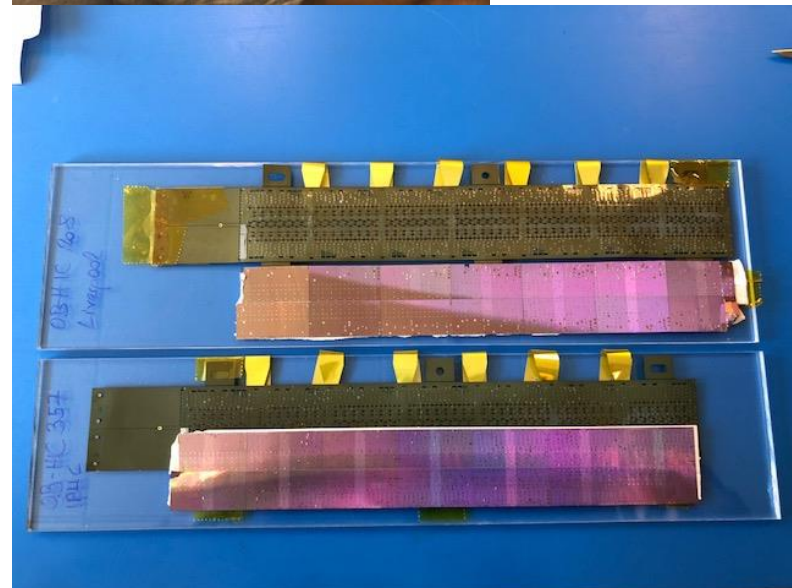
Peel test

In order to do a peel test (measure adhesion strength between chips and FPC, all wire bonds are removed.

The HIC is mounted on a translation stage and the FPC is peeled off from the chips.

The adhesion strength is measured with a force gauge.

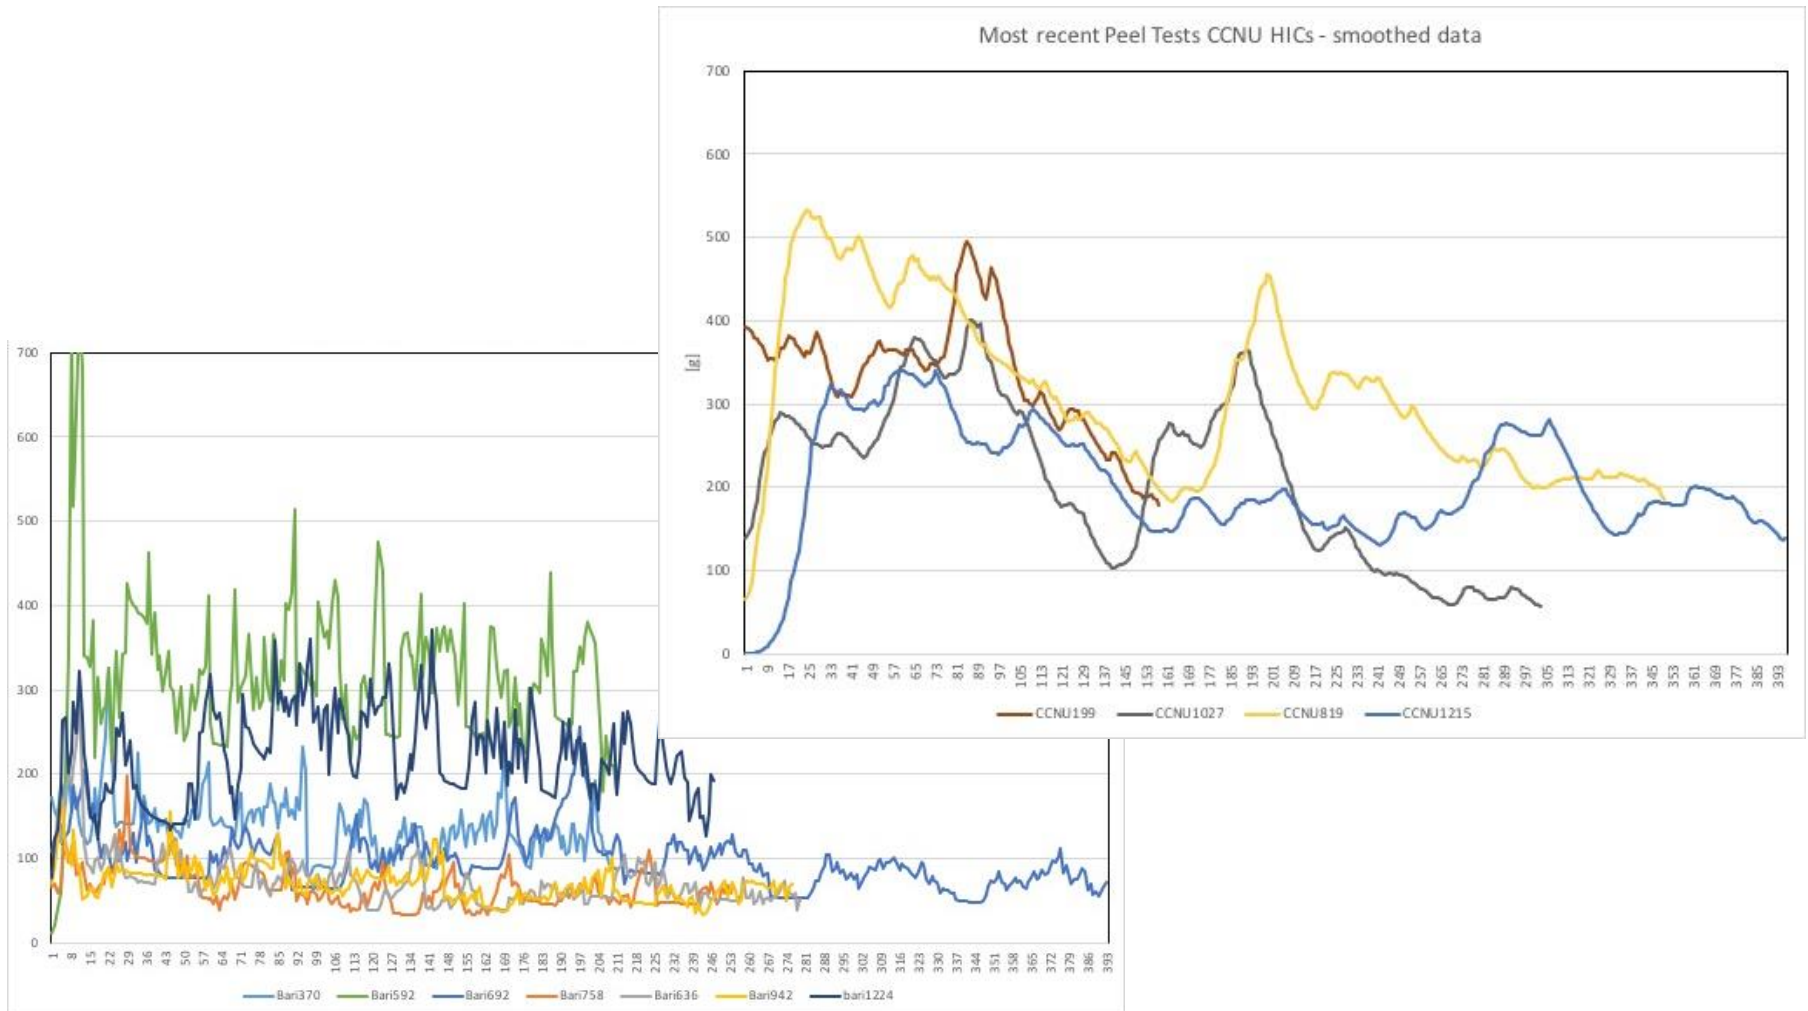
Peel test curves examples

Average peel force and standard deviation are important indications for good/bad adhesion, but also **other aspects need to be monitored closely:**

- Form of the curve
- Glue filaments during the peel test
- Inspection of FPC and chips after peel test

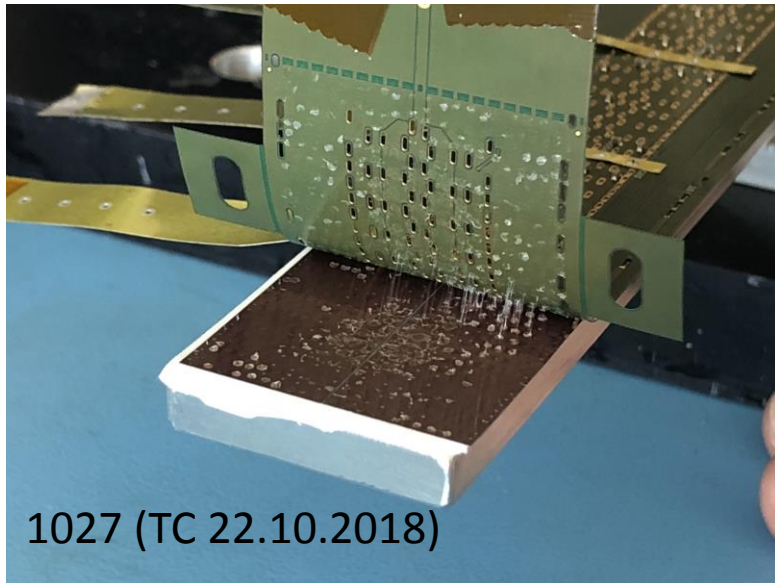
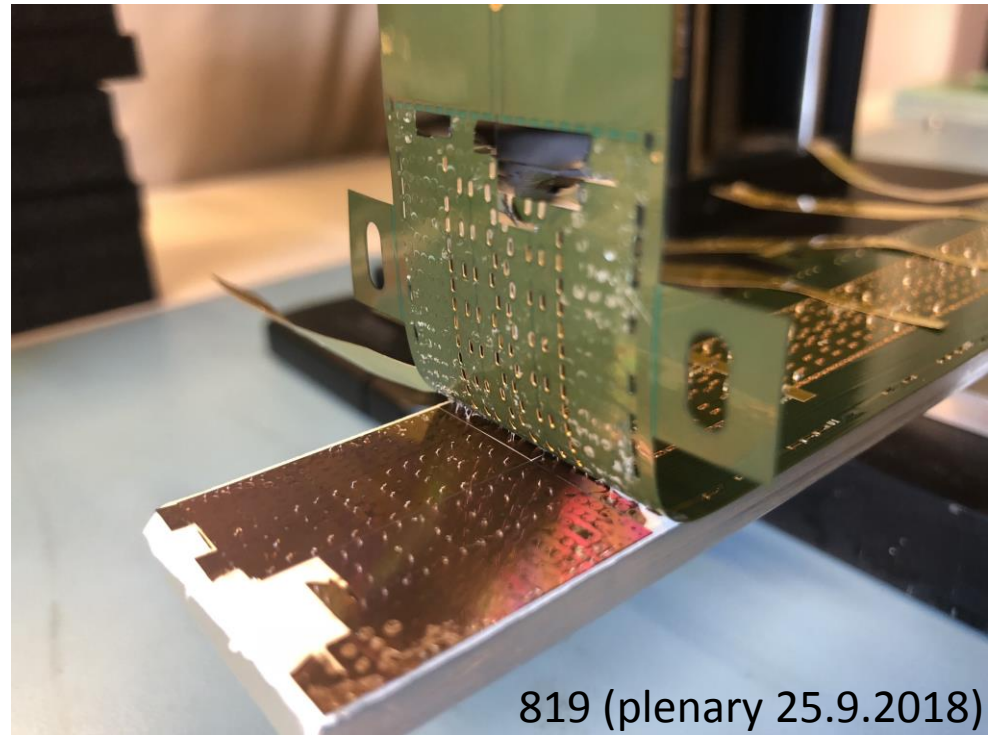
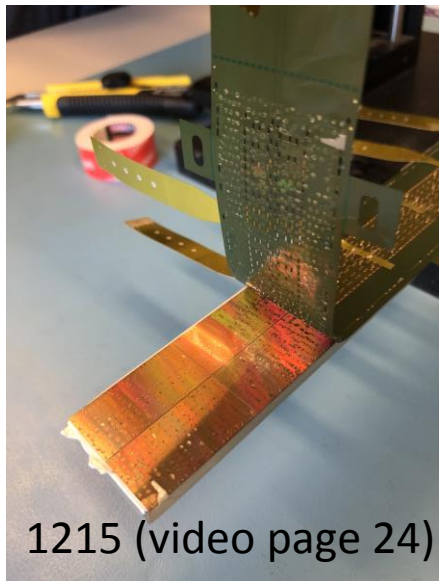
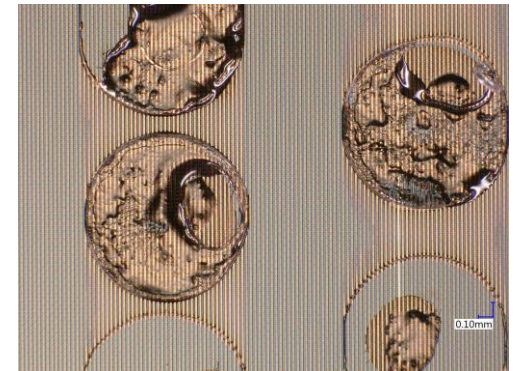
Peel test – most recent CCNU HICs

- Filaments observed since summer when we started to take pictures during the peel process
- Further details became visible with access to a high magnification microscope

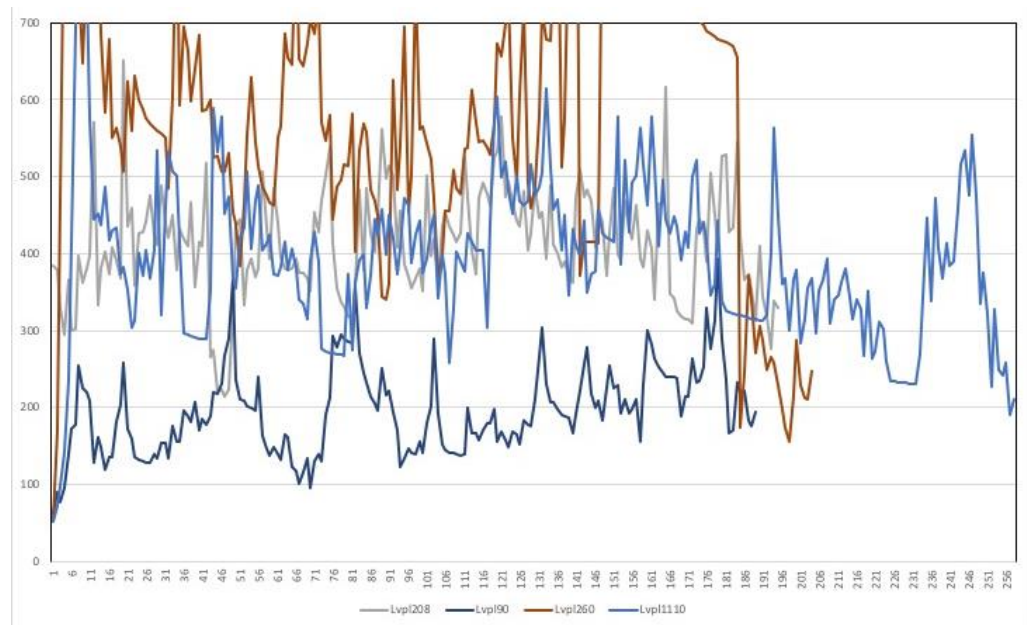
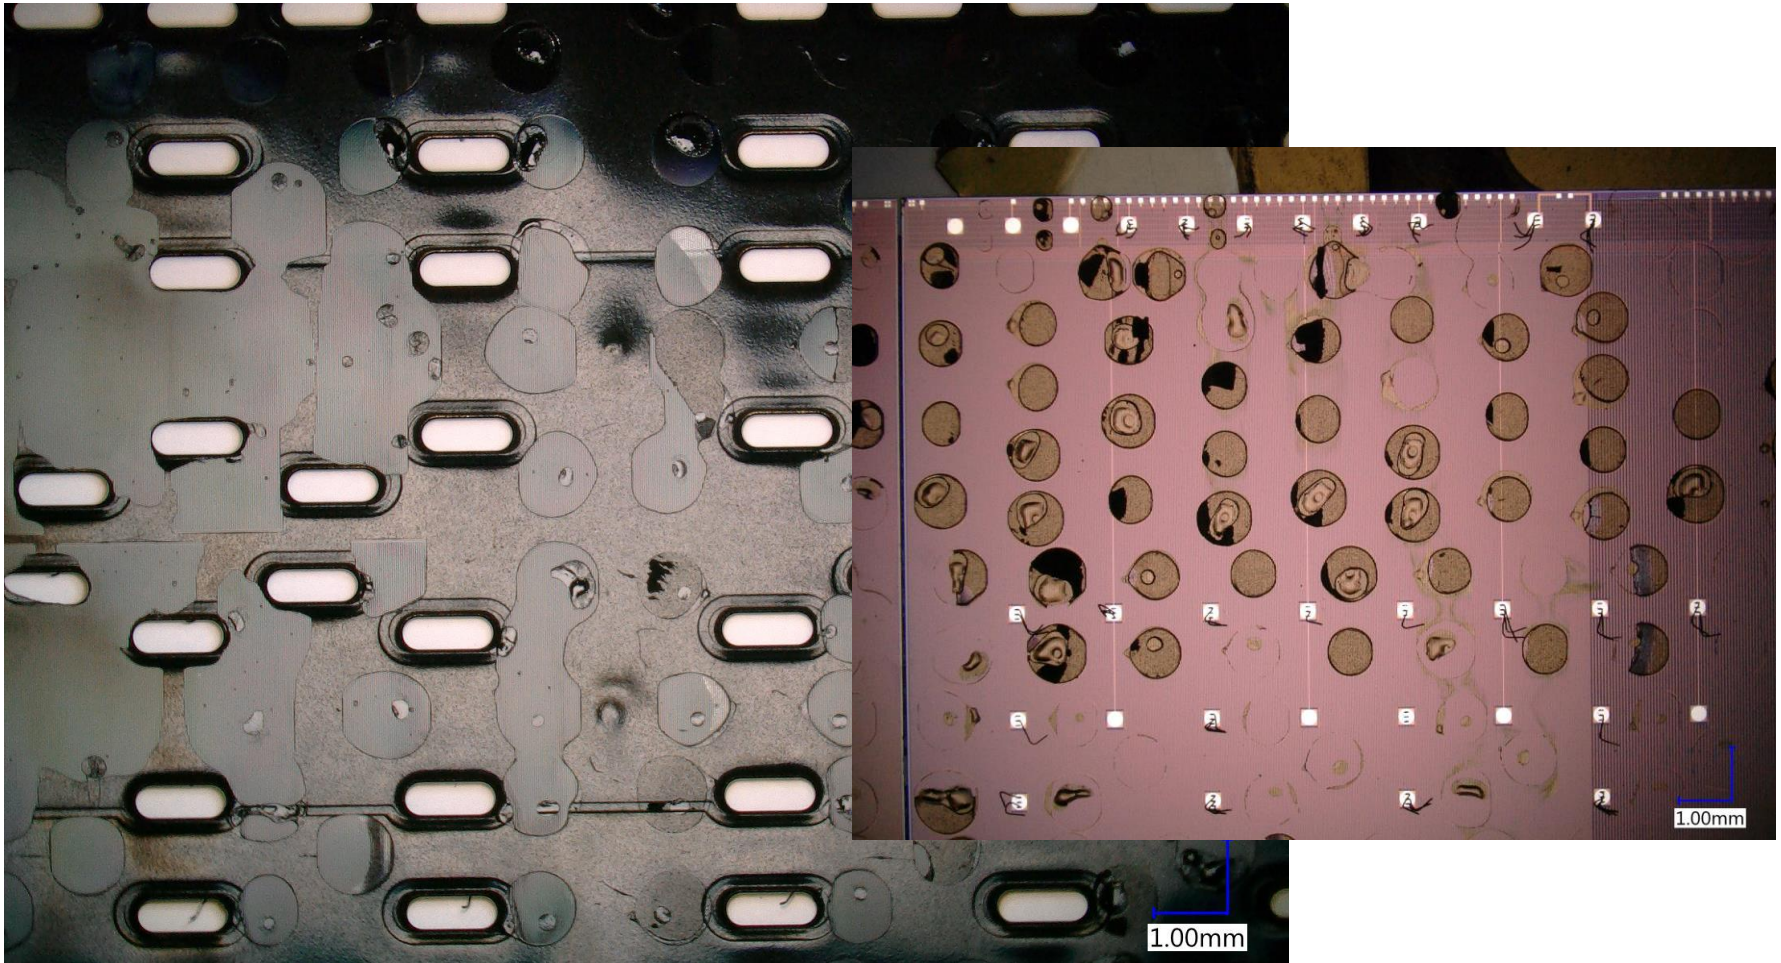
Liverpool 1110

2 HICs (398, 776) in cycling

Inspection after peel-test is important!
