Yale Update: Oct 4th

WILLIAM HEIDORN
IOWA STATE UNIVERSITY
ISU WEEKLY STAVE QC MEETING
OCTOBER 4, 2018

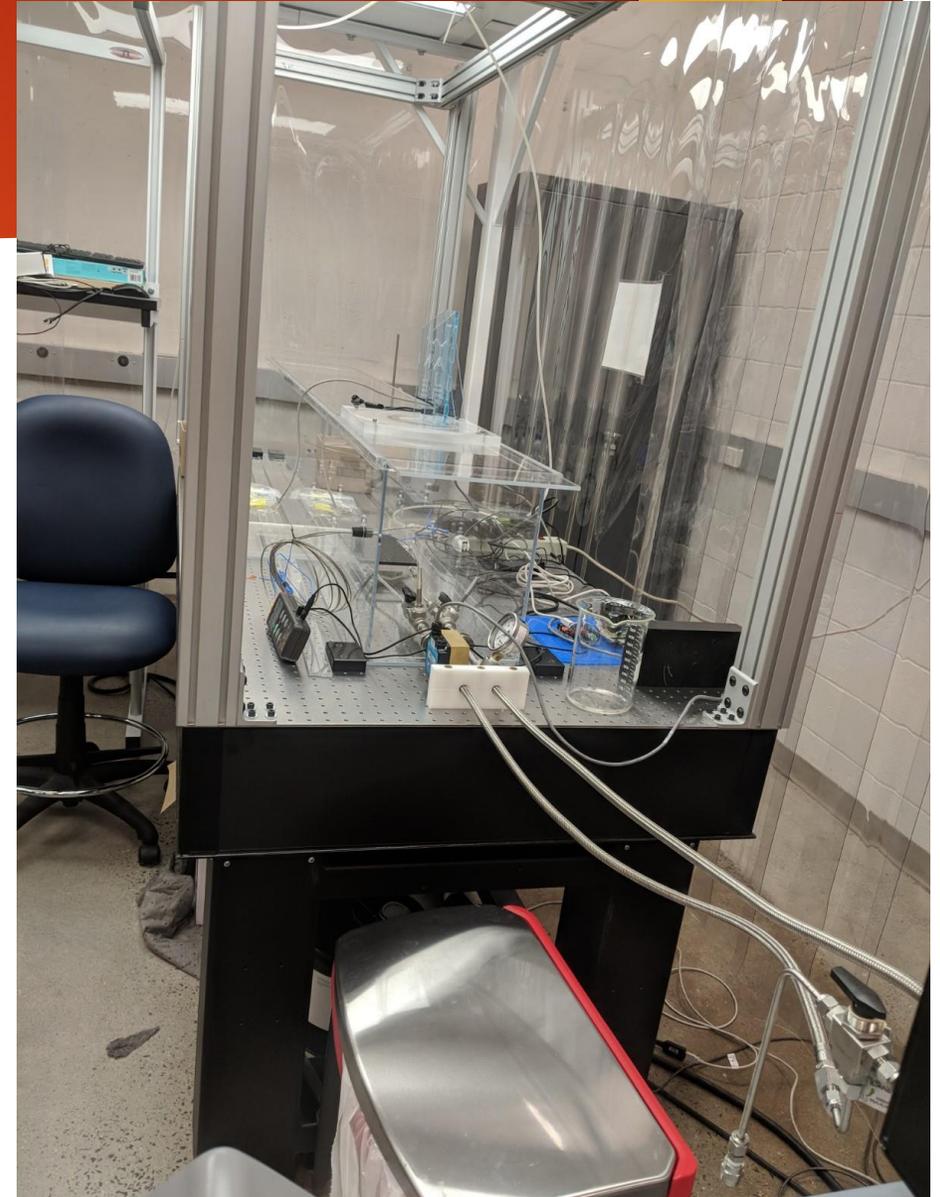
- ▶ Almost completed hardware setup!
 - ▶ Missing booster pump communication module
- ▶ Beginning main calibration studies
 - ▶ Flow calibration and vignetting
 - ▶ Long term background checks
- ▶ Currently manufacturing the stave supports for laser

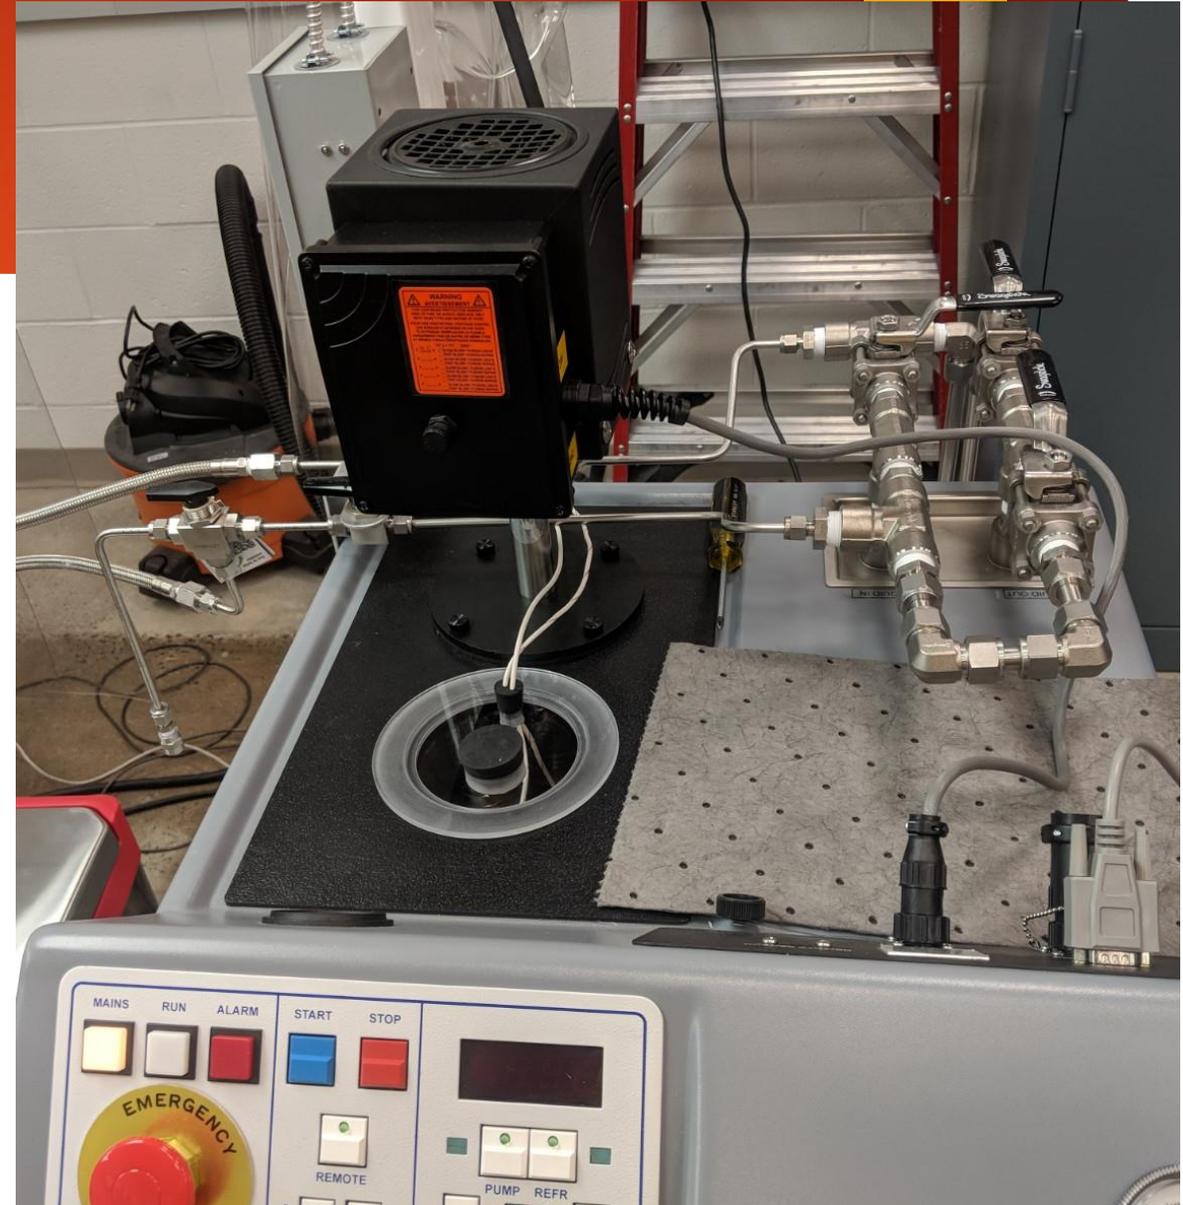
- ▶ Waiting on...
 - ▶ Communication Module
- ▶ Installed resistors into reservoir
 - ▶ Made a new lid. It is made from a clear plastic and has another aperture for putting in fluid and measuring the height.
- ▶ Have been updating the ChillerCtrl program and log extracting script.
 - ▶ ChillerCtrl now works appropriately when running from routines with humidity warnings.
 - ▶ Added a new system setting called BOOT: this is placed before start. Once all processes have been initialized, the system goes into START. This stops process log printing from mixing during startup.

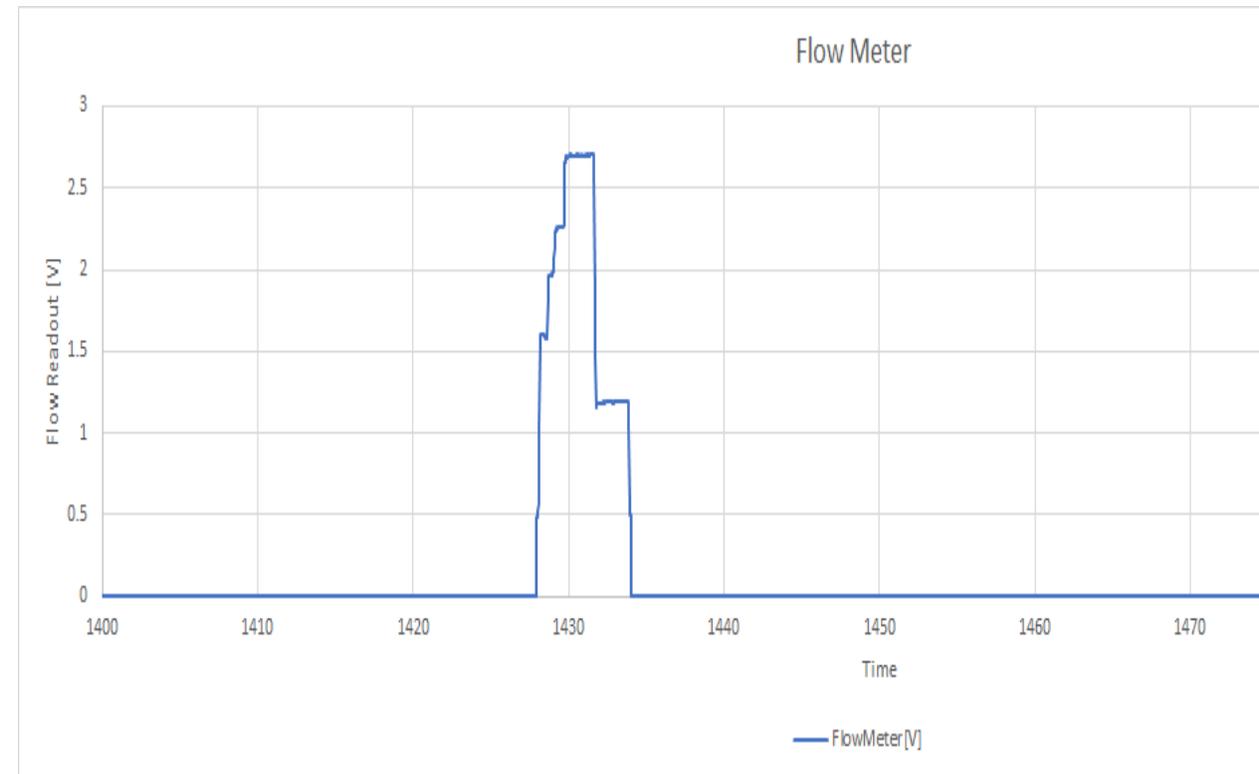
- ▶ Over the past 48 hrs I have had the logging software reading from the two thermal loggers and the flow meter to see what changes in temperature are normal in the current locations
- ▶ Temperature is pretty constant in all of the different measurements
- ▶ Humidity in the box does not change much
- ▶ Flow meter was tested for a small time and it seems to read out appropriately.

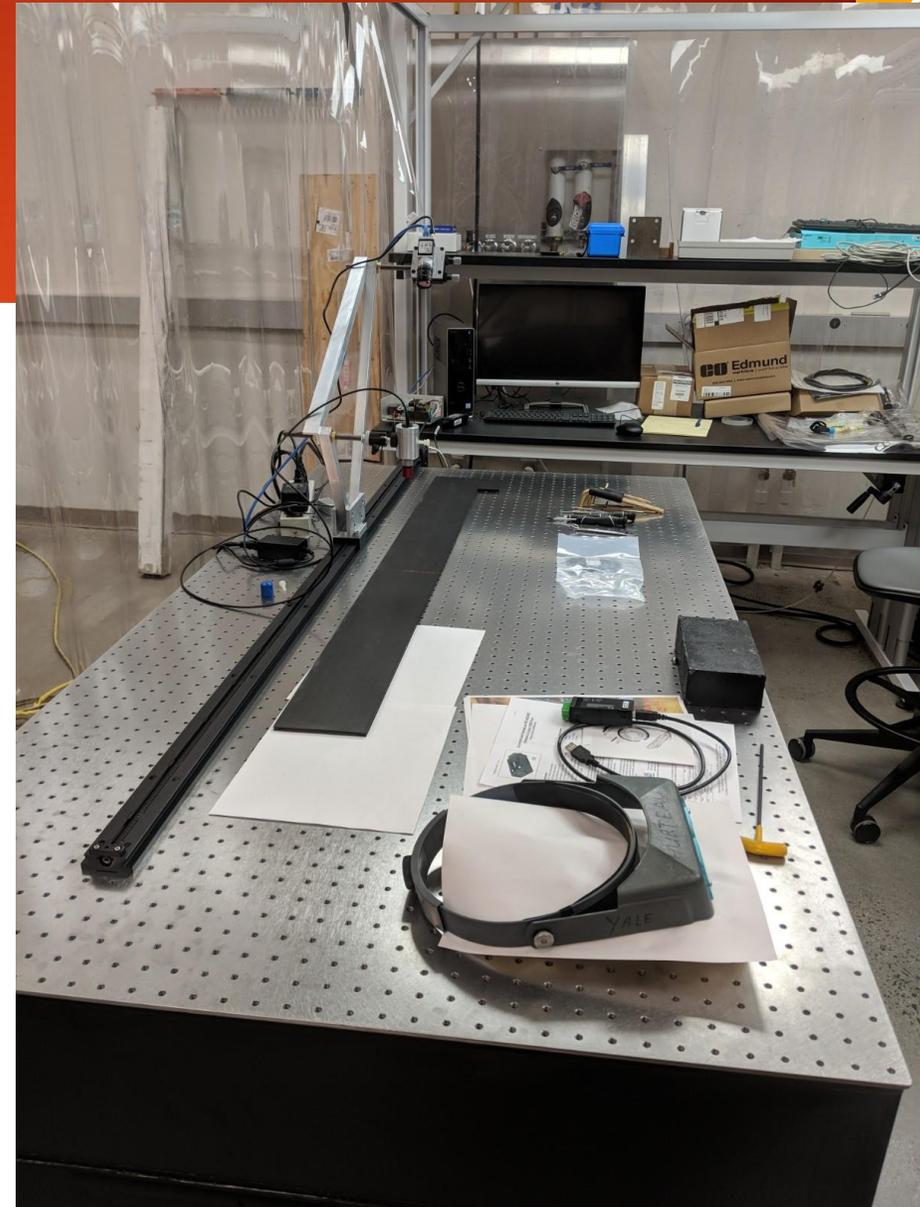
- ▶ Waiting on...
 - ▶ Support manufacturing
 - ▶ Shuaiyan to arrive and get labview to do its thing
- ▶ Thermal Study
 - ▶ Using the thermal camera, I watched the motor and driver for over 2 hrs with a script that moved the stage slowly one way and quickly the other.
 - ▶ The driver and linear stage get to max temperature(+45C) after ~40 mins
 - ▶ We have a few old fans that could be used if this becomes a significant issue
