Yale Update: Oct 11th

WILLIAM HEIDORN
IOWA STATE UNIVERSITY
ISU WEEKLY STAVE QC MEETING
OCTOBER 11, 2018

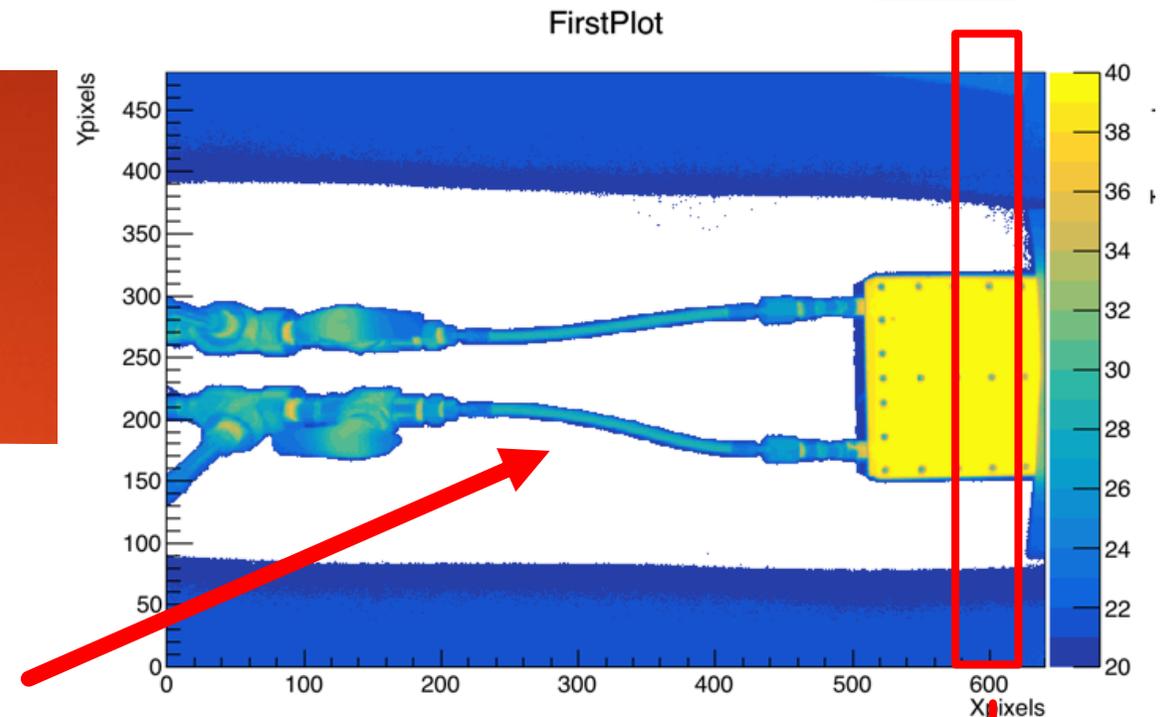
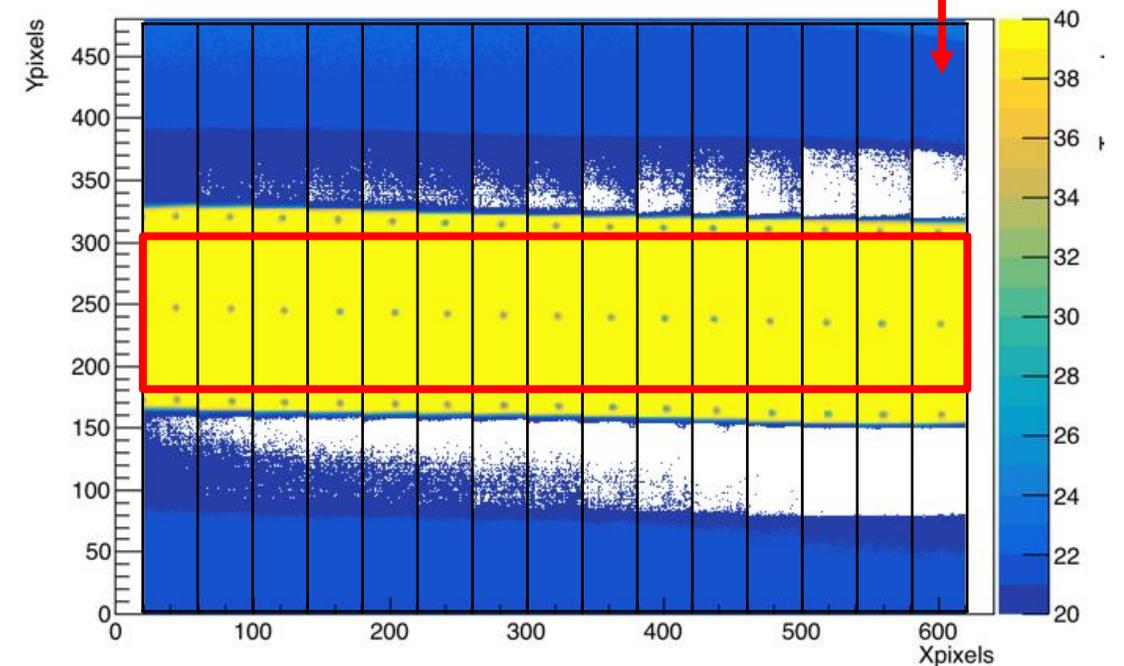
Vignetting

- ▶ The metal block was cooled/ heated to a stable temperature.
- ▶ The camera was focused and observed the plate 15 times. Each time, the same plate portion was observed with a different section of pixels of the camera.
- ▶ Before each image measurement the camera was recalibrated between each image using the NUC (non-uniformity compensation) feature of the camera.
- ▶ Images were taken with 100 frames over 4 seconds and averaged assuming an emissivity of 0.95

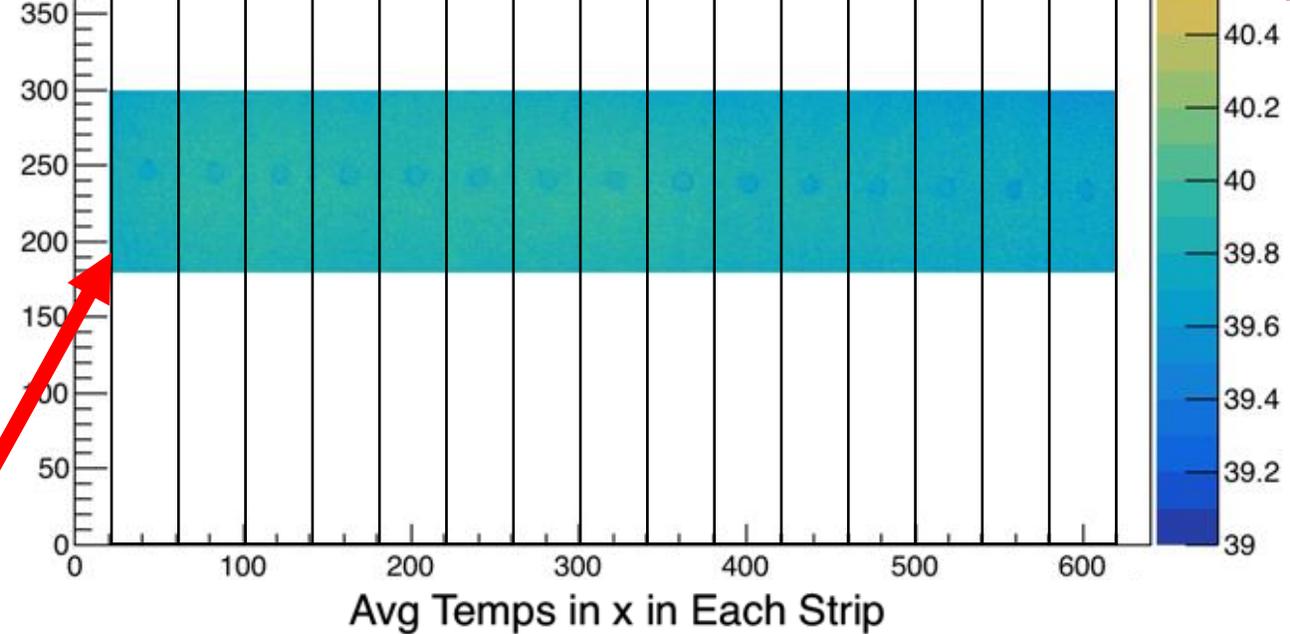
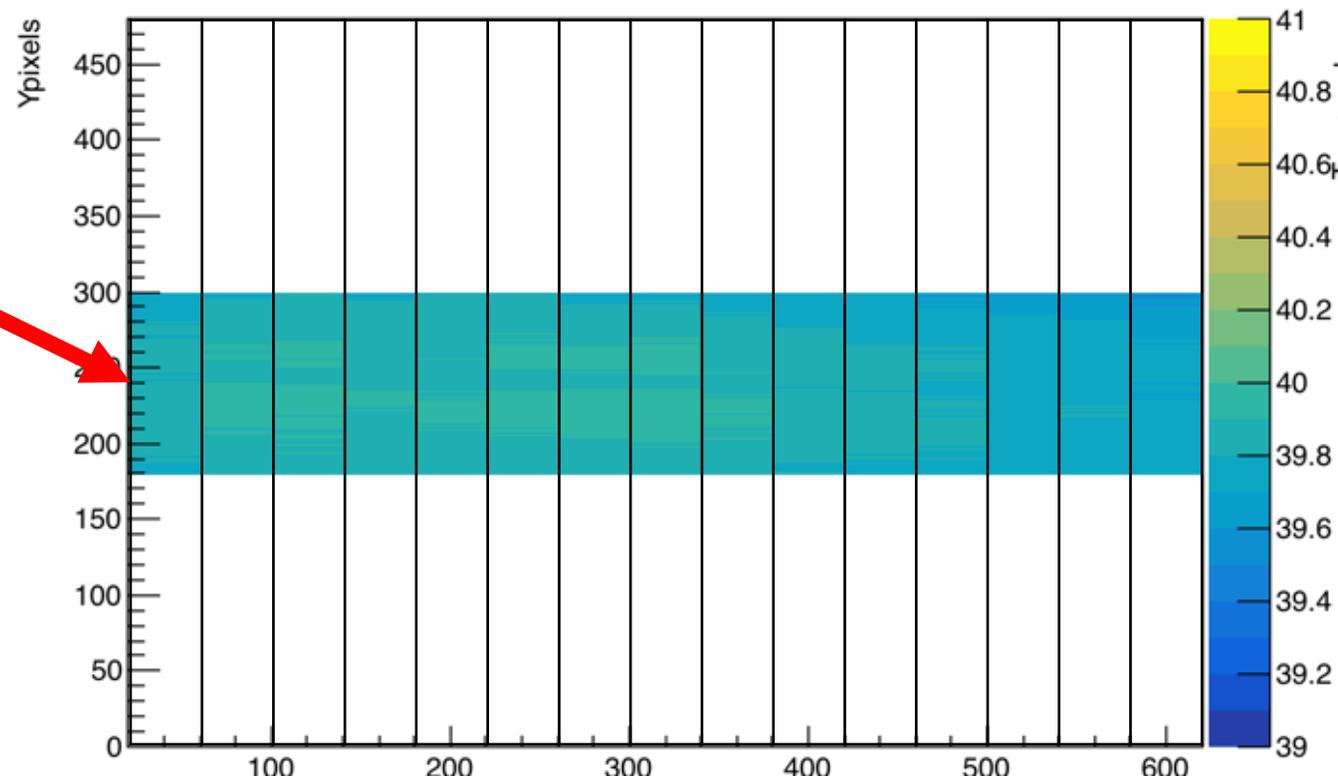
Vignetting cont.

- ▶ The image is smoothed within the region in which the stove will reside in measurements
 - ▶ Find average throughout the strip area and remove any temperatures outside one standard deviation and replace them with the average
- ▶ The temperature is next averaged along the x direction in each strip
- ▶ Finally the central strip is subtracted from the rest to give the vignetting

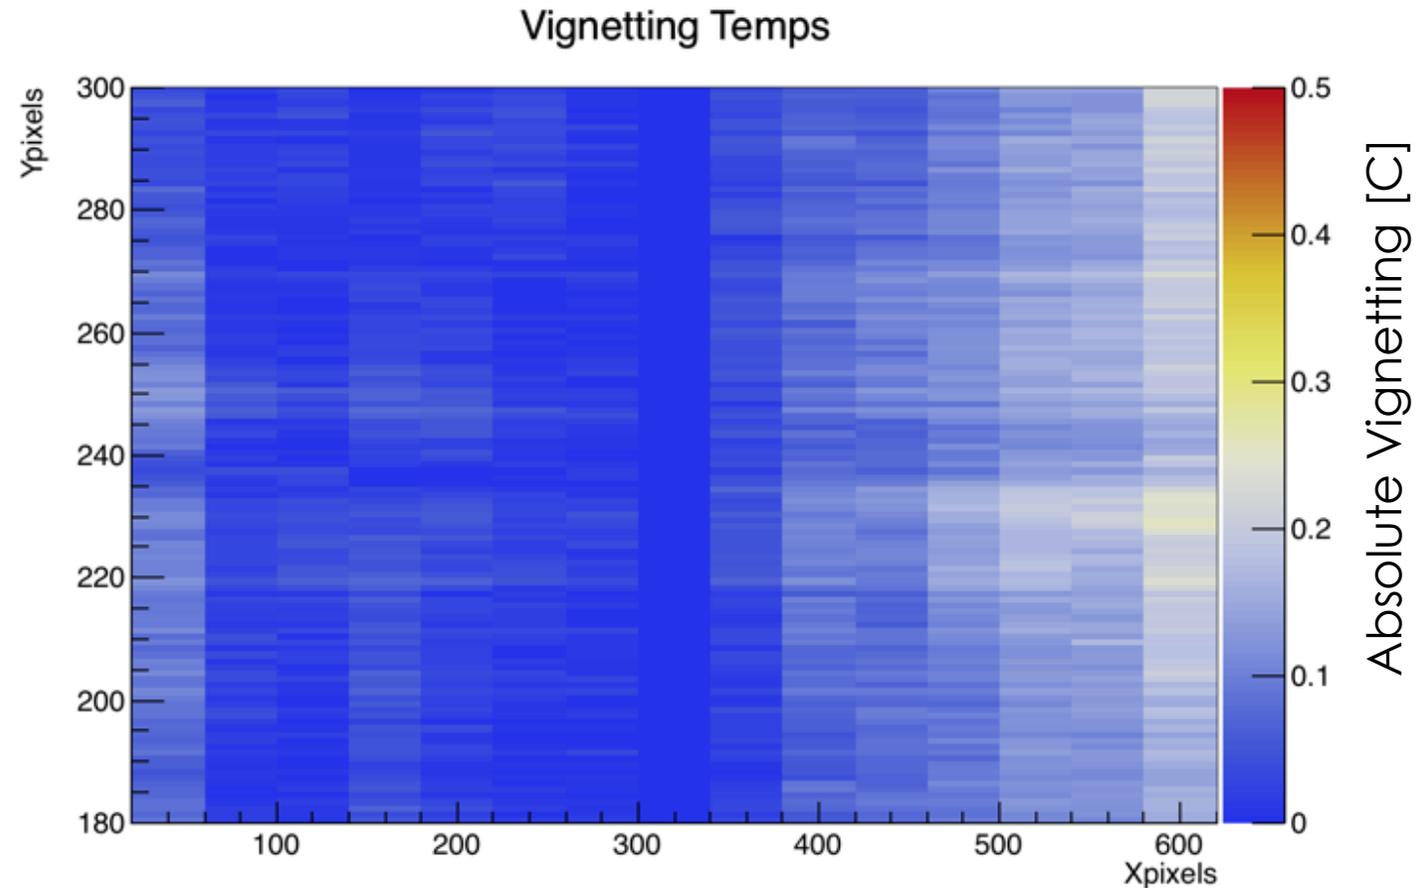
Vignetting +40C Block

- ▶ To the right you see the vignetting map
 - ▶ Max Vignetting: 0.26 C
 - ▶ Avg Vignetting: 0.07 C
- ▶ This is quite impressive given that the measurement is taken over a 10 min period

- ▶ The actual vignetting of the thermal camera's are much smaller than we had earlier measured.
- ▶ Using the NUC, the camera's maximum vignetting is below 1 C!
 - ▶ +40C Block: Avg Vignetting 0.07C, Max Vignetting 0.27C
 - ▶ - 40C Block: Avg Vignetting 0.17C, Max Vignetting 0.63C
- ▶ These fluctuations may mainly be due to the fluctuation of the temperature of the block during the measurement

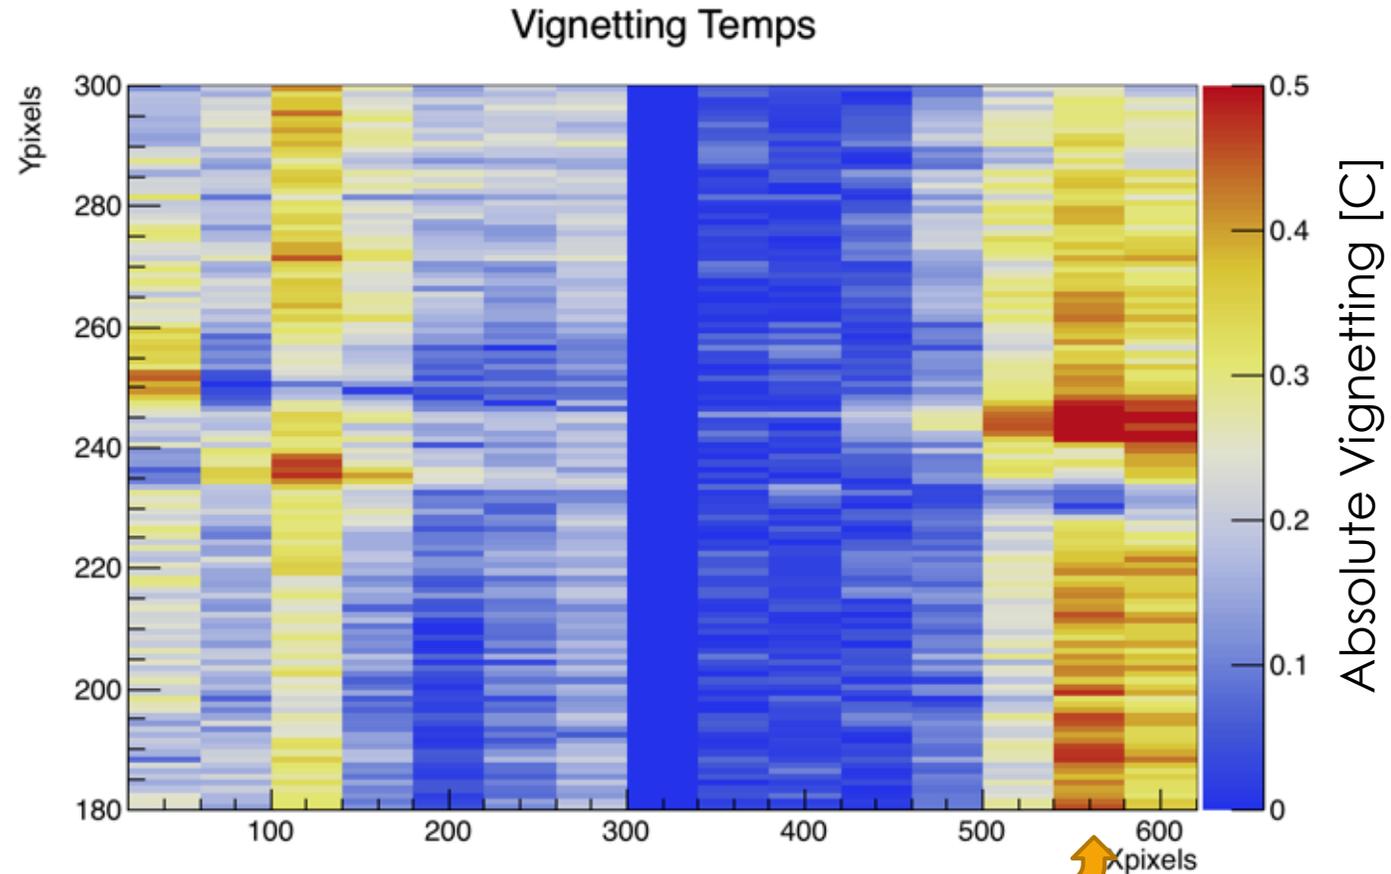
Vignetting -40C Block

- ▶ To the right you see the vignetting map
 - ▶ Max Vignetting: 0.63 C
 - ▶ Avg Vignetting: 0.17 C
- ▶ This is quite impressive given that...
 - ▶ The measurement is taken over a 10 min period
 - ▶ Alignment of metal was not right for one line

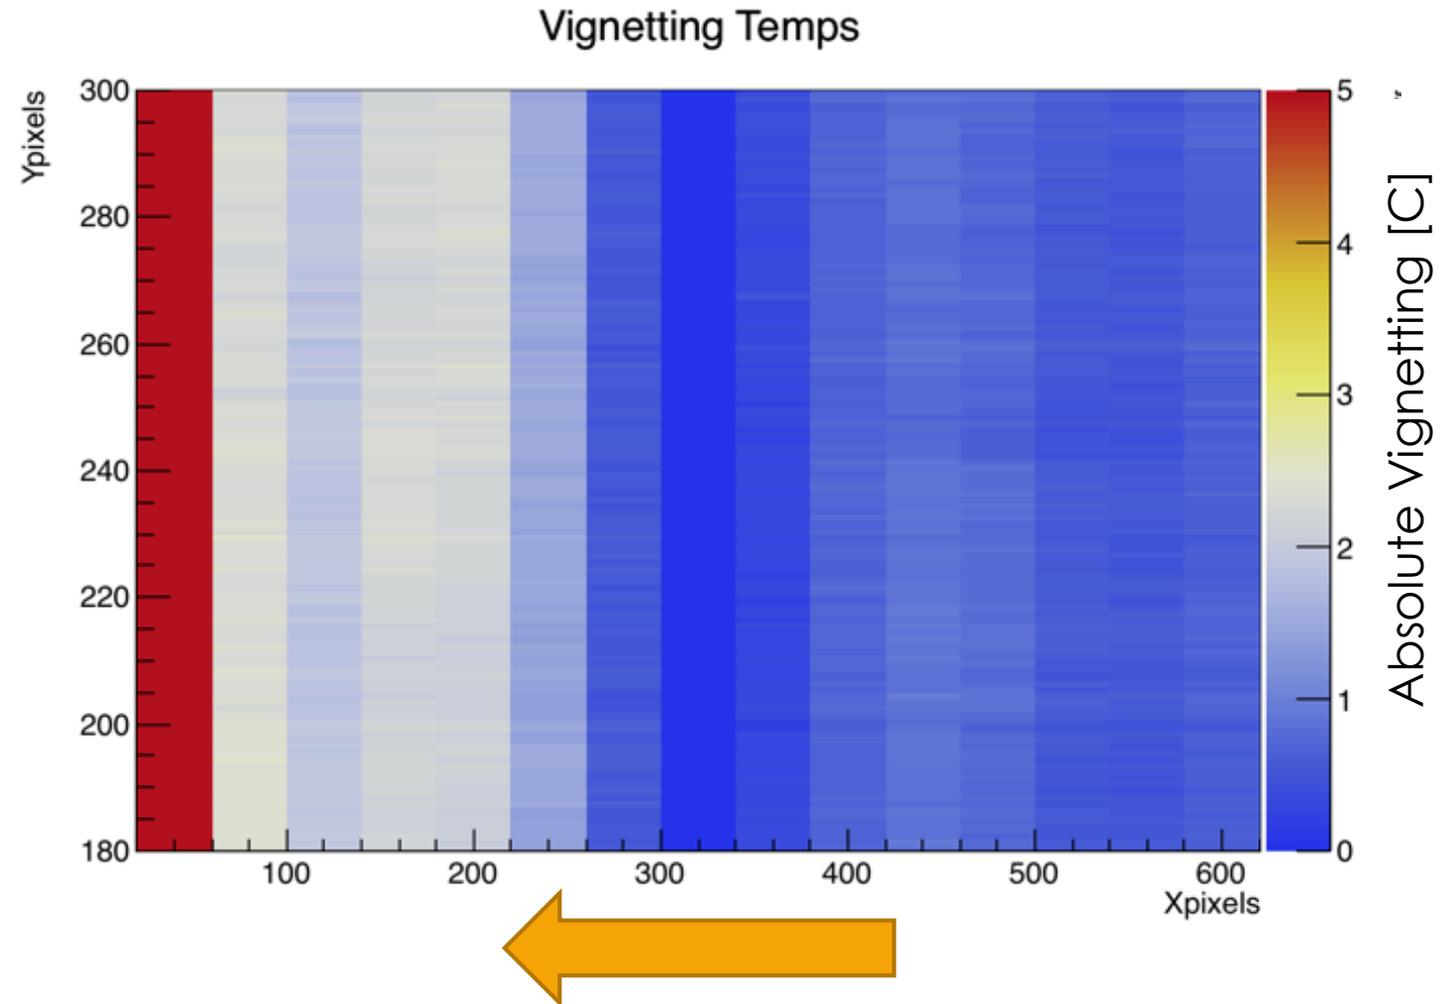
First Yale Trip -40C Block

- ▶ No NUC utilized during this run
- ▶ Similar to what we saw at ISU (~3 max)
- ▶ Vignetting worsens over time (orange arrow)
- ▶ Error in the last row

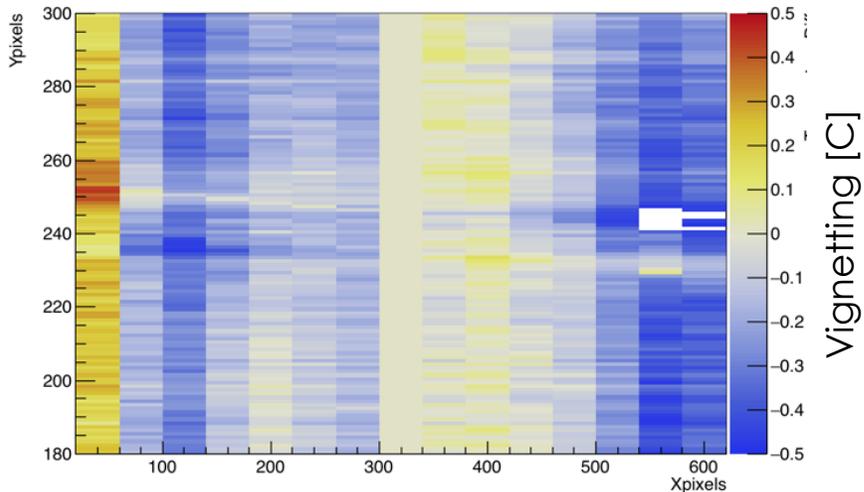
Vignetting Temps

- ▶ For the cold measurement, fluctuations of the temperature are at most 0.2 C
- ▶ Orange arrows display direction of taken data

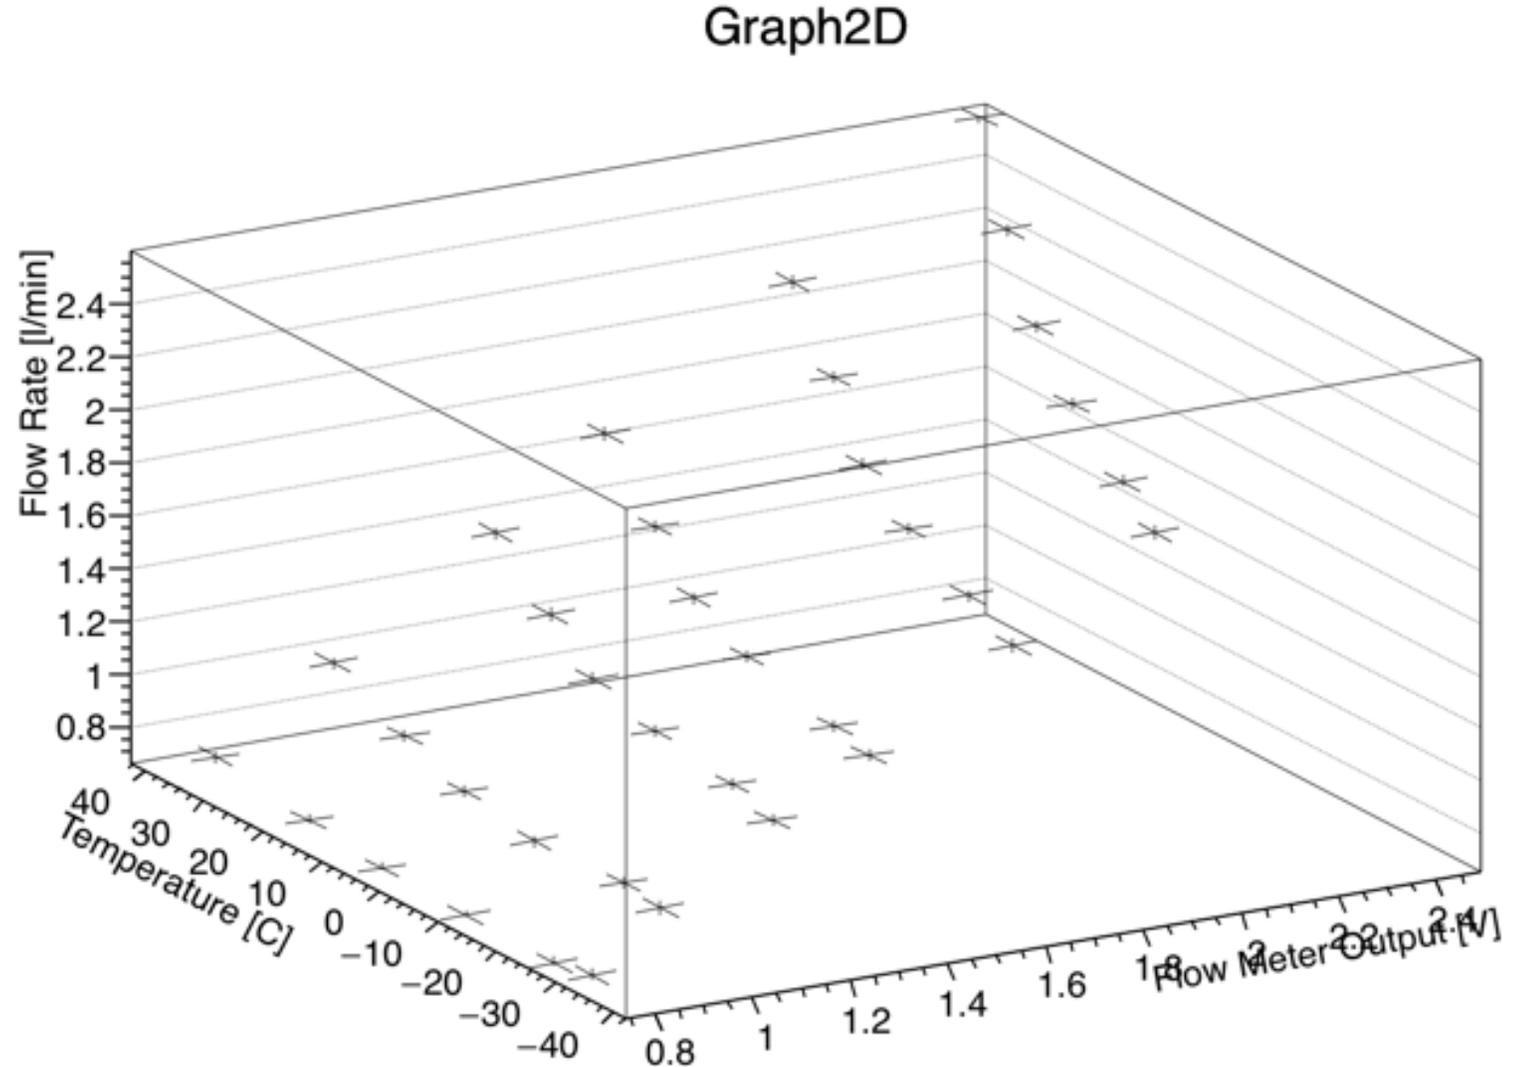
Flow Rate Calibration initial plots

- ▶ Novec 7100 fluid was passed through the flow meter with the metal calibration plate in line.
- ▶ The bypass was opened and the fluid was pumped into the 1l graduated cylinder while the time was measured with a stop watch
- ▶ The temperature of the chiller and booster pump were set to varying values
- ▶ Initial plot of the data is shown at the right...
- ▶ I will have nicer plots in the future
