MICROWEEKLY MEETING
RICCARDO CALLEGARI

19/09/2018

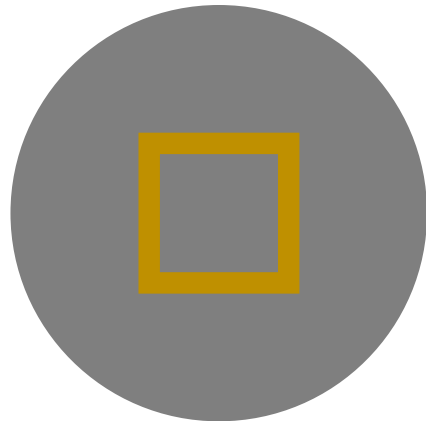
2. Kapton tape which recreates a shape a little smaller than the external dimensions of the chip
