Study of beam induced damages to the ATLAS ITK pixel and strip detectors

International HiRadMat Workshop: 12-July-2019

Introduction

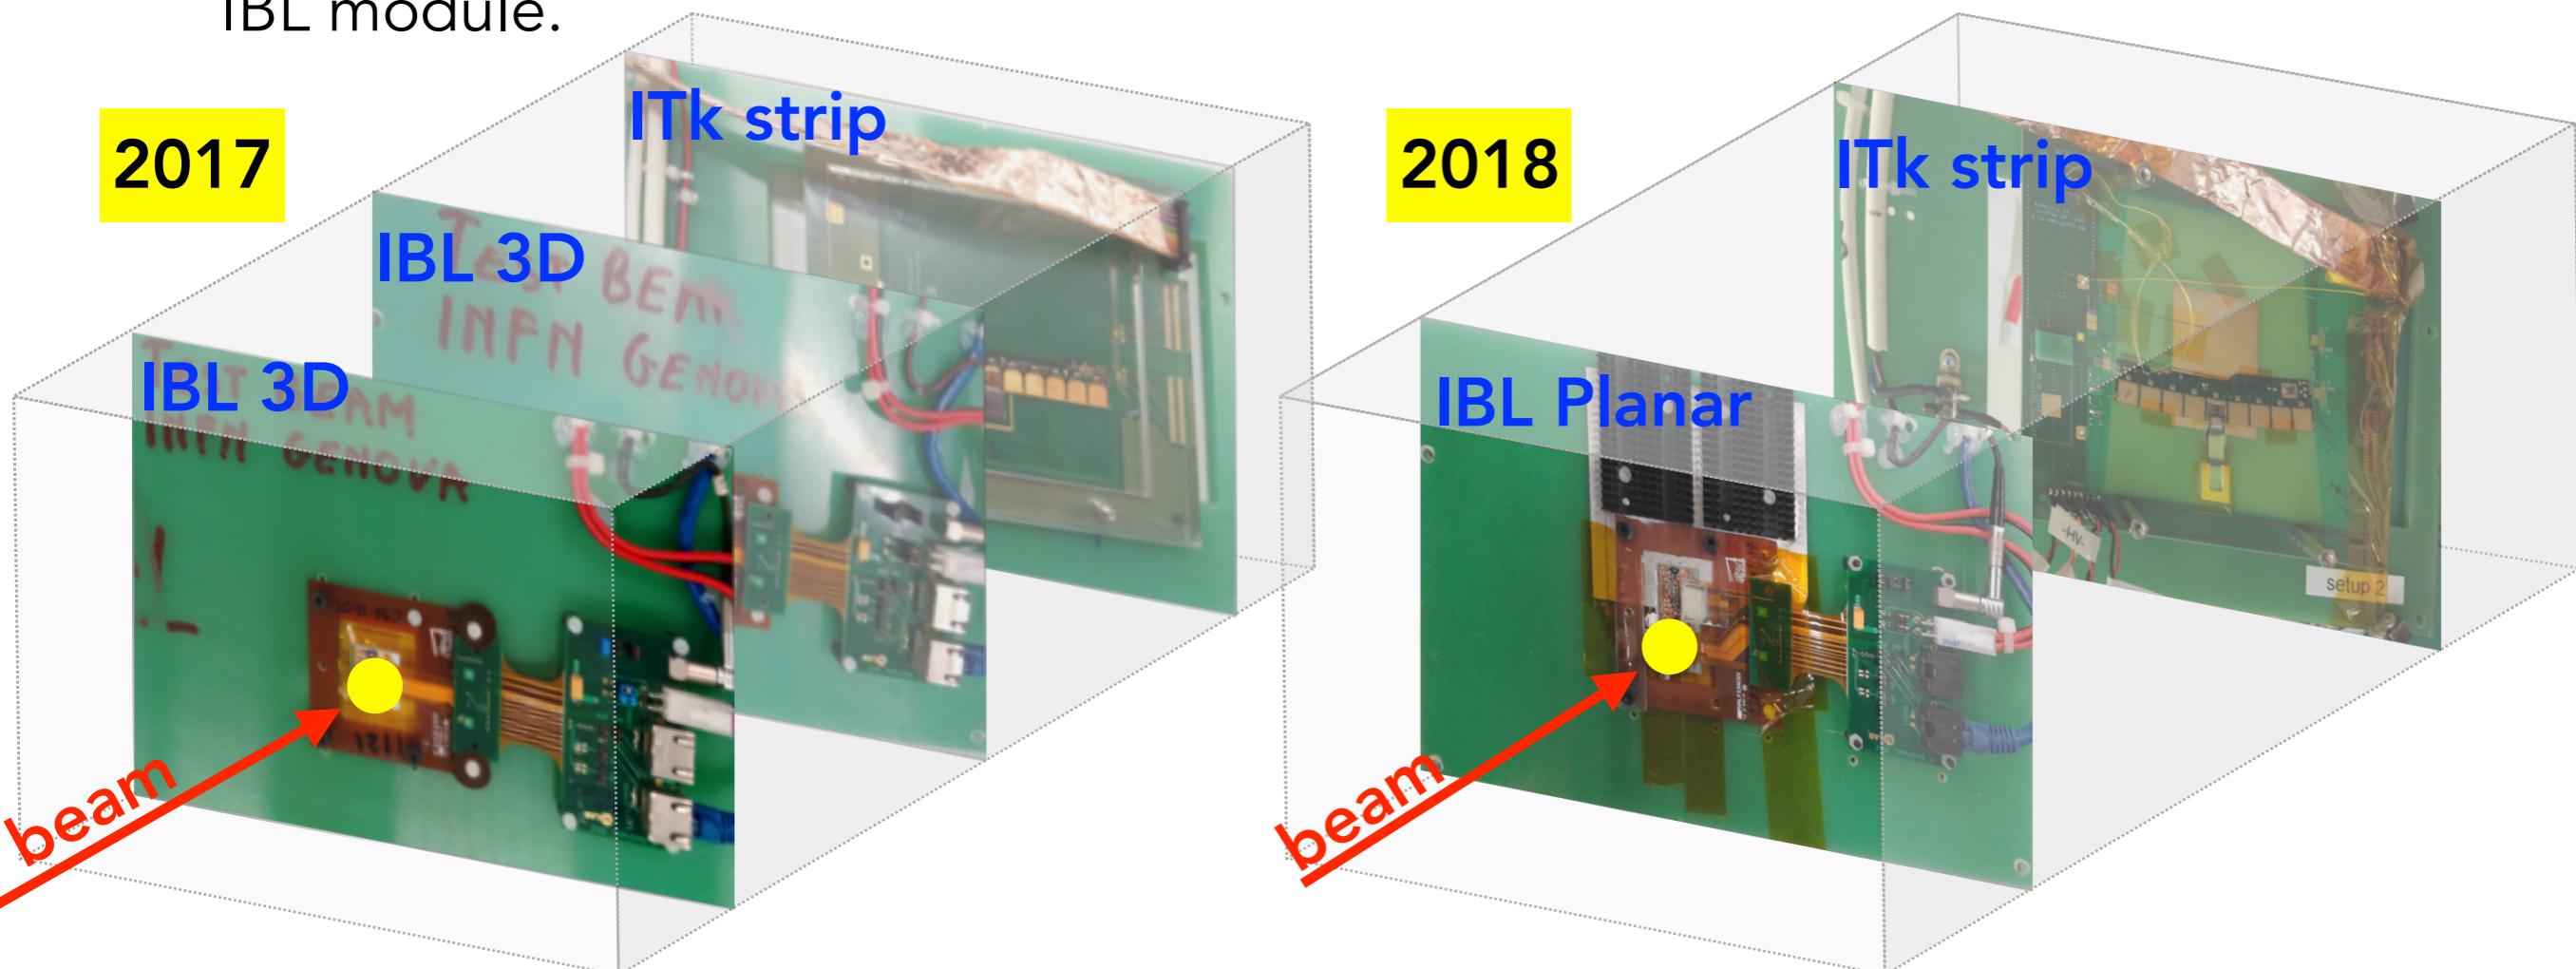
Text Box

Design and construction of the test-box:

- ▶ Material: epoxy fiber glass, makrolon and aluminium.
- ▶ Designed to host a maximum of 8 detector modules mounted on dedicated frames: module frames separated by 5 cm.
- ▶ Cooling system: 4 fans (12x12 cm) with filters.
 - ▶ In 2017: important temperature variation affected modules performance
 - ▶ Aluminium plane and dissipator added in 2018 to stabilise the temperature for IBL module.
