# SPS SEY drum measurements

Valentine Petit, Holger Neupert, Danilo A. Zanin, Mauro Taborelli

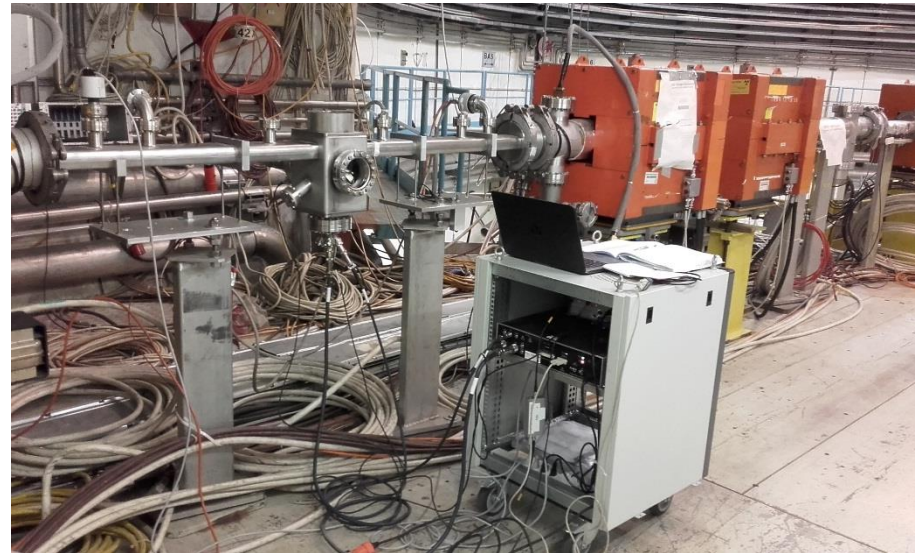
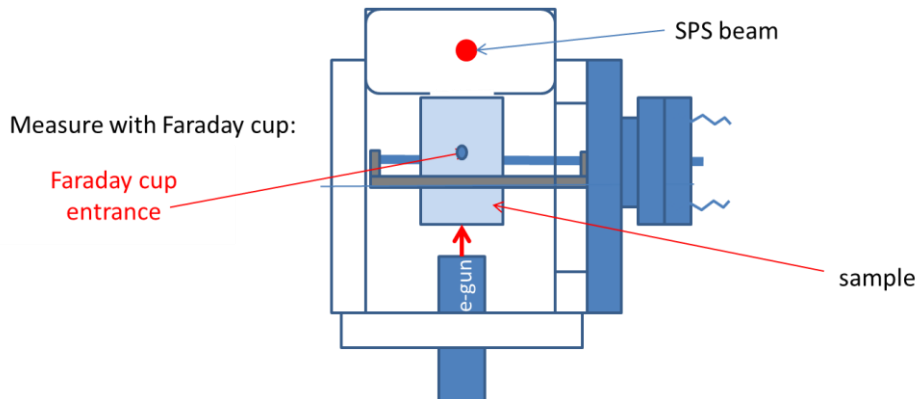
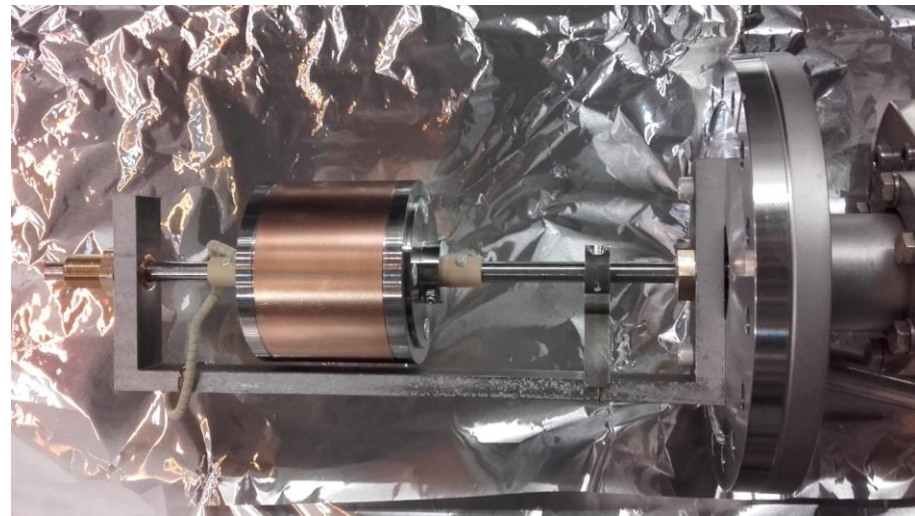
- BA5
- In situ SEY measurement
- Field free region
- MBB chamber

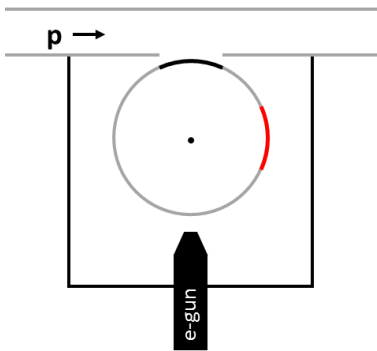
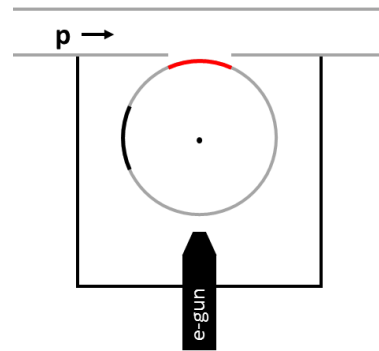
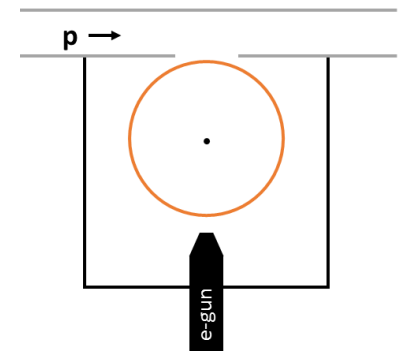
## Installation

- Surface 1 exposed to beam
- Rest of the drum (incl. surface 2) in beam vacuum

## Changing surface configuration under vacuum

- Surface 2 exposed to beam
- Surface 1 in beam vacuum

## Venting, changing material

- 1 surface exposed to beam
- Rest of the drum in beam vacuum

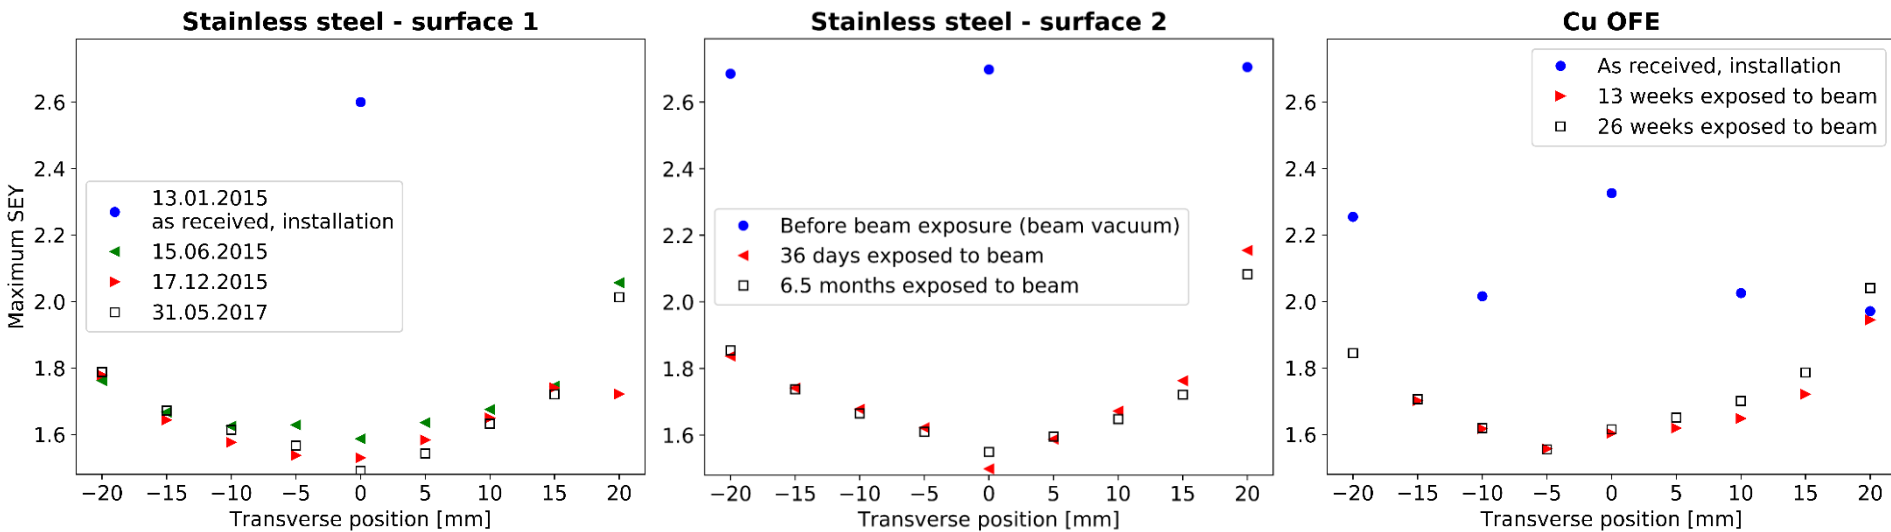
- Clear conditioning effect visible on the two materials : the maximum SEY decreases all over the exposed surface, the minimum  $\delta_{\max}$  being in the center of the chamber.
- Maximum SEY decrease saturates at  $\sim 1.55$ , already after 36 days of beam exposure
- Compatible with e-cloud build up threshold?

- Conditioning is effective down to  $\delta_{\max} = 1.55$  for both copper and stainless steel
- During conditioning  $E_{\max}$  shifts to lower energy (opposite to lab)
- For long-term beam exposure the surface is getting dark and the high energy tail of the SEY curves goes down
- Surface (even not directly exposed to beam) is full of carbon

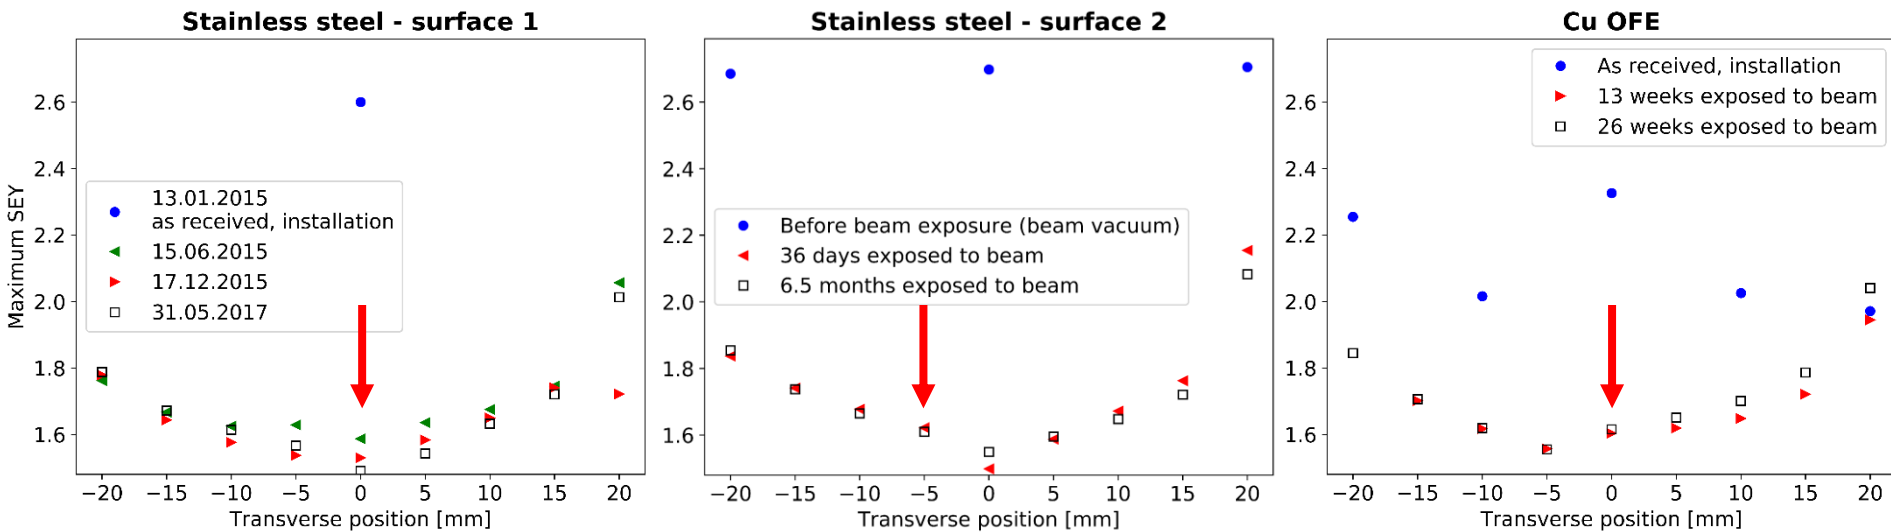
- Clear conditioning effect visible on the two materials : the maximum SEY decreases all over the exposed surface, the minimum  $\delta_{\max}$  being in the center of the chamber.
- Maximum SEY decrease saturates at  $\sim 1.55$ , already after 36 days of beam exposure
- Compatible with e-cloud build up threshold?

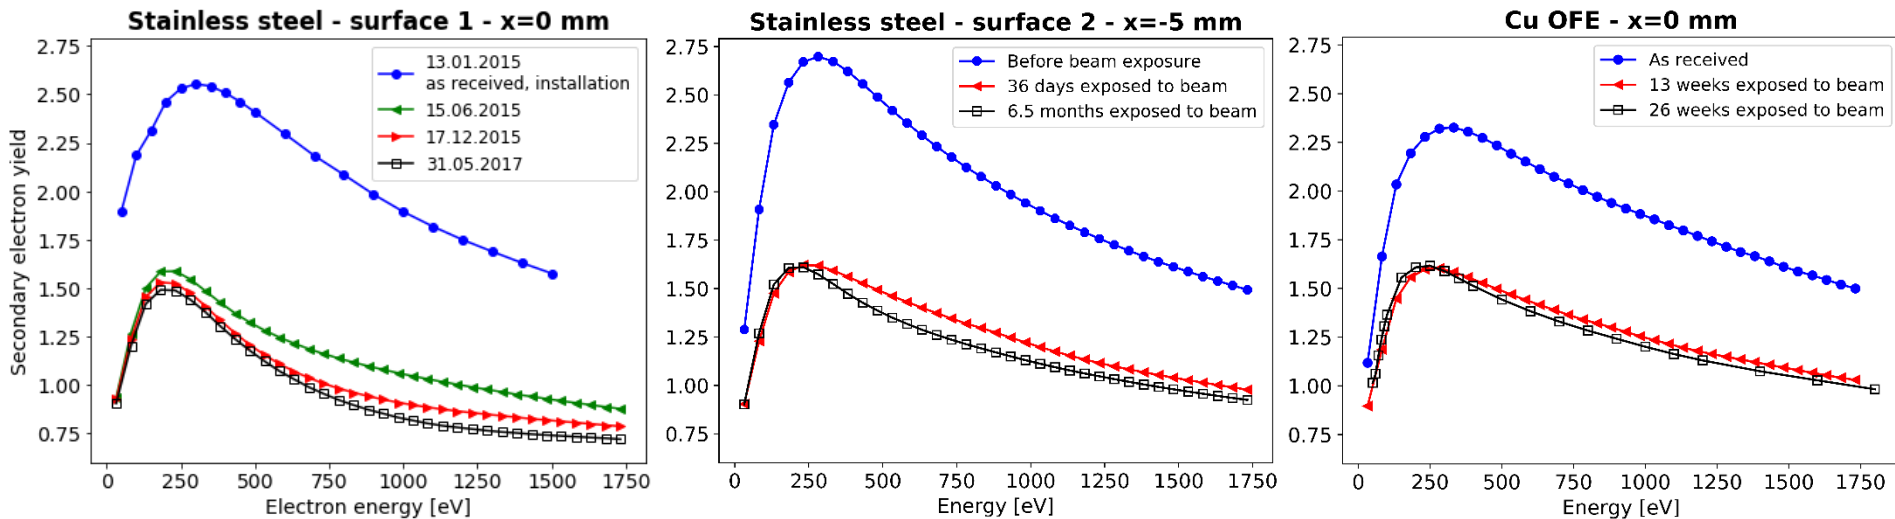
- Decrease of SEY together with a shift of  $E_{\max}$  to lower energy (opposite to lab)
  - For the longest beam exposed surface, modification of the SEY curve: the tail is moving down
- maximum SEY does not decrease anymore, but something is still happening!

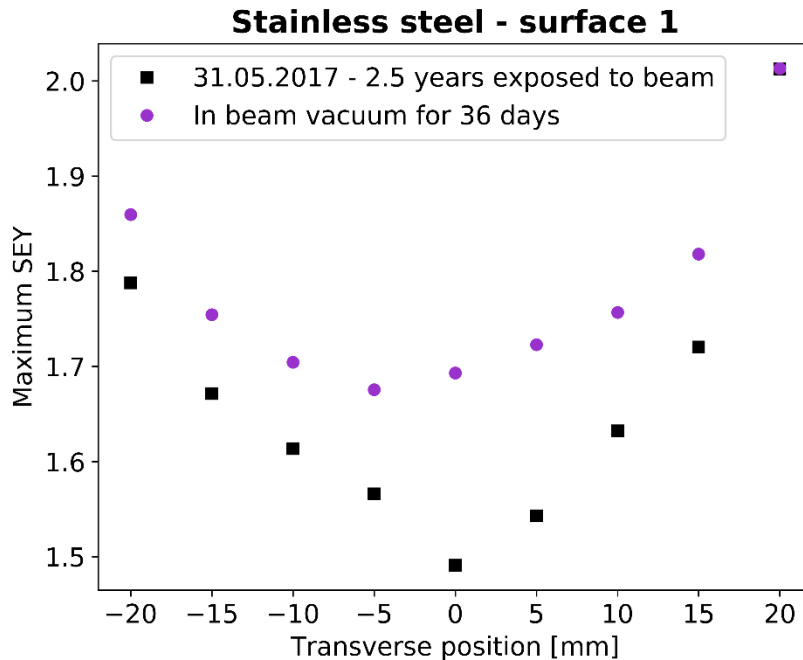
- Maximum SEY increase observed for a conditioned surface « stored » in beam vacuum
- The lowest the SEY after conditioning, the largest the increase of  $\delta_{\max}$

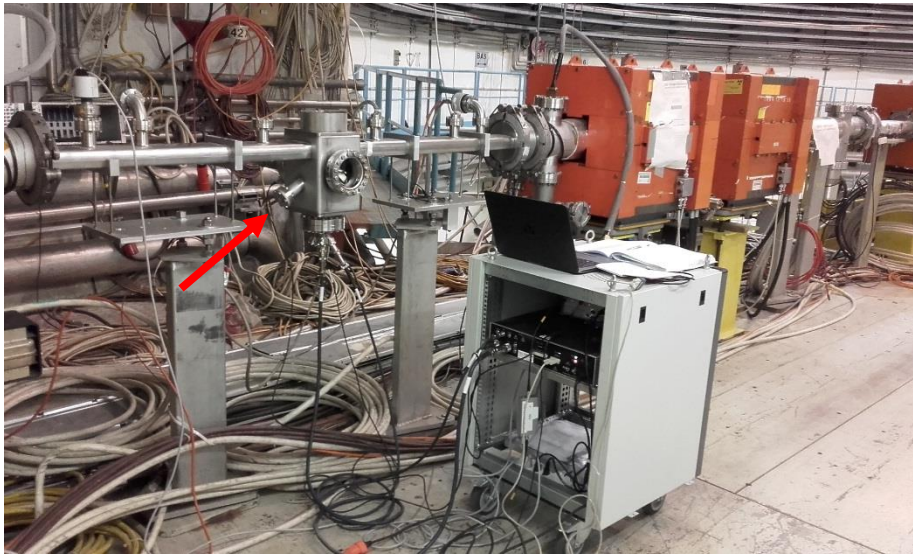
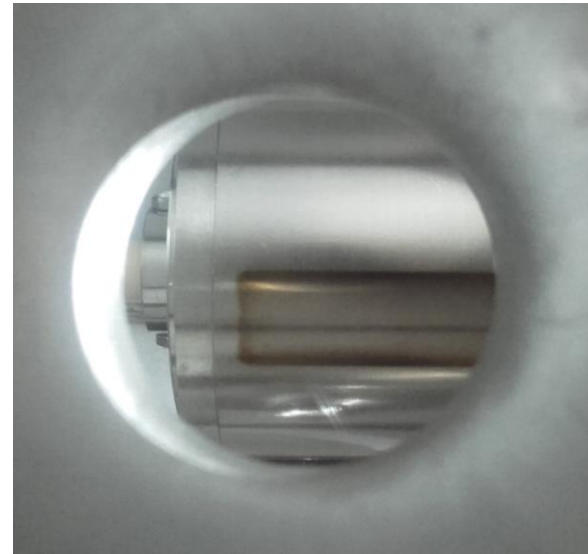
Surface exposed to beam for 2.5 years

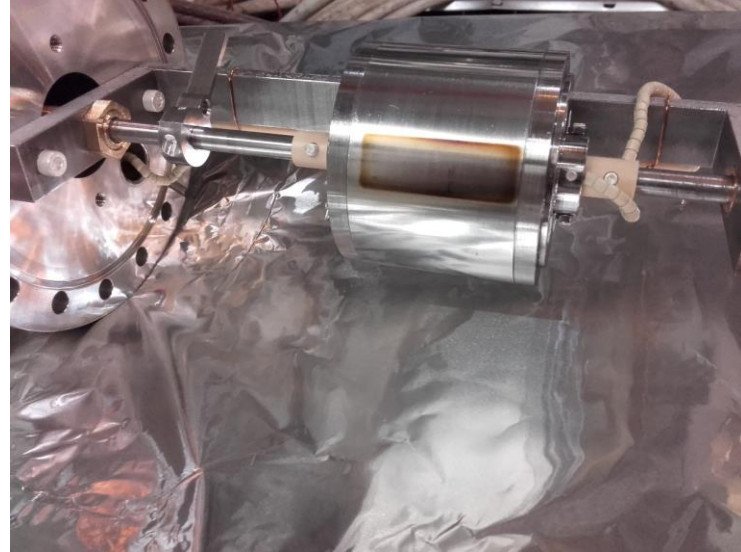
- Clear print of the beam pipe window on the 2.5 year exposed surface (change of color mainly visible on the contour of the area)
- Dark trace barely visible on the surface exposed for 6 months
- Would have been a nice idea to look at the beam pipe surface facing the window...

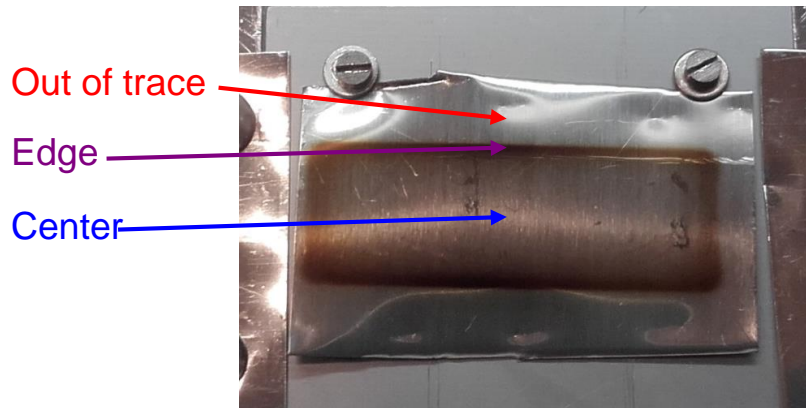
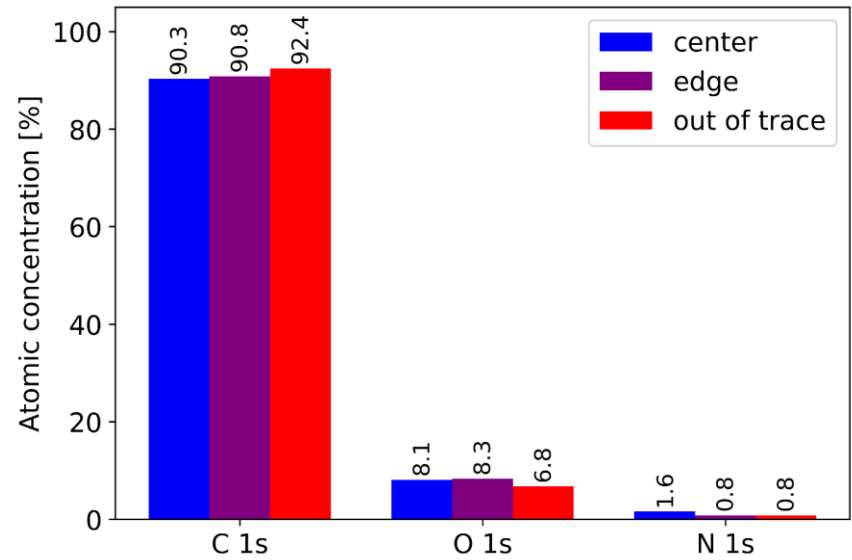
Stainless steel foil: 2 weeks in air

- Carbon everywhere, including outside of the exposed area!

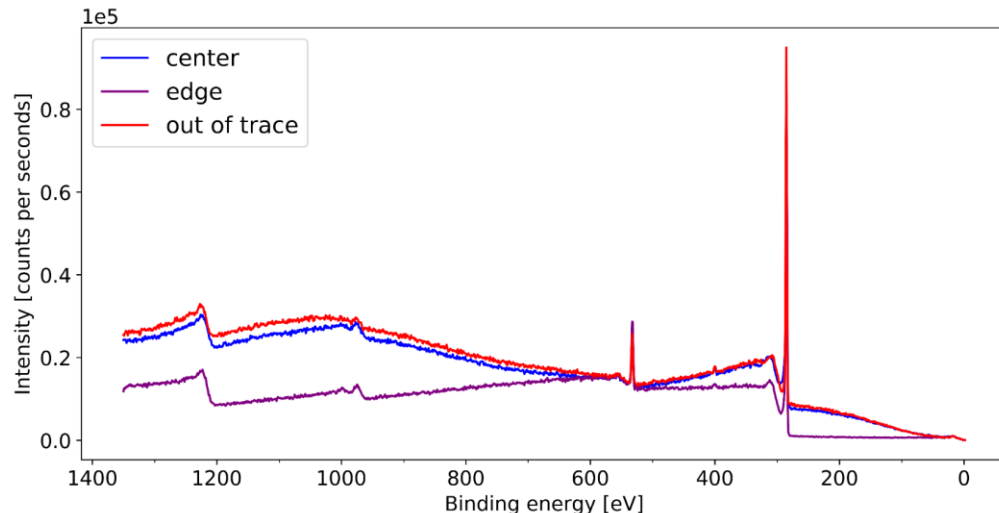
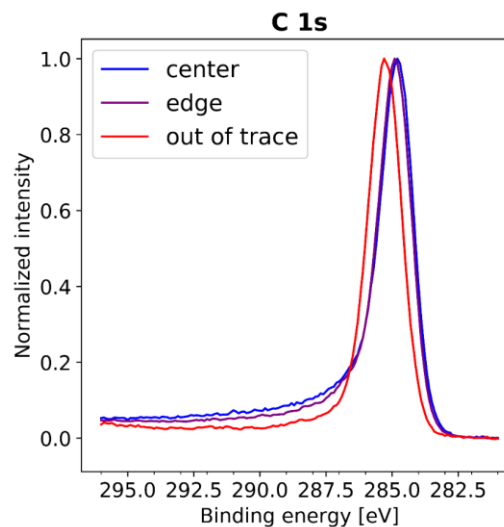
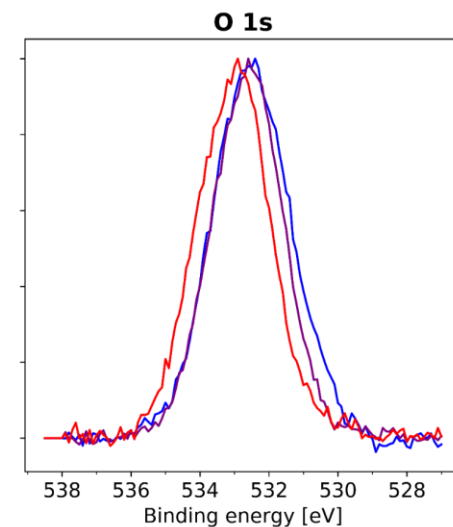
Stainless steel foil: 2 weeks in air

- Different background for the point measure at the edge of the trace (darkest area)  
→ effect of carbon thickness or cristallinity?
- Exposed area: C 1s shifted to lower binding energies (more graphitic, coherent with lab), and higher high energy tail
- Exposed area: O 1s shifted to lower binding energies (coherent with lab)

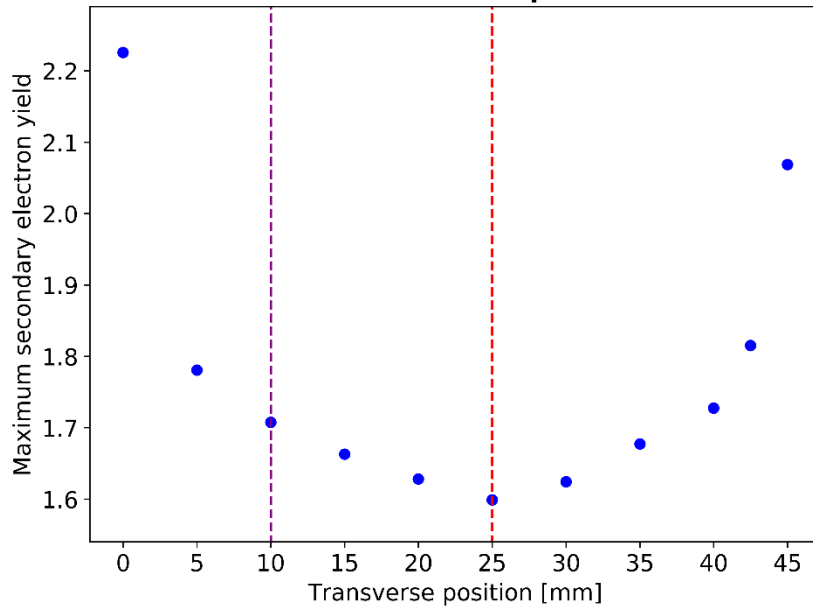
Transverse SEY profile

- After 2 weeks in air, minimum  $\delta_{\max} \approx 1.6$ , while it was almost 1.7 under vacuum... One cannot exclude that in-situ measurement is not performed perfectly in the center of the trace, or that we have an effect of different measuring setups In anycase, the SEY increase during two weeks is small!
