Radiation Damage Experiments Update from the RaDIATE Collaboration

27 August 2019

21st International Workshop on Neutrinos
from Accelerators (NuFact 2019)
Daegu, Korea

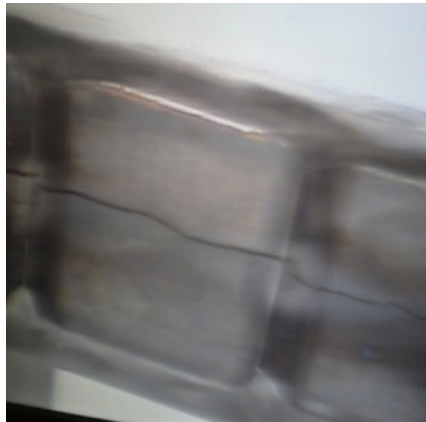
Cracked NuMI target, FNAL

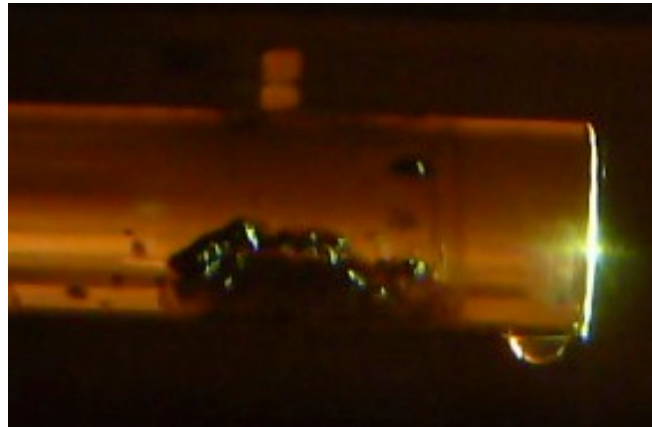
NuMI-MINOS target cooling water leak and radiation-assisted corrosion, FNAL

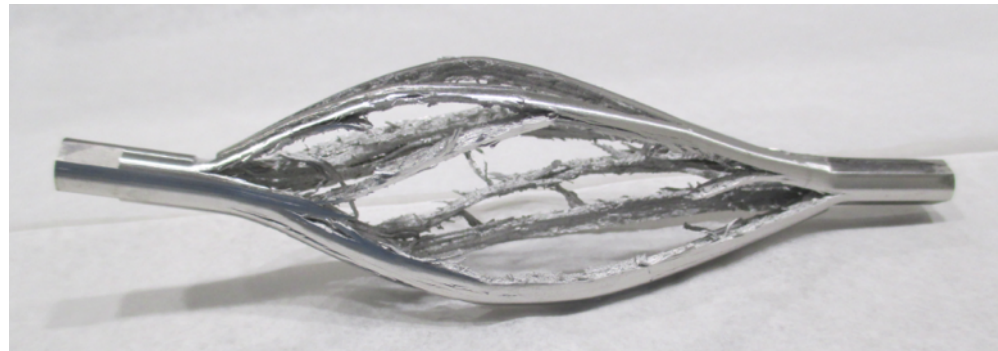
Ir rod after a single proton pulse (1.27×10^{12} pot)
Torregrosa et al. 2016. CERN-EN-2016-004

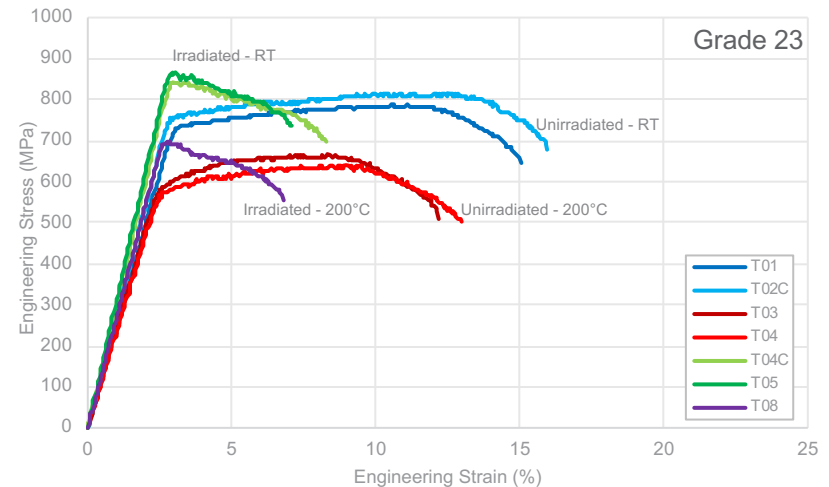
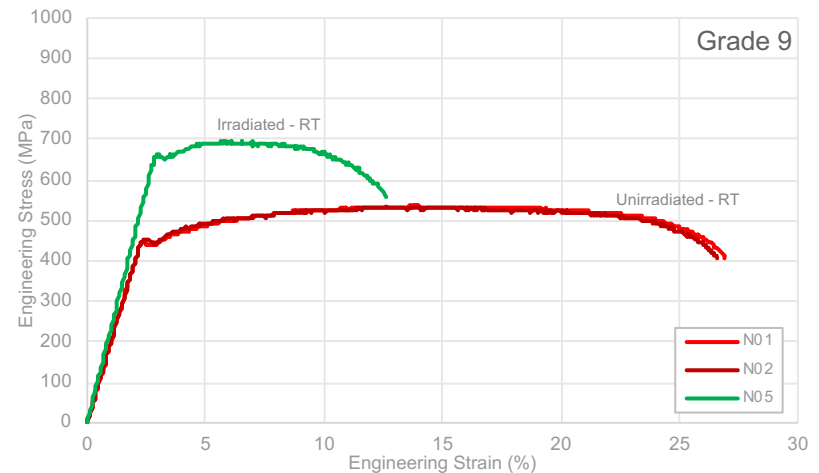
- Irradiated samples received ~0.25 dpa
- Distinct radiation hardening observed for each of the four grades
 - Ti-6Al-4V
 - Grade 5 – Standard commercial grade
 - Grade 23 – Extra low interstitials (ELI)
 - Grade 23-F – ELI, alternate processing
 - Ti-3Al-2.5V
 - Grade 9 – Standard commercial grade
- Ti-3Al-2.5V retains some uniform elongation after irradiation while Ti-6Al-4V grades have essentially none
- Ti-6Al-4V grades stronger than Ti-3Al-2.5V but less ductile
- Additional irradiated (1.0-1.5 dpa) tensile tests currently underway

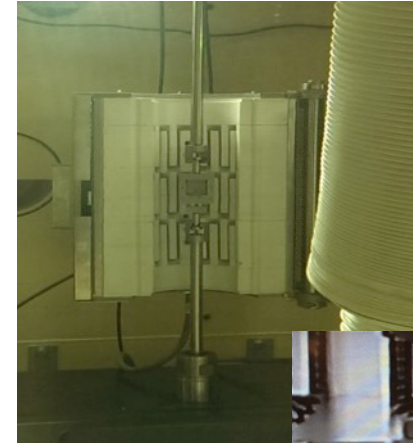
Load frame and furnace in the hot cell at PNNL

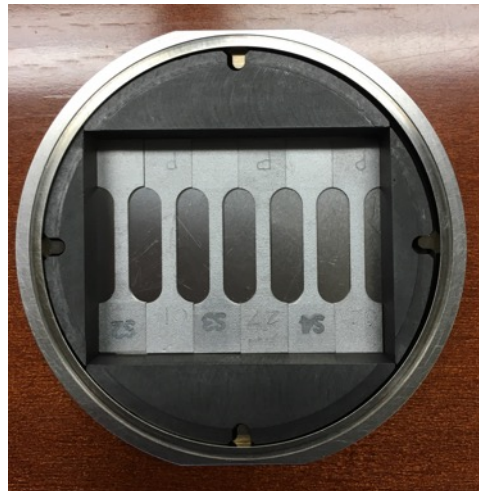
One layer of Be (PF-60) tensile samples during assembly of the irradiation capsule

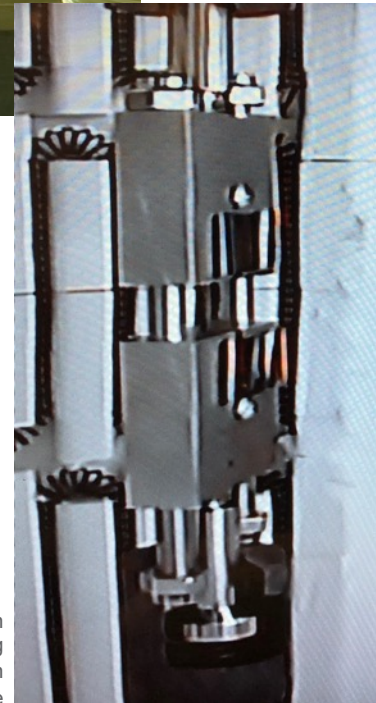
Be sample loaded in the tensile testing fixture and mounted in the load frame
