The Nuts and Bolts Affecting Accelerator Reliability

Andreas Stolz

NSCL / Michigan State University

A1900 Dipole Magnet 3 Failure

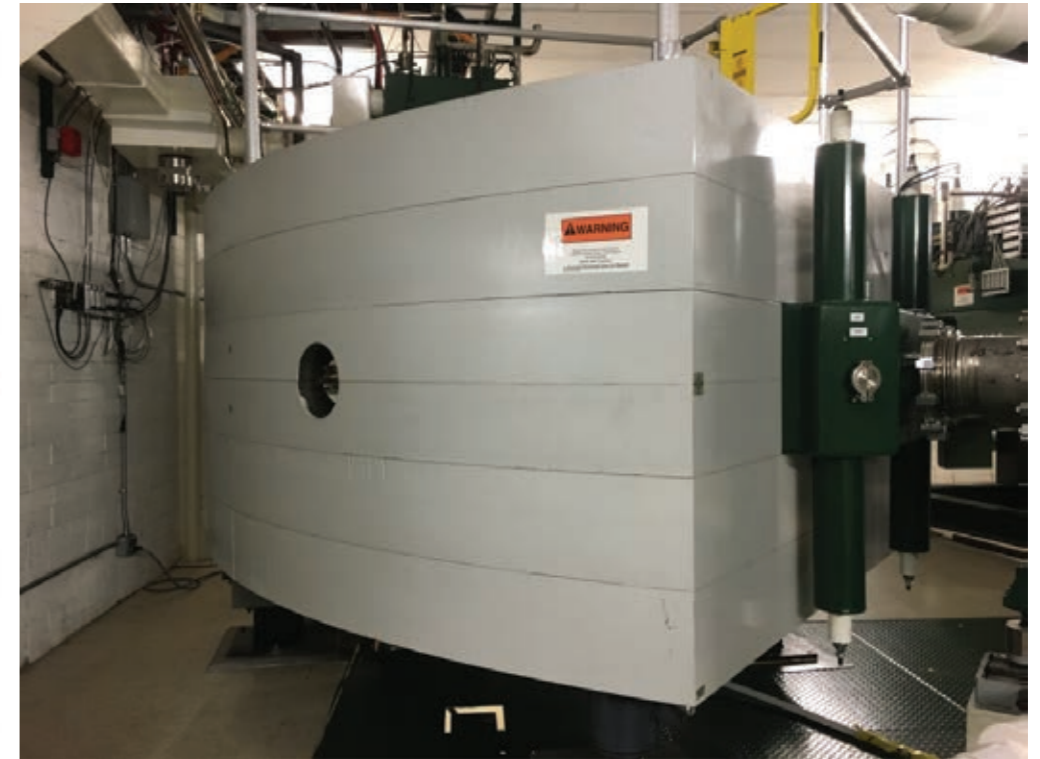
A1900 fragment separator
to produce rare isotope beams
by projectile fragmentation

Superconducting Dipole Magnets
maximum current: 160 Amps
maximum field: 2 Tesla
Inductance: 45 Henry @ 100 Amps
maximum stored energy: 500 kJ
weight: 50 tons

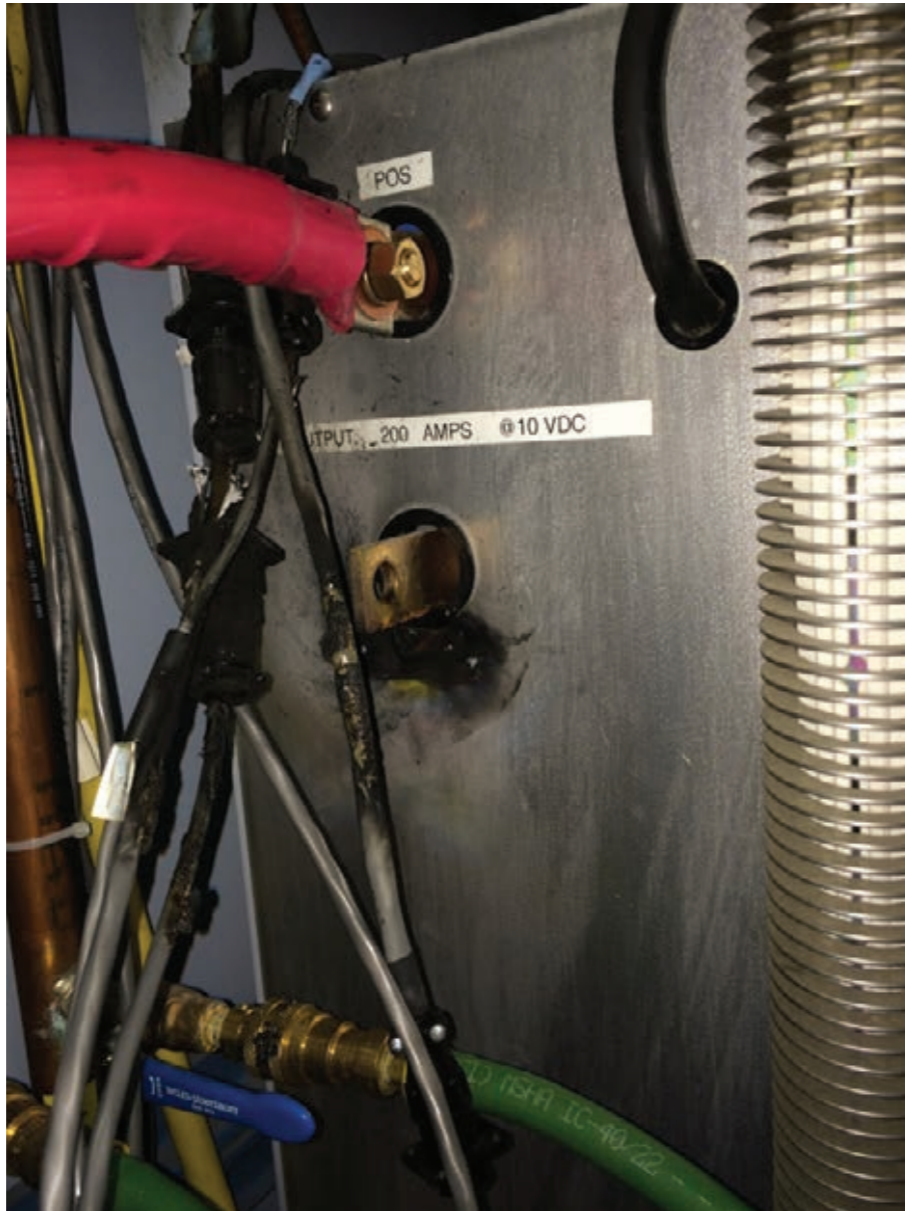
A1900 Dipole Magnet 3 Failure - Power Supply

Back of the power supply

During power supply replacement original stainless steel bolt was replaced with brass bolt in order to increase conductivity.

This bolt was found broken inside the power supply rack.

Stored energy in magnet: 137 kJ

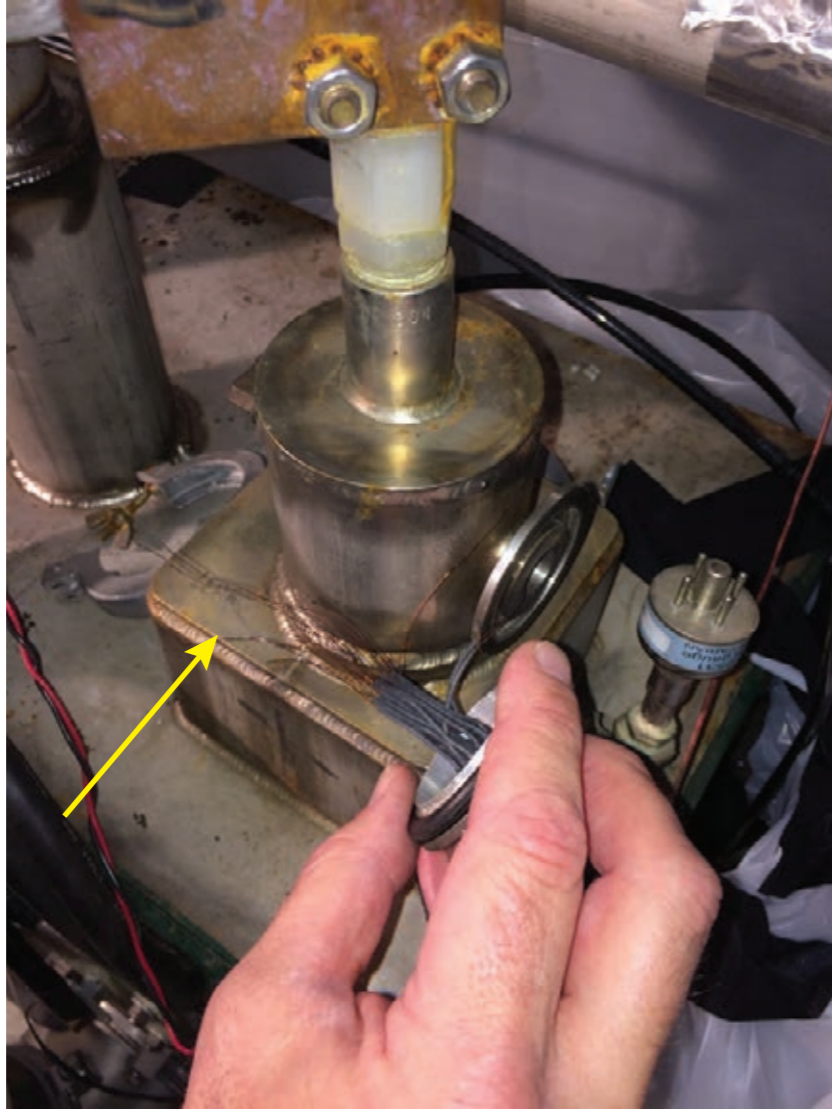
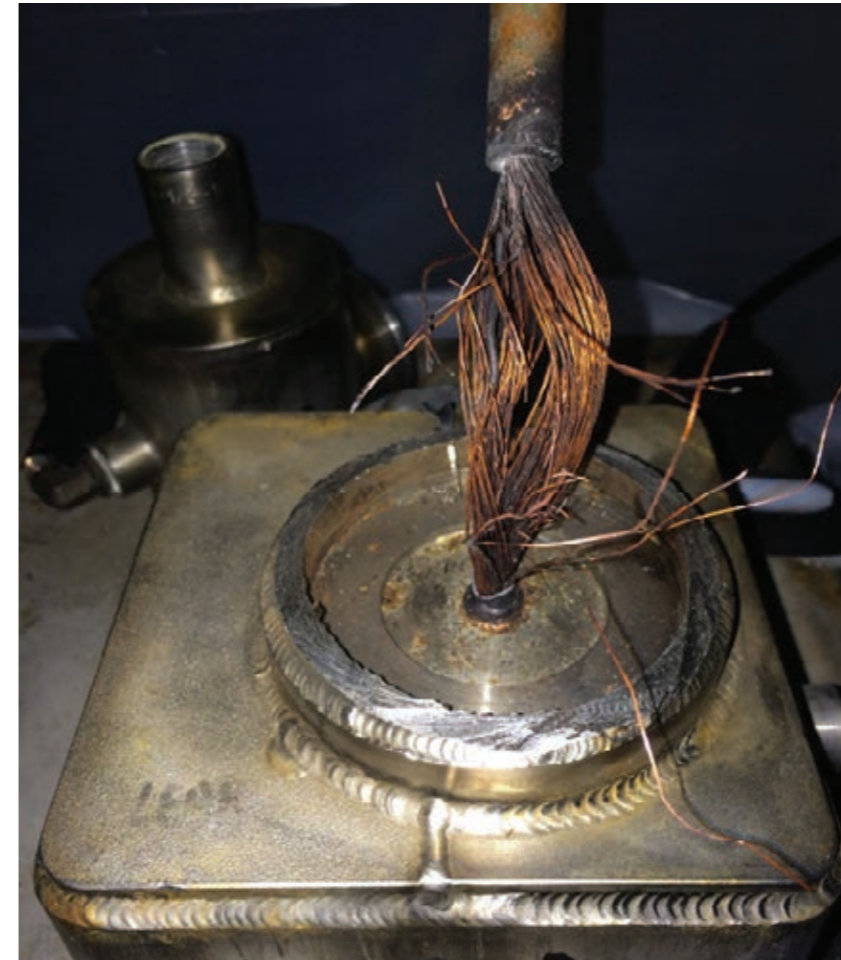
A1900 Dipole Magnet 3 Failure - Magnet Leads

Broken diagnostic wires

After removing the lead can it became obvious that superconducting lead wires were significantly damaged.

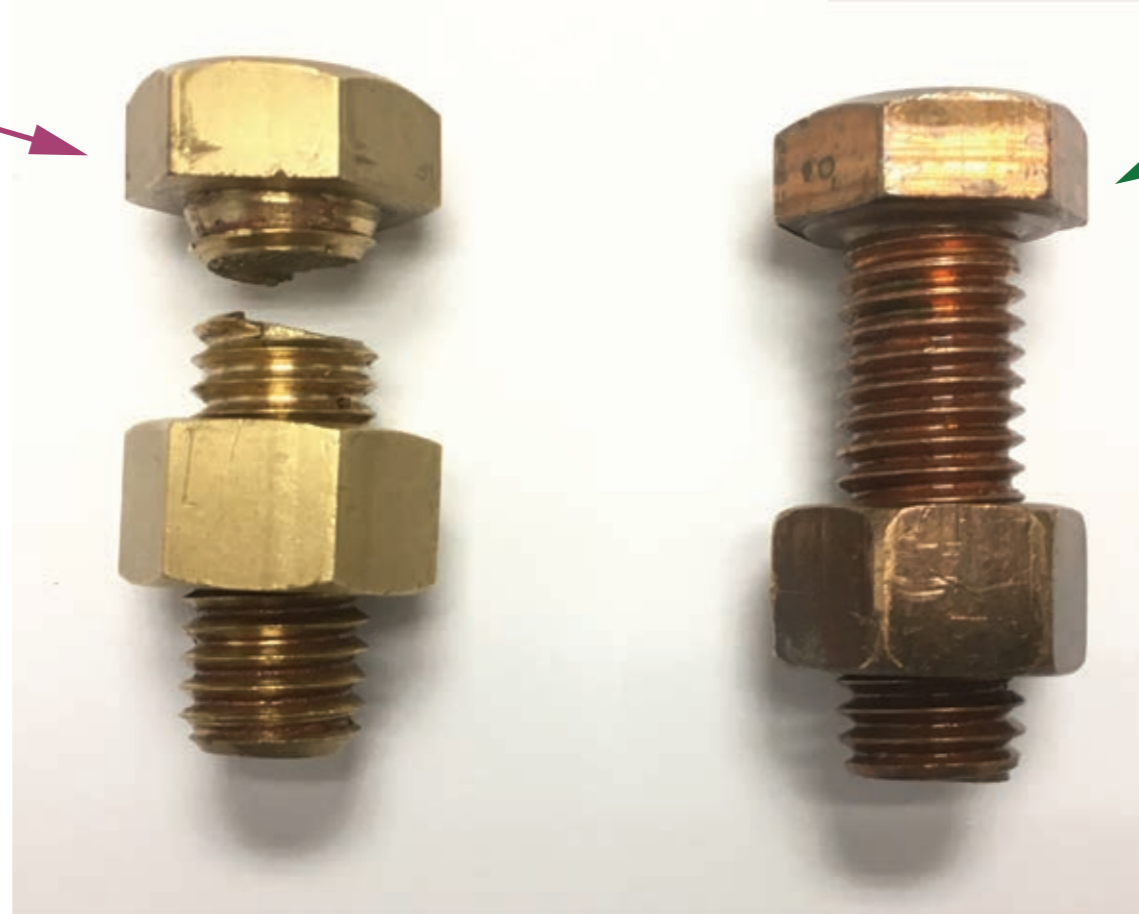
Identifying the Root Cause

This bolt was used

“Ornamental” Brass Bolt

Unknown material property

This bolt should have been used

Silicon-Bronze Hex cap bolt
Alloy 651 silicon bronze
(98.5% copper, 1.5% silicon)

Minimum tensile strength
tested according ASTM F468
to 50,000 psi.

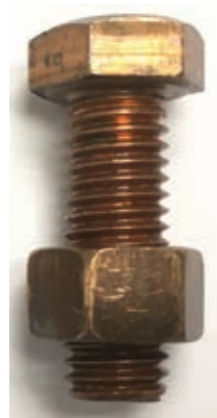
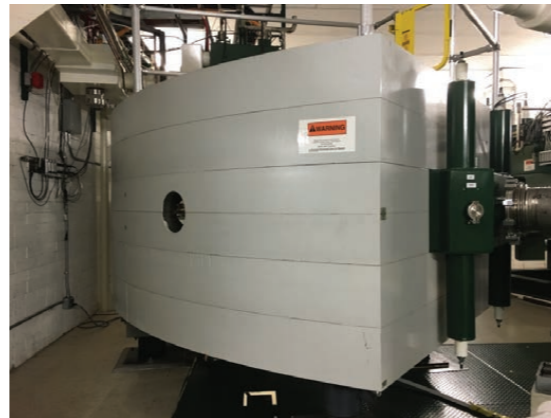
Failure of a bolt in an electric lead connection can lead to catastrophic results (particularly with super-conductive magnets)

- **Prepare written instructions for electric connections**
- **Buy quality hardware from reputable vendor**
- **Train your employees**
- **Inspect your connections on a regular basis**
