CMS GEM FRONT-END ELECTRONICS OPERATIONAL EXPERIENCE

Federica M. Simone¹, on behalf of the CMS Muon Group

1.0 INTRODUCTION: THE UPGRADE OF THE CMS MUON SYSTEM WITH TRIPLE-GEM DETECTORS

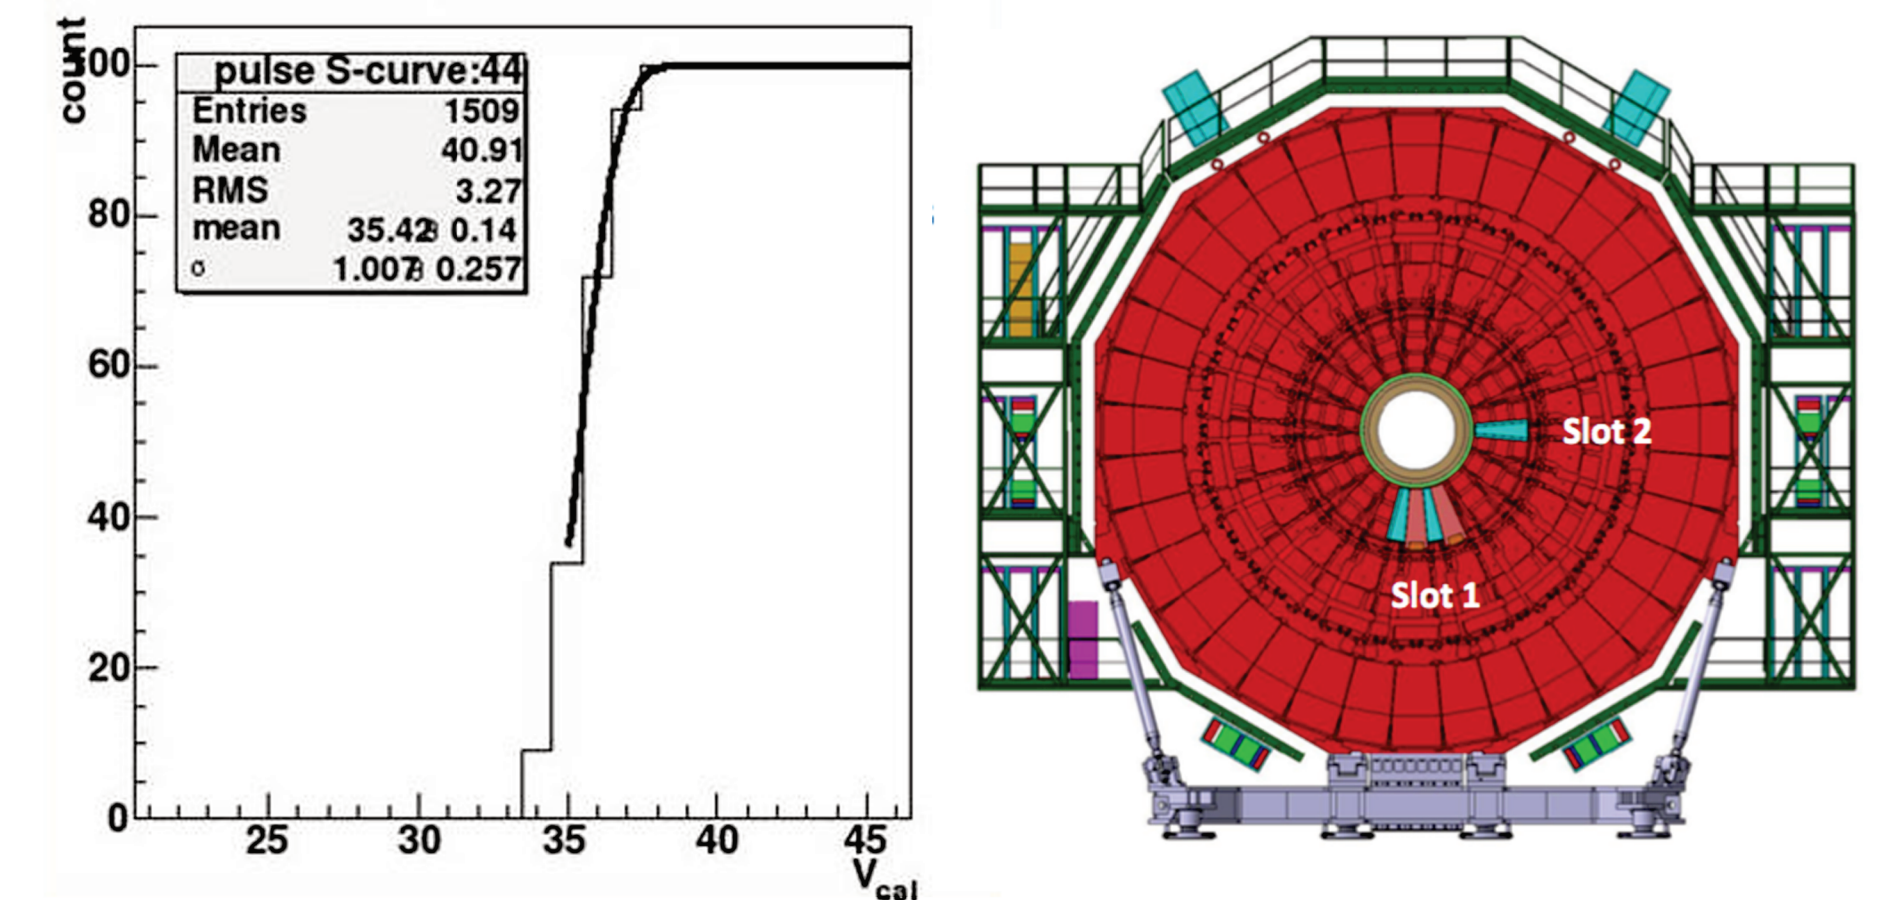
During Run II of the LHC, CMS has observed irreversible channel loss in the VFAT chips. Such channel loss has been detected during the daily "s-curve" measurement using the VFAT calibration module.

Being the width of the s-curve the channel ENC, disconnected channels show a low value consistent with zero added capacitance.

Left: S-curve measurement. Sweeping the input signal amplitude (Vcal) on a given channel and counting hits for a constant threshold. [2]

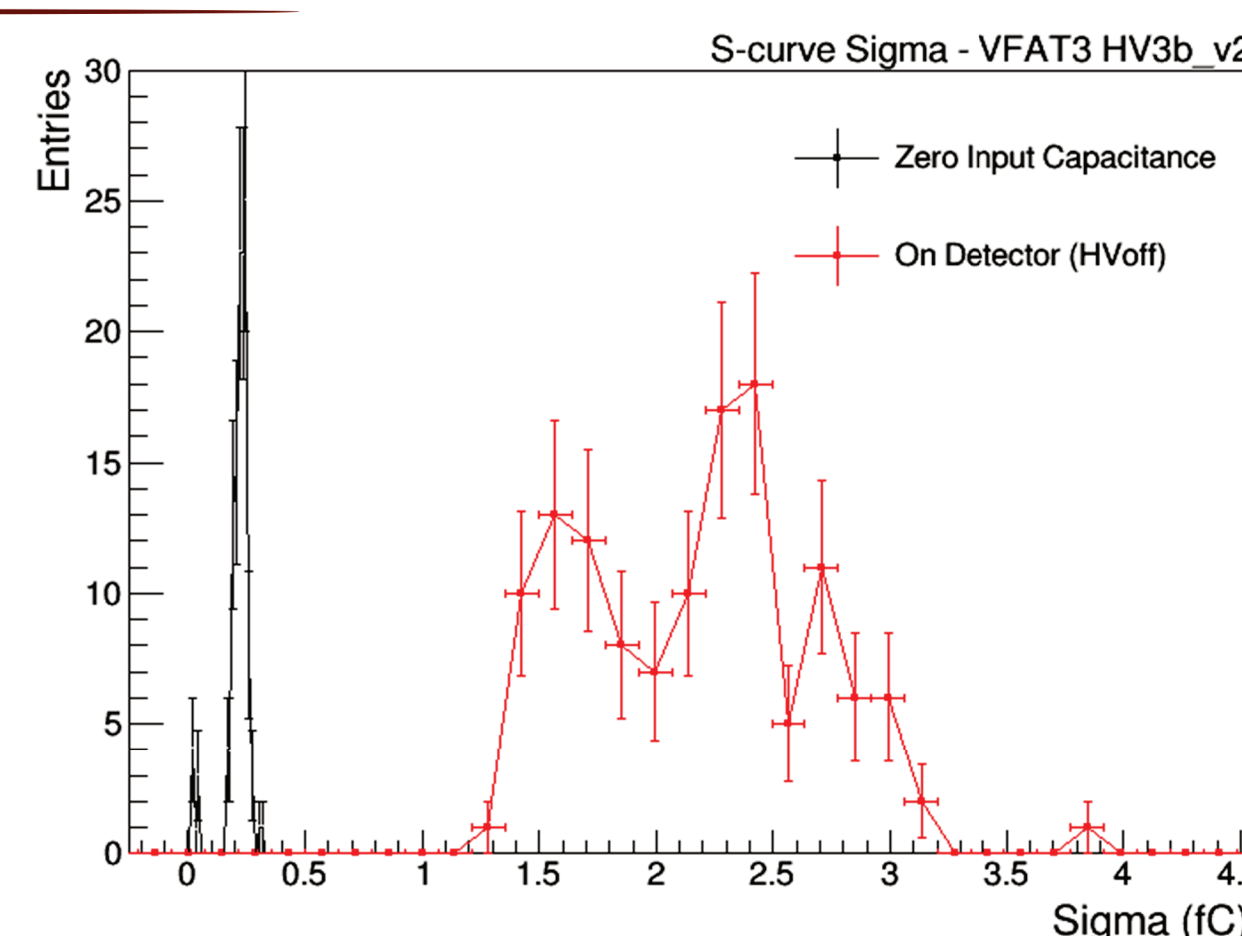
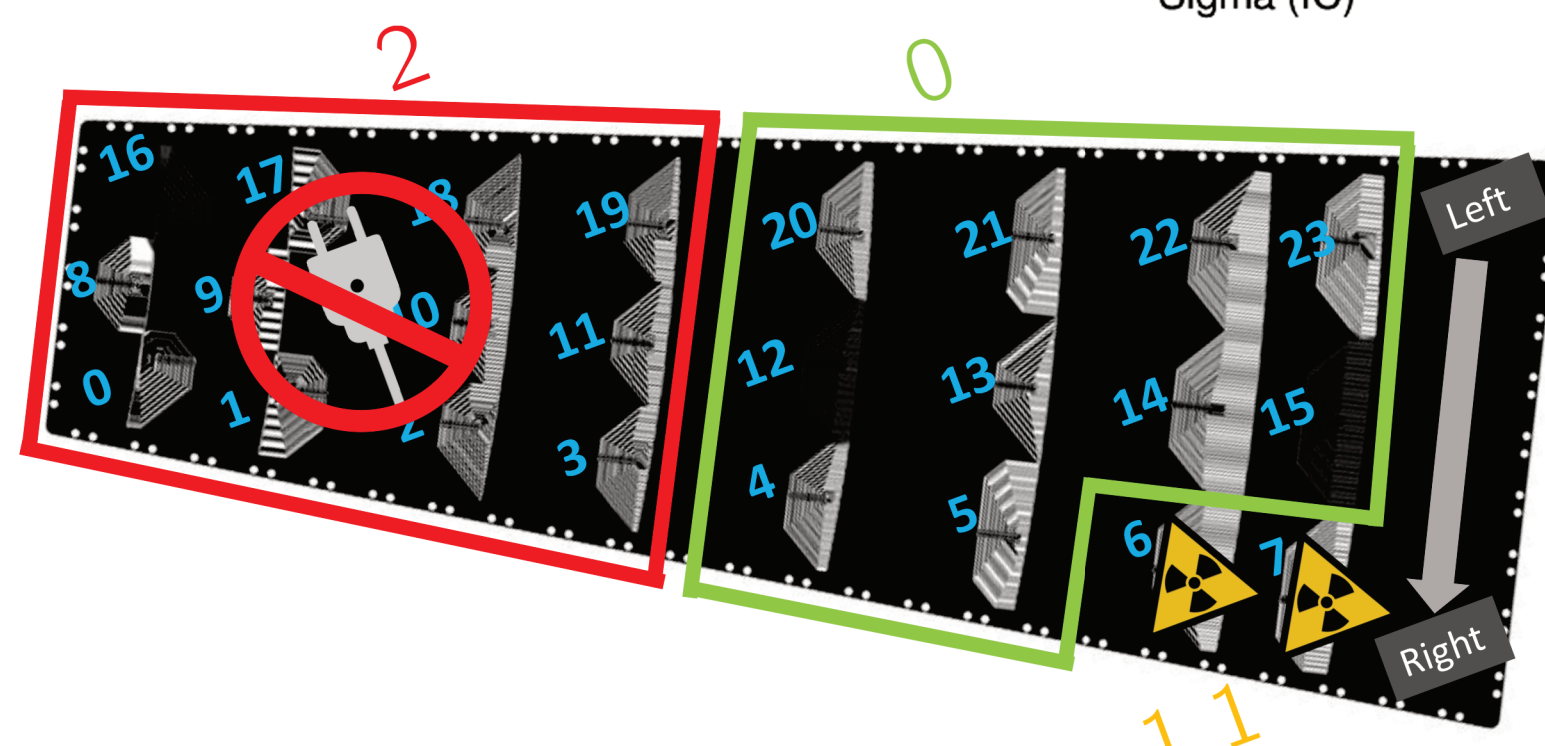
Experimental setup to reproduce scenarios 0, 1.1 and 2: GE1/1 detector operated at gain 1E4 in Ar/CO2 70/30 VFATs splitted in different groups:

- 1.1 VFATs continuously irradiated with Cd109 x-ray source
2. Low Voltage is off while High Voltage is on

Definition of "dead" VFAT channel = the ENC is compatible to the hypothesis that the channel is no more connected to the strip ($\approx 0 \text{ pF}$ input capacitance -> $\text{ENC} \leq 0.5 \text{ fC}$), or the channel is no longer responding (empty Scurve).

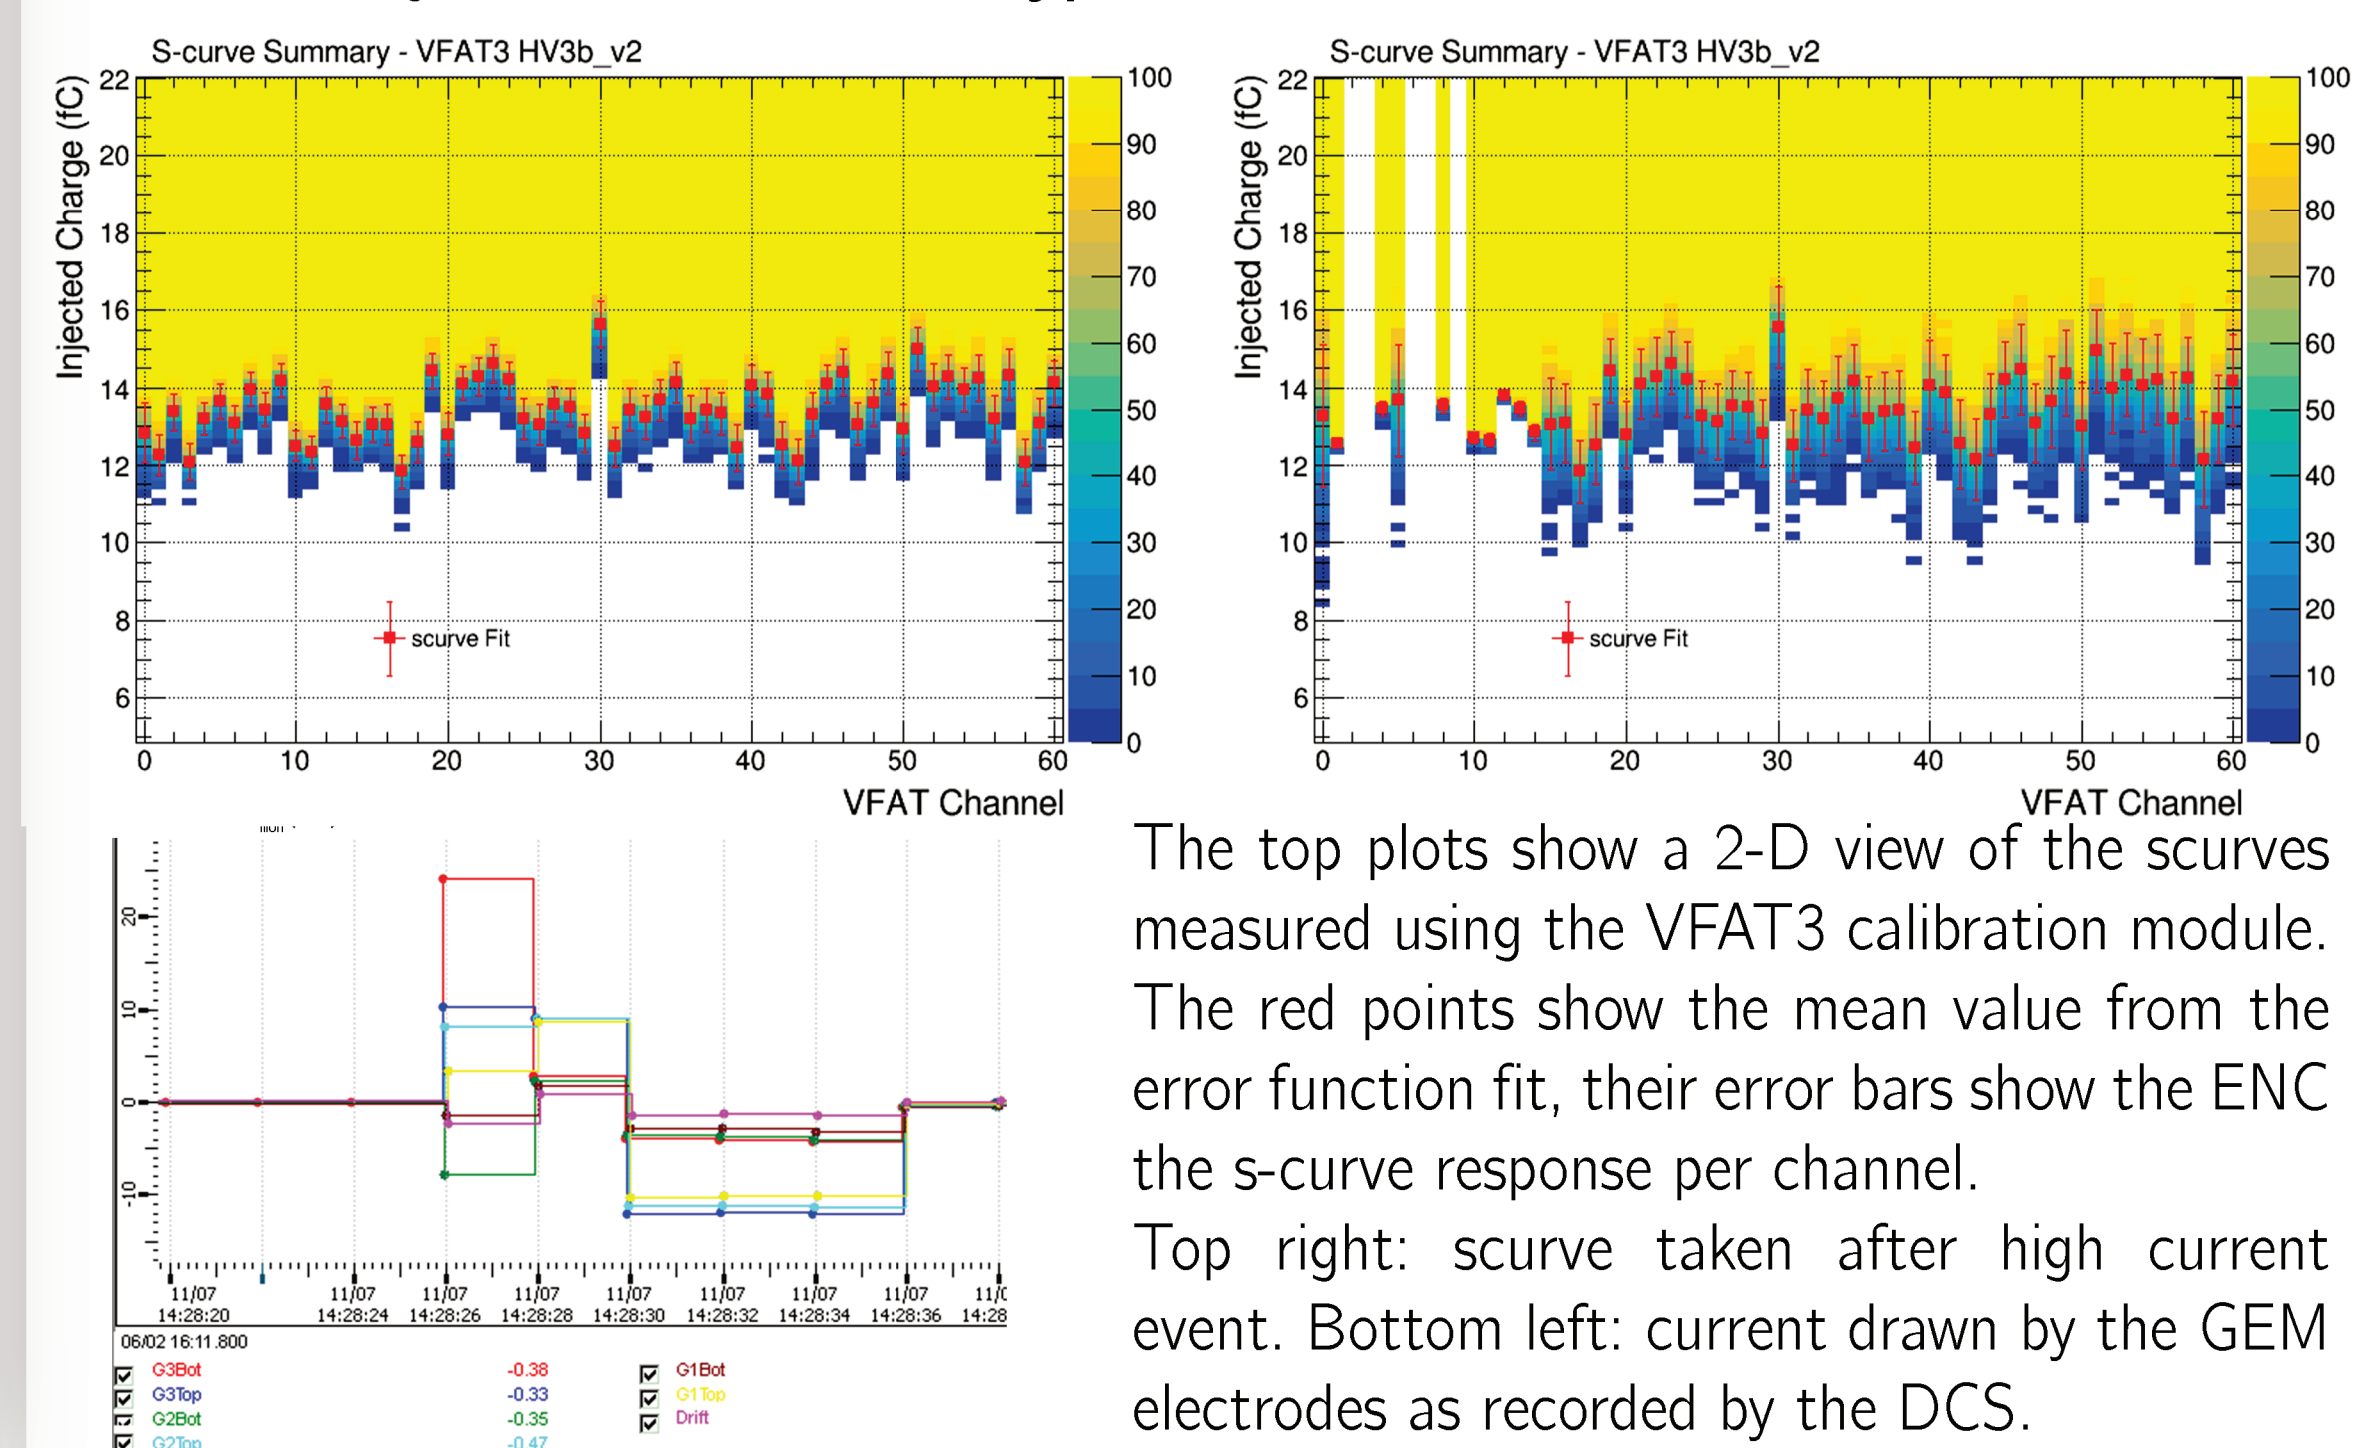
- No channel losses in normal operation (even in VFAT6 and 7, continuously irradiated with two Cd109 xray sources)
- We found dead channels only after 3 different high current events recorded by the HV DCS -> **Hypotesis 0, 1.1 and 2 ruled out**

The top plots show a 2-D view of the scurves measured using the VFAT3 calibration module. The red points show the mean value from the error function fit, their error bars show the ENC the s-curve response per channel. Top right: scurve taken after high current event. Bottom left: current drawn by the GEM electrodes as recorded by the DCS.

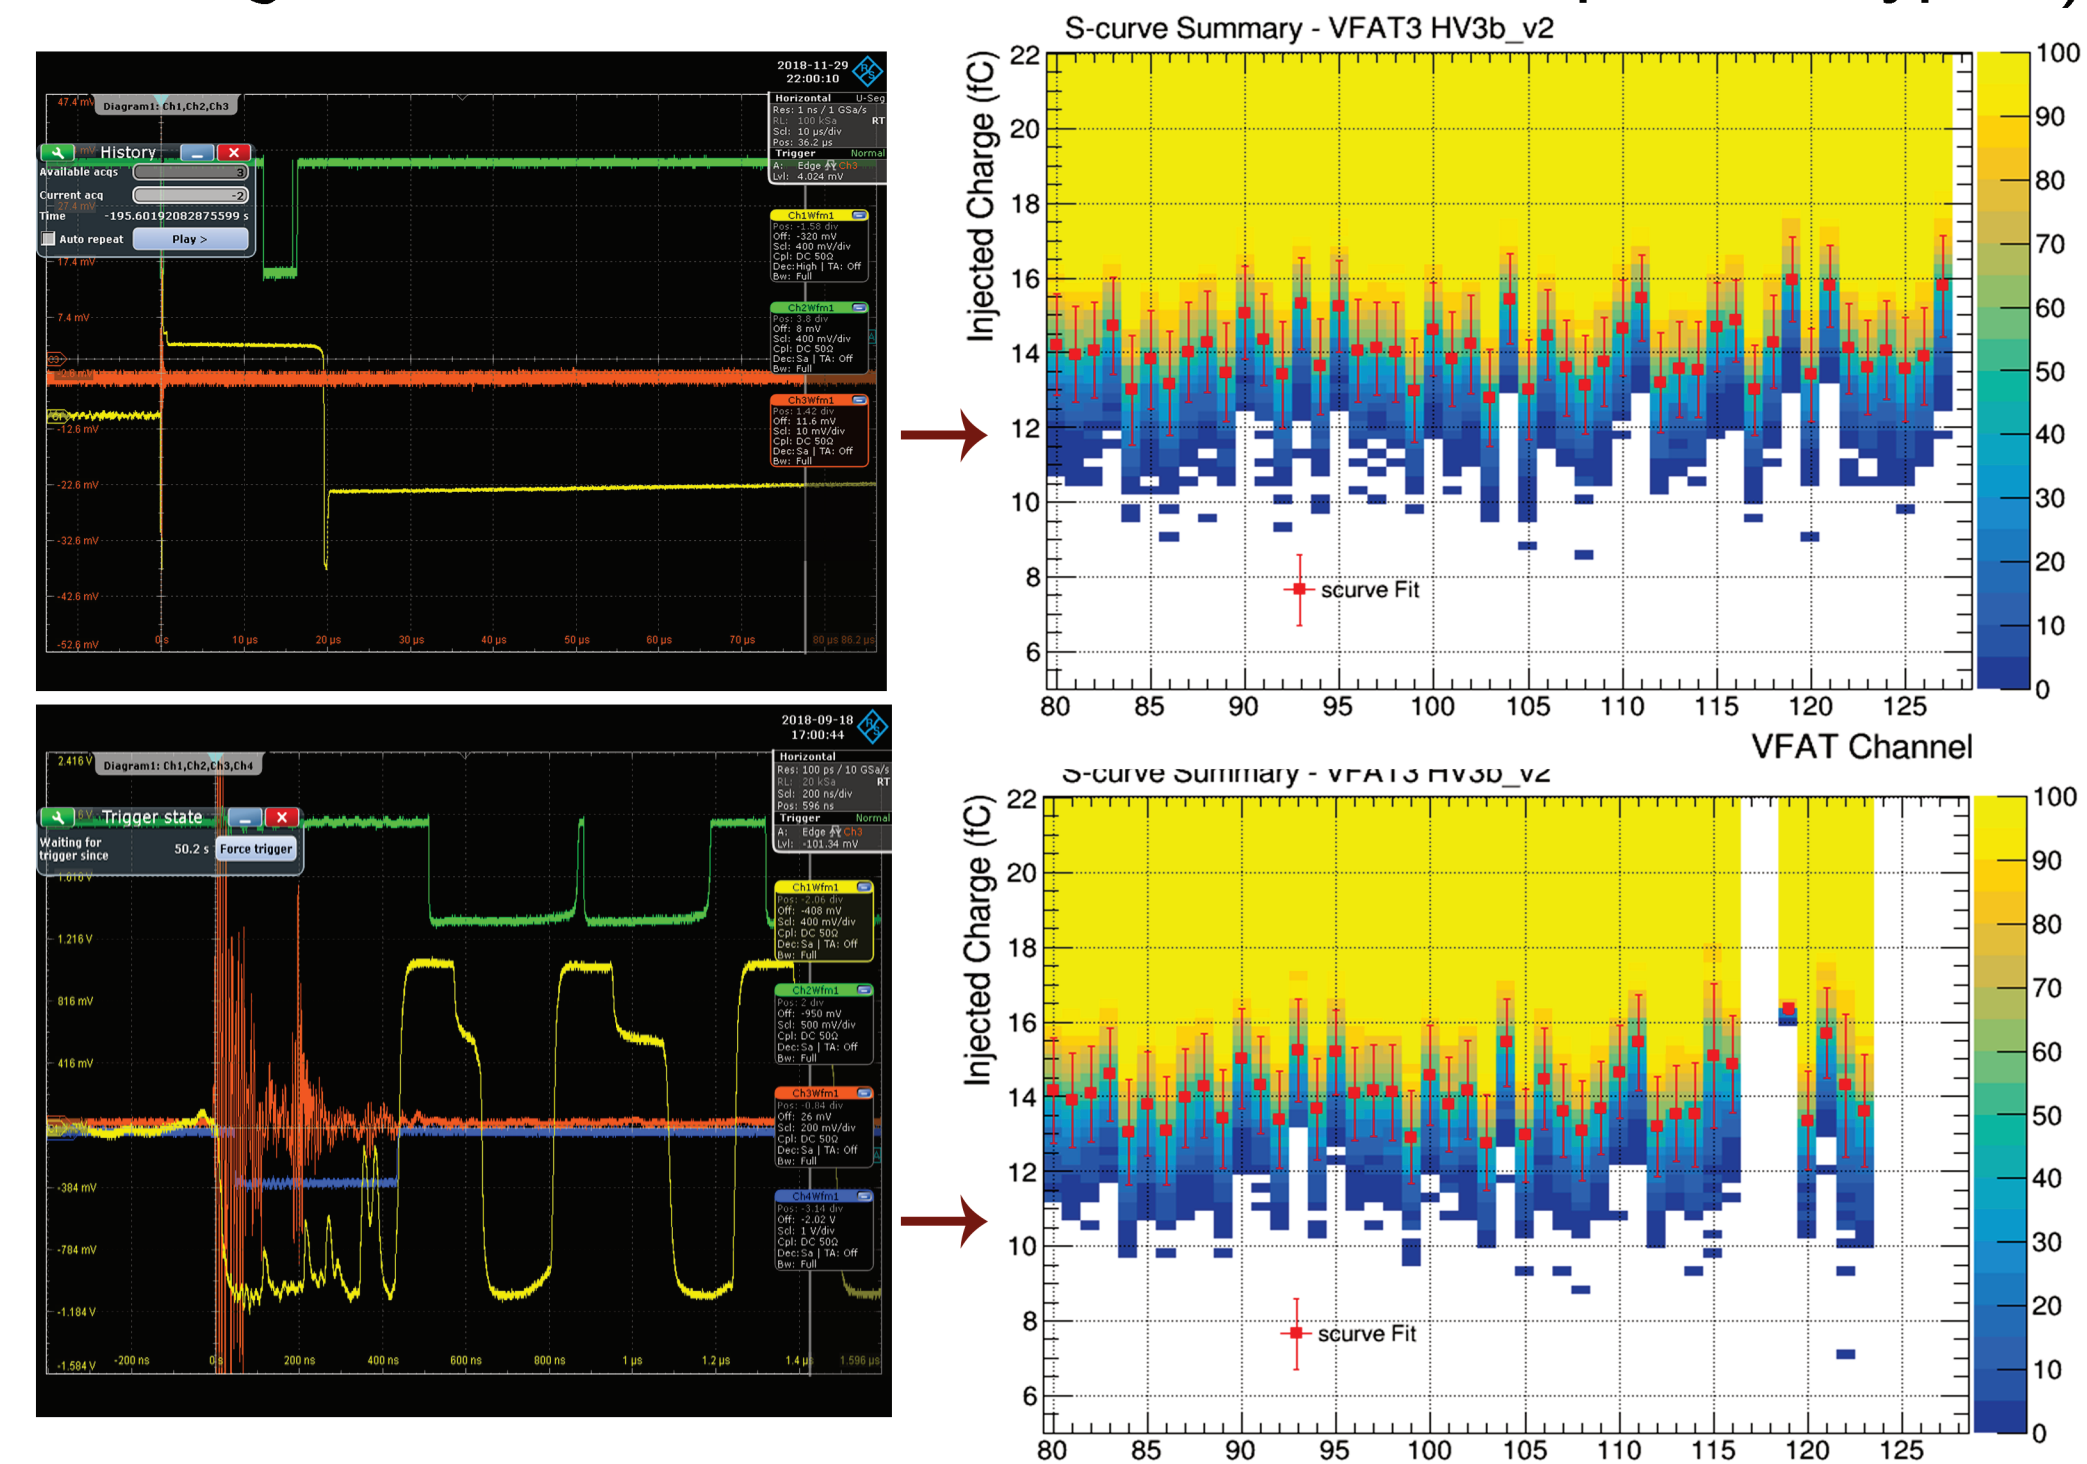
- a) Single pulse on antenna + high current drawn by only one electrode: called **PRIMARY DISCHARGE**
- b) Multiple afterpulses + almost all electrodes show high current: called **SECONDARY DISCHARGE**

Discharge at $G = 1E5$ -> some channels lost & pulse of type b)

Left: Oscilloscope screenshot. Green: Discriminated G3B pad signal. Yellow: G3B pad signal. Orange: antenna signal. Blue: Discriminated antenna signal

During successive tests, the correlation between secondary discharges has been confirmed, and the hypothesis 1.2 has been ruled out. The behaviour of the GEM3 bottom electrode indicates that **the discharge propagates to the anode plane**, causing the energy of the discharge to be released to the input channels of the ASIC.

The addition of external components in front of the ASIC inputs can mitigate the damage. Other mitigation strategies to be implemented on the detector side are under investigation.
