Damage Thresholds for New Collimator Materials, Experiment Detectors and SC Magnet Components

F. Carra (EN-MME), C. Bertella (EP), A. Sbrizzi (EP), D. Wollmann (TE-MPE)
With contributions from colleagues of EN-MME, BE-ABP, EN-STI, TE-MPE, EP

MPP Workshop 2019

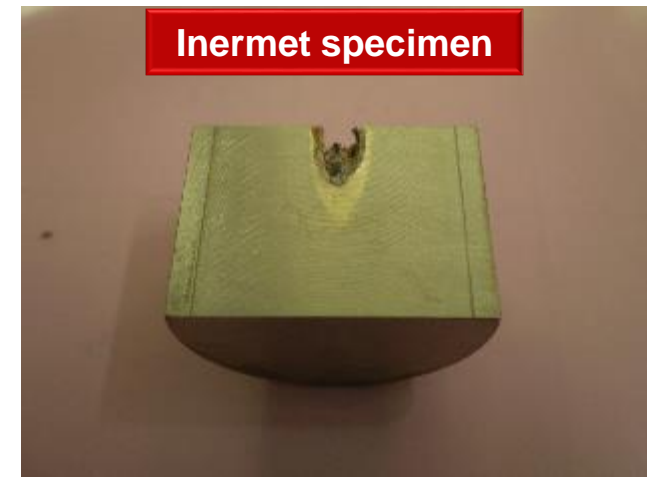
HRMT-14 (2012)

- Test of specimens from 6 different materials: Inermet180, Mo, Glidcop, MoCuCD, CuCD, and MoGr (very old grade with high density, 5.4 g/cm^3)
- Allowed **characterization of materials of interest for collimators**
- **Tuning of numerical models, with very good benchmarking between measurements and simulations**

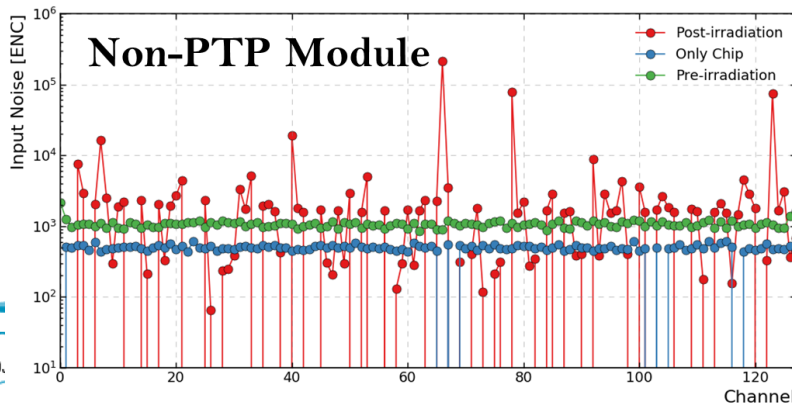
Non-PTP Module:

- Unfortunately, due to connectivity problems during the experiment, the on-line monitoring of this sensor was not possible
- Noise and gain measurements before and after the beam-loss experiment showing typical values for silicon strip modules
- **Apparently no damage of beam-loss on the read-out channels for the non-PTP module**

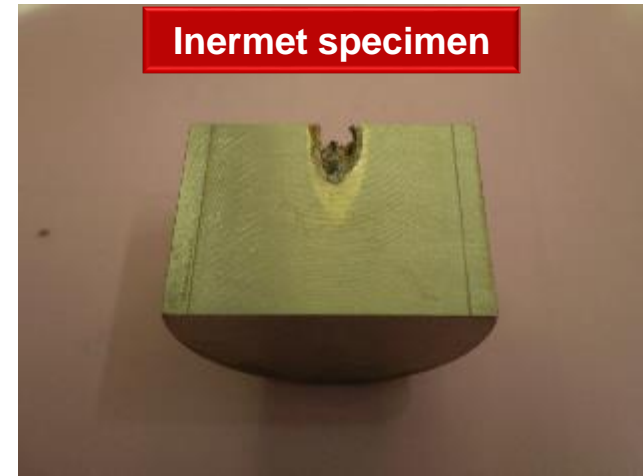
HRMT-14 (2012)

- Tank opened in **May 2015** in b. 109 (CERN), after 2 ½ years of cool-down
- Activation was low, but **risk of contamination** due to radioactive fragments and powders (mostly Cu and W)
- Non-destructive and destructive testing campaign
