U of A Low Radon Laboratory

Aksel Hallin
July, 2019

Radon Stripping System

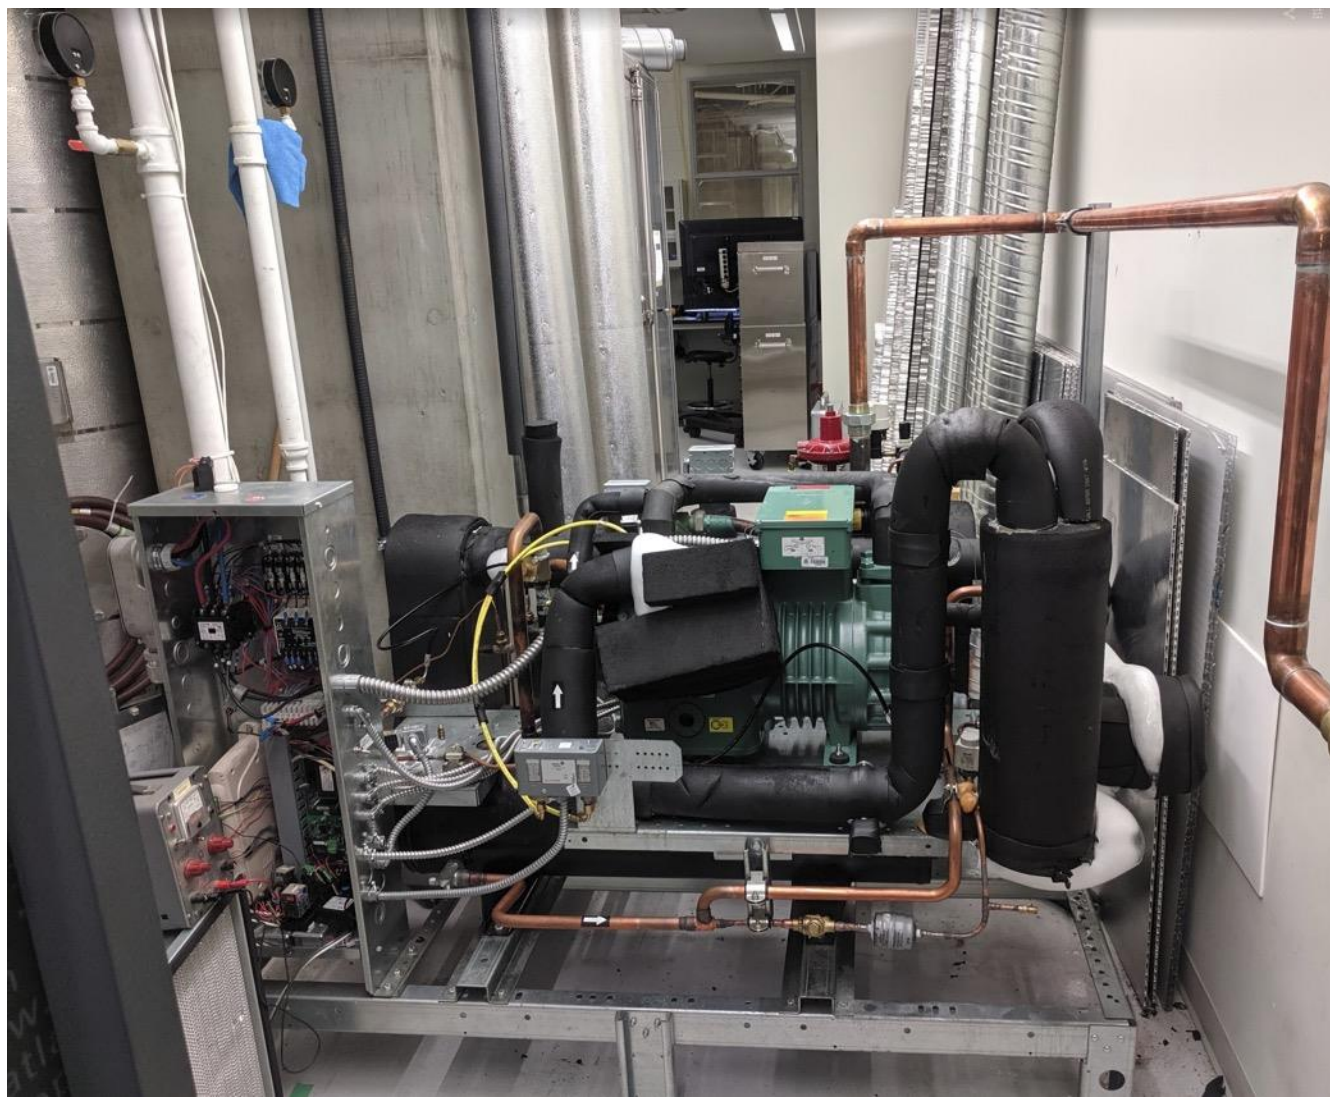
5 columns, 200 kg coconut carbon

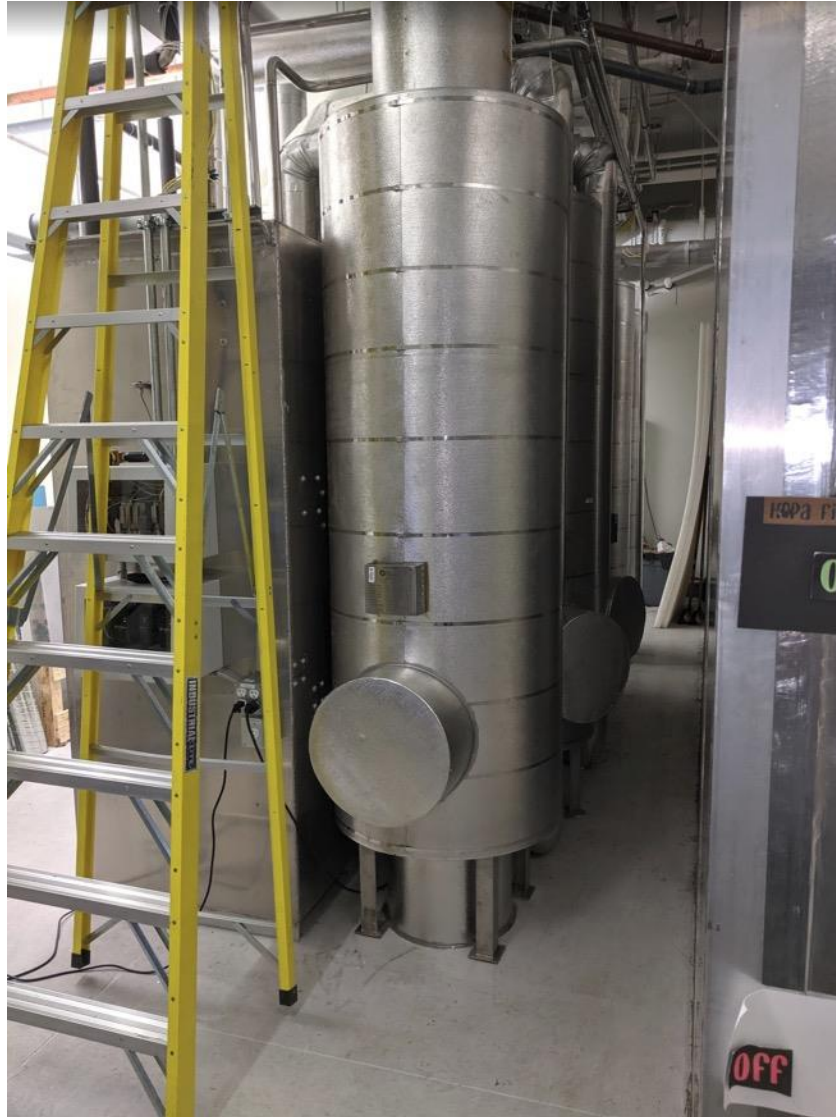
Valve cabinet (has warm and cold sides)

System can operate as continuously cold, pressure swing, temperature swing.

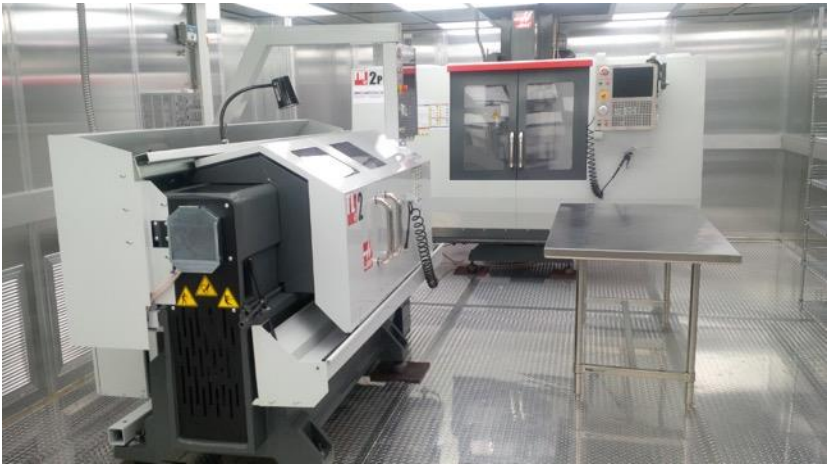
Clean Room

This modular cleanroom was purchased from CleanAir Solutions, and custom sealed with low radon caulking compounds and tape. The ceiling consists of a top plenum cap 10" high which provides the outer air seal and an 8" suspended inner ceiling holding the lights and 17 HEPA filters. The floor of the cleanroom is sealed with a 1cm thick layer of Precidium 550D, a polyurea industrial floor coating. The cleanroom is unique in that it is designed as a small machine shop. Contained within is a CNC mill and a CNC lathe. It also contains its own water purification system that provides low radon water [3].

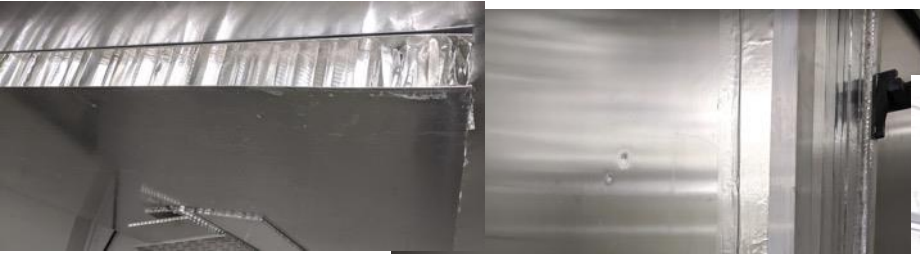
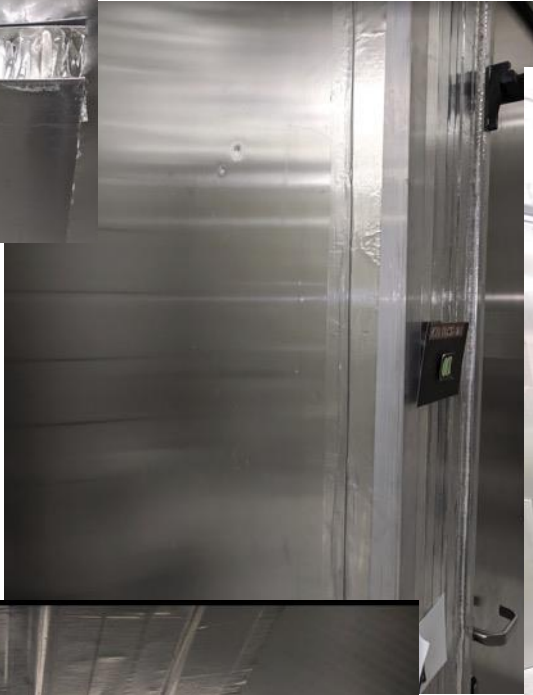
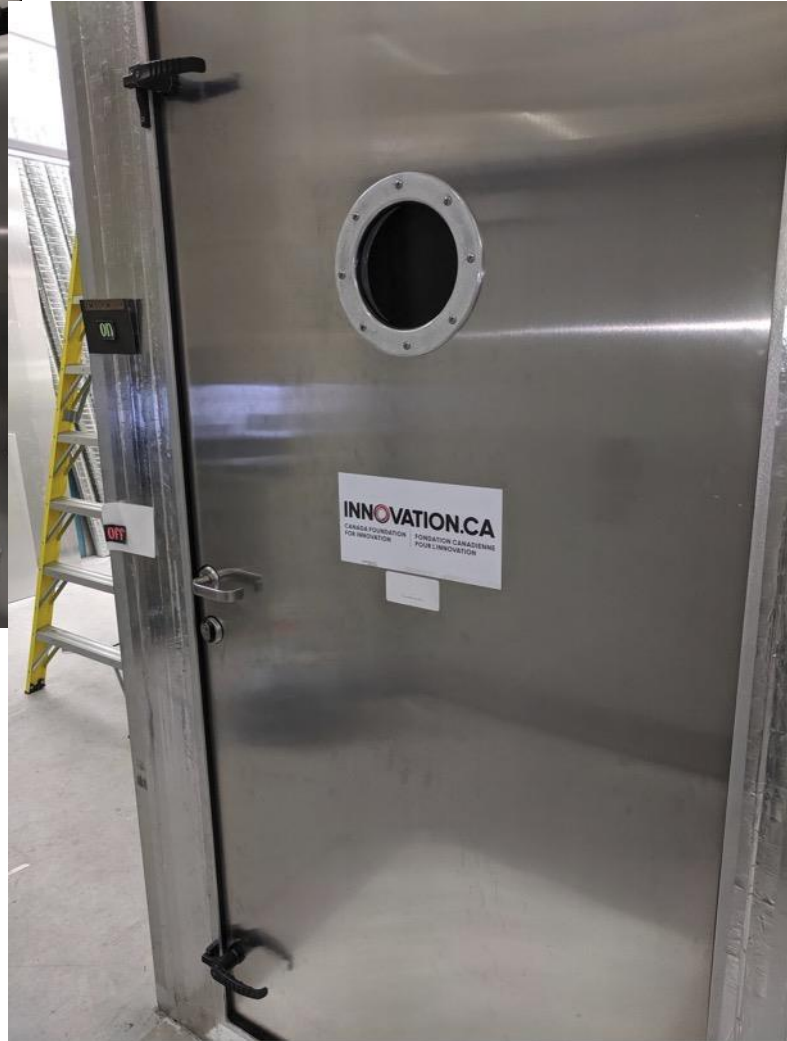
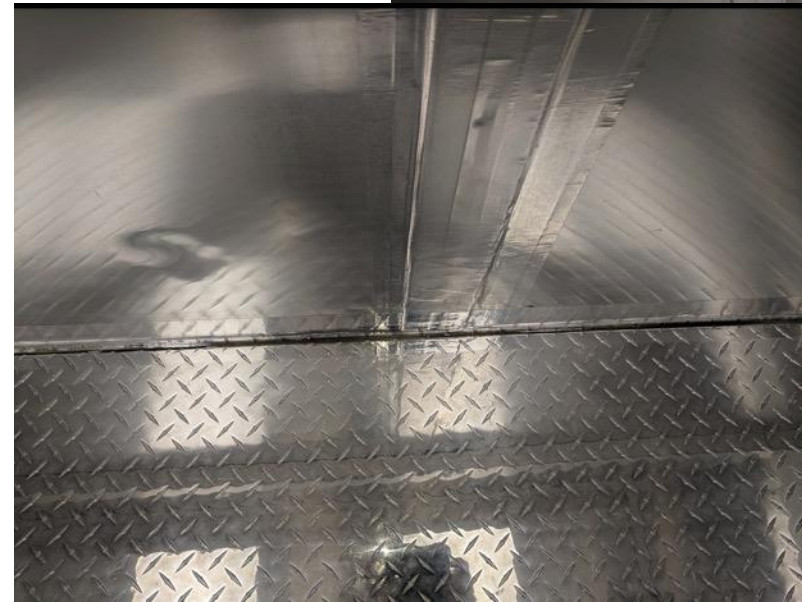
Construction of walls and doors:

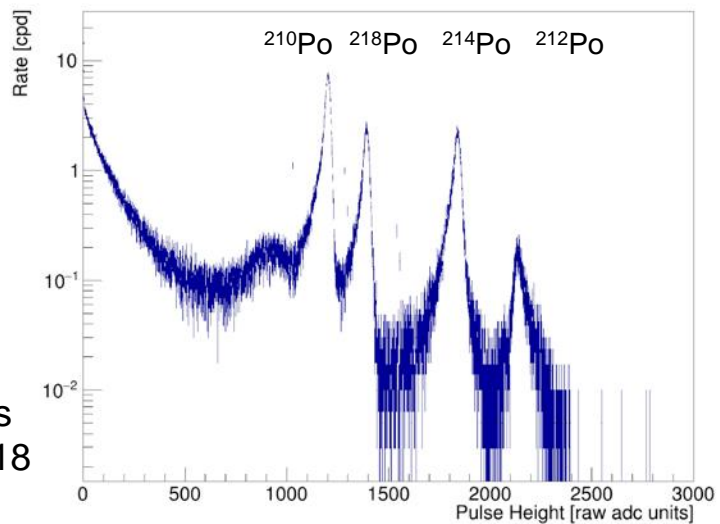
Air leaving cleanroom

Air entering the room is suppressed in radon by about a factor of 300 over ambient air (in Edmonton $\sim 5\text{-}10 \text{ Bq/m}^3$); leaving the room is about a factor of 60.

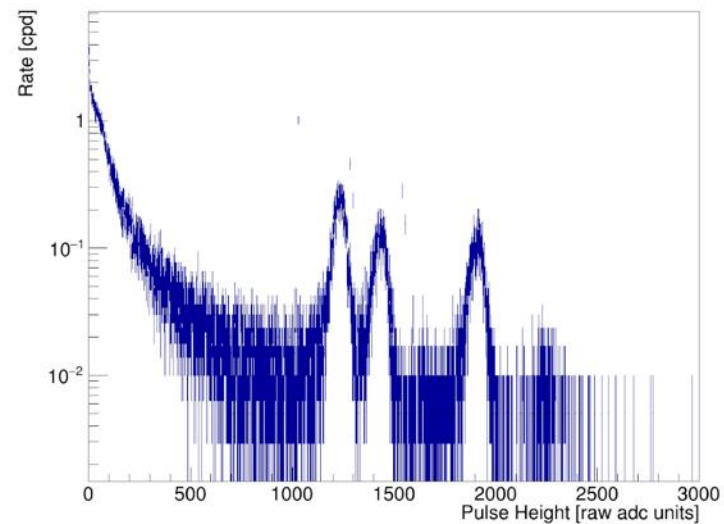
Air entering cleanroom

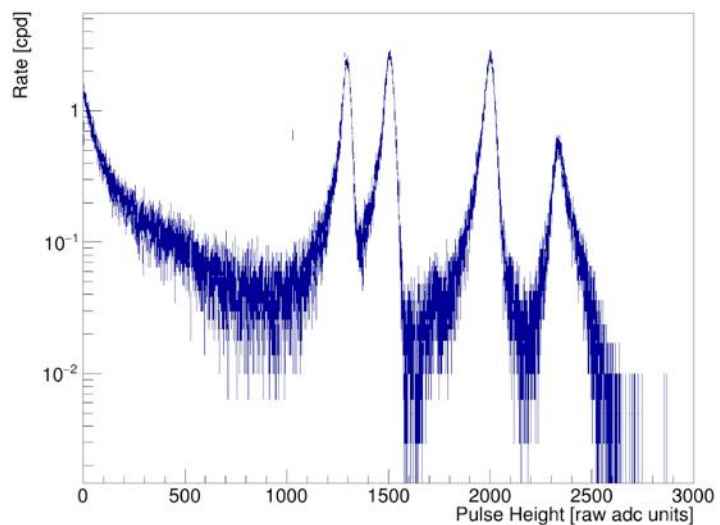
Sum spectra 200 days
Sept, 2017-March 2018

Air leaving anteroom 1

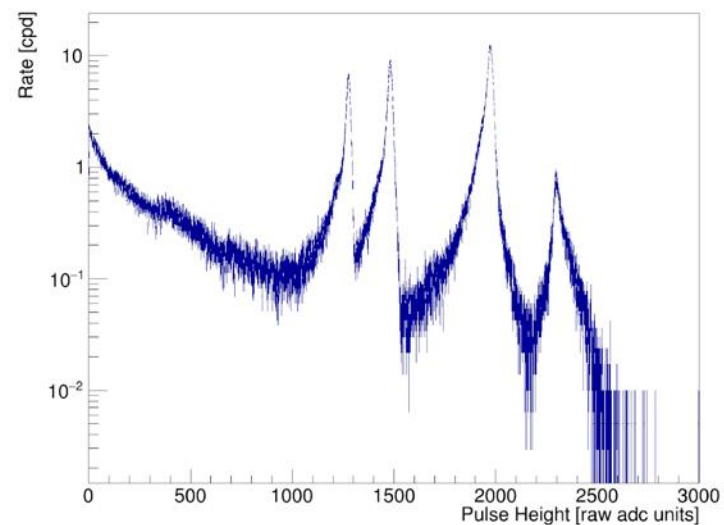
Air leaving anteroom 2

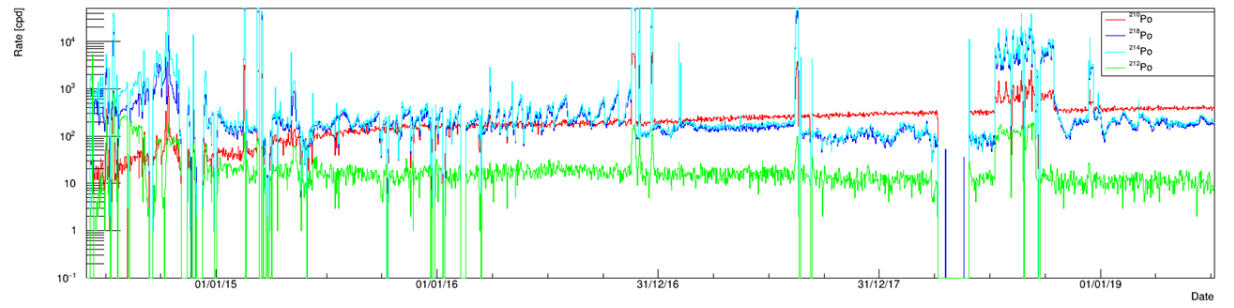
Air leaving cleanroom

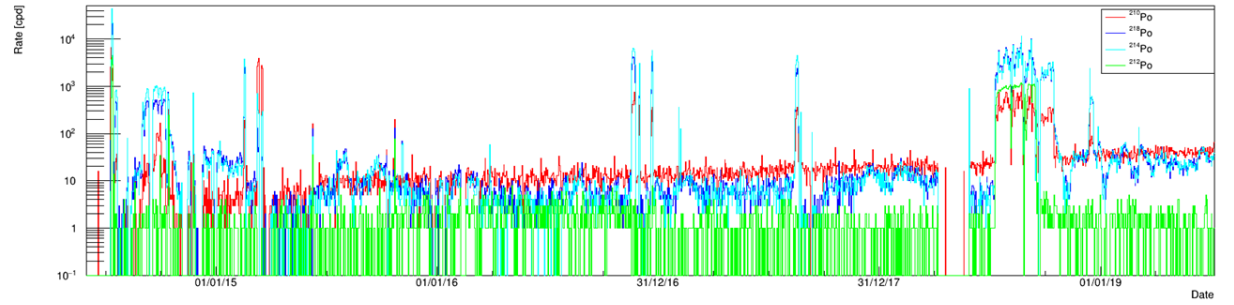
Air entering cleanroom

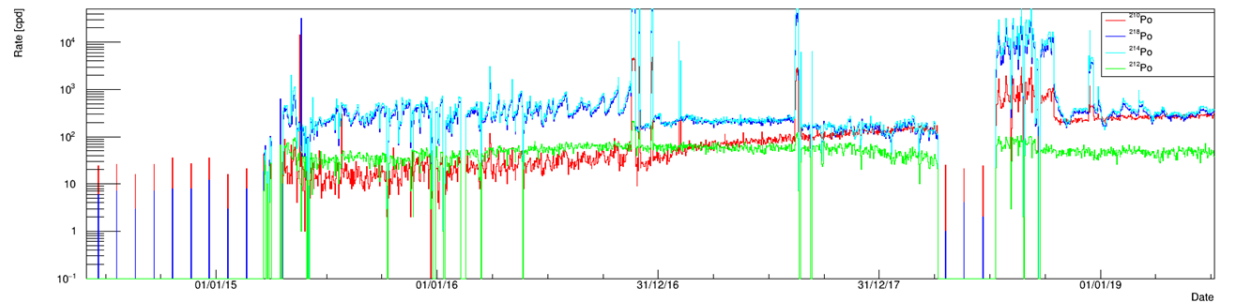
Air leaving anteroom 1

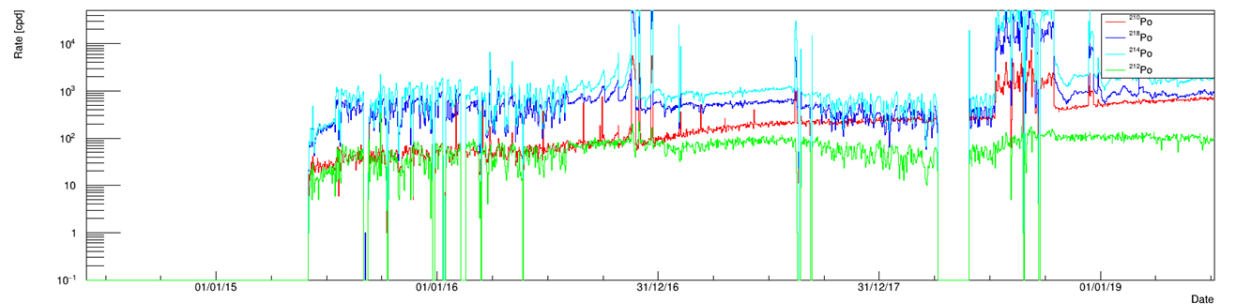
Air leaving anteroom 2
