Study of surface contamination on ultralow background (ULB) materials

July 22, 2019

Maria Laura di Vacri
Low Background Lab Workshop

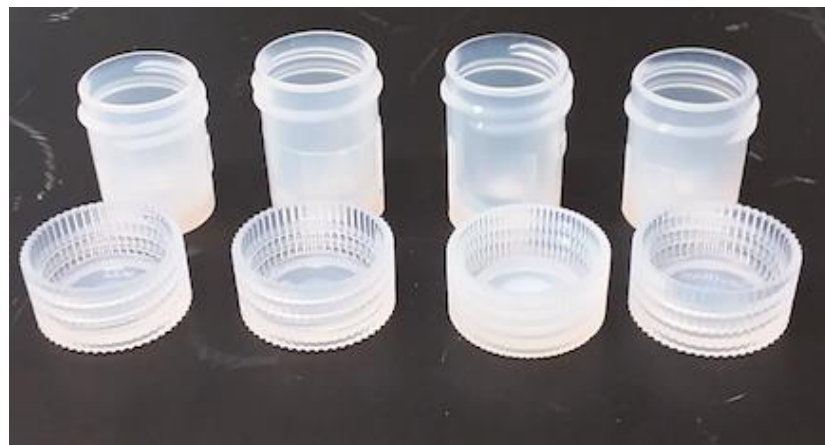
PFA (Perfluoroalkoxy alkane)
Exposed surface ~ 7cm²

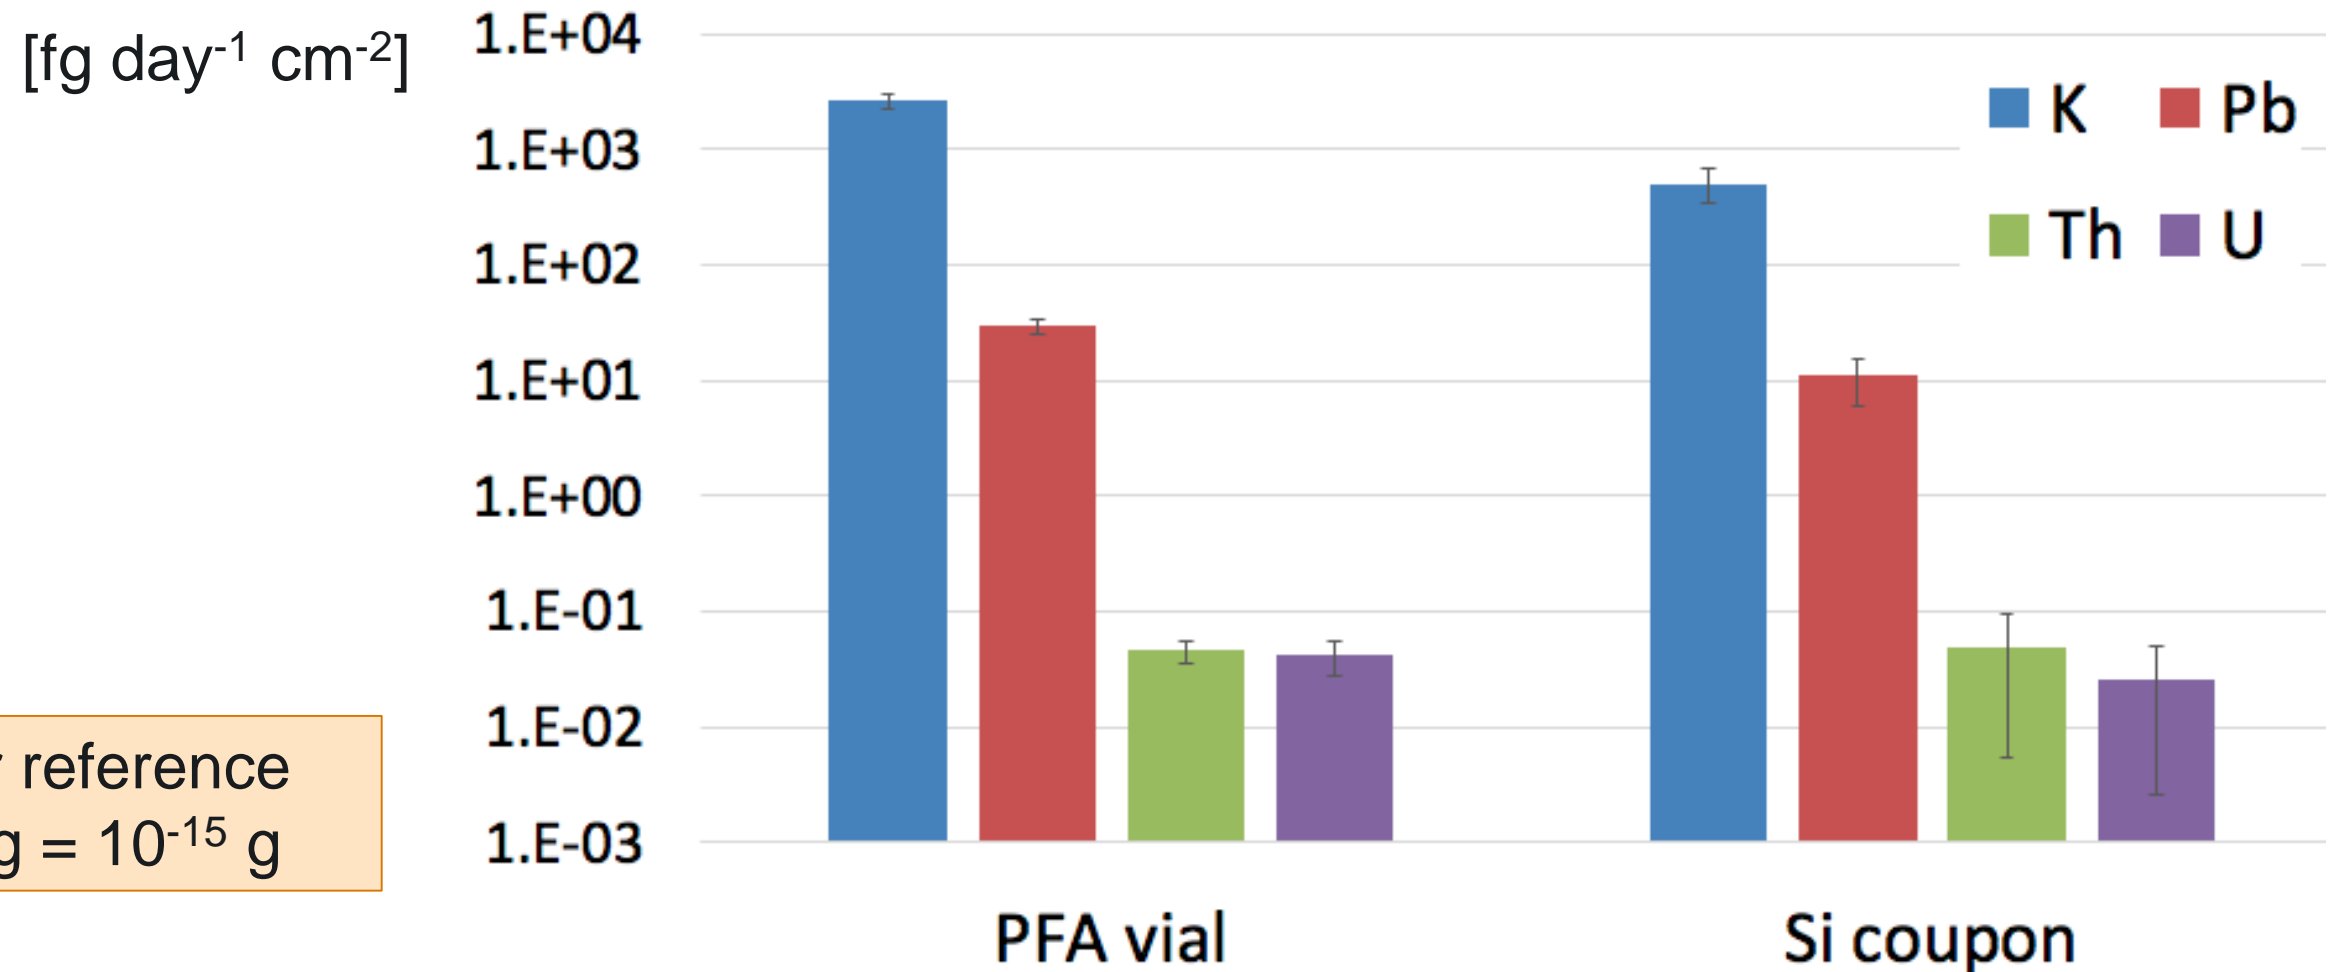
Accumulation rate on PFA and Si surfaces

Class 10000 clean room at PNNL, 29 day exposure

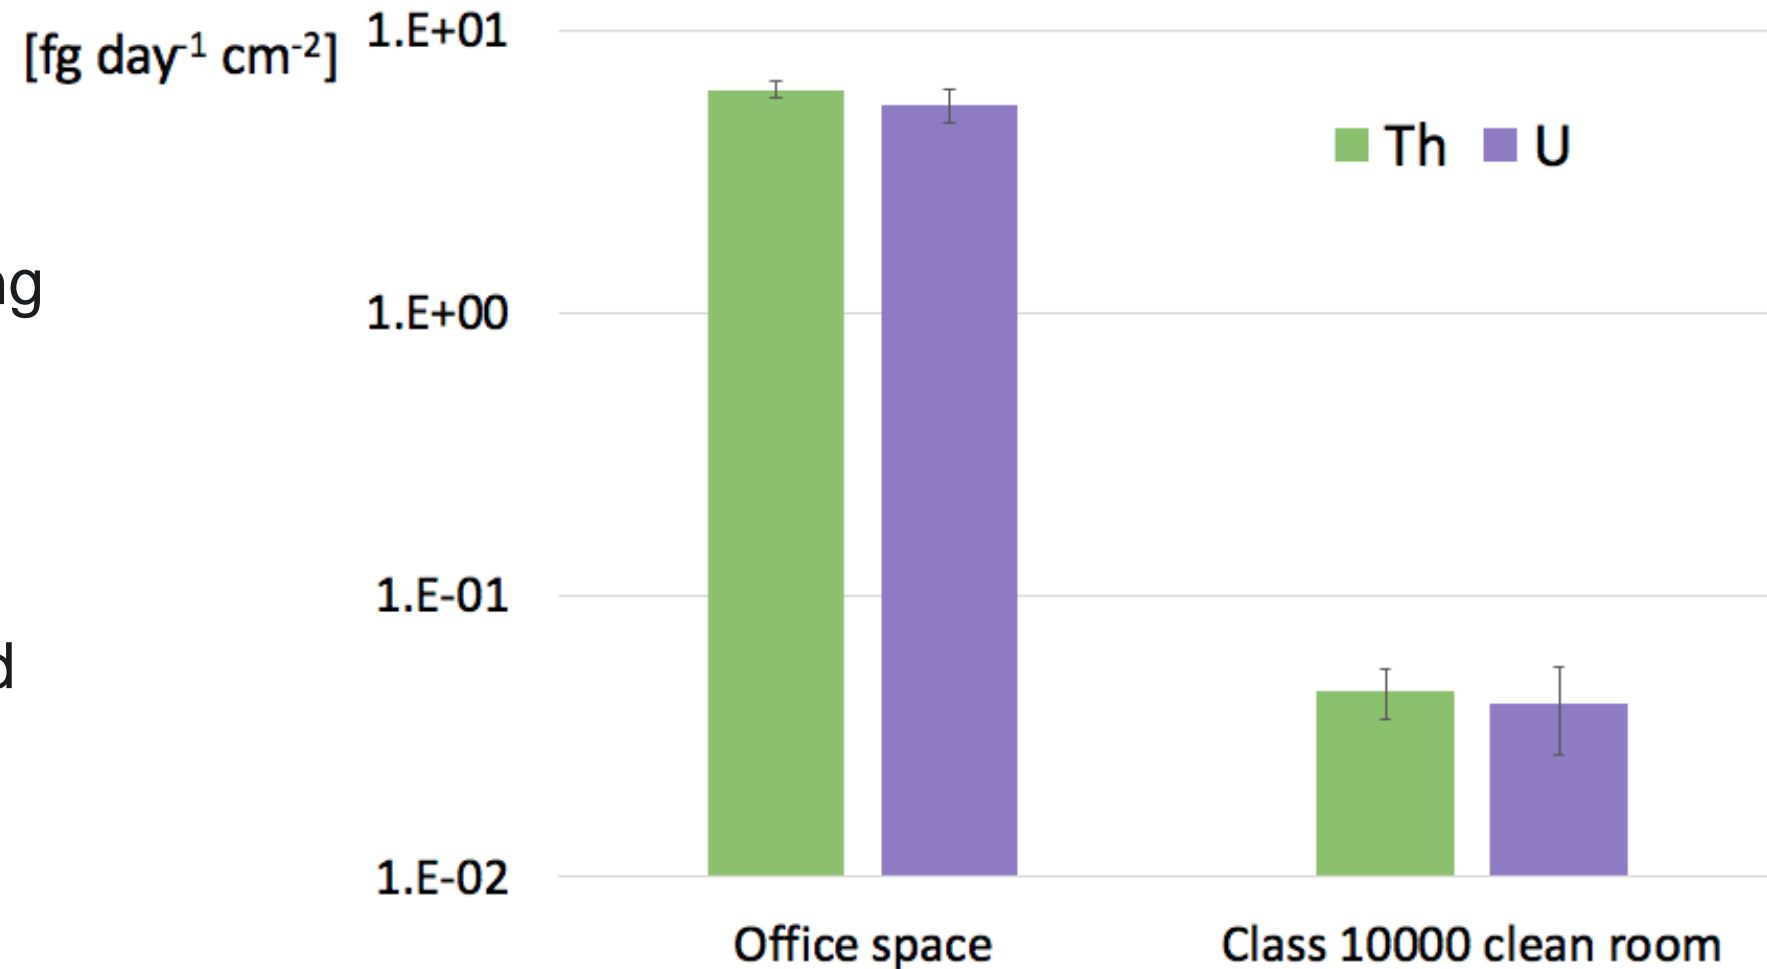
Room air – Class 10000 clean room comparison

- Accumulation rate scaling of 100X, as expected
- Exposure in a Class 10 area (30 days) : instrumental background level

PFA surface, 30 day exposure

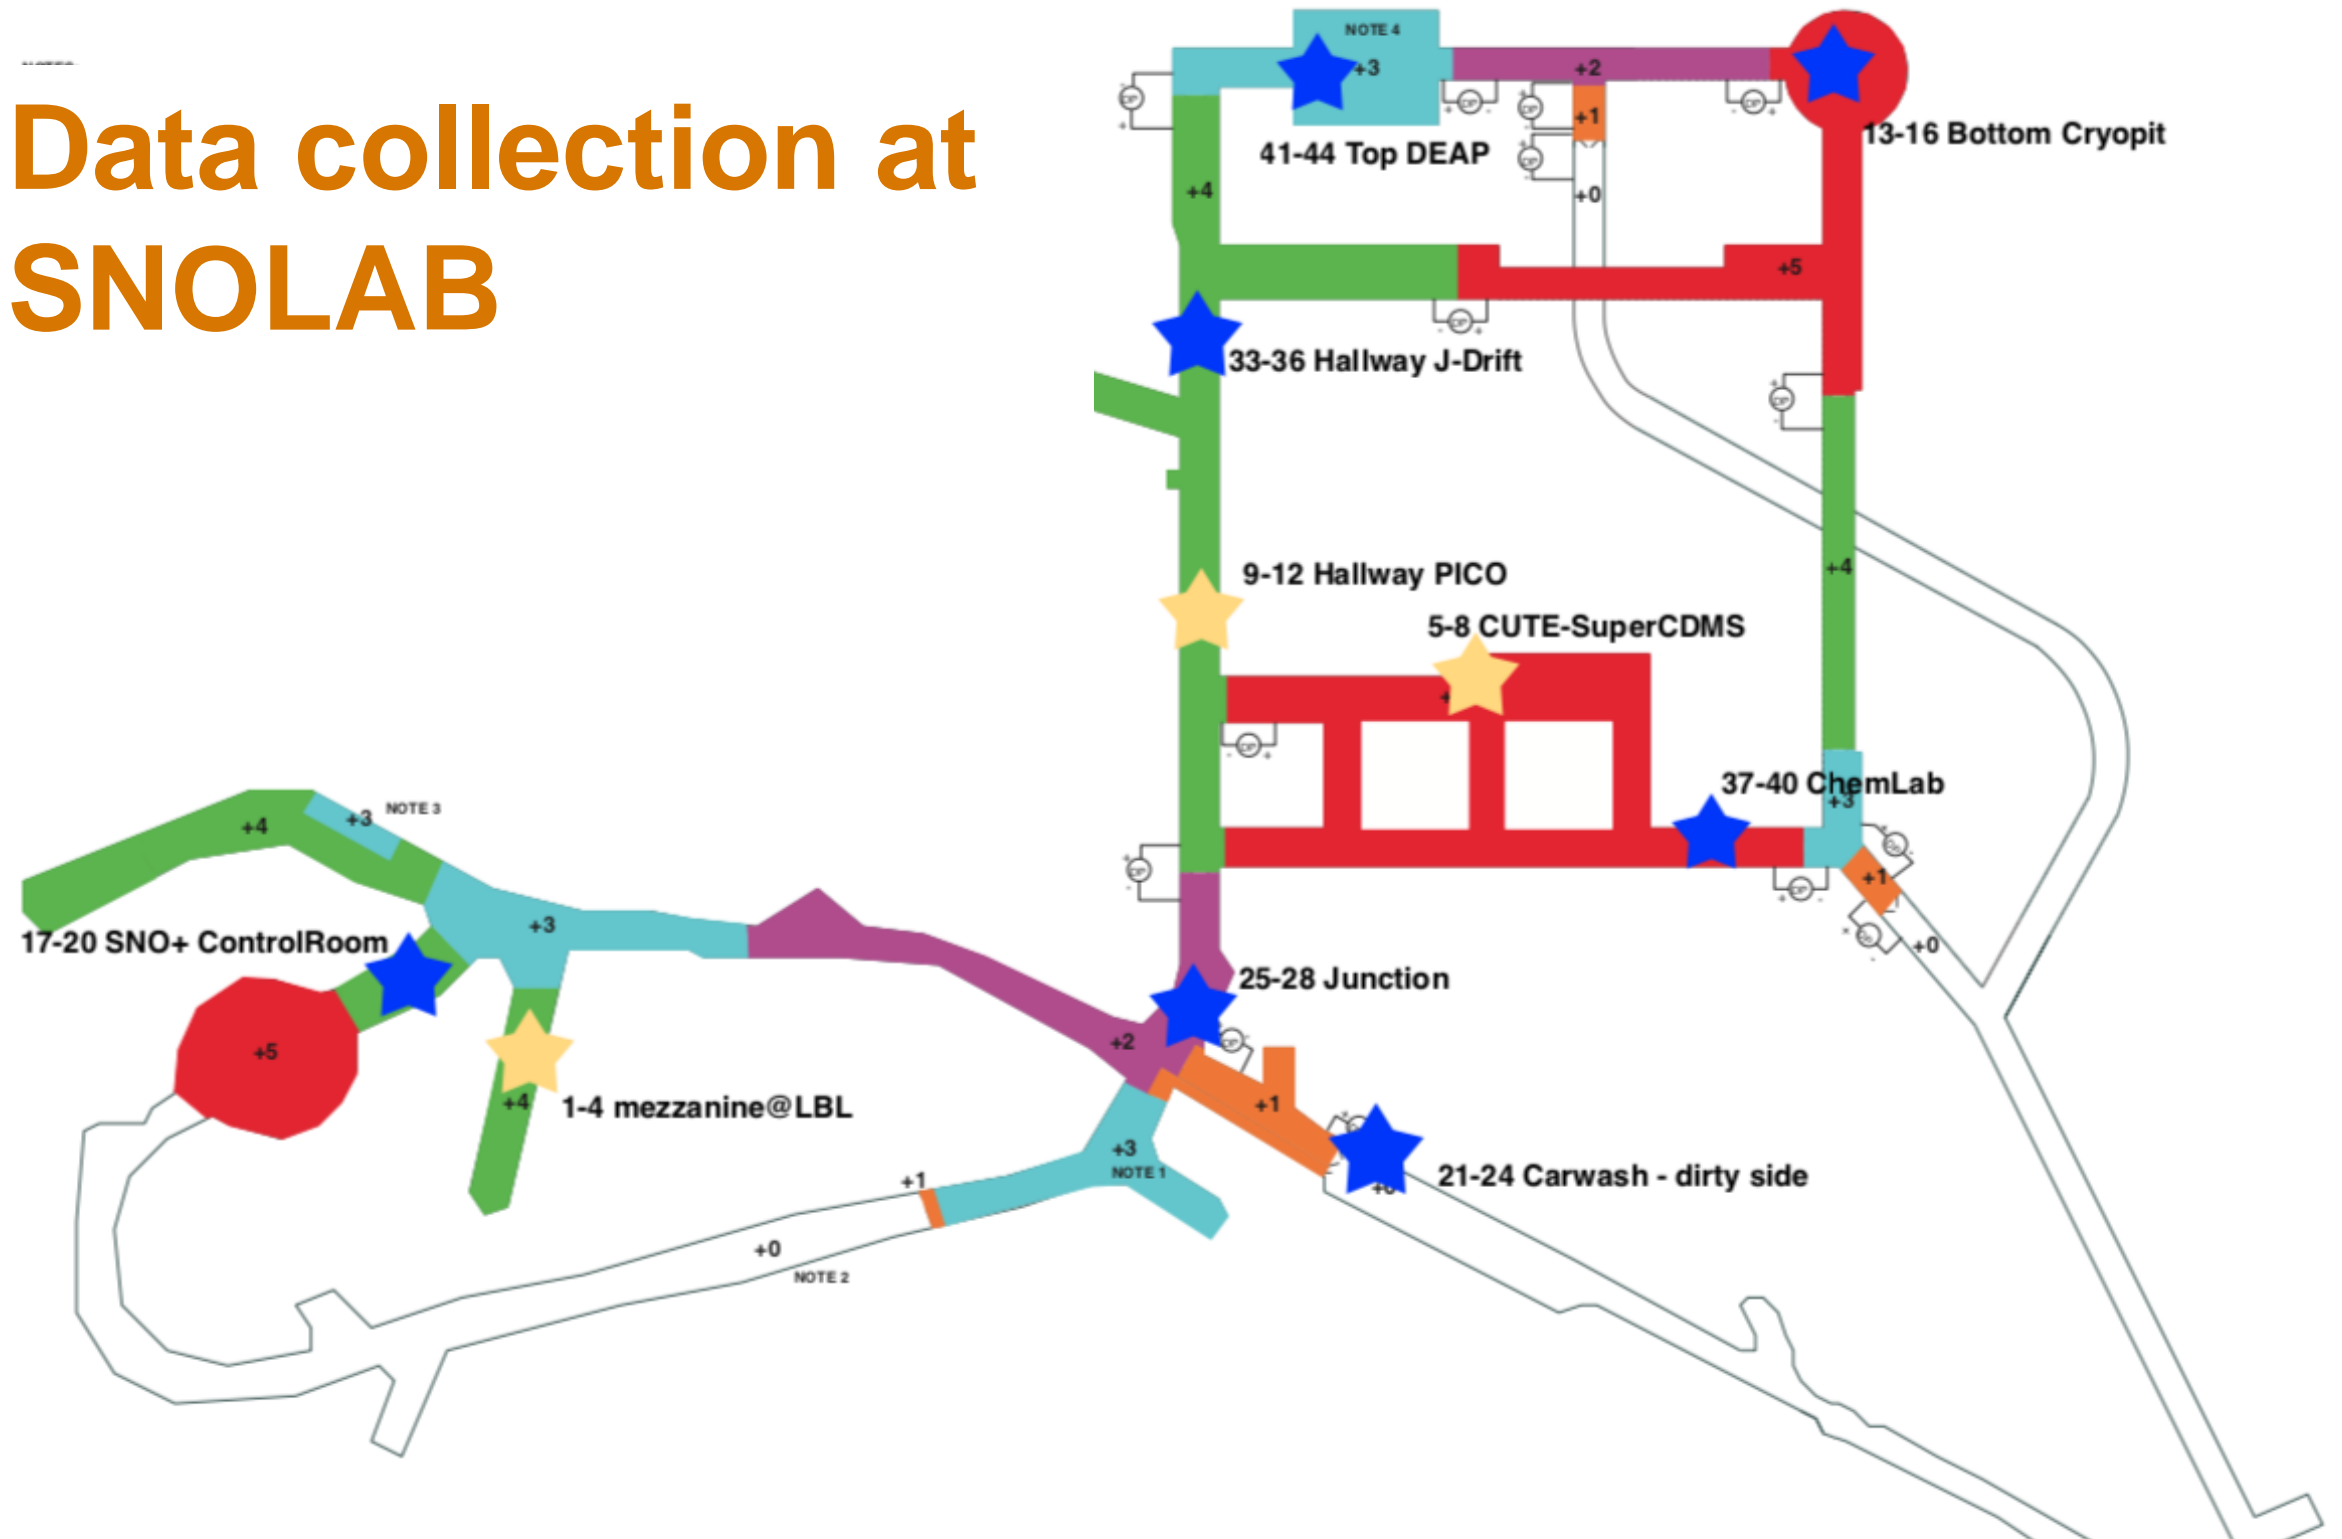
Data collection at SNOLAB

42 days exposure in all locations, except *Bottom cryopit* and *top DEAP* locations → 50 day exposure

- A: Mezzanine at LBL on desk
- B: Close to dust monitor in SCDMS area
- C: Hallway close to PICO @ 2.5m
- D: Bottom of cryopit (quiet area) on desk
- E: SNO+ control room
- F: Dirty side of the carwash
- G: Close to dust monitor in junction carwash-refuge-old lab
- H: Surface building at 3rd floor
- I: Hallway drift at 2.5m
- J: Chem lab on top of cabinet
- K: Top of the stairs entering the DEAP area

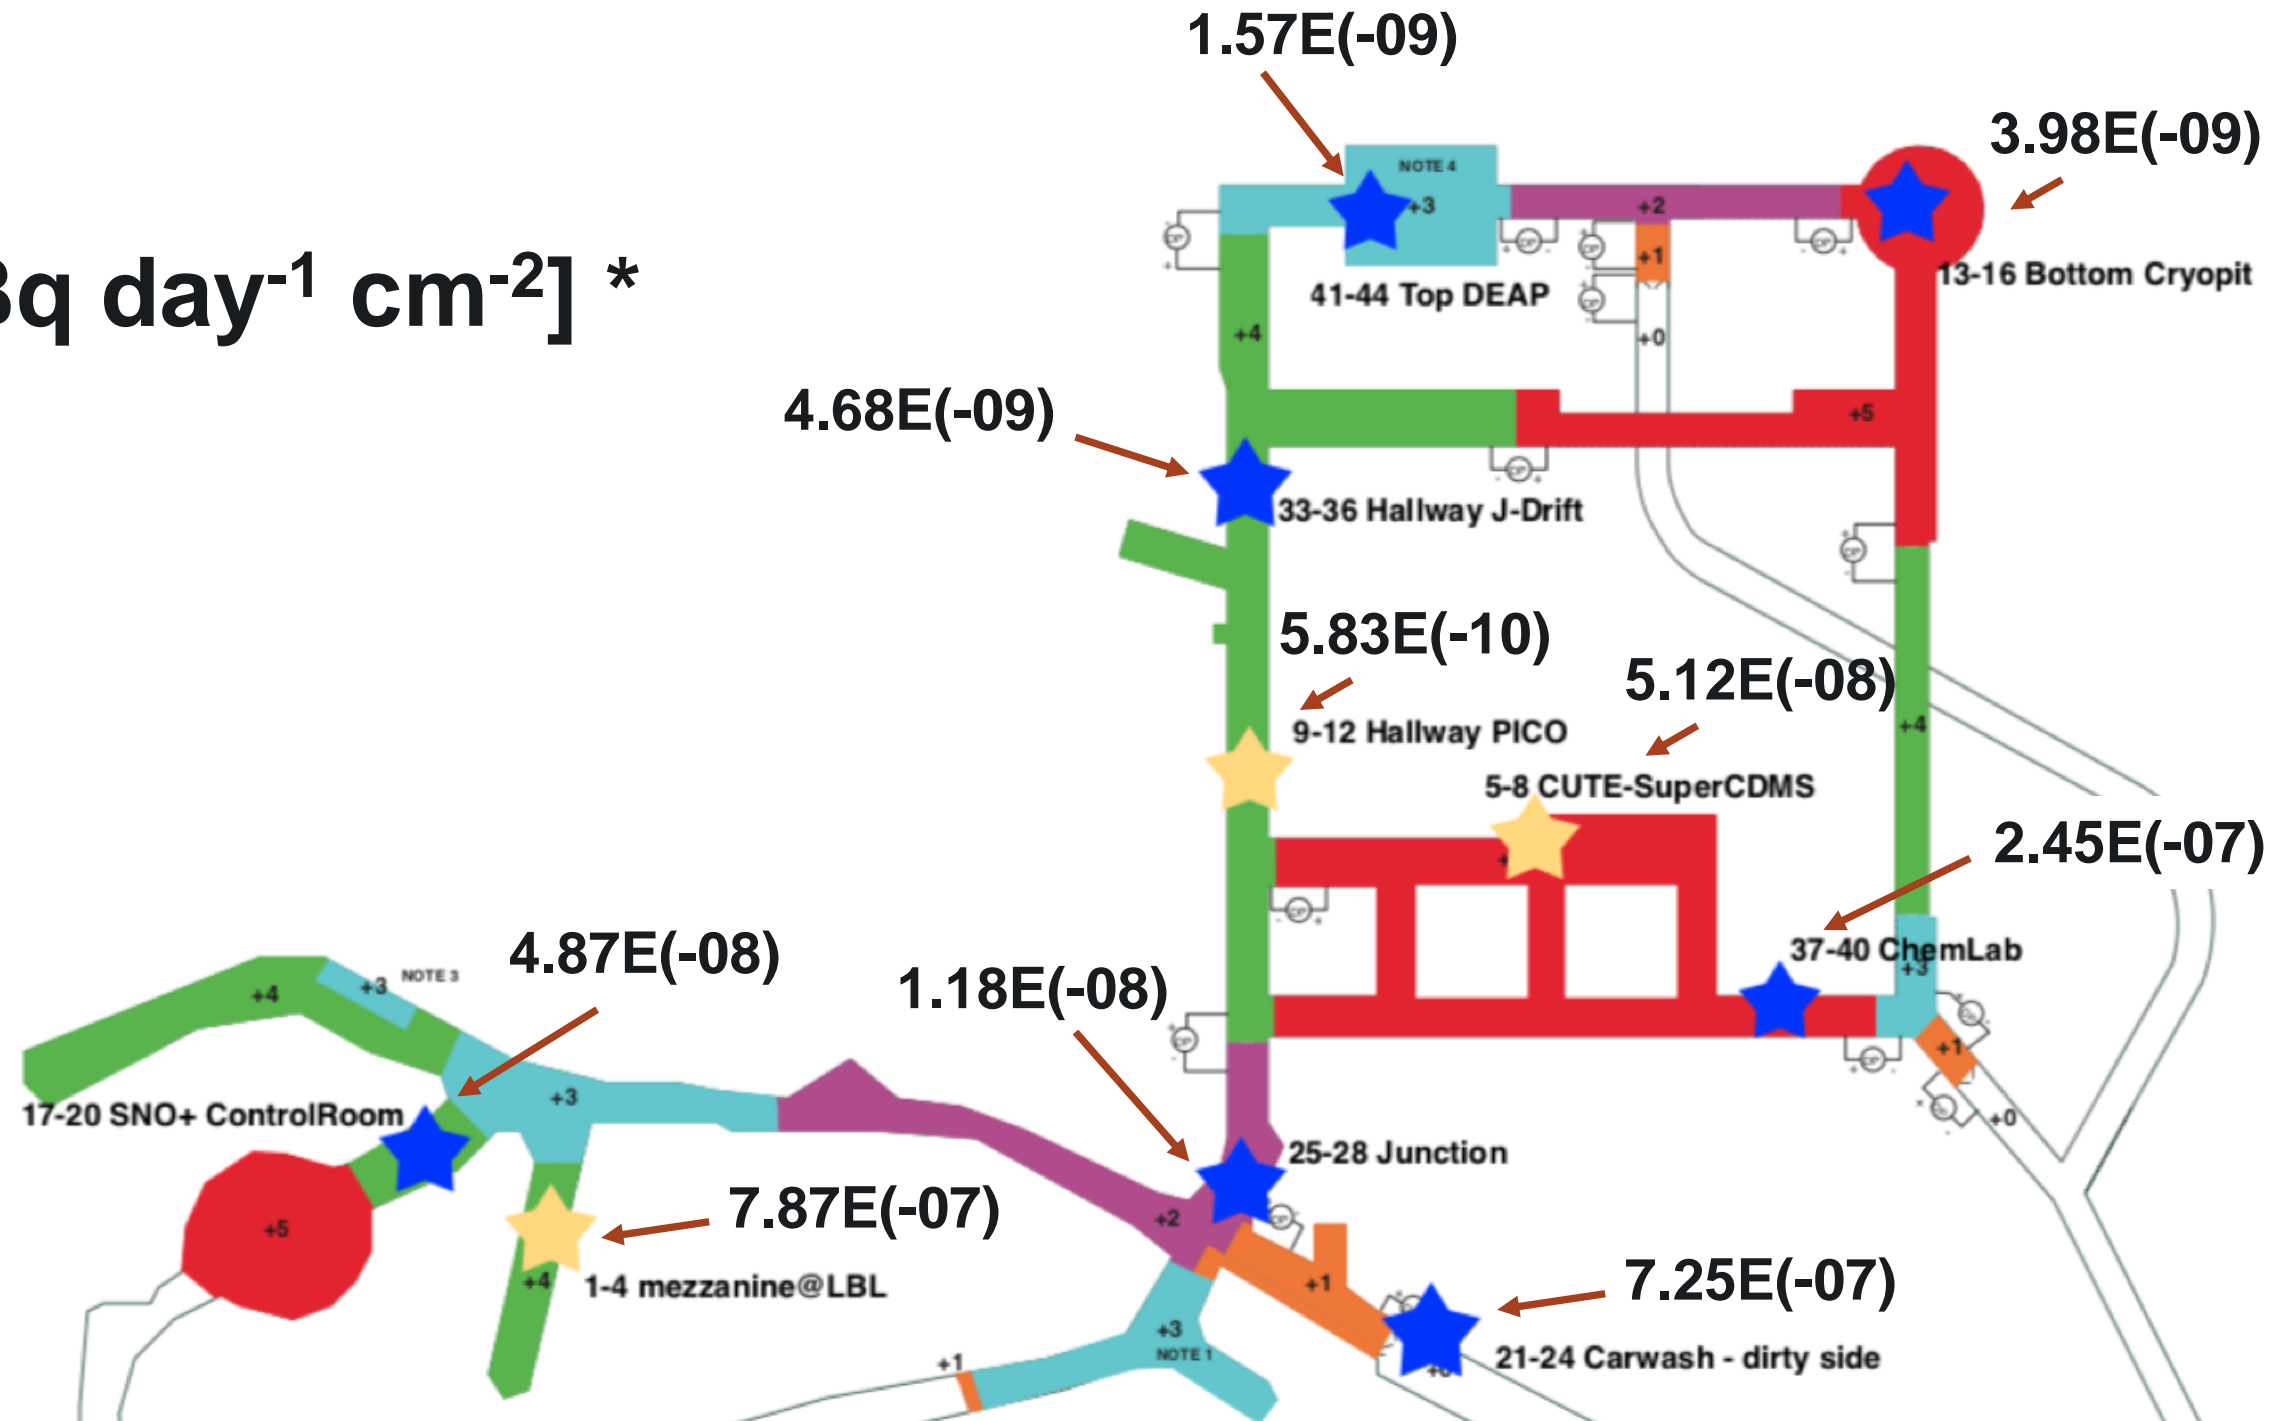
Pb [$\mu\text{Bq day}^{-1} \text{cm}^{-2}$] *

* Nat Pb activity from A.Alessandrello et al./Nucl. Instr. And Meth. In Phys. Res. B 142 (1998) 163-172

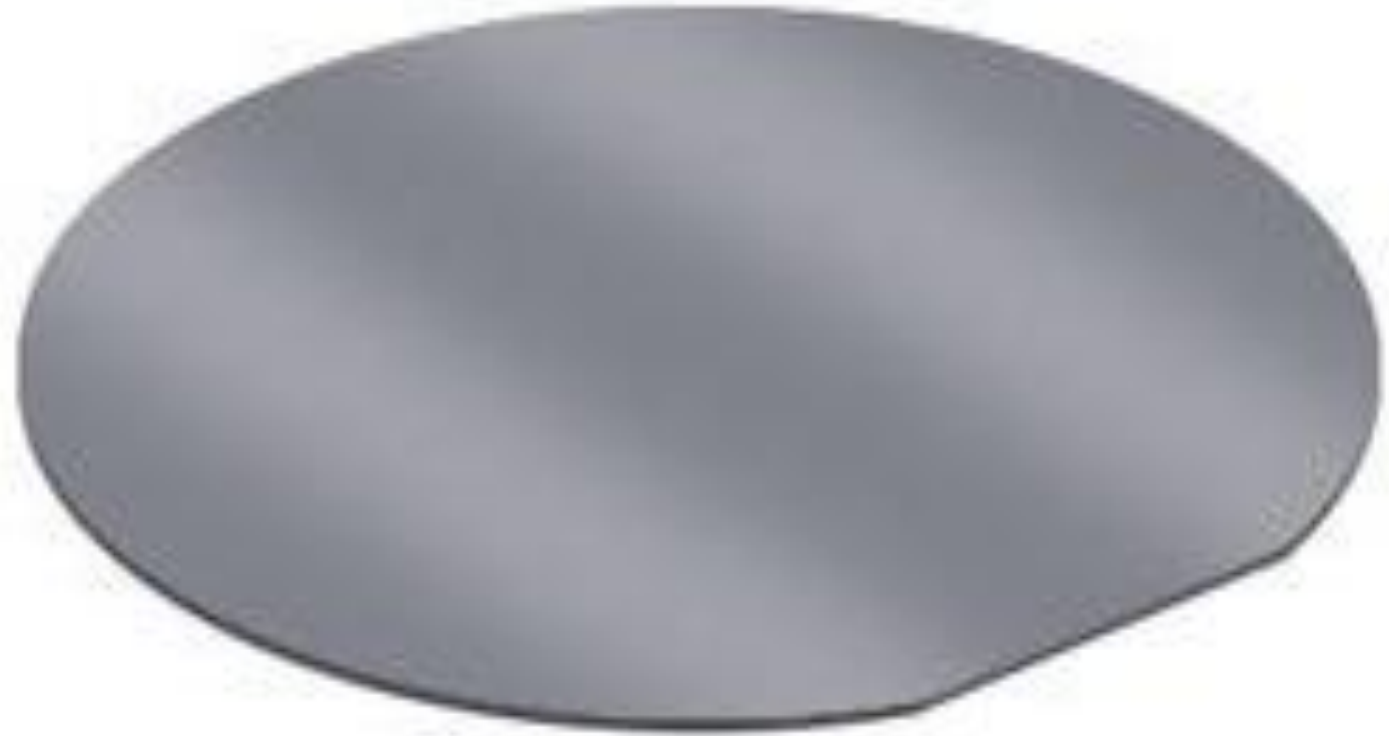
Exposure of a Si wafer

Si wafer
Surface $\sim 700 \text{ cm}^2$
Thickness 0.77 mm
Density 2.33 g cm^{-3}

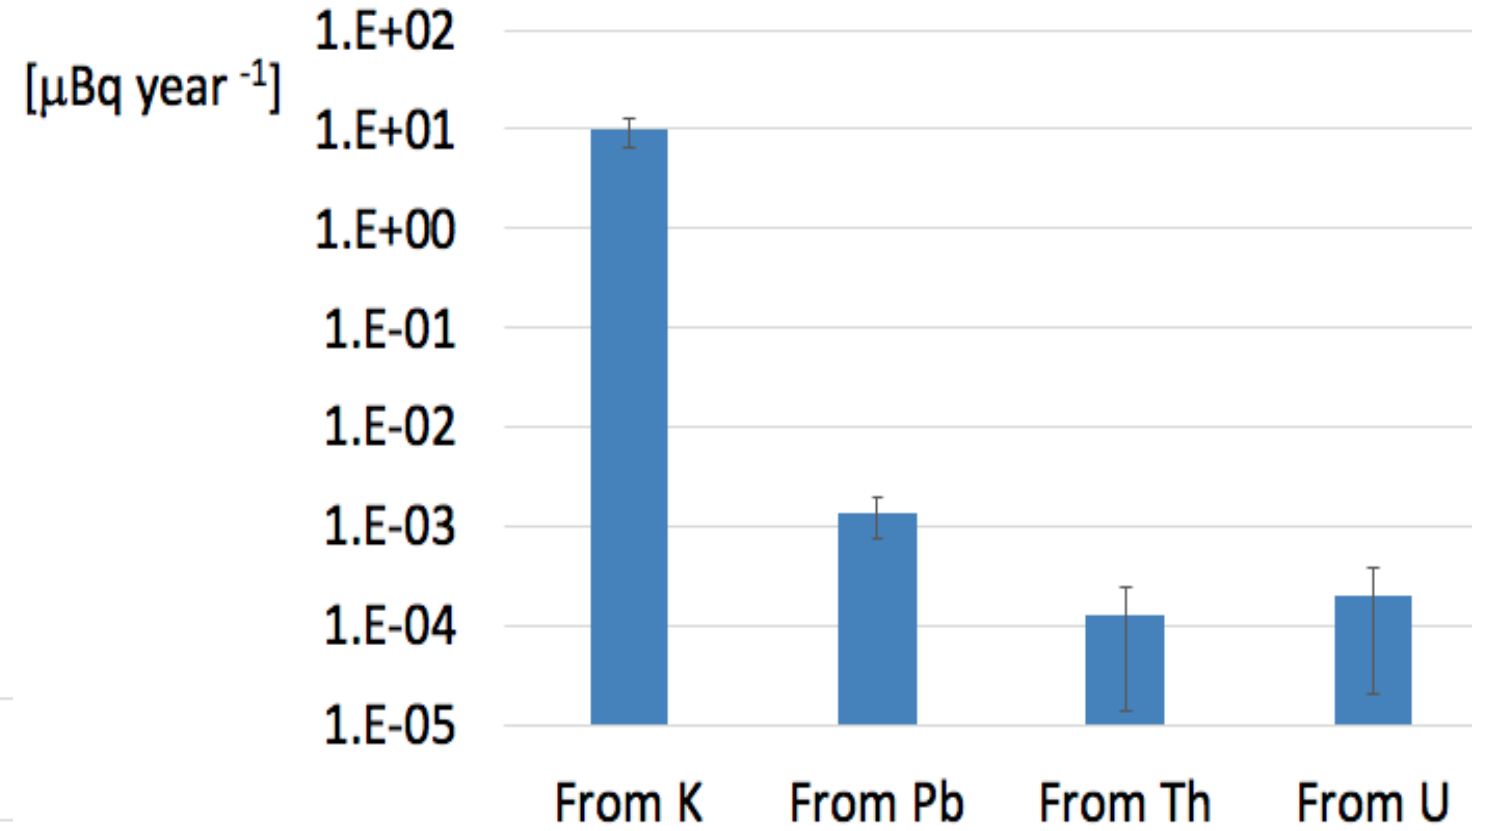
1 year exposure in a Class 10000 clean room
