MBRD status: MBRDS1 and MBRDP1

Andrea Bersani o.b.o.
INFN Genova group

MBRDS1 2019 summary

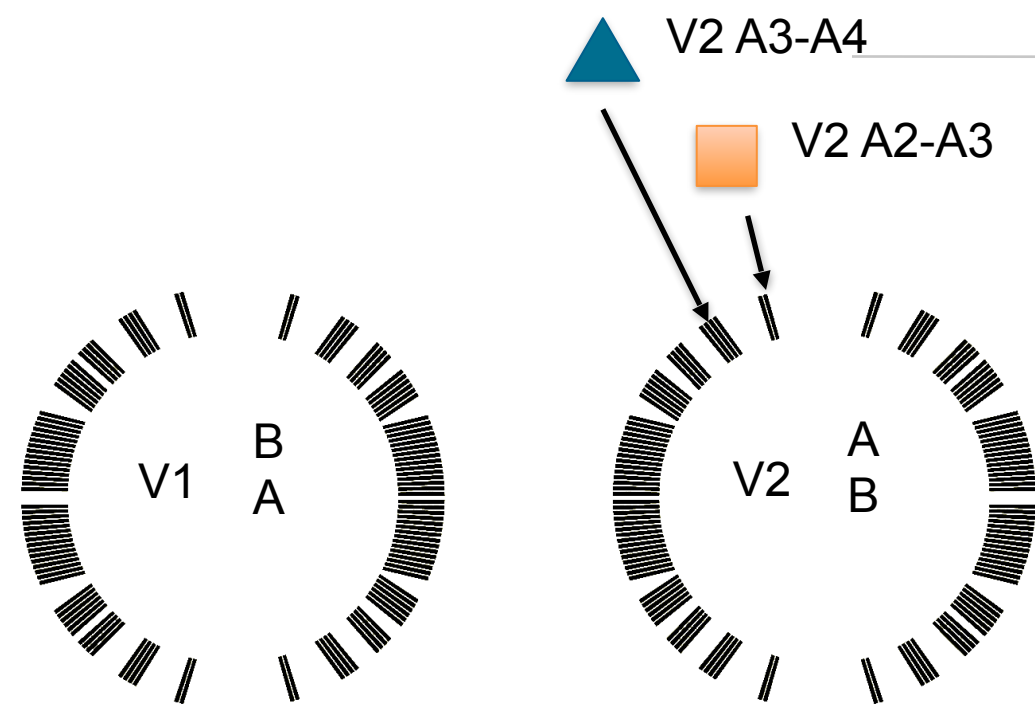
MBRDS1 cold tests

- ↪ All quenches but one in the same location
- ↪ "Small" training effect observed
- ↪ Negative precursor of the ■ quenches
- ↪ Damage on the cable expected in V2
 - ↪ fifth block, were a short circuit was detected during construction
- ↪ Further tests were performed on V1 alone
 - ↪ Data: courtesy of F. Mangiarotti

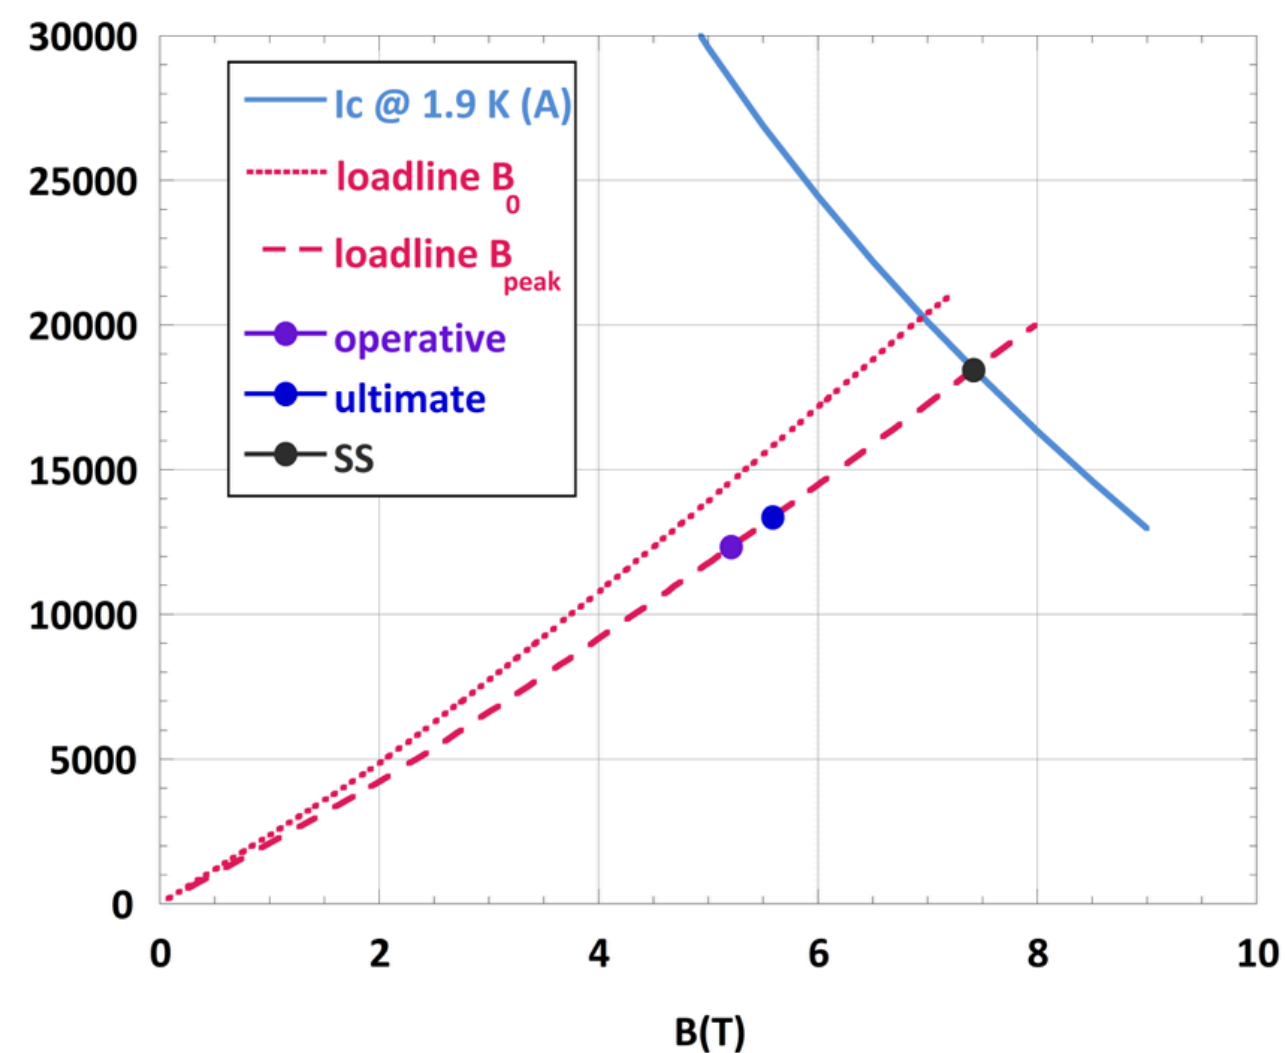
double aperture

- $I_{\text{nom}}=12340$ A, $B_0=4.5$ T
- $I_{\text{ult}}=13357$ A, $B_{0\text{ ult}}=4.82$ T
- $B_{\text{SS}}=7.42$ T, $I_{\text{SS}}=18468$ A
- loadline fraction:
 $f_{\text{nom}}=66.8\%$, $f_{\text{ult}}=72.3\%$

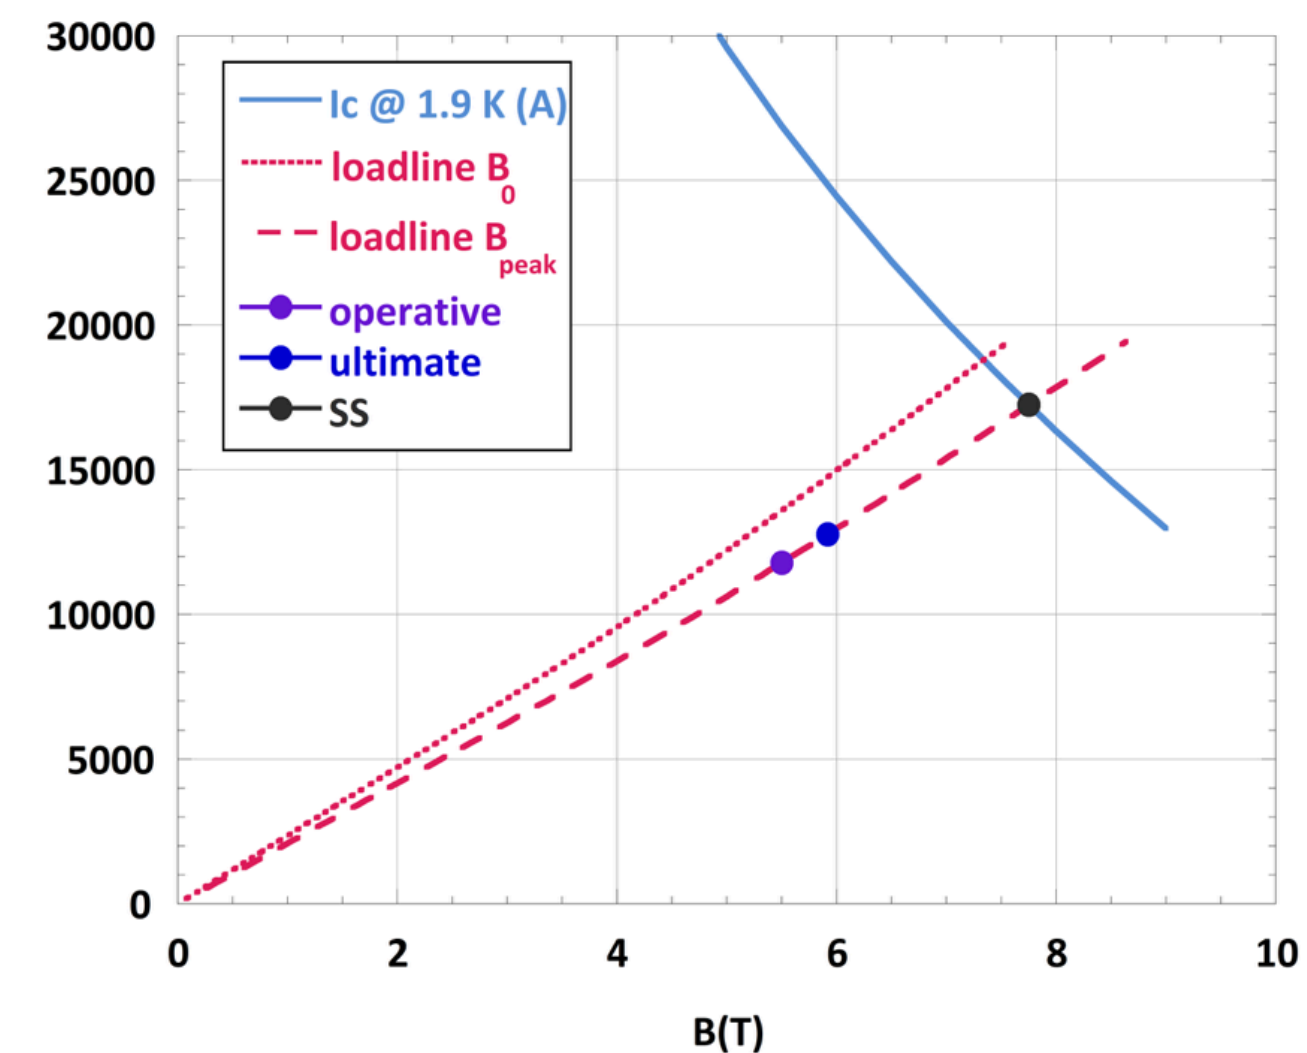
single aperture

- $I_{\text{nom}}=11800$ A, $B_0=4.85$ T
- $I_{\text{ult}}=12780$ A, $B_{0\text{ ult}}=5.21$ T
- $B_{\text{SS}}=7.75$ T, $I_{\text{SS}}=17243$ A
- loadline fraction:
 $f_{\text{nom}}=68.4\%$, $f_{\text{ult}}=74.1\%$

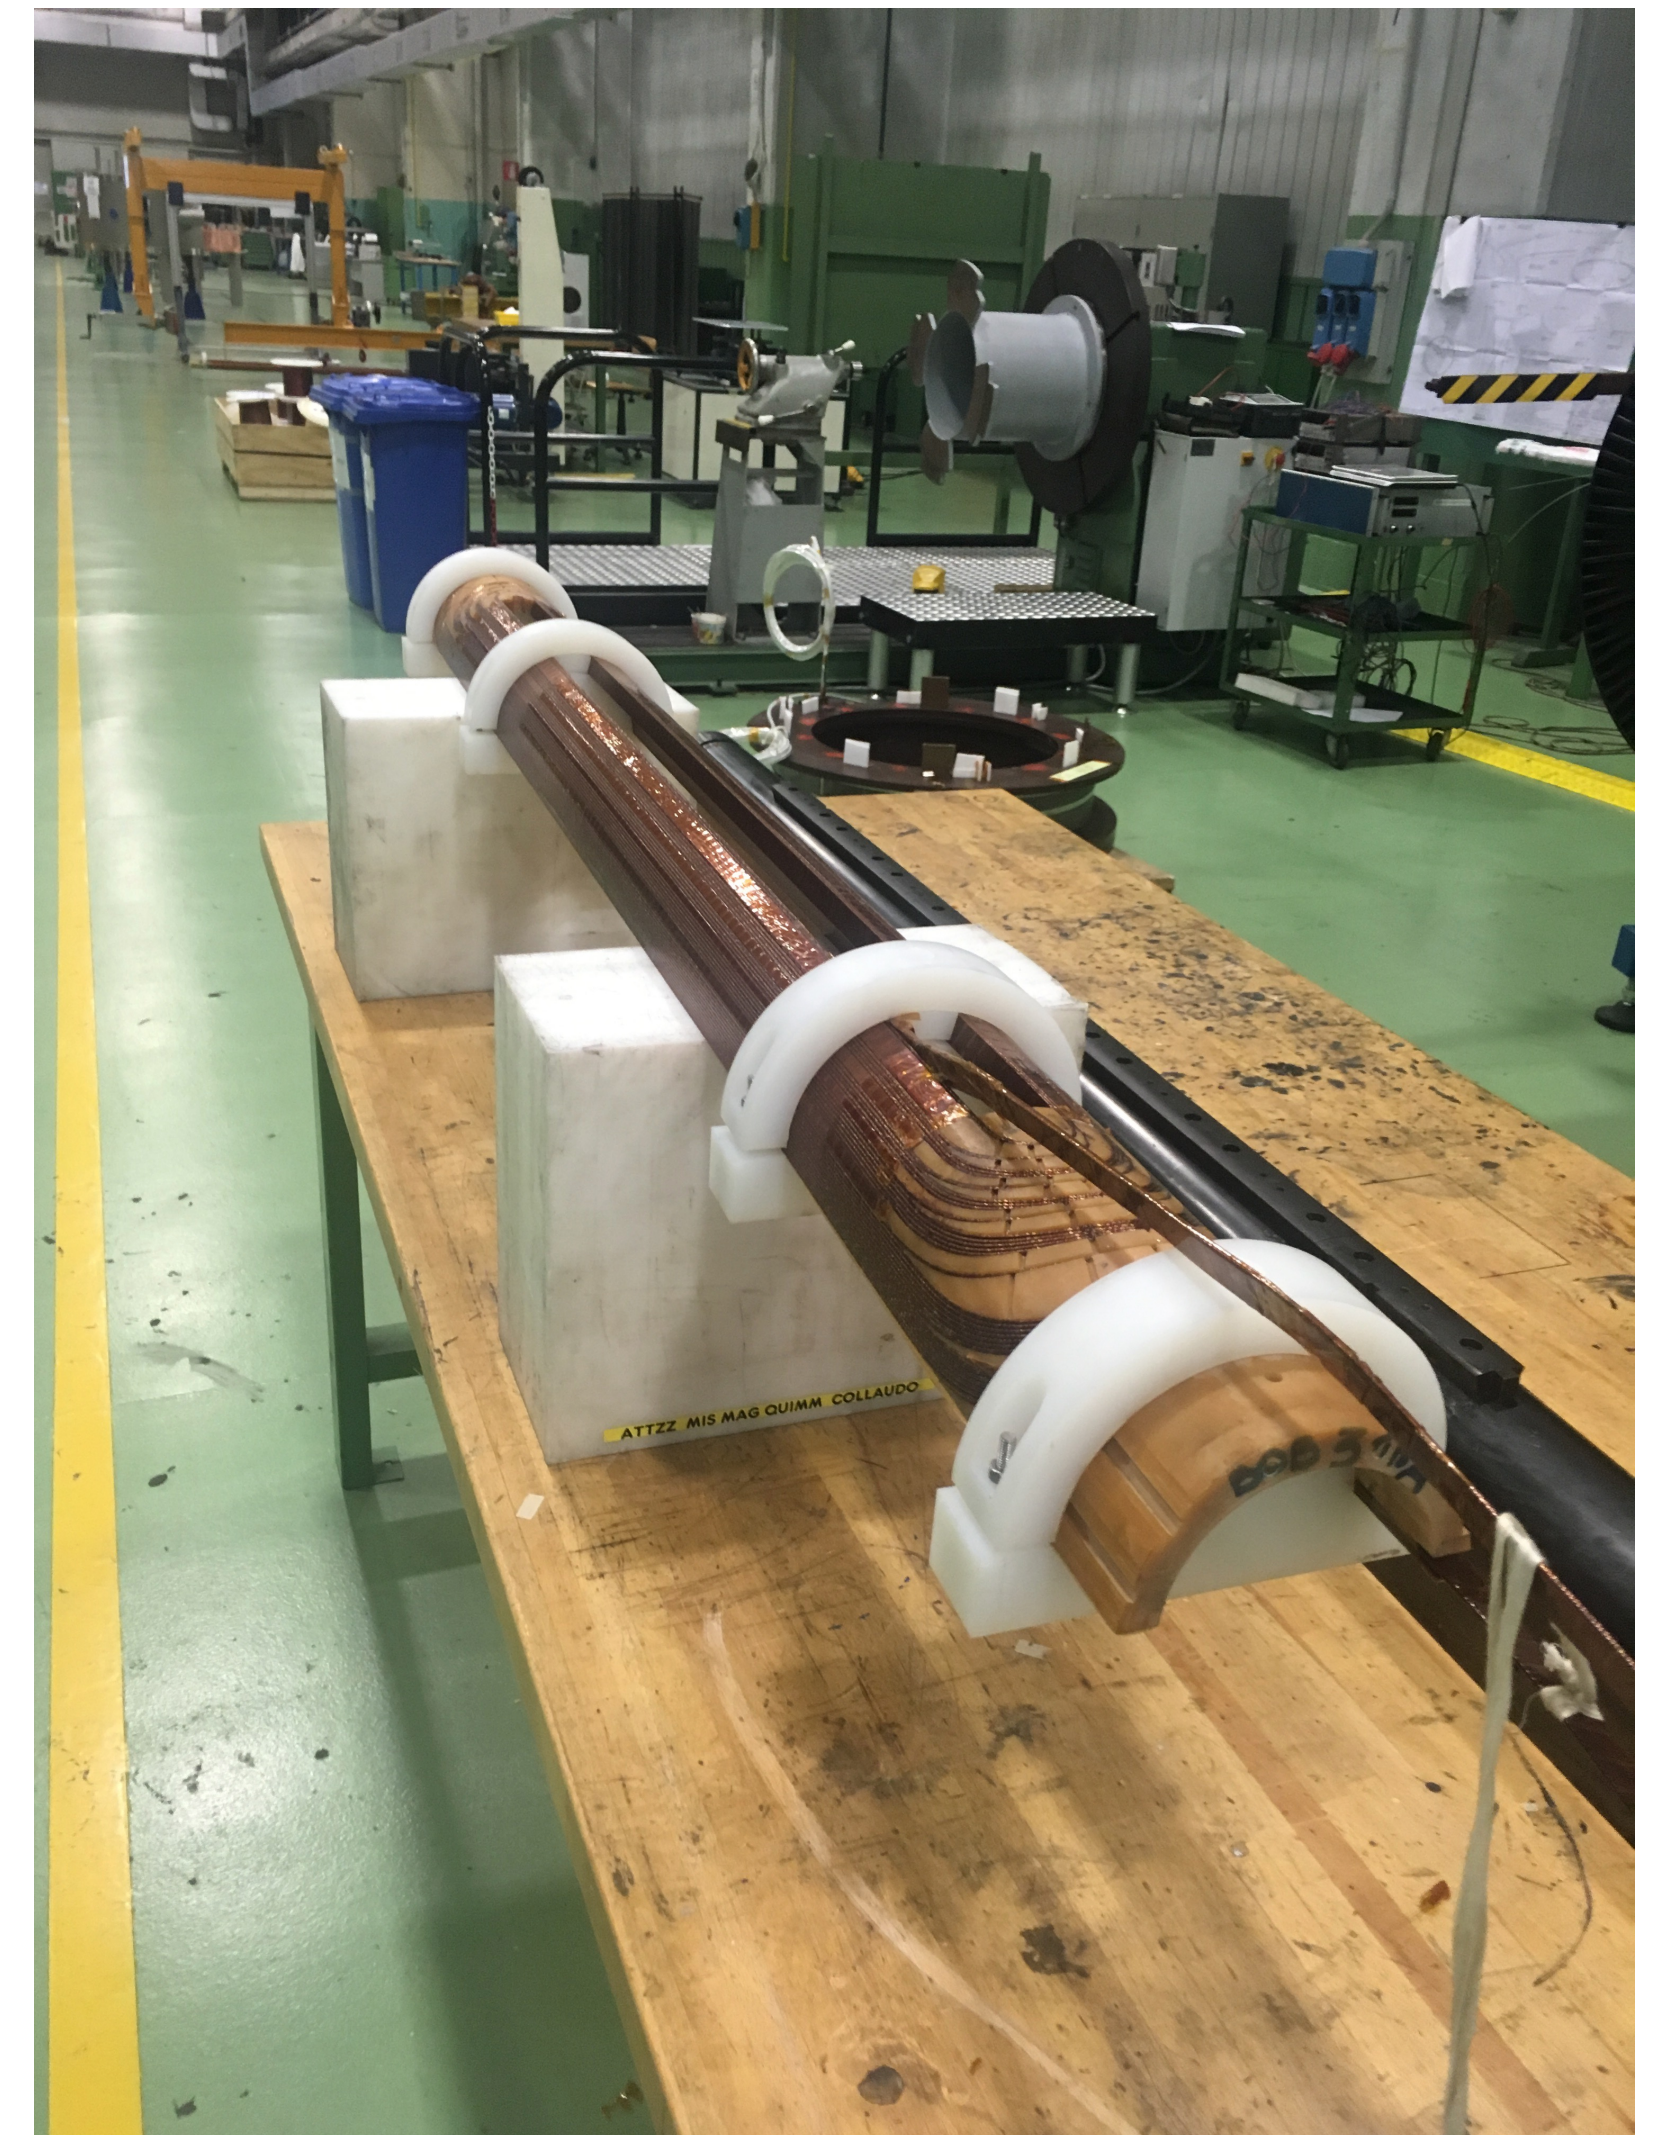
Replacement of V2 coil A

- ↪ A completely new coil has been wound
- ↪ It came out to be slightly larger than nominal (0.43mm along the transverse section)
 - ↪ all the other coil were indeed 0.2 to 0.3 mm larger than nominal
- ↪ Most of V2 ancillary parts have been replaced
 - ↪ ground insulation
 - ↪ G11 protection boxes
 - ↪ voltage taps and strain gauges
- ↪ Steel shield were reused
- ↪ Quench heaters were removed after the first collaring

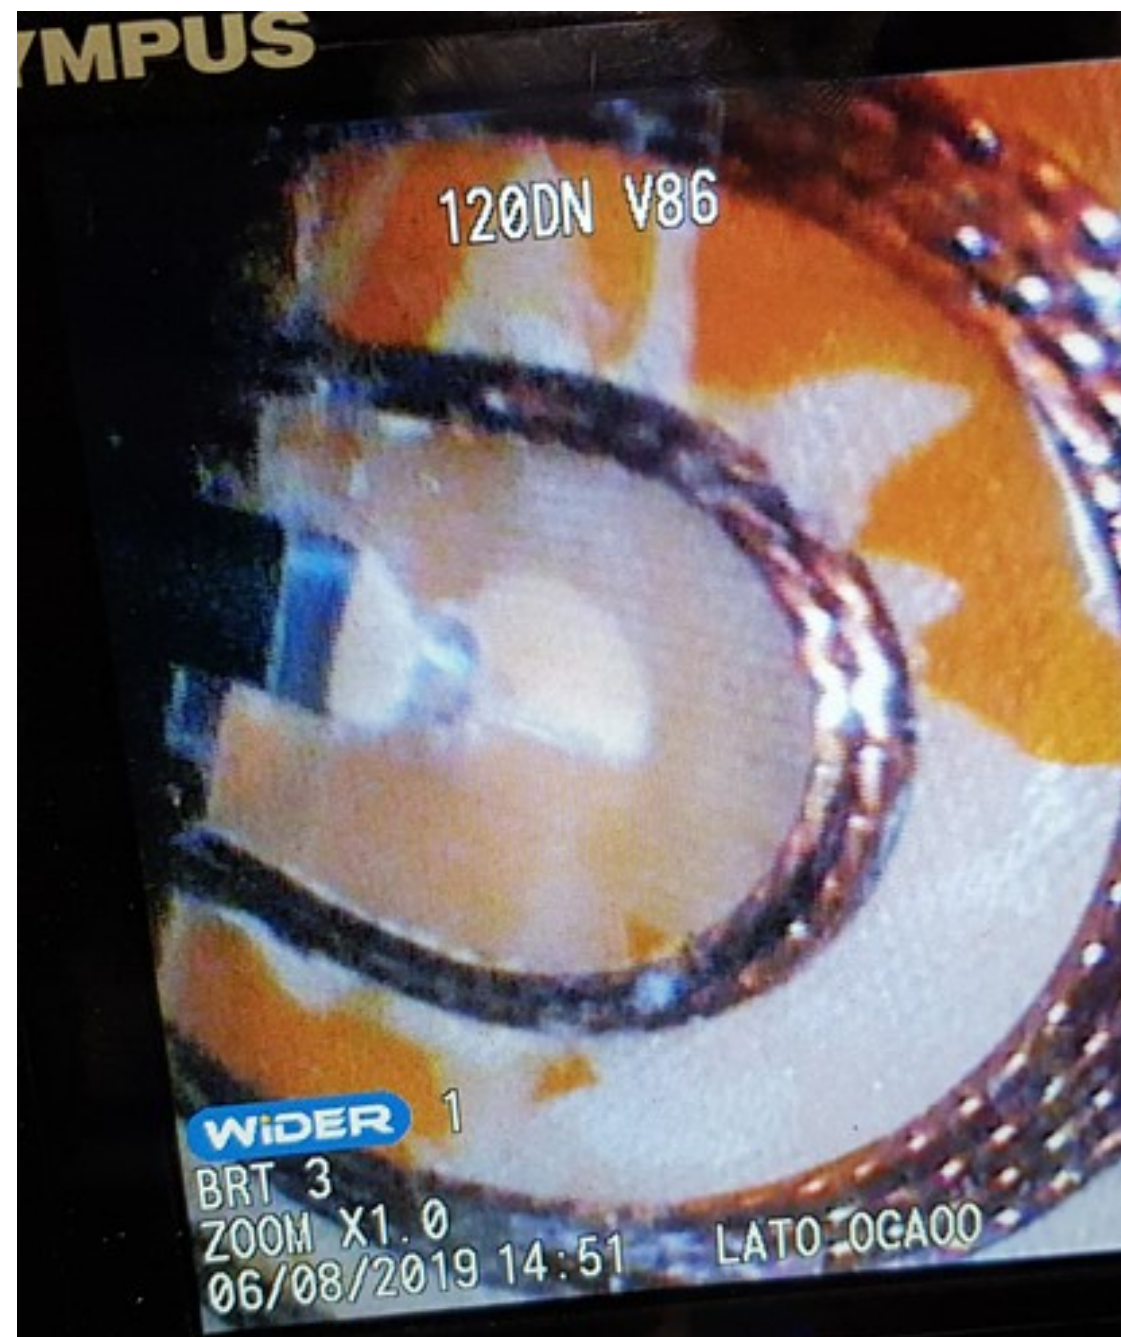
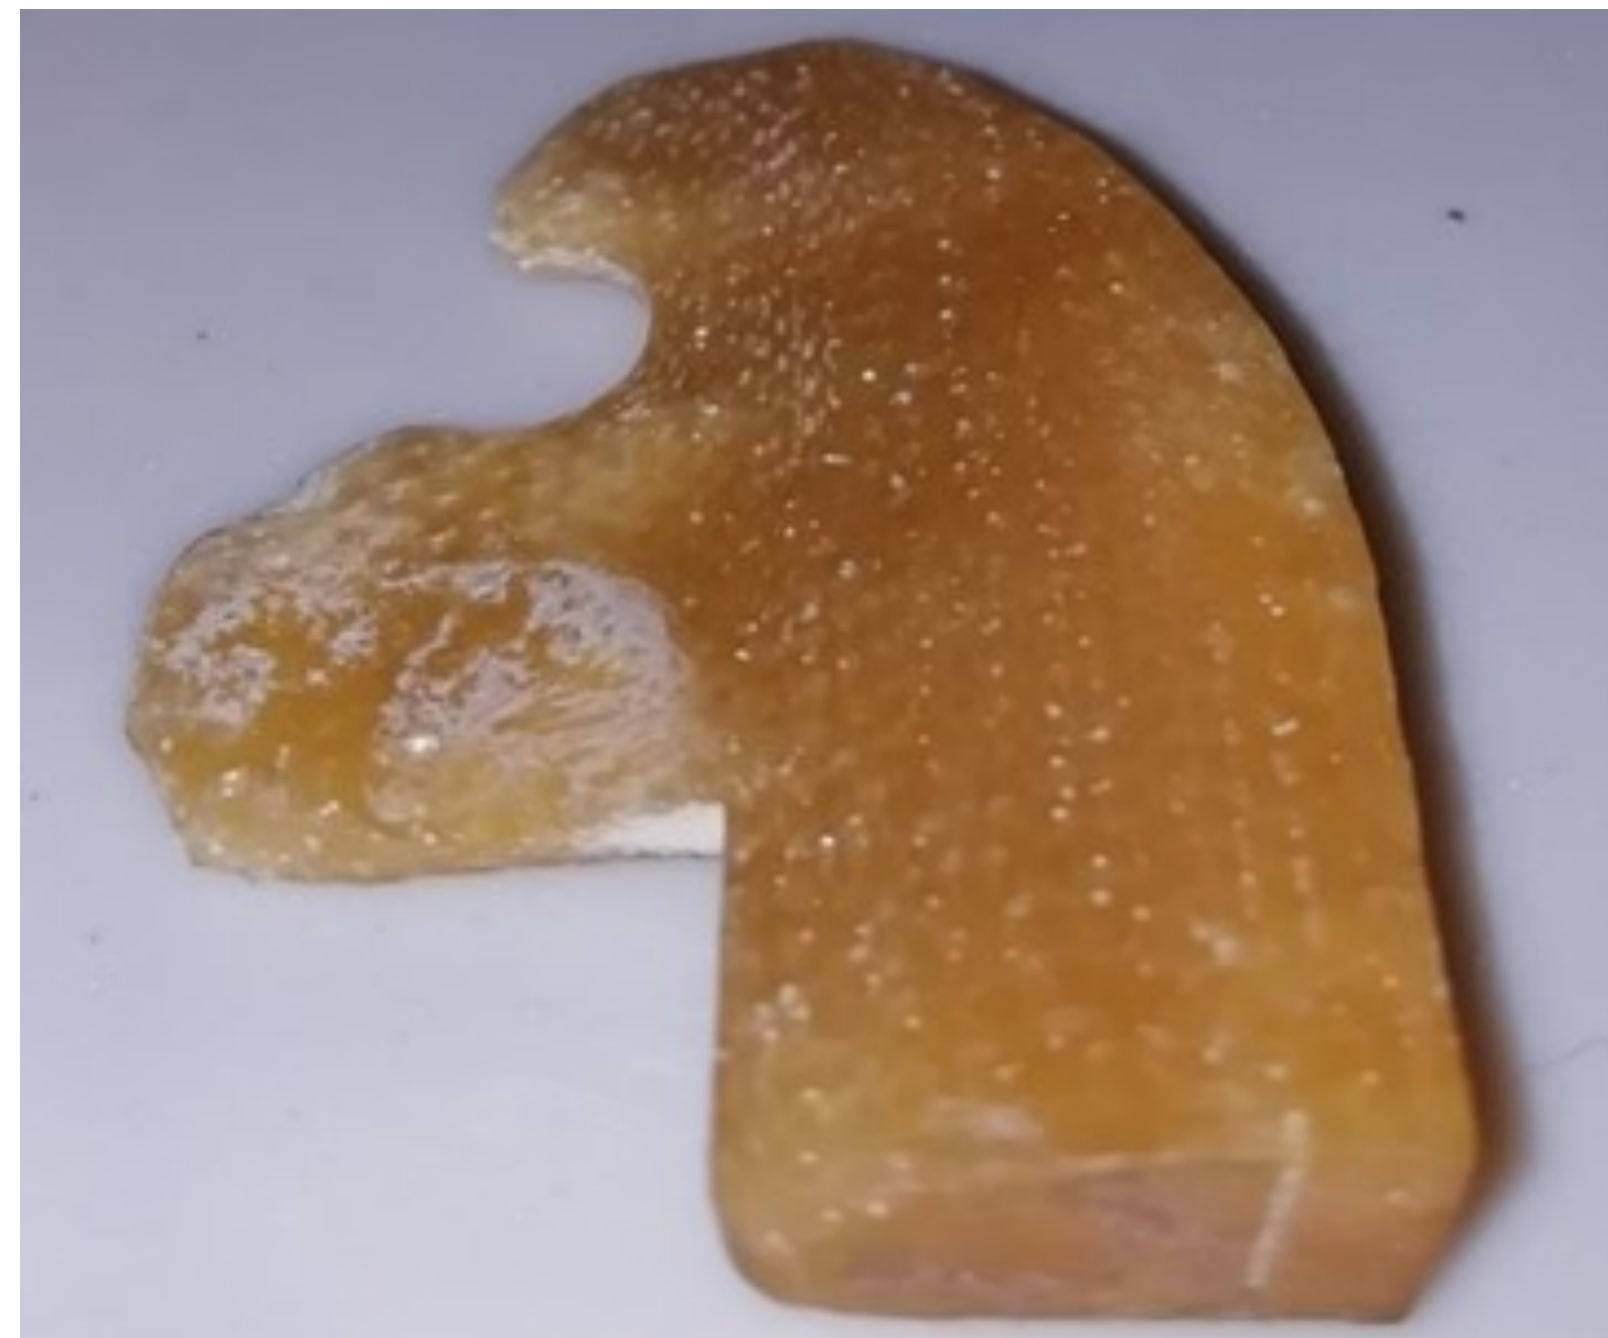
V2 new collaring issues

- ↪ Due to higher pressure, significant G11 delamination has been observed on the pole
- ↪ After inspection, minor delamination has been observed in all the other coils
 - ↪ modification in the pole design has been introduced
- ↪ Repairing has been performed in presence of INFN personnel
