MQXF Quench Heaters Assessment

Giorgio Ambrosio *HL-LHC AUP Magnets L2 Manager, FNAL* Paolo Ferracin *HL-LHC WP3 WP Engineer, CERN* with contributions from many colleagues

> 9th HL-LHC Collaboration Meeting, Fermilab, USA, 14-16 October 2019

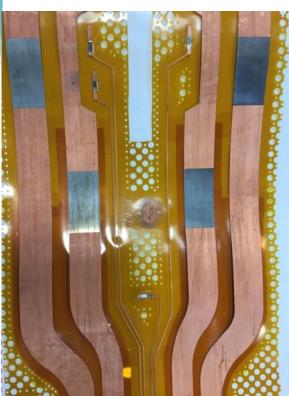
MQXFA Quench Heater Design

- MQXFA Quench Heaters:
 - 50 um polyimide + 12 um glue + 25 um steel + 10 um copper (in some areas) → 200 um Heater-Coil distance (including 145 um cable insulation)
 - Additional 50 um polyimide in the ends
 - Holes in polyimide at <u>4 mm</u> from heaters → Max V at 300 K in He gas is 900 V

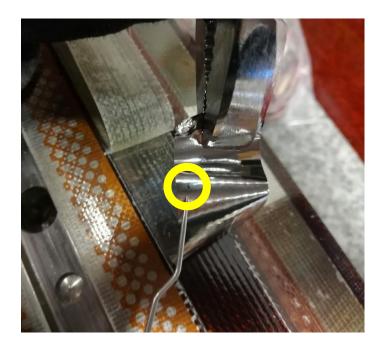
The First Hipot failure location

Short caused by series of HiPot tests (first failure at V > 1.5 kV) and thermal image analysis

Subsequent locations found by acoustic analysis and pick-up coils
