## Fast turn around Quench Heater tests

**Vittorio Marinozzi**

# Outline

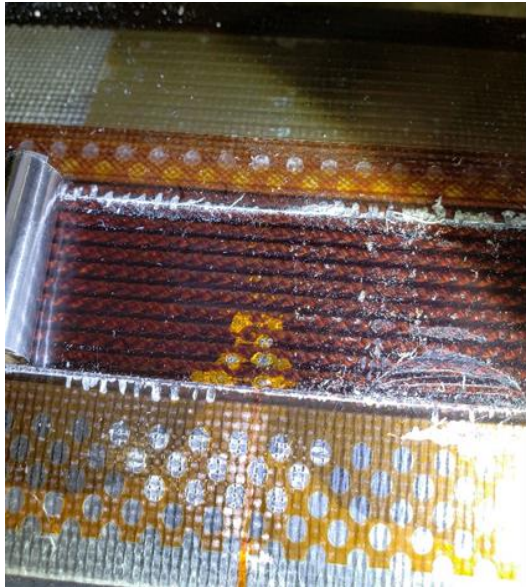
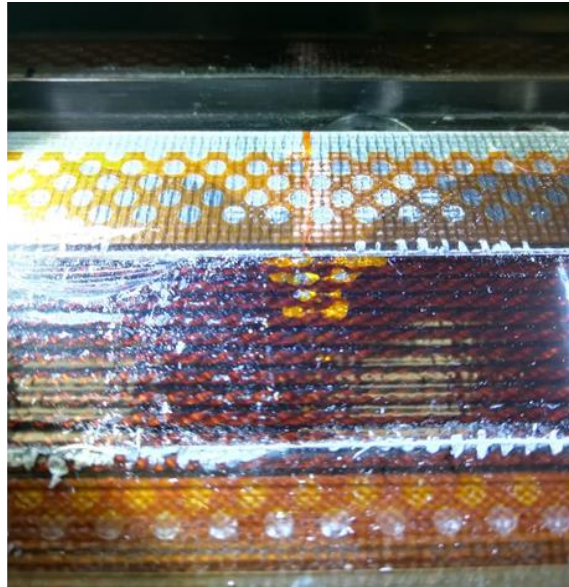
- Autopsy of coils QXFP1 and QXFP5 showed evidence of thickness reduction of the heater-coil polyimide insulation after testing

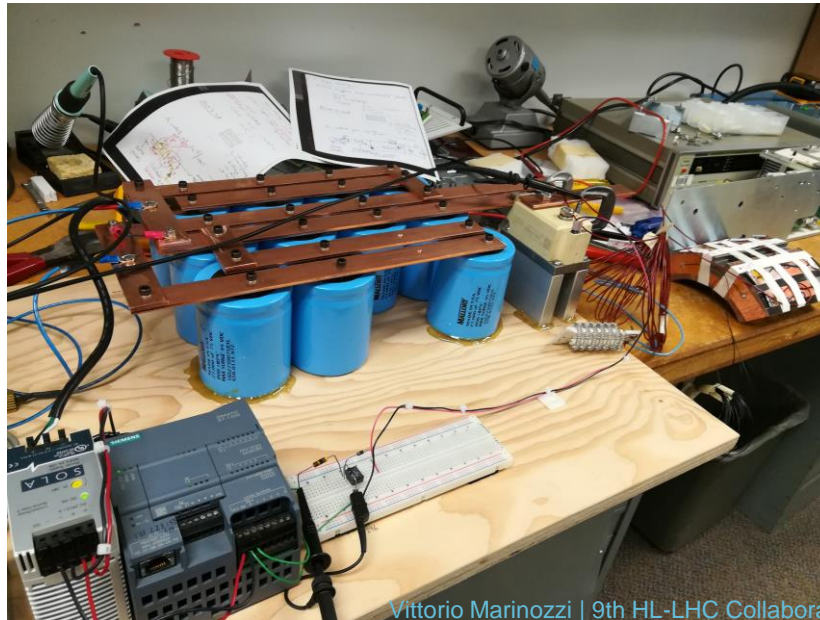
## Capacitor bank to fire heaters

- In order to fire the heaters, a dedicated capacitor bank has been built:
  - Twelve 75 V, 27 mF capacitors in parallel
  - Able to reproduce the peak power density which occurs in long coils ( $236 \text{ W/cm}^2$ ), with the correct discharge time (32 ms)
- Capacitor bank has to be discharged on 4 heater strips put in series

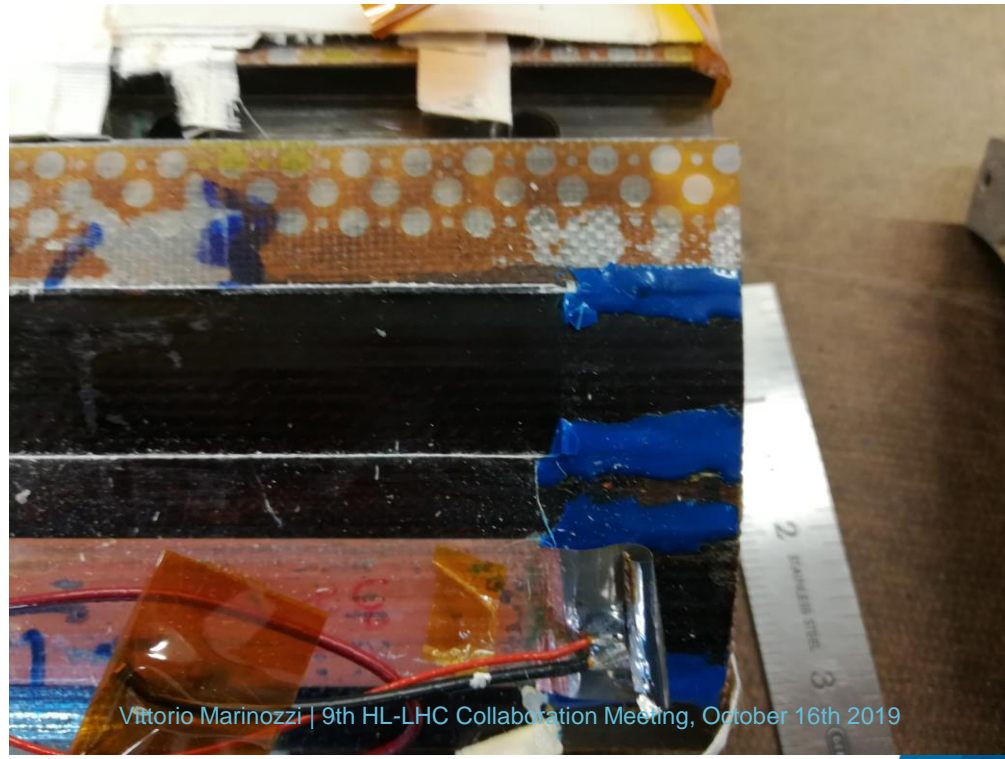
- After testing, heater traces have been hipotted up to 4 kV individually, to check the limiting ones
  - Test was limited by the ends of the traces, where sparkles were visible where the strips had been cut
- After completely peeling off the heaters, no sign of bubbles can be found on both samples
- **Conclusion: In this experiment, heater firing seems not to degrade electrical insulation**

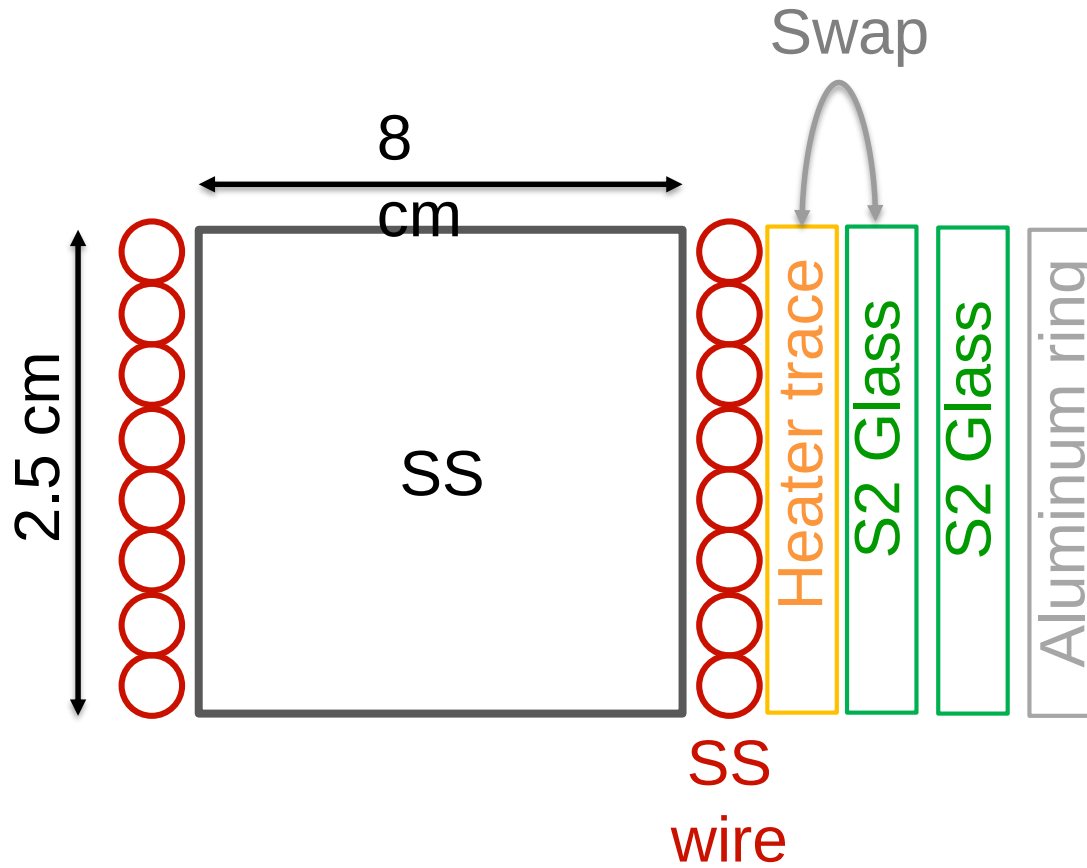
# Coil design

- Fast turn around experiments with coil/magnet quenches are very difficult to perform
  - Lots of time and resources needed
- We are building Ni-Cr (stainless-steel-like) coils to “simulate” quench
  - Coils are built using same procedures as MQXF coils
    - Reaction, impregnation, same materials
  - During test, then they are heated up from 4 K to 200 K in the same time as MQXF magnet during a quench by a current discharge
  - We will allow impregnation voids using different techniques, to create areas that will be filled by helium during testing

<b>Wire diameter</b>	1.3 mm
<b>Insulation material</b>	S2 glass
<b>Insulation thickness</b>	0.15 mm
<b>Wire length</b>	3 m
<b>Number of turns</b>	15
<b>Inductance</b>	37.5 $\mu$ H
<b>Conductor Weight</b>	34 g
<b>Energy from 2 K to 200 K</b>	1.75 kJ
<b>Warm Resistance</b>	1.6 $\Omega$
<b>Resistance @ 4.2 K</b>	1.1 $\Omega$
