# Safety in the East Area Renovation Project

E. Harrouch on the behalf of the East Area Renovation Project Team

**EAST AREA RENOVATION**

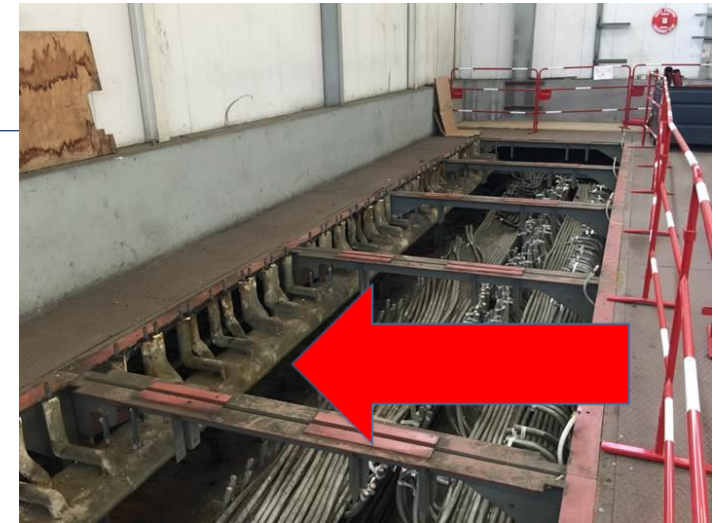
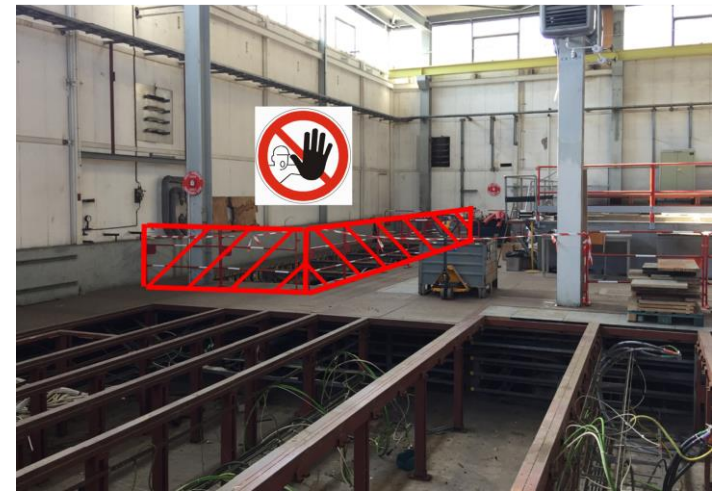
- L'isolation plâtre des tuyauteries contient de l'amiante (amosite en traces),
- Des fibres d'amiante sont probablement présentes sur le sol ainsi que sur les câbles,
- Cette zone est donc à considérer comme « polluée » à l'amiante mais ne présente pas de risque majeur dans les conditions actuelles pour les personnes devant accéder impérativement dans le hall.

Aussi par précaution, et jusque la zone soit assainie par une entreprise spécialisée (prévu mi-juin), il est interdit de :

- Descendre dans cette zone, de marcher sur le sol ou sur les câbles présents,
- De manipuler les câbles présents par le dessus,
- De retirer les câbles présents depuis une autre partie des faux-planchers,
- De retirer les plaques métalliques de faux-planchers directement à proximité,
- D'effectuer des travaux pouvant provoquer des courants d'air importants (ou des vibrations) à proximité directe et donc pouvant entraîner la mise en suspension temporaire de poussières dans la zone concernée (sans que l'on puisse en connaître la concentration en amiante).
