Our experiences and troubles on FPCs for RIKEN QWR

OZEKI, Kazutaka RIKEN Nishina Center

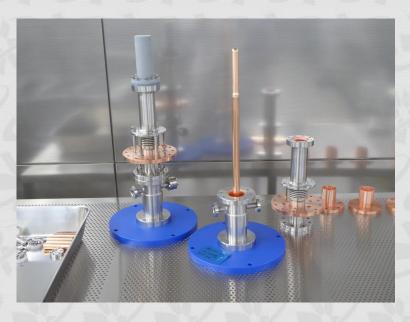
All processes were performed in ISO-class 1 clean room.

"KOACH" system by KOKEN-LTD. Report in detail by K. Yamada Feb. 06, WG4

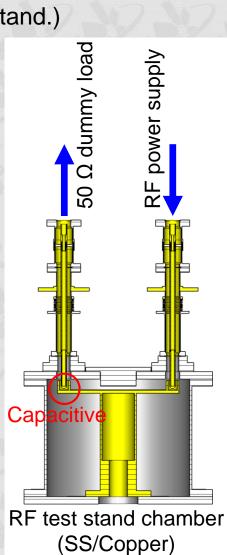
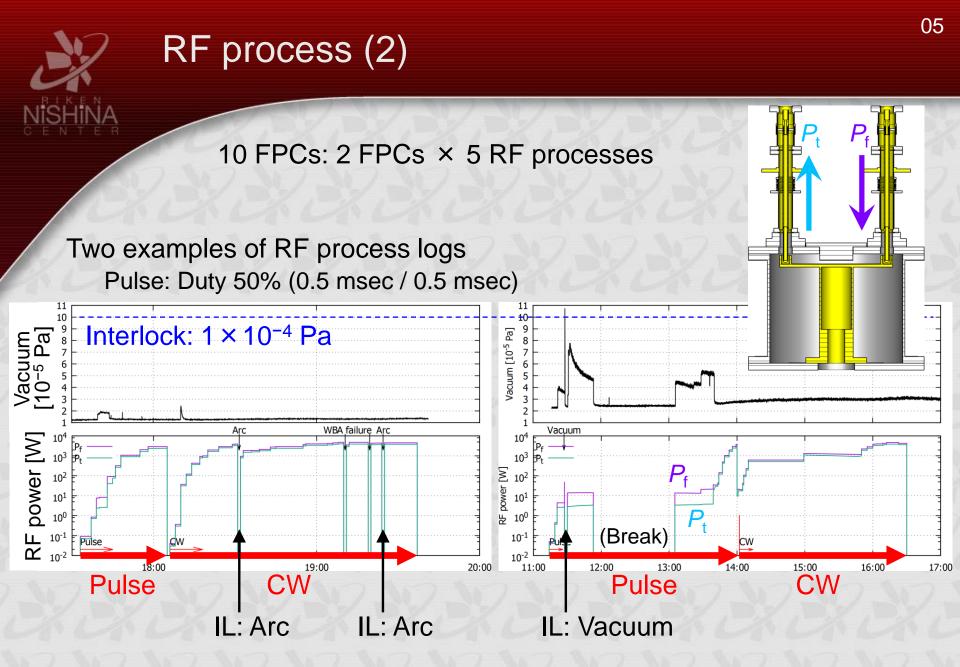
Pickup port

- Interlock
 - Vacuum (Vacuum gauge was mounted on test stand.)
 - Arc

RF power seemed to be fed up to ~5 kW without any difficulties.

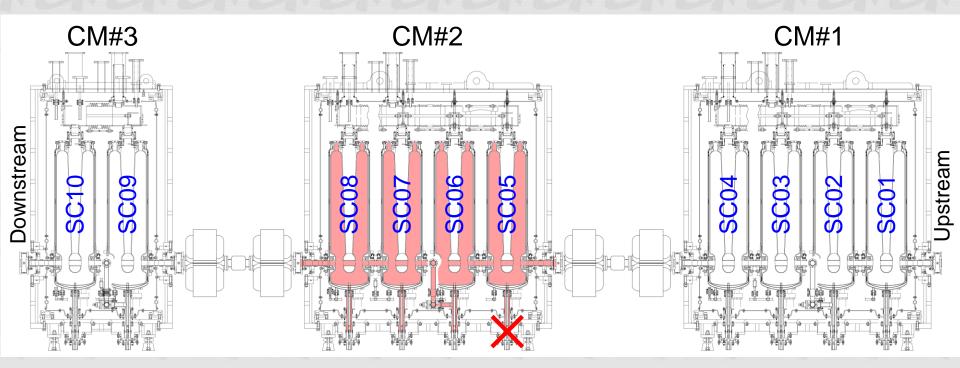
Trouble: Vacuum leakage (1)

Nov. 2019 (After 2 months of evacuation) Vacuum leakage @ vacuum window of FPC mounted on SC05. $\sim 10^{-7}$ Pa $\rightarrow \sim 10^{0}$ Pa

- During warm-up process after cooling test.

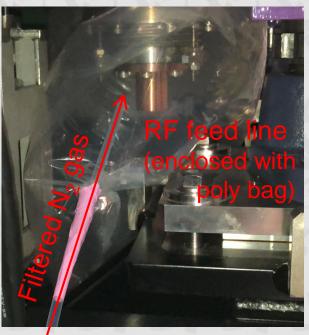
First aid to prevent air leak in.

Preparation of evacuation flange

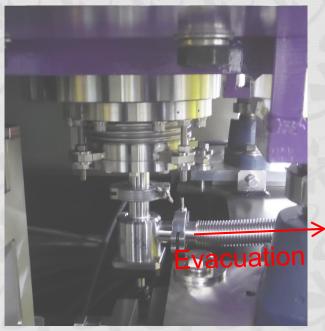
Evacuation from air-side of the vacuum window.

Cavity vacuum has restored to almost same level as CM#1 &3.

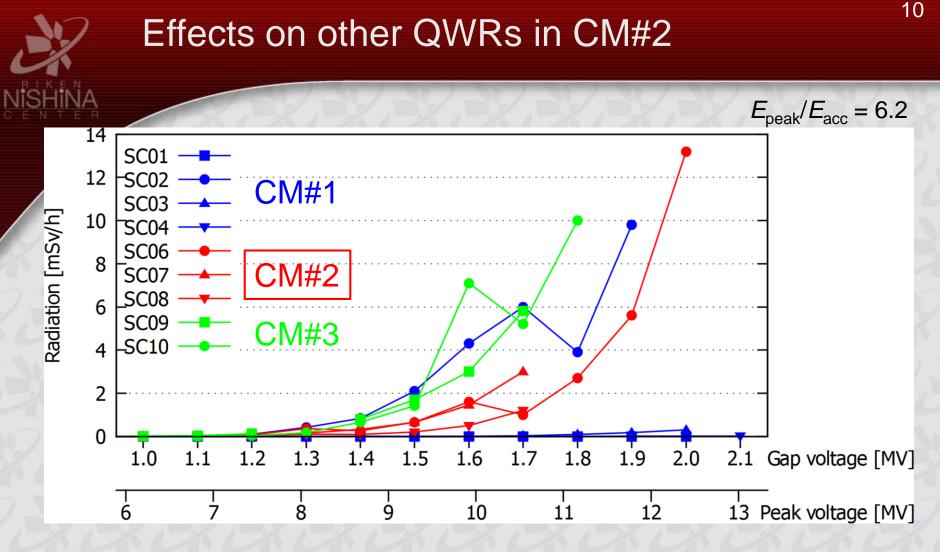
Cavity vacuum (@ 4 K) CM#1: 2.5 × 10⁻⁸ Pa CM#2: 4.0 × 10⁻⁸ Pa CM#3: 2.4 × 10⁻⁸ Pa

No serious performance degradation compared with QWRs in CM#1 & 3. Vacuum degradation happened during CMs were in cryogenic condition. $T_{FPC} < 240 \text{ K}$ \longrightarrow Contaminants were trapped in FPC itself and SC05?
