# TEST BENCH CONDITIONING OF THE ESS COUPLERS FOR ELLIPTICAL CAVITIES

TTC MEETING –Christian ARCAMBAL

4TH FEBRUARY 2020

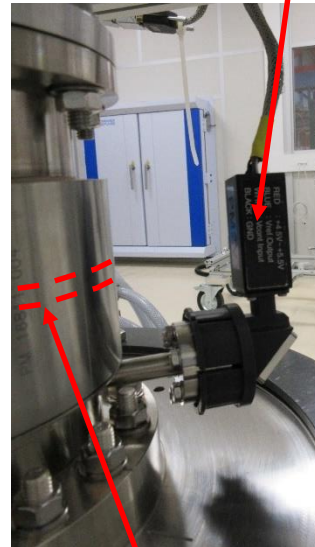
Electron pick-up

Photomultiplier (vacuum side)

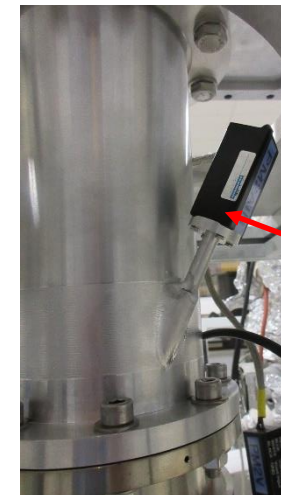
Position of the ceramic disk

Photomultiplier (air side)

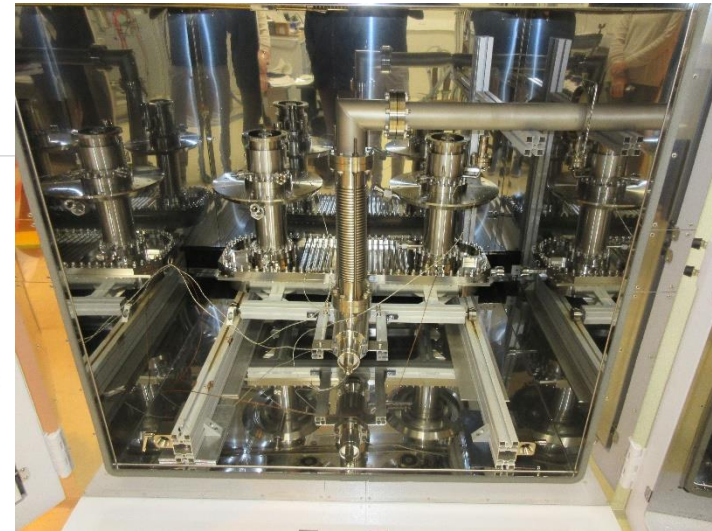
- Cleaning of the components:
  - Ultrasonic bath for double-wall tubes (Tickopur R33 detergent)
  - Manual cleaning for window (absolute ethanol, antenna cleaned with RBS T310)
- Assembly in a ISO5 cleanroom
- Baking in an oven (couplers 170°C for 4-5 days, pumping system 120°C then 60°C)

Couplers in the oven

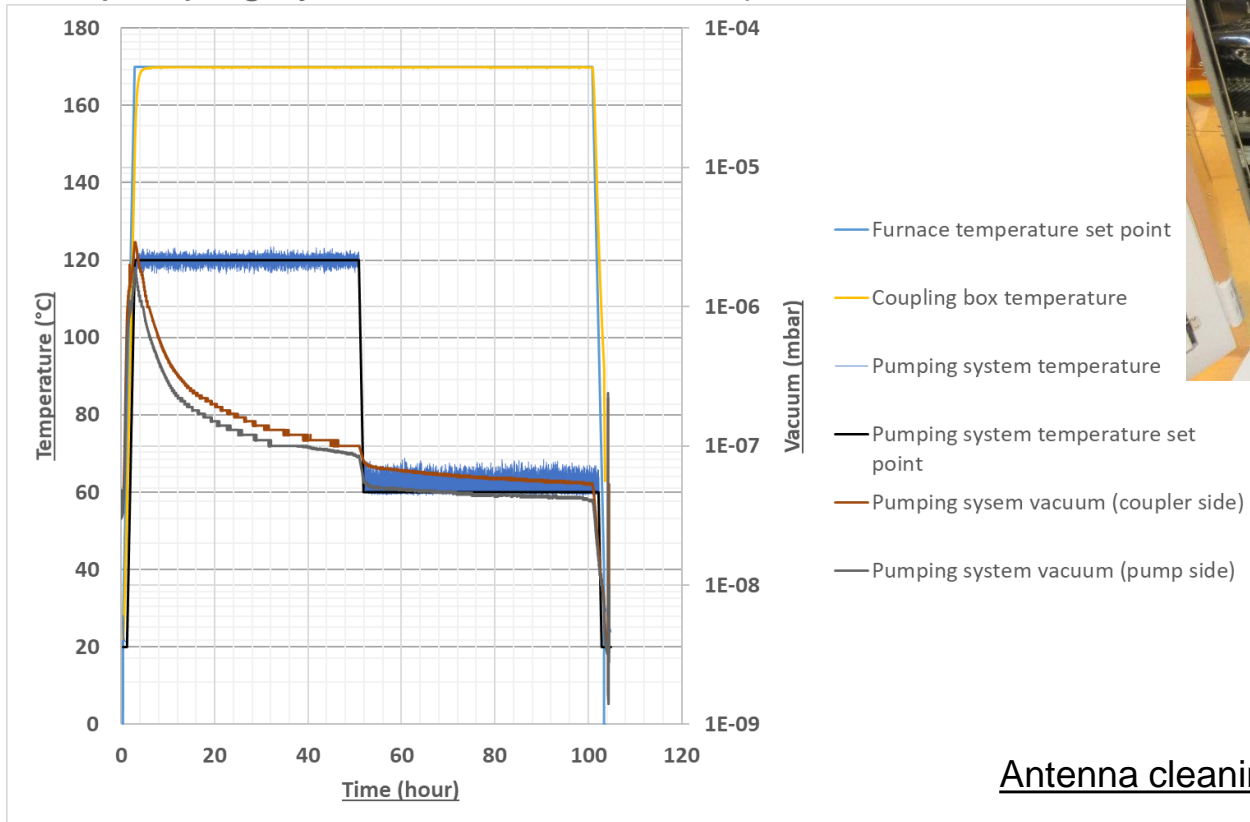
Baking (temperature and vacuum)

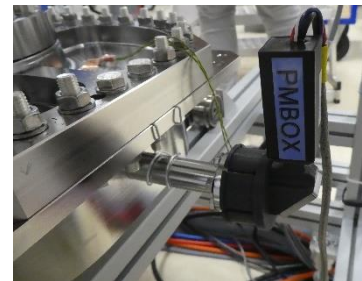
Photomultiplier on the coupling box

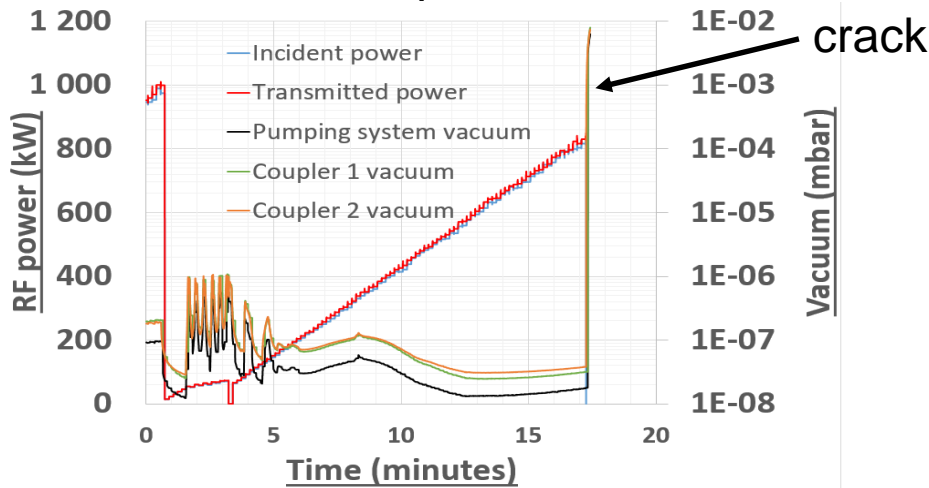
## Series coupler

- During the conditioning of the first series couplers pair, **a crack** occurred on the ceramic (travelling wave, 14Hz, 2.5ms at 800kW) ⇒ loss of vacuum tightness
- Inspection of the other diagnostic signals ⇒ window temperature increased highly

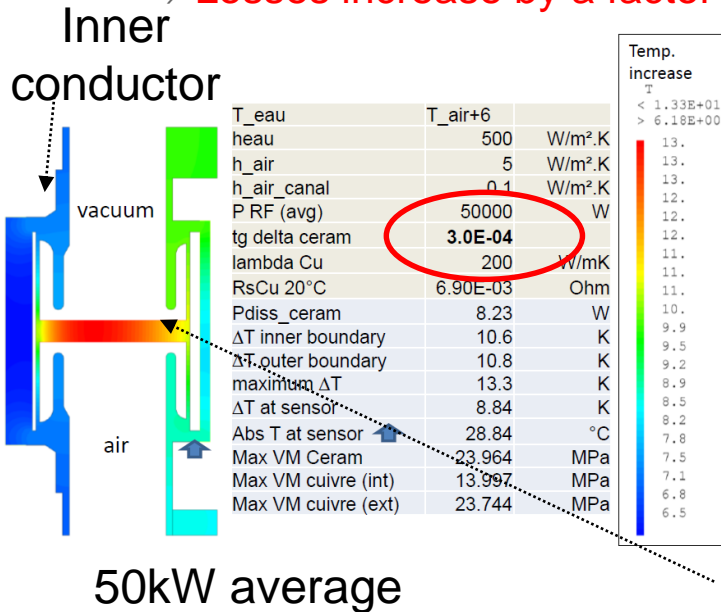
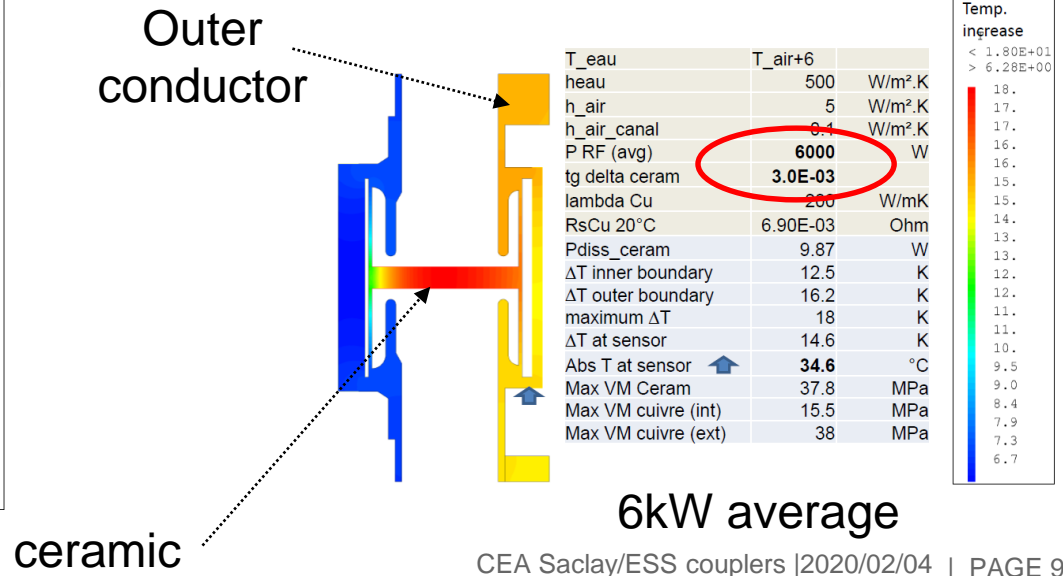
- We performed the conditioning with another pair, same temperature behavior as for the coupler with crack. Stop of the conditioning.
- Simulation performed to explain the temperature behavior of the couplers
  - With the nominal dielectric properties of the ceramic (nominal average power 55kW-3.6ms, 14Hz, 1MW peak), impossible to find the high temperature in spite of pessimistic heat transfer coefficients
  - Increase of dielectric losses (x10), average power 6kW obtained when we stop the conditioning ⇒ simulation similar to the temperature measurement
- Characterization of a ceramic without TiN ( $\epsilon_r=9.47$  and  $\tan \delta= 2.78 \cdot 10^{-4}$ ) and a ceramic with bad TiN ( $\epsilon_r=9.44$  and  $\tan \delta= 2.04 \cdot 10^{-3}$ ) with measurements at 1.8GHz in a resonant cavity  
 ⇒ **Losses increase by a factor 10 with the TiN coating**

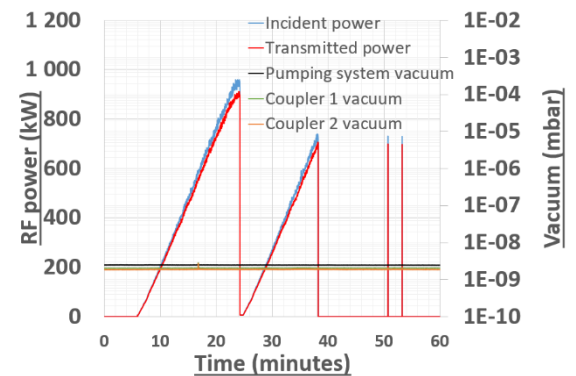
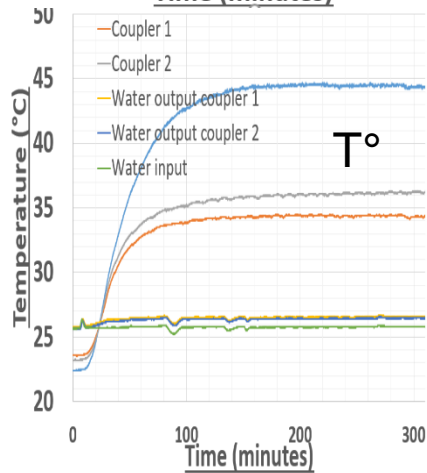
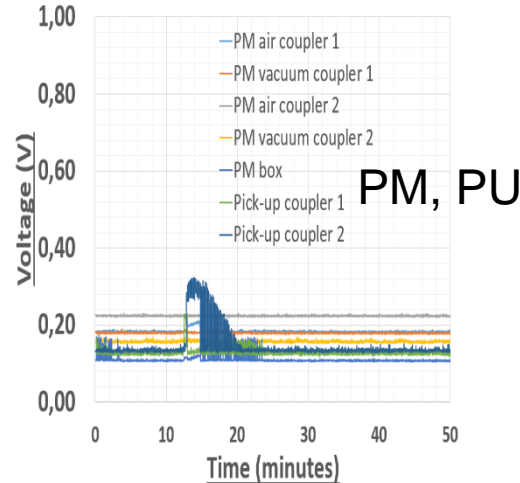
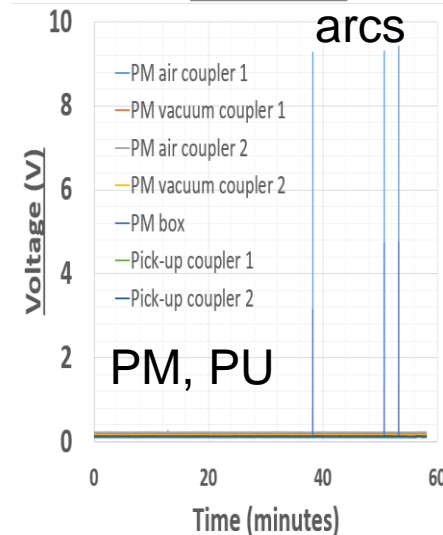
SW, 1Hz, 50µs, Max E

⇒ Normal temperature behavior but conditioning stopped in SW (Max E) due to lots of electrical arcs
