Measurement of particle contamination in vacuum at the cryomodule section on the Linear IFMIF Prototype Accelerator

TTC(TESLA Technology Collaboration) meeting 2020
CERN – 6st February 2020

Linear IFMIF Prototype Accelerator (LIPAc) Rokkasho Fusion Institute (BA Site)

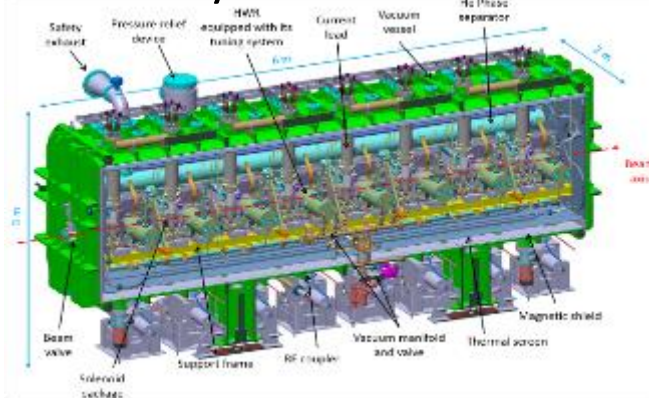
SRF Linac cryomodule of the LIPAc.

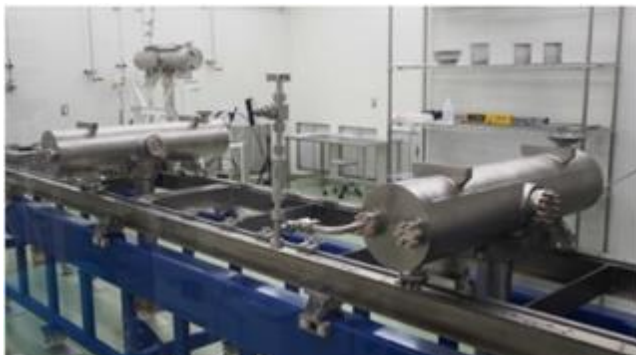
Cavity string assembly in ISO-class5 cleanroom.

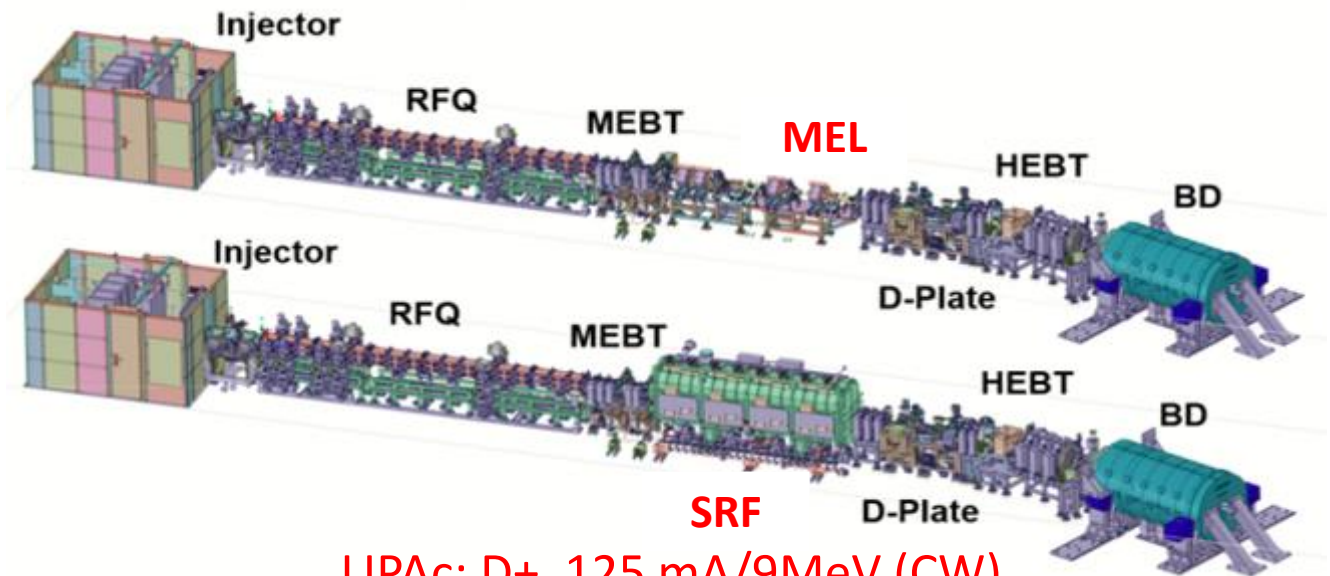
Current status: Installing MEBT extension line (MEL) instead of the SRF to perform the beam commissioning.

LIPAc: D+, 125 mA/9MeV (CW)

Future: SRF will be installed.

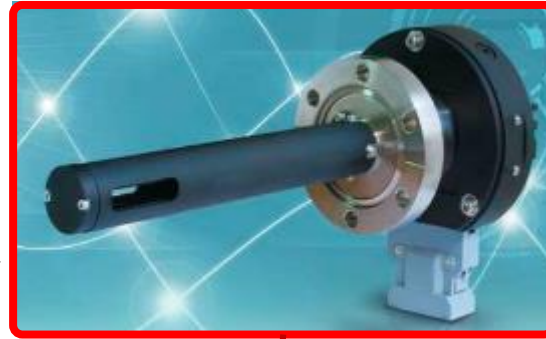
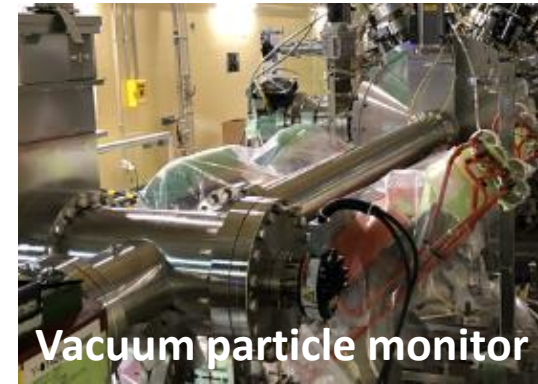
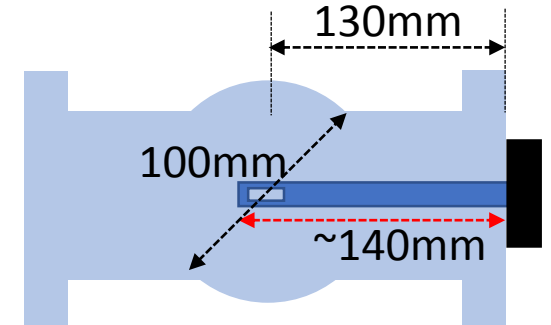
Vacuum particle monitor
Principle: Laser scattering
Resolution: 0.3~3.6 μm
Developed by Wexx Company

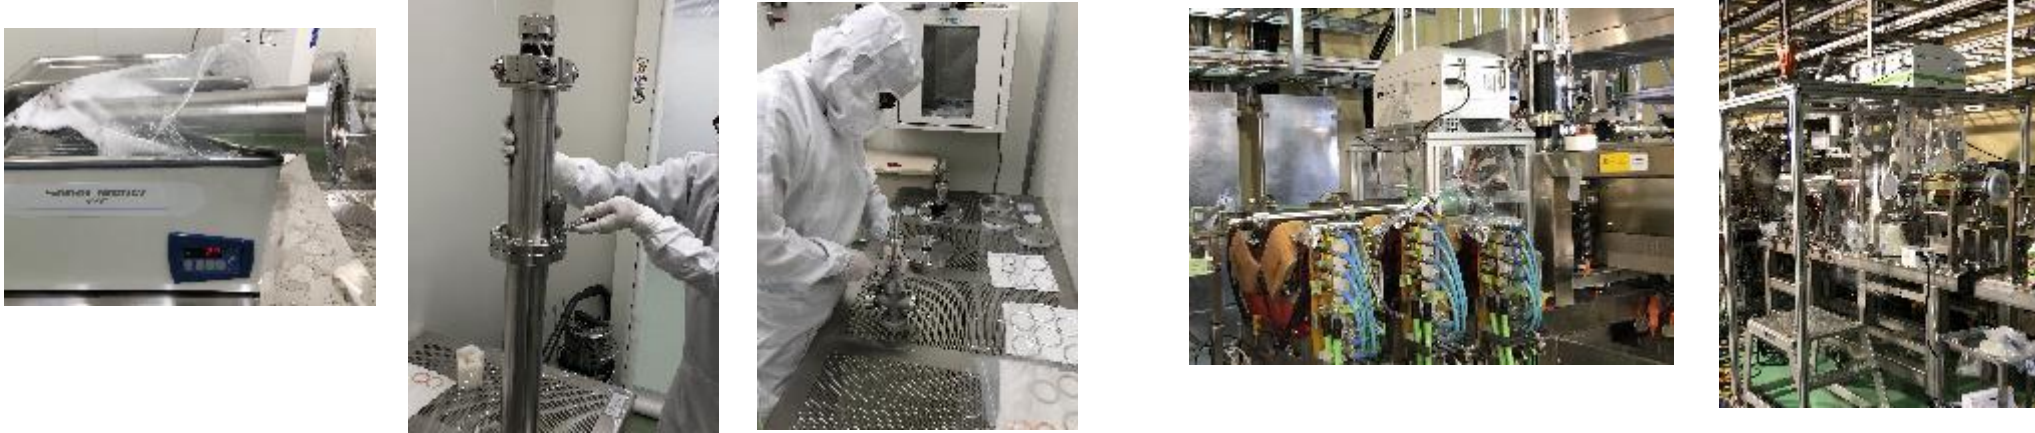
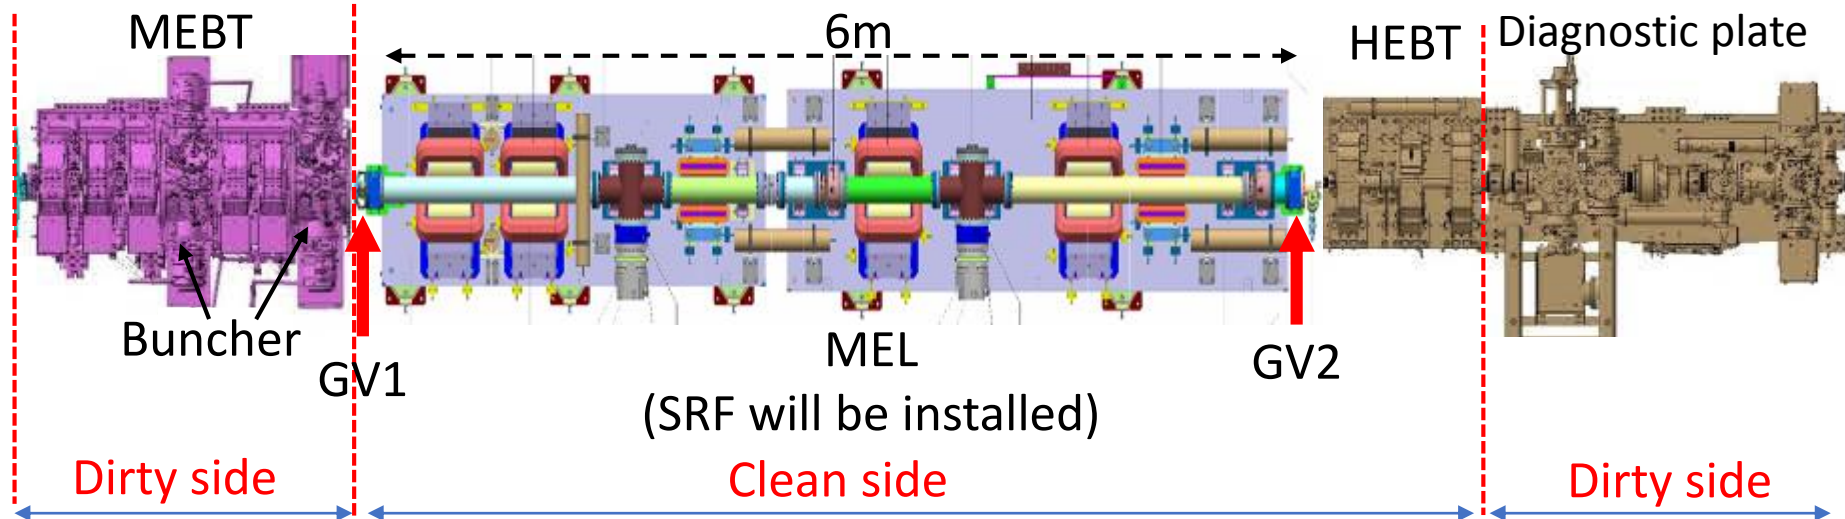
Washing and assembling in clean room.

Construction of the beam line in local clean unit.

MEL and HEBT beam duct were processed in clean room to keep cleanliness of the beam line .
 MEBT and Diagnostics were not installed in clean environment... But, Bunchers were well conditioned.

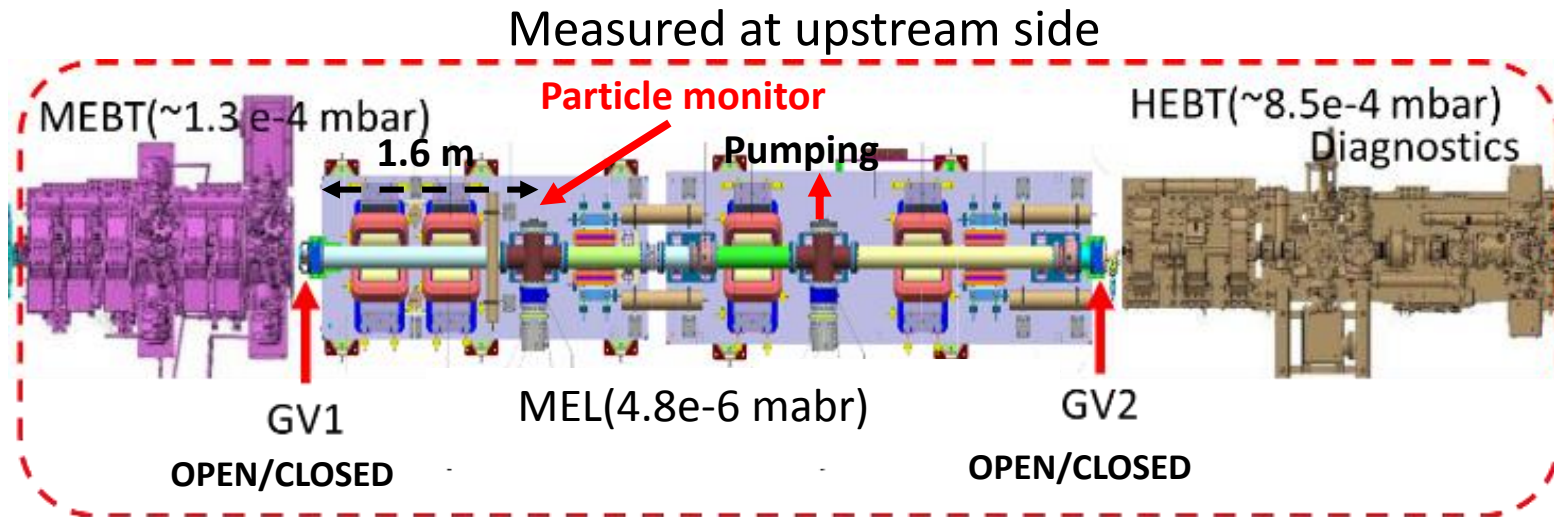
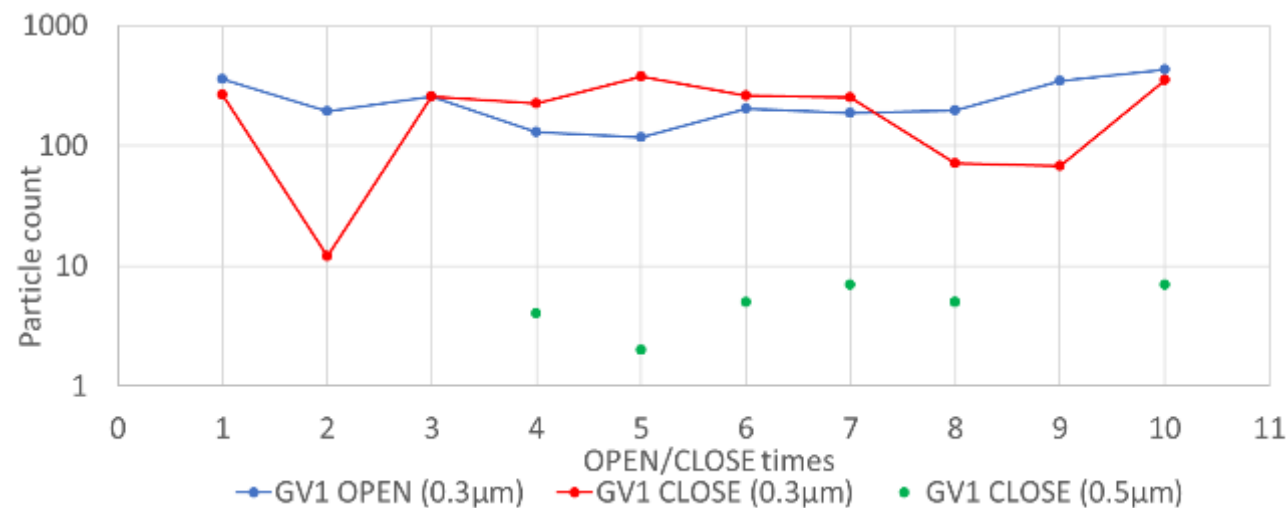
First operation of the GV

GV	OPEN	CLOSE
GV1 (MEBT side)	0.3 μ m x 356	0.3 μ m x 264
GV2 (HEBT side)	No count	No count

Several hundreds of 0.3 μ m particles were detected by GV operation of MEBT side. Repeating the valve operation, 0.5 μ m particles were detected. No detection by GV operation of HEFT side.

- Using vacuum particle monitor, we could visualize the particle moving under vacuum by GV operation in a MEL corresponding to the SRF section.
- Comparing up/downstream, particle count was significantly different. Due to a distance? With/without clean work? There is a controversial discussion about the factor of the difference.
- Considering the results, the cavities of the superconducting linac could be seriously contaminated during the operation of the GV. Further tests are needed to reduce the number of particles released during the opening/closing of the GV.

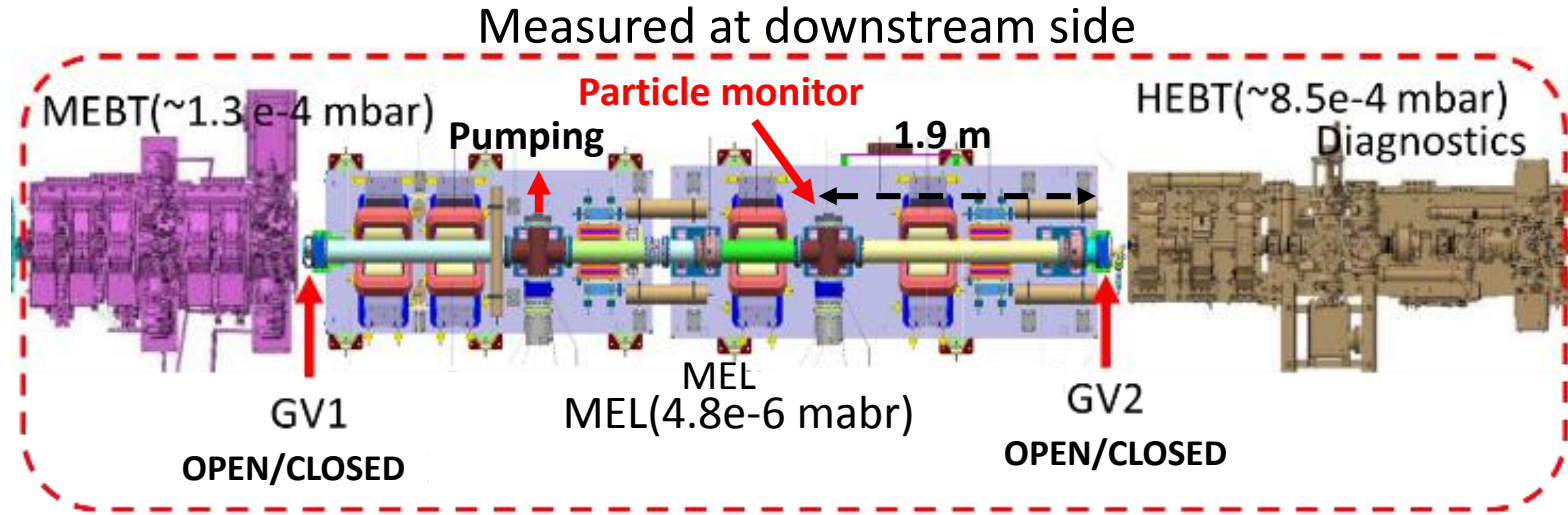
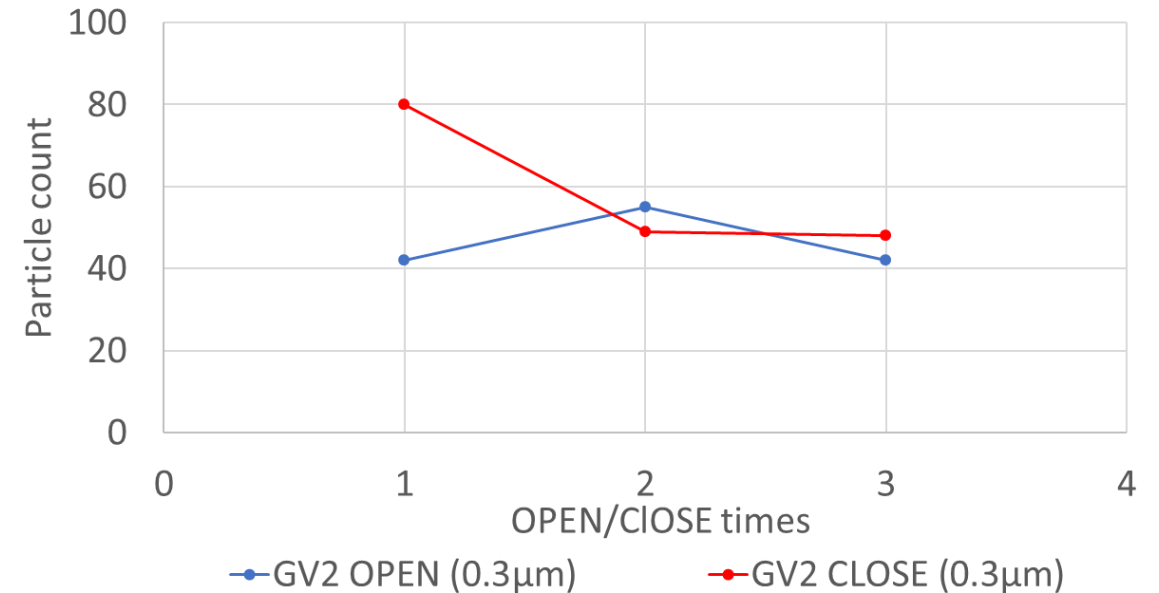
First operation of the GV

GV	OPEN	CLOSE
MEBT side	No count	No count
HEBT side	0.3 μ m x 42	0.3 μ m x 80

Several tens of 0.3 μ m particles were detected by GV operation of HEBT side.
No detection by GV operation of MEBT side.
