First results from CLICTD lab measurements

CERN, August 2nd 2019

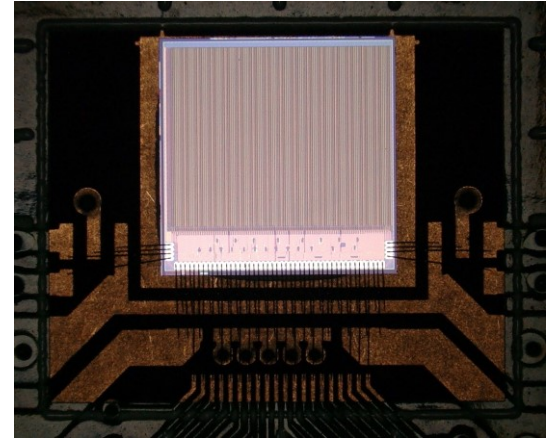
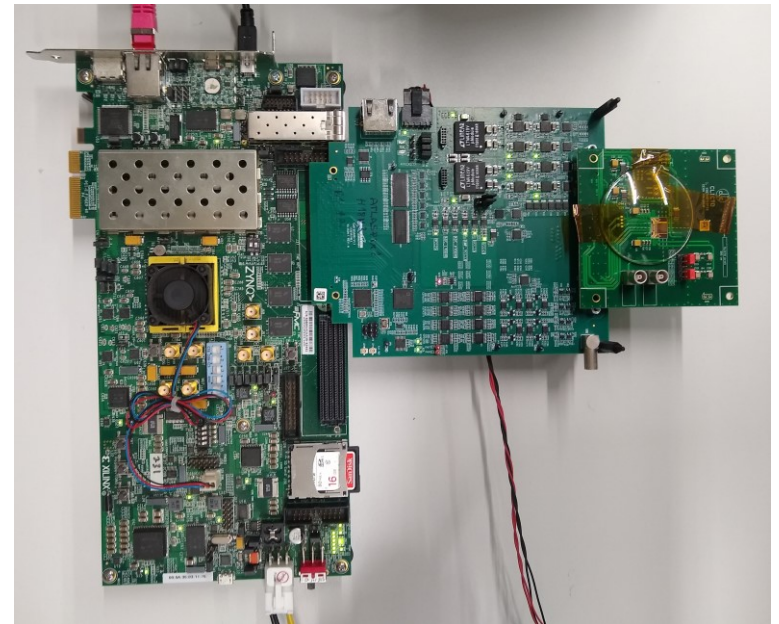
- CLICTD chips received: 02 July 2019
- Matrix size: 16 x 128 pixels (4.8 x 3.84 mm²)
- Chip size: 5 x 5 mm²
- Wire-bonding:
 - 2 samples from “Rev. A” – continuous N-implant
 - 1 sample from “Rev. B” – gap in N-implant
 - Wire-bonded samples received: 04 July 2019
- Communication established using CaRIBOu

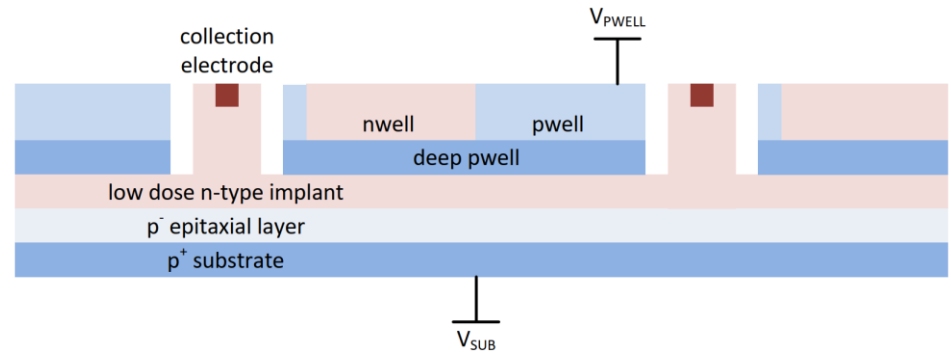
- 1st process split: continuous N-layer

- Sensor I-V measured by scanning the substrate bias, for different values of the deep P-well bias
- Leakage current was measured at both nodes: SUB and PWELL

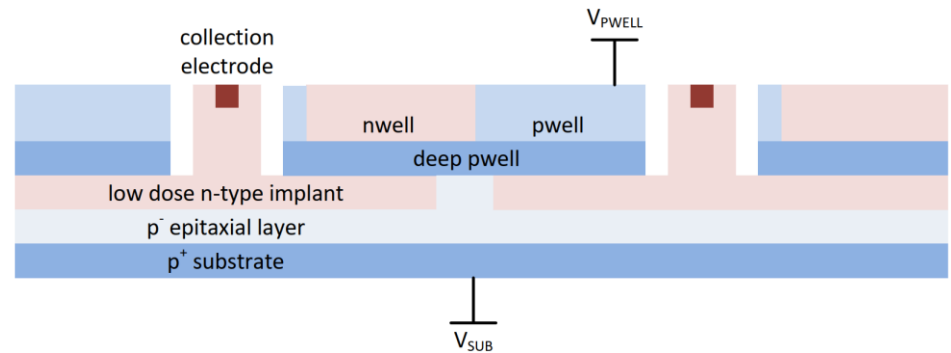
- 2nd process split: gap in N-layer (only in the long dimension)

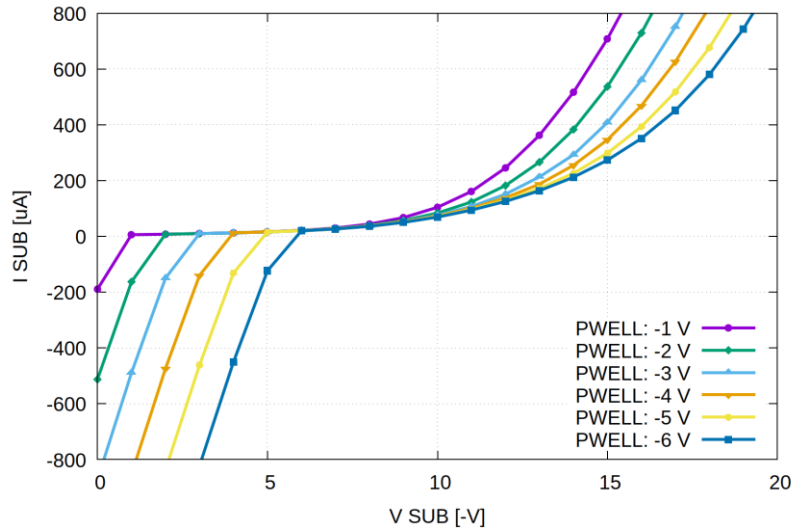
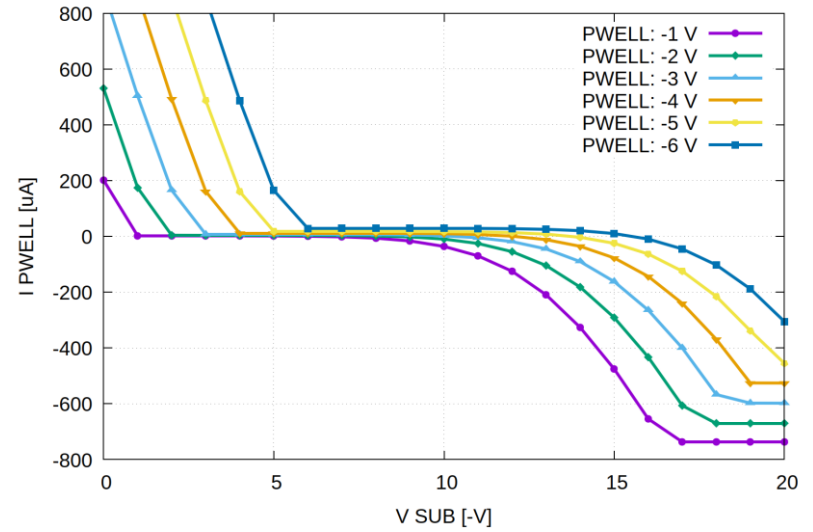
- 1st process split: continuous N-layer

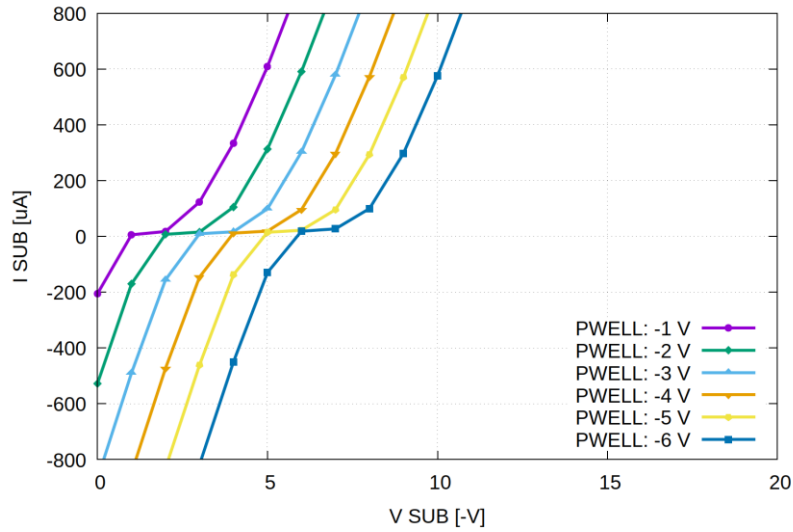
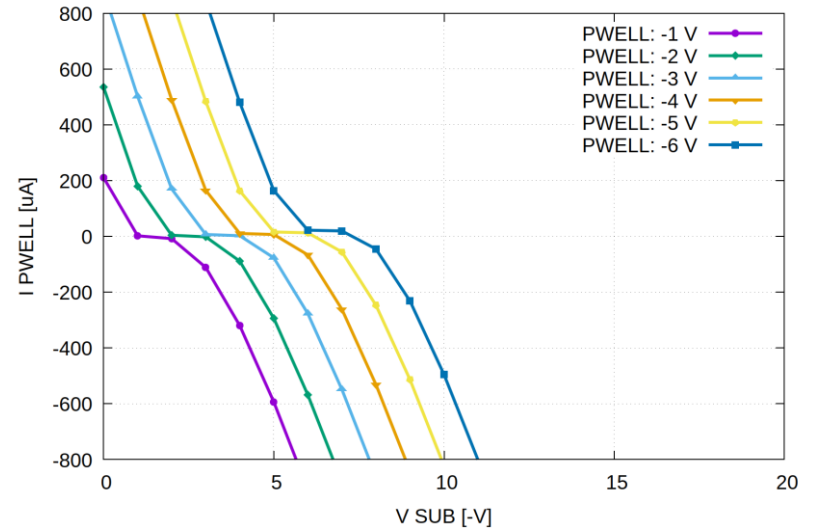
- 2nd process split: gap in N-layer

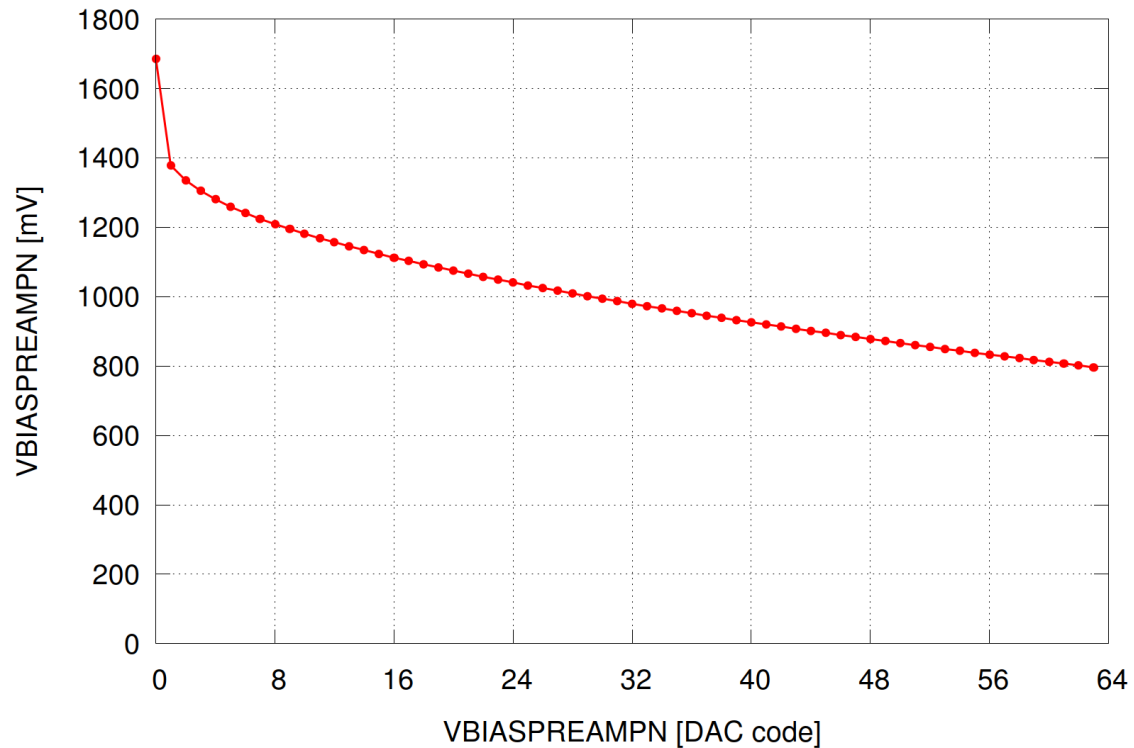
- Current and voltage DACs were scanned, confirming that they operate as expected
- Example current DAC: preamplifier bias current

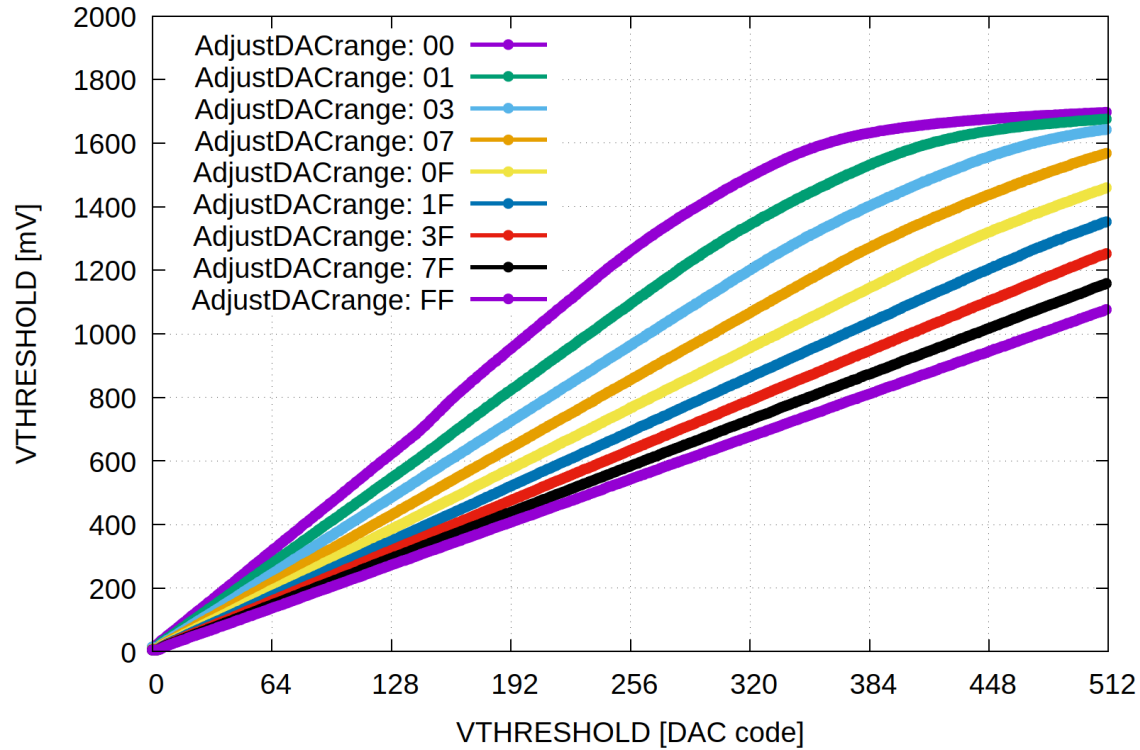
- Example voltage DAC: threshold voltage
- 'AdjustDACrange': register tuning the DAC range, by a set of current mirrors
- Threshold voltage scanned for different values of 'AdjustDACrange'

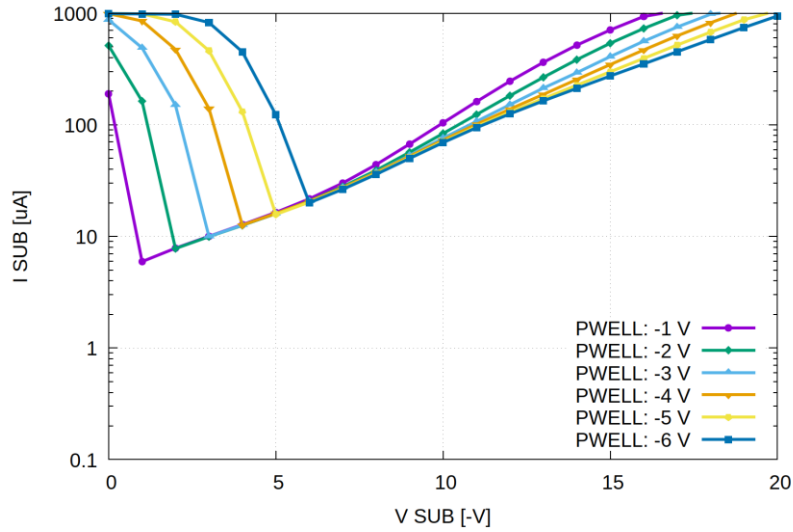
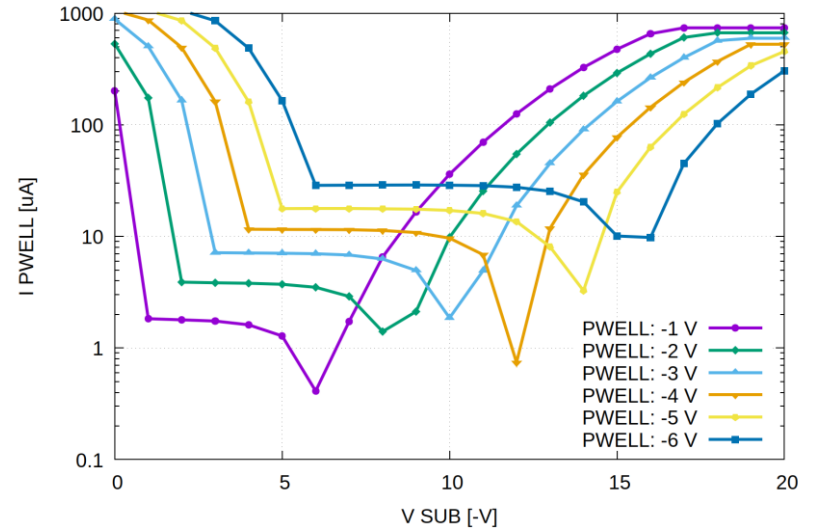
- 1st process split: continuous N-layer (log scale)

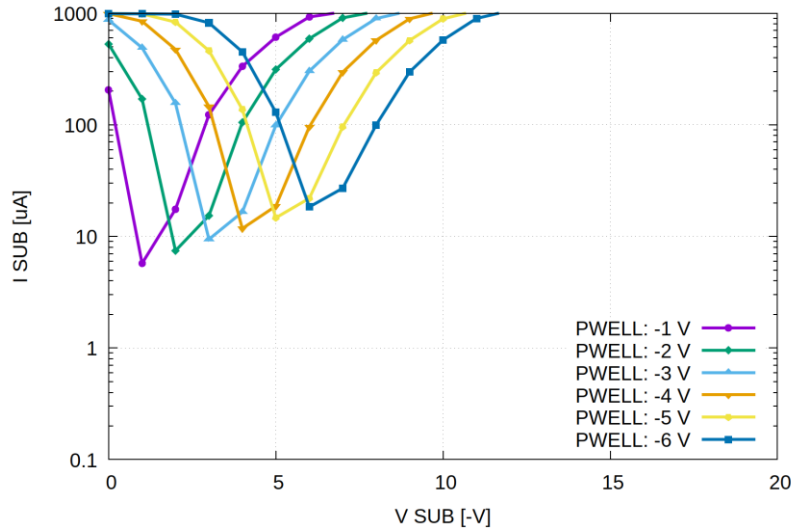
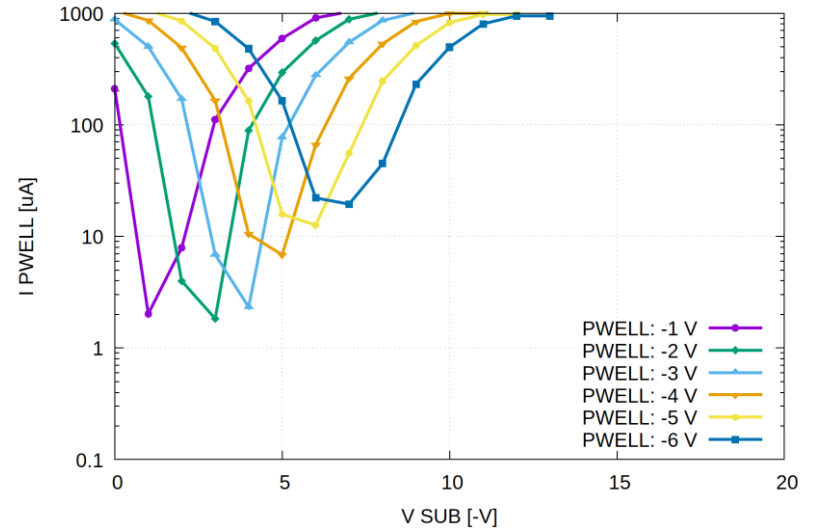
- 2nd process split: gap in N-layer (log scale)
