SPS Beam Dump Facility target prototype tests results

E. Lopez Sola (EN/STI)

MSWG Meeting 2019 #4

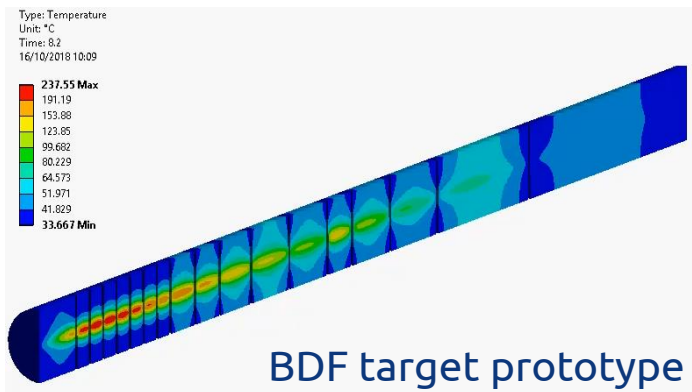
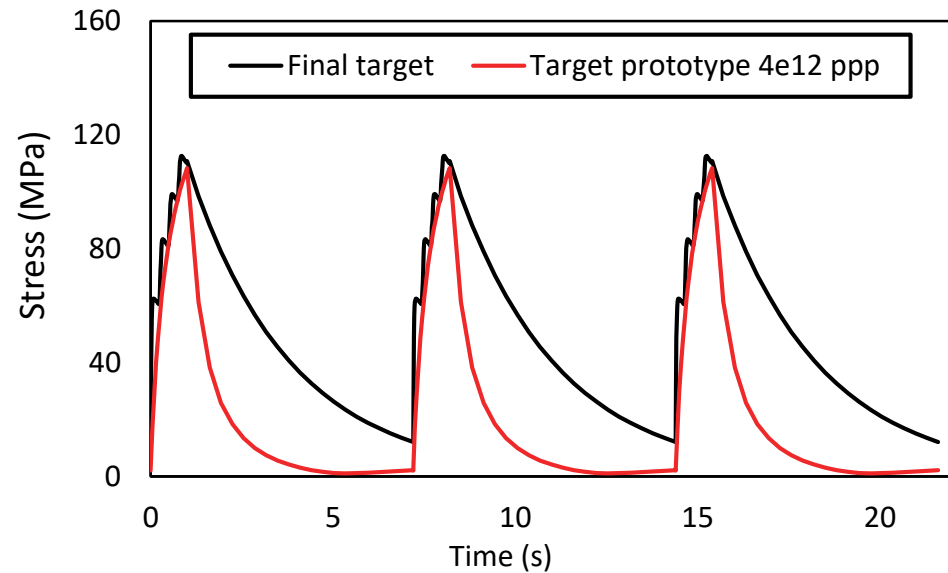
Von Mises Equivalent stress Ta2.5W cladding

Reasonable approximation of the level of stresses in the core and cladding materials, despite lack of dilution and lower intensity

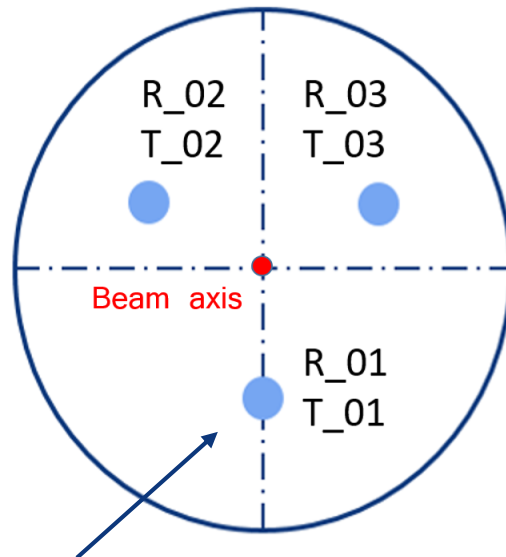
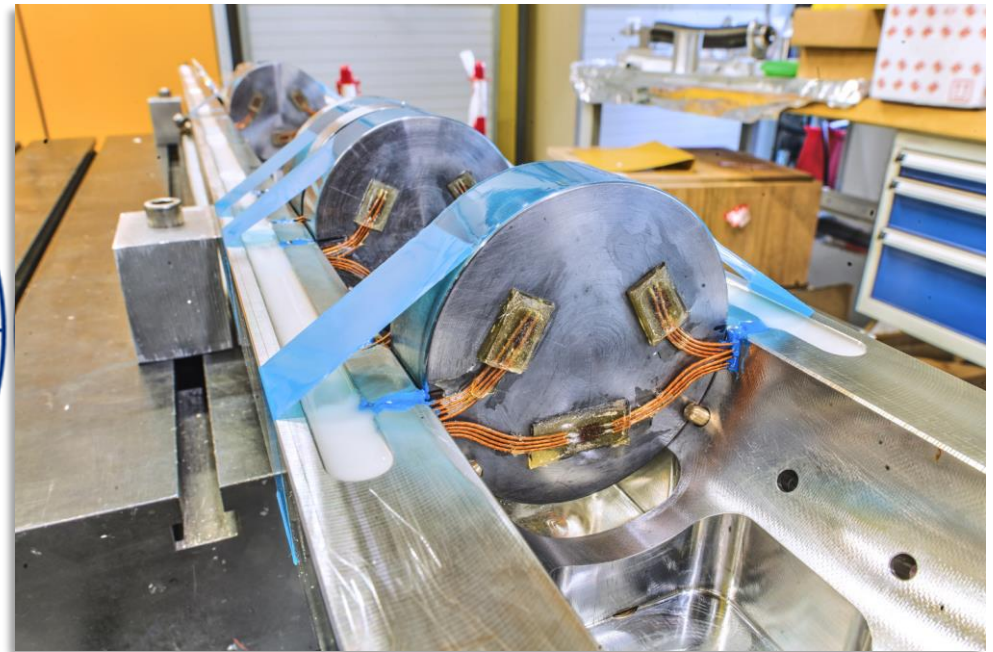
- Target prototype instrumentation
- 4 instrumented blocks

Strain gauges
(radial and transversal)

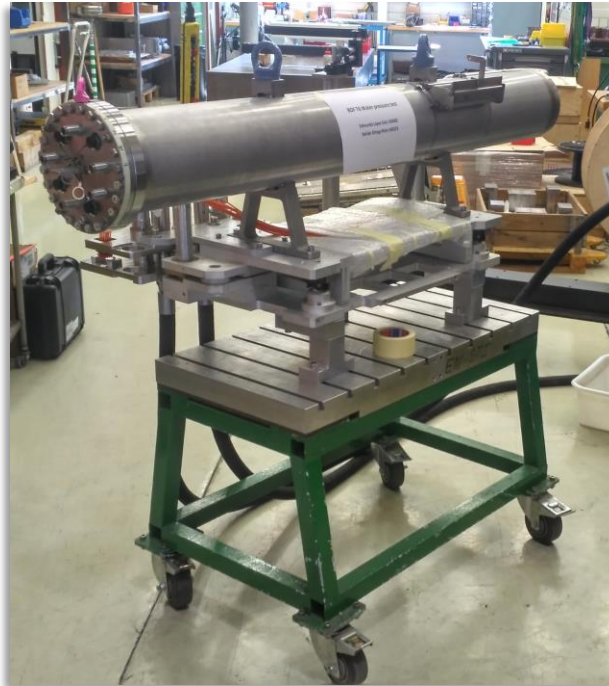
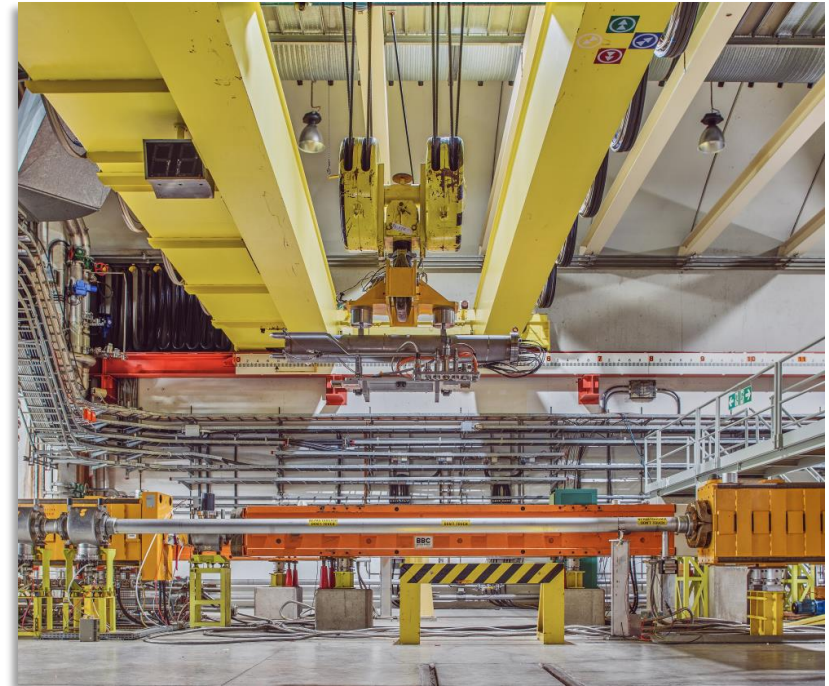
- Target prototype assembly
- Fully remote installation in TCC2 during TS

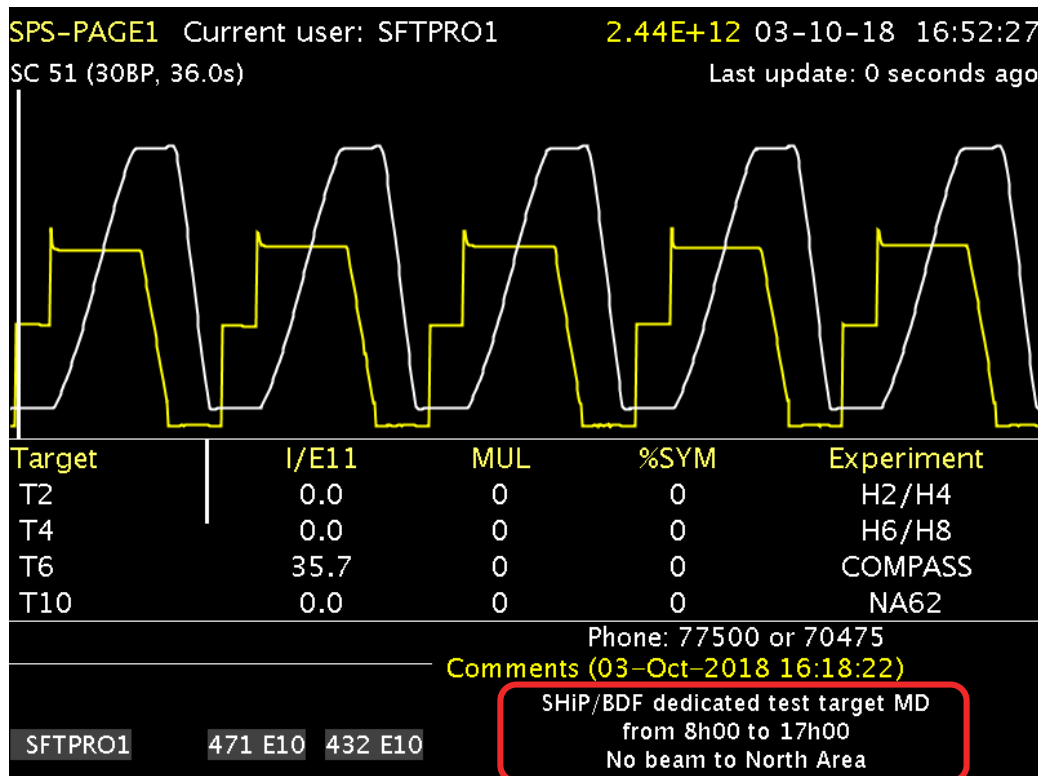
Dedicated SPS supercycle

- SHiP cycle achieved (1 sec spill, 7.2 sec pulse)
- > 6h of dedicated beam
- $\sim 1 \cdot 10^{16}$ POT
- Maximum power on target = **33 kW**

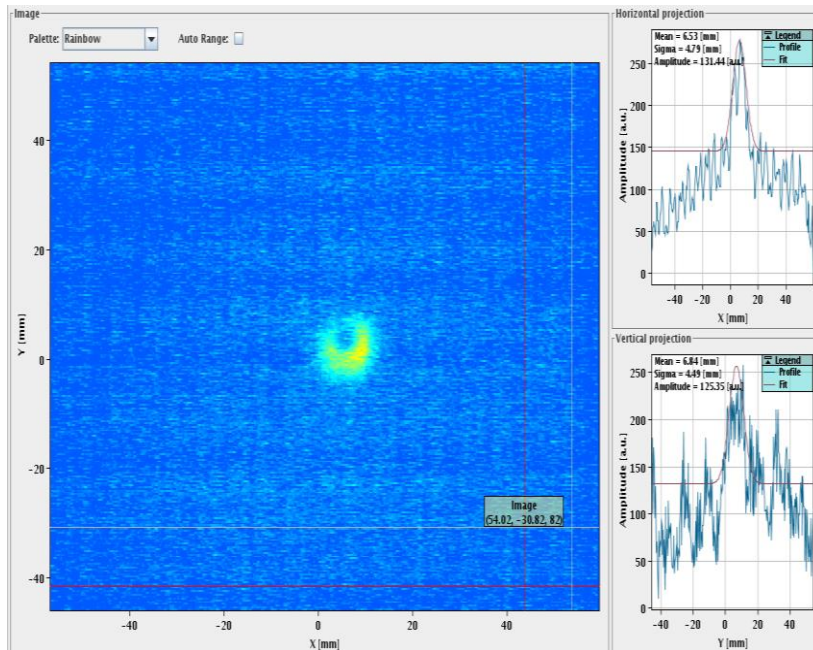
- **Upstream BTV camera failed (radiation exposure)**
→ Beam tuning performed with downstream BTV

- > 5h of dedicated beam
- $\sim 1.5 \cdot 10^{16}$ POT
- Maximum power on target = **45 kW**

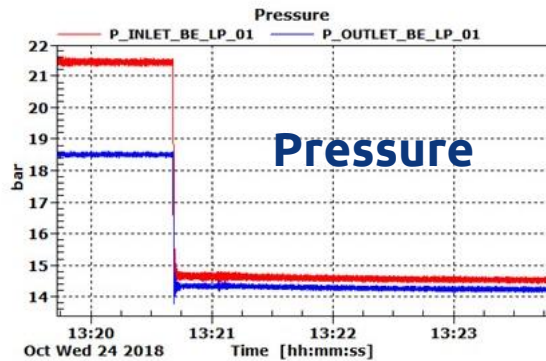
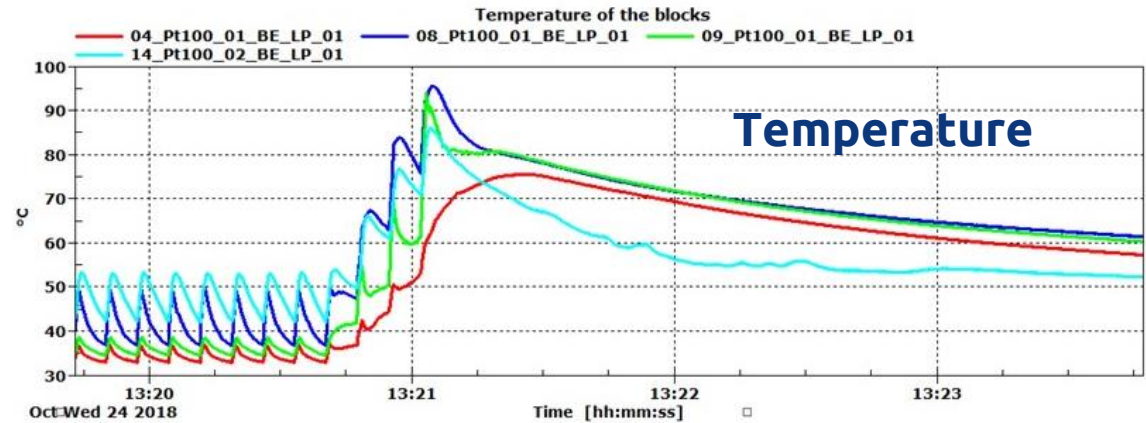
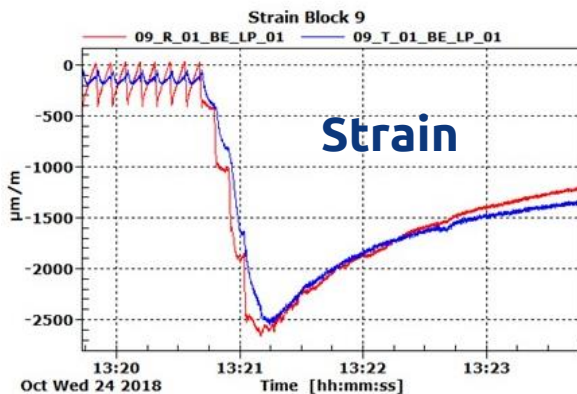
- 2nd MD day
 - Cooling skid pump failure (Loss Of Coolant Accident)

Beam interlocked after 4 pulses
on target without cooling

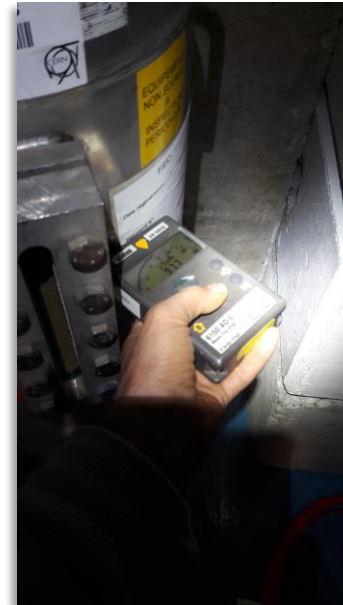
■ Dose rate measurements

- Good agreement with simulations
- Expected after 1 year:
~Sv/h @ contact

→ Fully remote dismantling

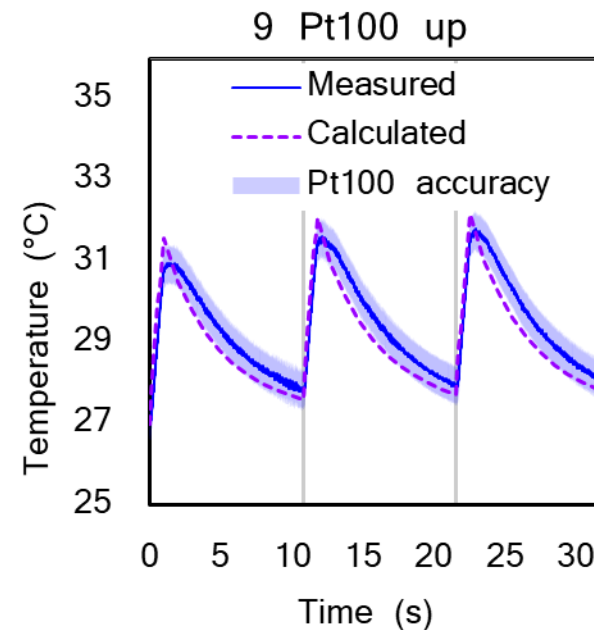
- **Temperature sensors vs. FEM (1st MD)**
 - Temperature evolution first beam pulses

Accurate estimation of the trend ✓

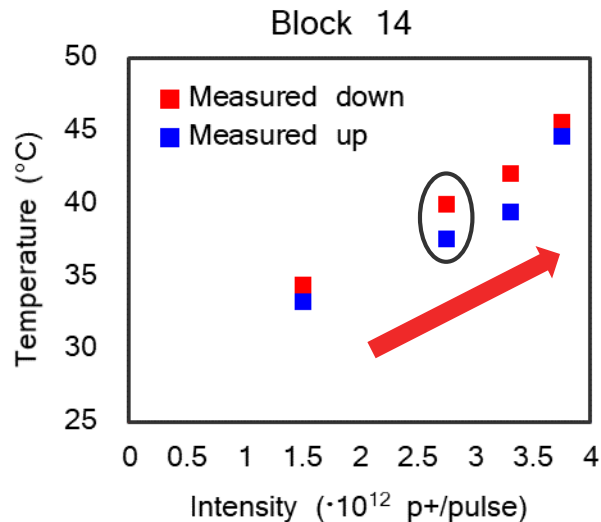
- **Temperature sensors vs. FEM (1st MD)**
 - Maximum temperature at different intensities

Beam offset 2 mm down
 $\rightarrow T_{\text{down}} > T_{\text{up}}$

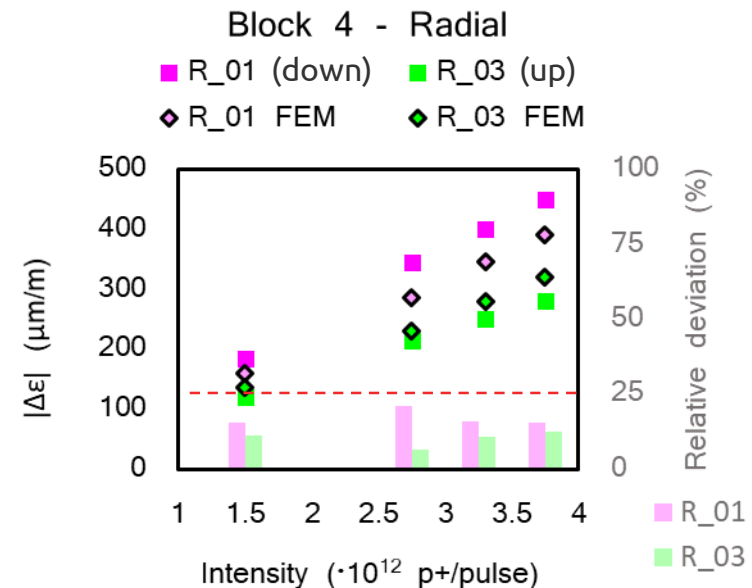
Strain sensors vs. FEM (1st MD)

- Δε after beam impact at different intensities

< 25% relative deviation ✓

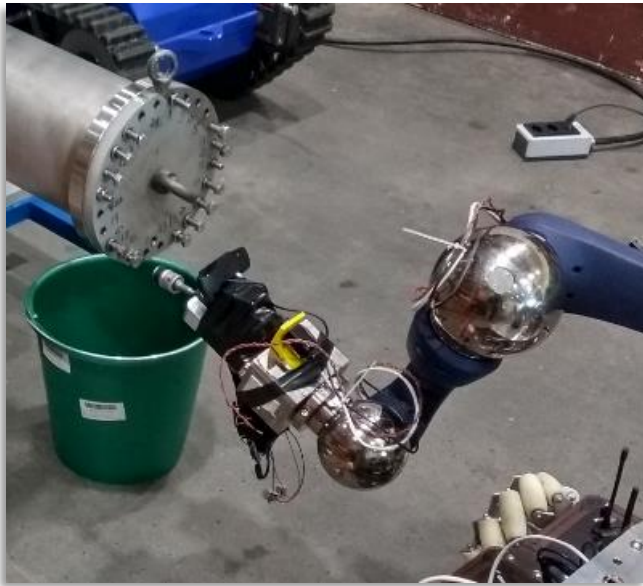
- Fully remote target dismantling (ALARA 3)
 - October – November 2019

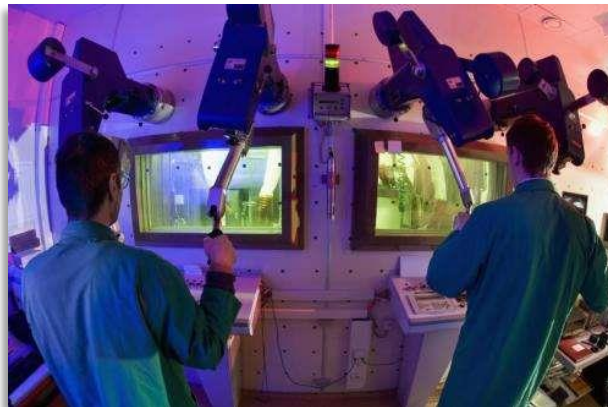
■ Post Irradiation Examination (PIE)

- 6 irradiated blocks to be examined → **influence of stress, thermal cycles, cooling and irradiation** in material properties, interface bonding,...

- Metrology – microscopy
- Non-destructive testing
- Destructive testing
