Linac 4 ion source continuous caesiation results

180th Machine Protection Panel Meeting, Continuous caesiation at Linac 4
CERN, 30.08.2019

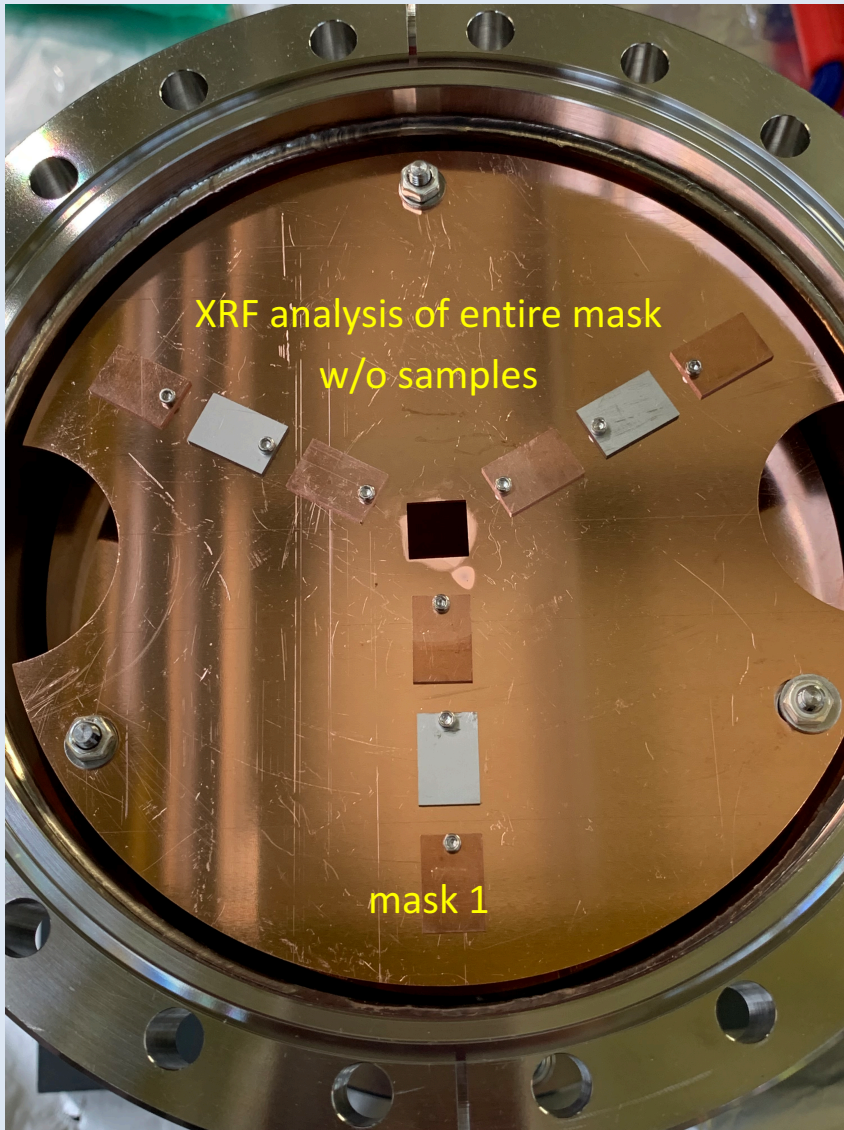
XRF results

- Samples removed from mask 1
- all 4 masks analysed
- front (A) and back (B) side measured

No evidence of Cs found on any of the four copper mask surfaces, within the XRF detection limit of $3 \times 10^{-3} \mu\text{g}/\text{cm}^2$

1 ML = $10^{-1} \mu\text{g}/\text{cm}^2$ -> 0.03 ML detect. limit

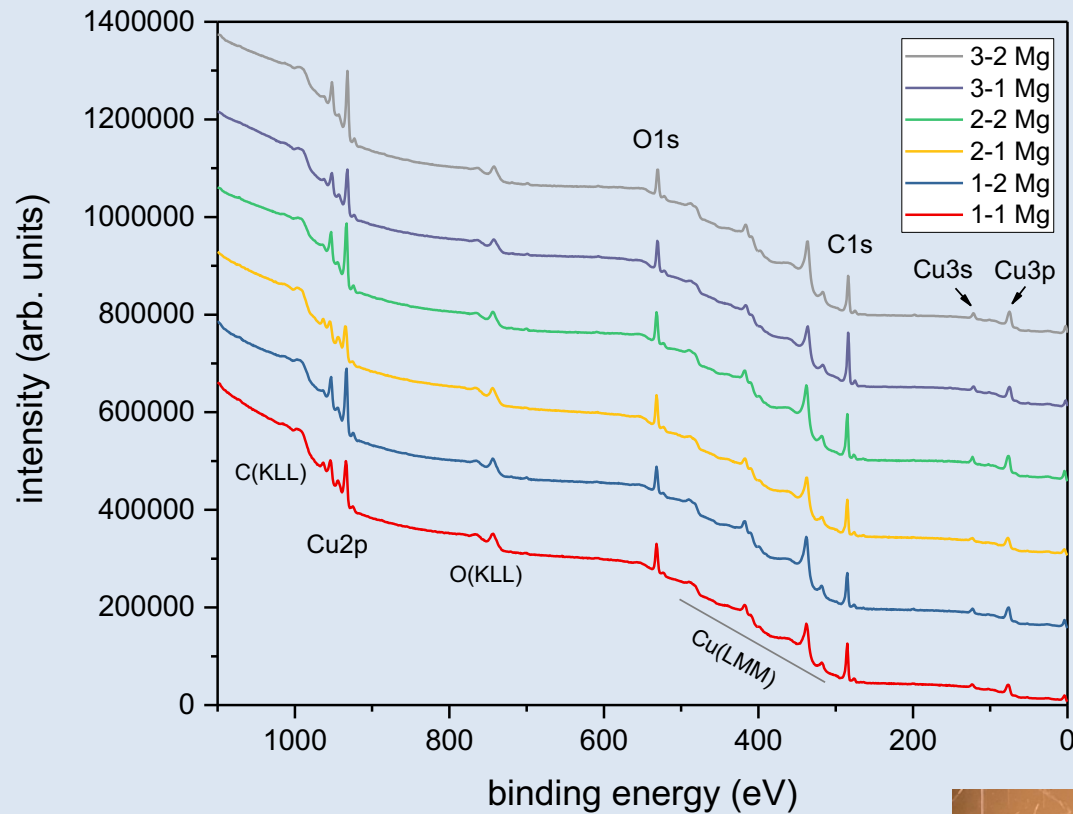
FIG. 1. XPS survey spectra

- **Measurements** were performed **on two spots of each sample** (see previous slide)
- The **survey spectra** (FIG.1) indicate the main lines detected, which correspond to **Cu, O, and C**.

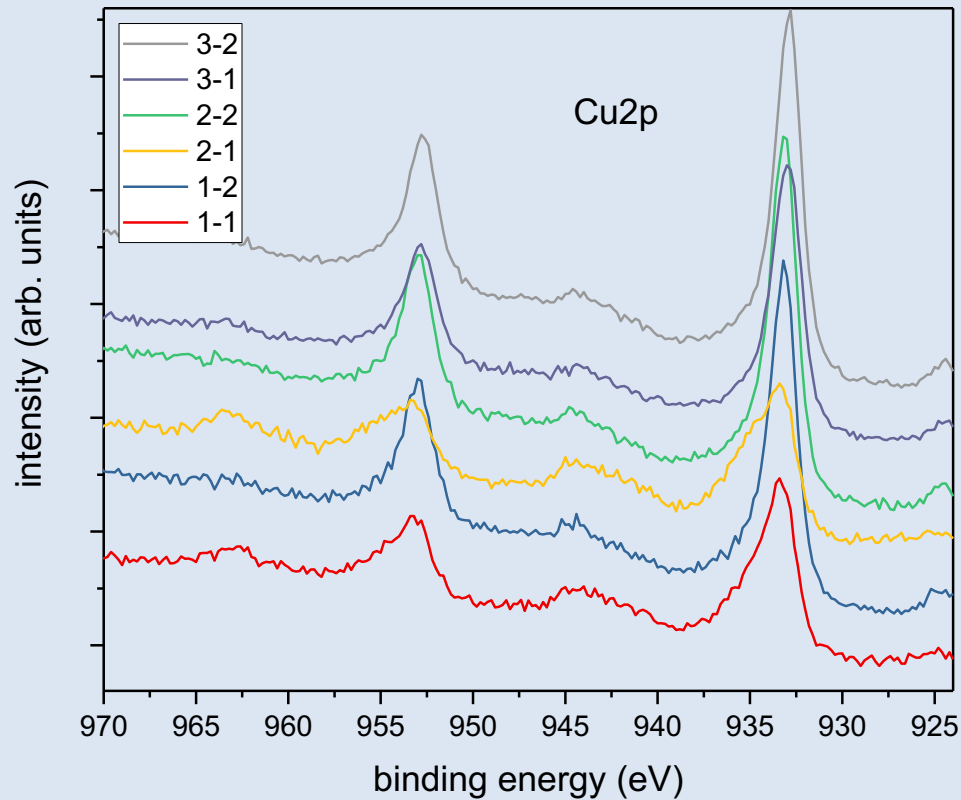
FIG. 2. XPS Cu2p spectra

- Slightly **different colour shading** for the **two regions** of samples 1 and 2 observed
- The colour difference **correlates with the shape of the Cu2p state** shown in Fig. 2 and points to **differences in oxidation**. This could be related to the dose from the experiment that the different regions were exposed to.

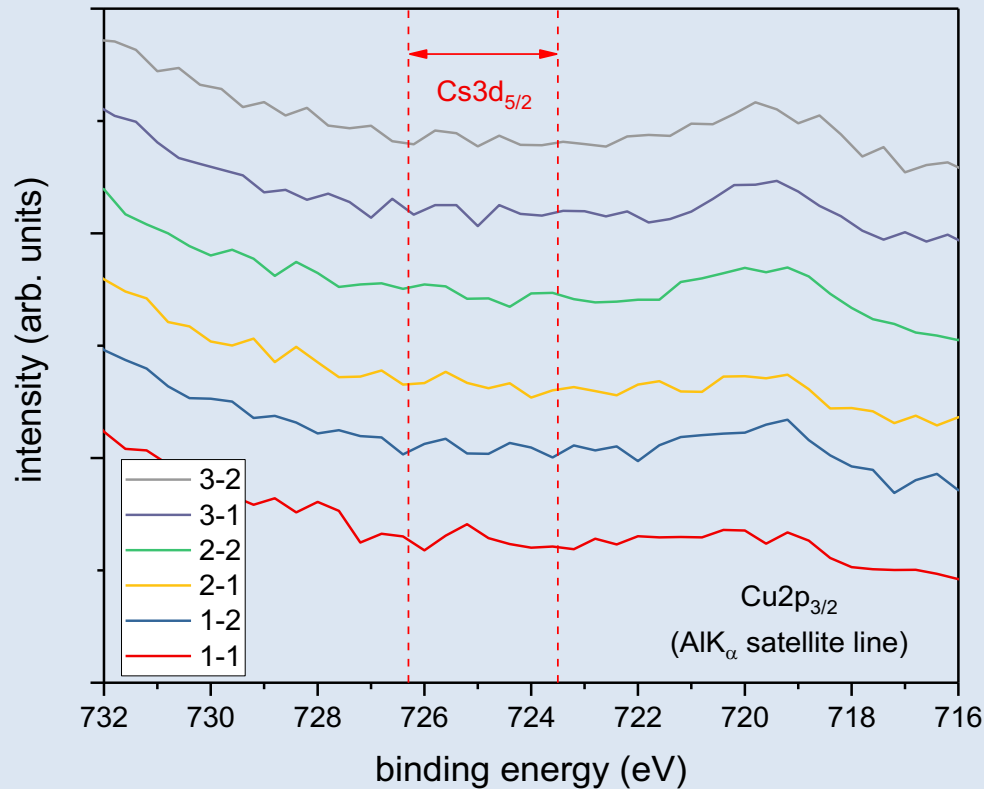
FIG. 3. XPS spectra around the Cs3d line

- For Cs analysis, the spectrometer was operated at highest possible sensitivity, i.e. large pass energy of 150 eV and long integration time. FIG. 3 includes the related spectra.
- **No signal within the binding energy region of possible Cs compounds (indicated by red dotted line) was detected.**
