**KM3NeT_QUAL_00n_ARCA_base_module qualification_DRAFT**

This document reports the qualification tests applied to the titanium ARCA base module for the KM3NeT project.

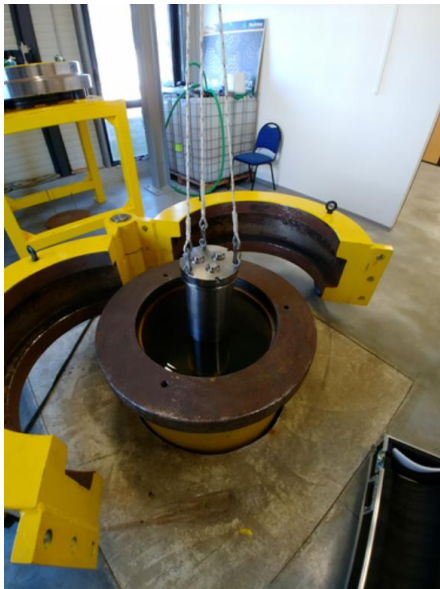
Figure 2: Picture of the insertion of the base container in the chamber

No mechanical support was used. The container has been inserted into the hyperbaric chamber by lifting it with belts attached to screws fixed to the work holes provided on the container flange.

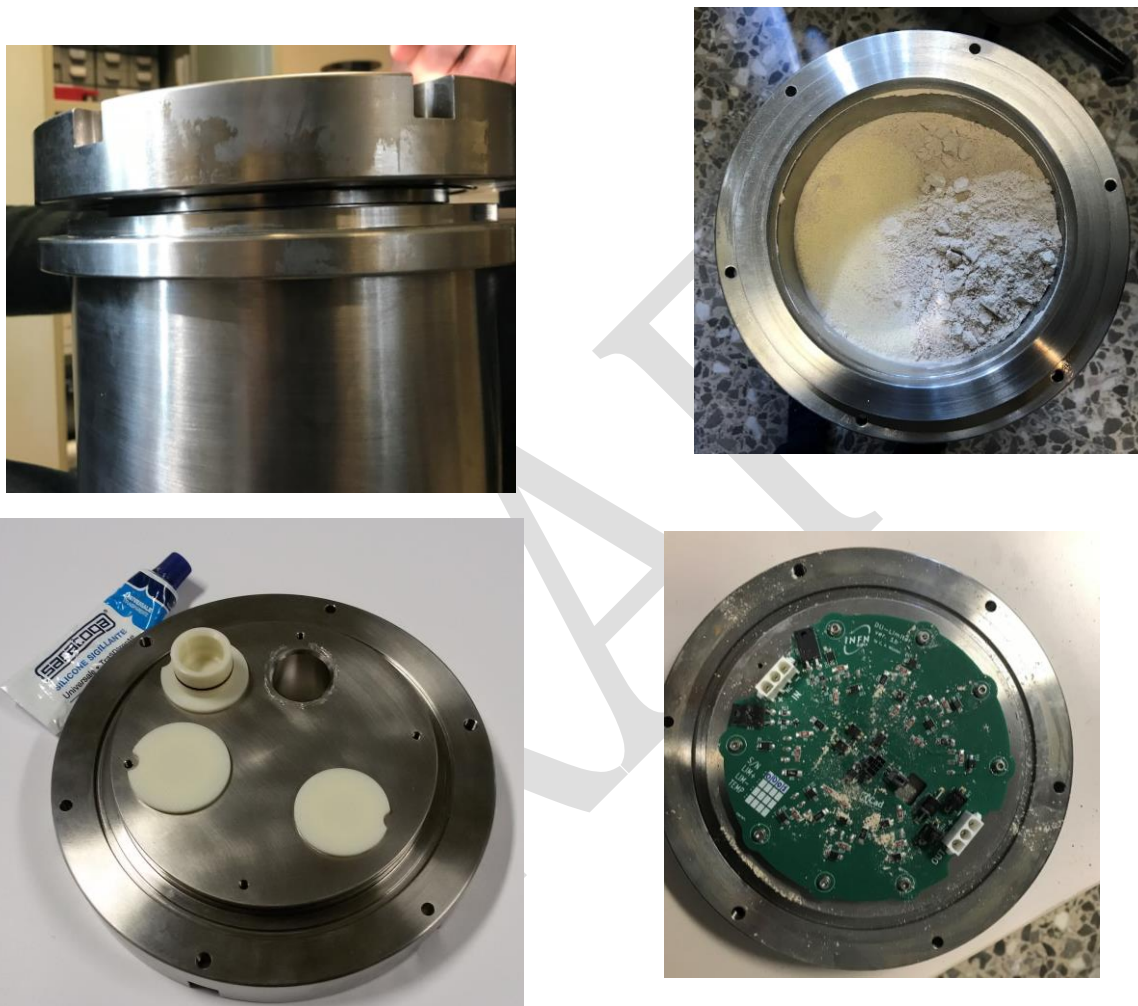
Figure 3

A single and sealed chamber (5 in total) filled with chestnut flour was coupled to each interface, in case of water ingress this should be revealed by its own chestnut flour.

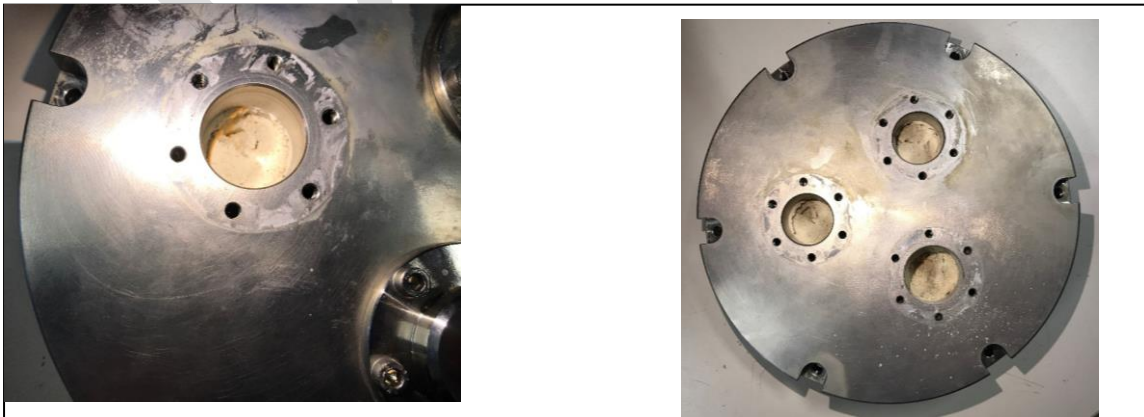
The container was opened, no change of colour was observed neither clumps
