Assessment, radiation tests and design specifications for a novel CMOS monolithic pixel detector integrated on a transmission electron microscope setup

Andrea Ferretti ESR 13 – WP5
Horacio Mateos ESR 4 – WP2

Smart Sensor Technologies and Training for Radiation Enhanced Applications and Measurements (STREAM) is a project funded by the European Commission under the Horizon2020 Framework Program under the Grant Agreement no 675587. STREAM began in January 2016 and will run for 4 years.

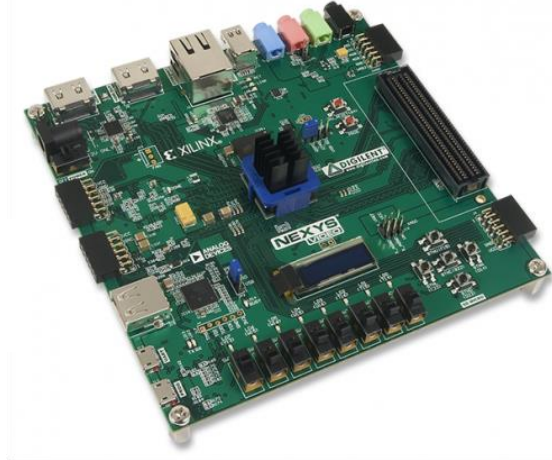
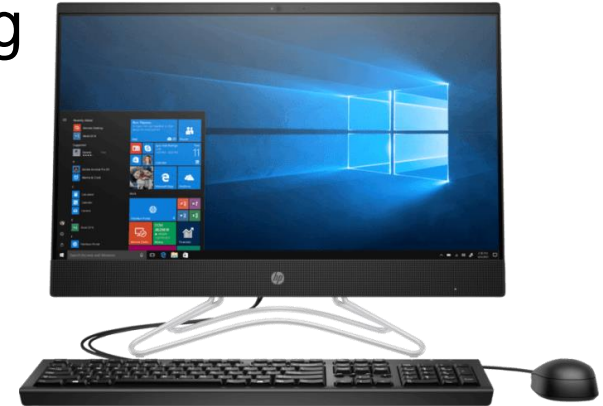
Usage of the Chip

- Interface through Nexys Video (Artix 7)
- Qt/C++ interface on PC
- MatLab + Python for image processing

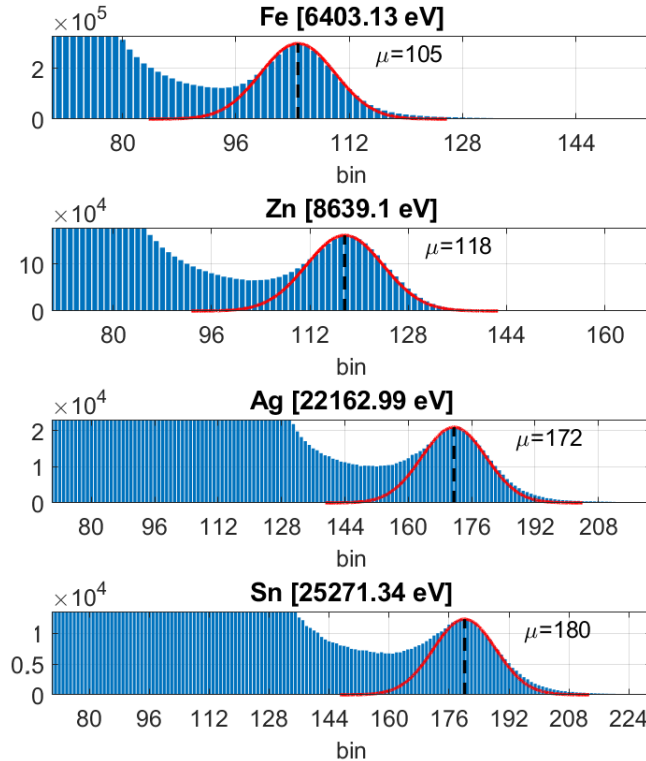
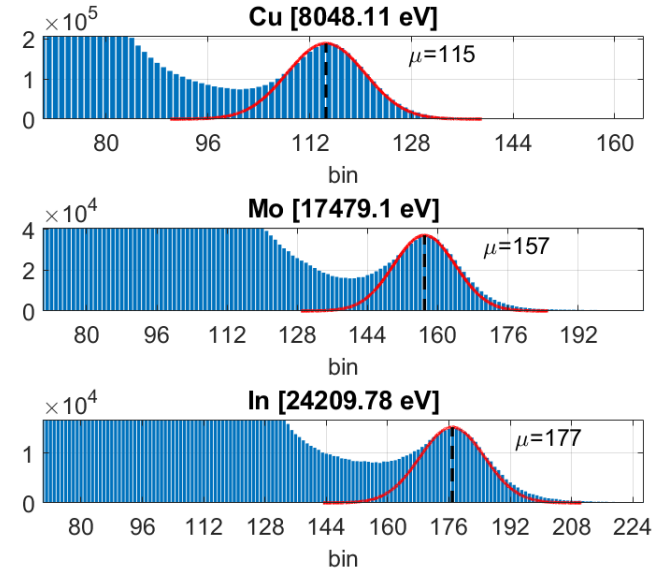
X-Ray Measurements

- **Successfully tested the functionality of the HPIXEL with X-Rays**
 - The system was able to detect X-rays of 6.4 KeV ~ 25.3 KeV
- Simulations of the chip performed with variable the external voltages and DAC values

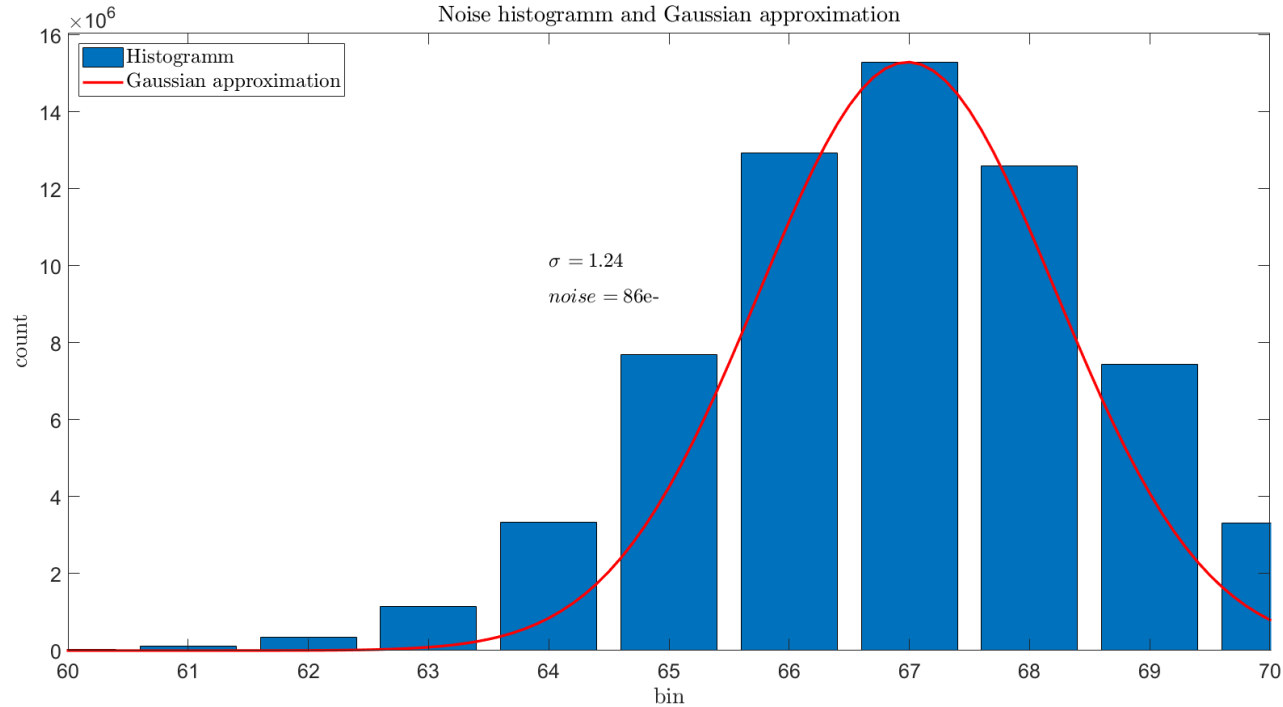
X-Ray Measurements

- Noise levels around 86 e^- (for the lowest energy)

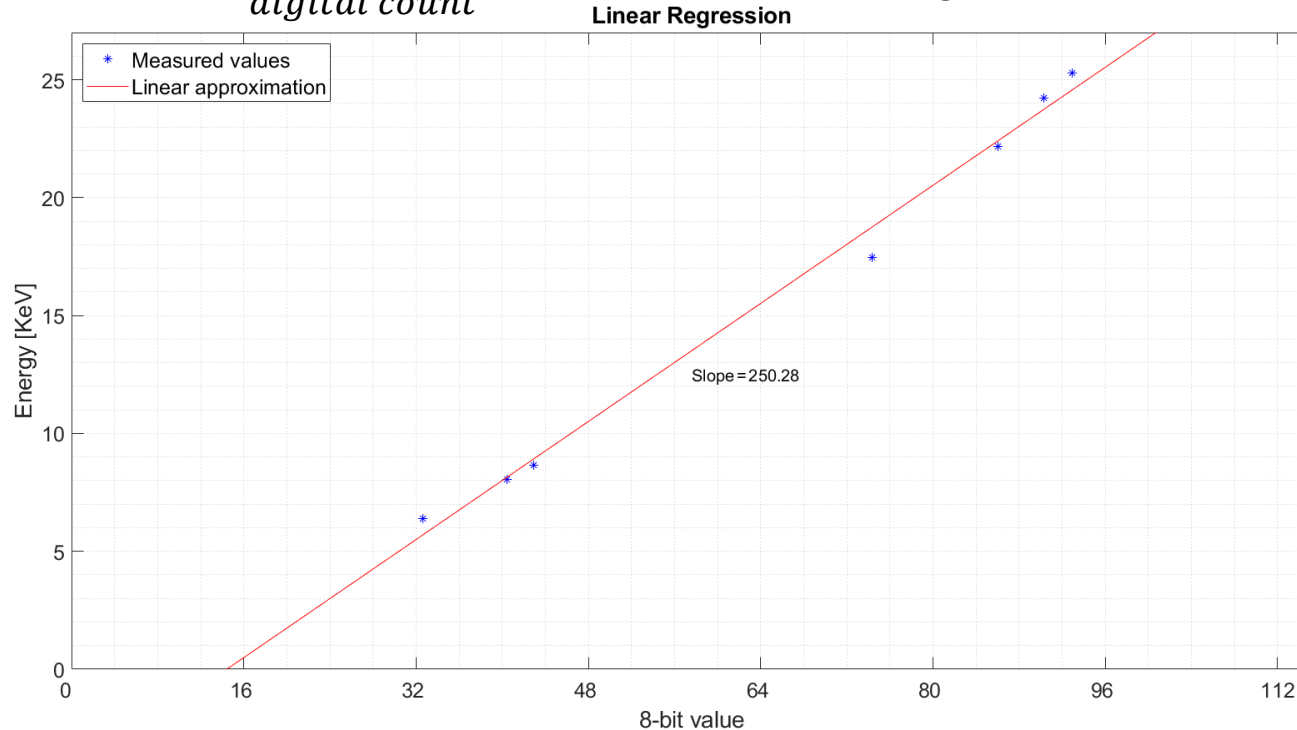
X-Ray Measurements

- Resolution: $\sim 250 \frac{eV}{digital\ count}$ with a theoretical range between 6 KeV \sim 43 KeV

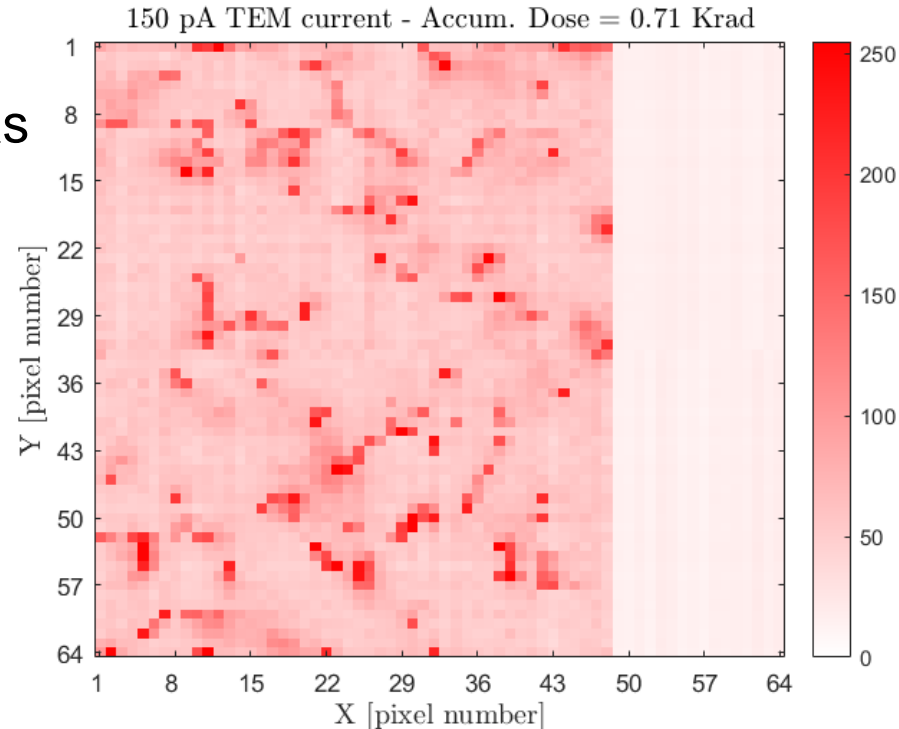
Electron measurements – test chip 1

- The chip was able to detect single electrons
- The readout block stops to work when the ionizing radiation dose was around 78 kRad
- Background noise
 - before irradiations: 47 ADC counts
 - after last working measurement (61.42 kRad accumulated dose) was 65 ADC counts

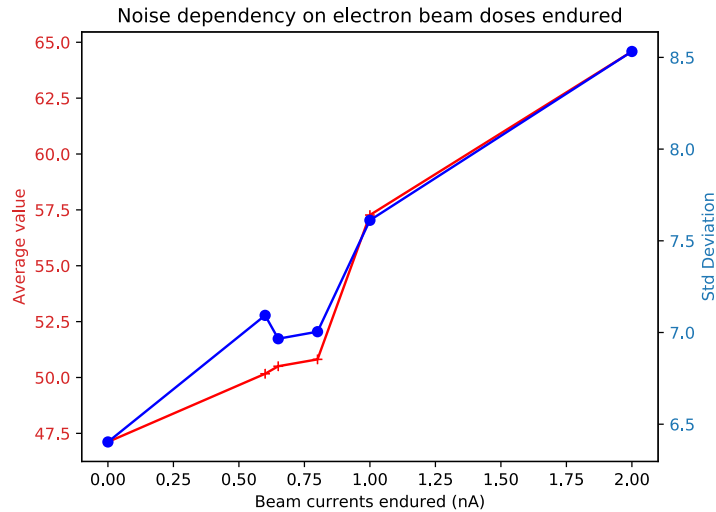
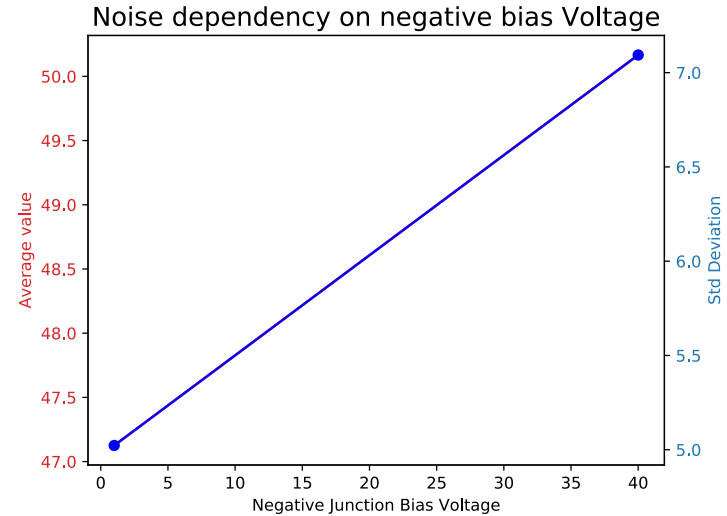
Dark Noise – mostly Fixed Pattern Noise

Both pixel types are considered together, a more thorough analysis would involve splitting the analysis

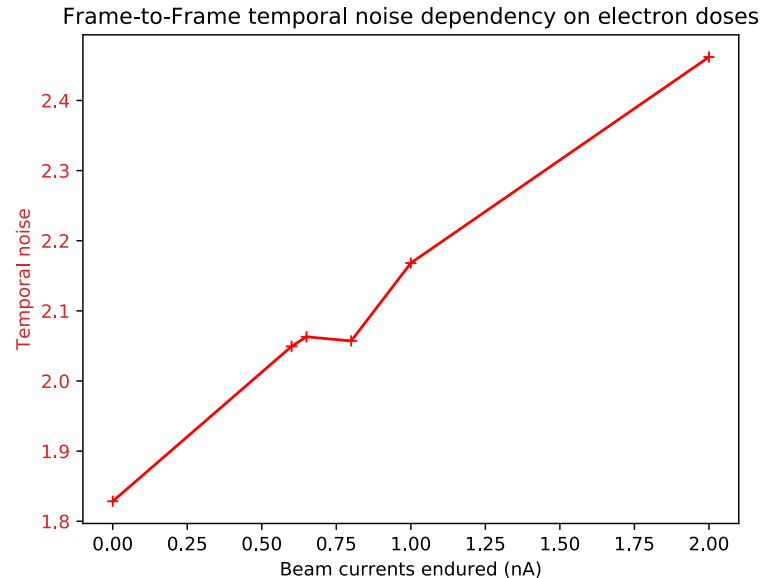
Dark Temporal Noise – Frame-to-frame standard deviation

Both pixel types are considered together, a more thorough analysis would involve splitting the analysis

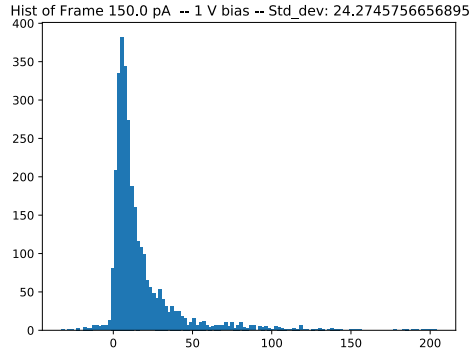
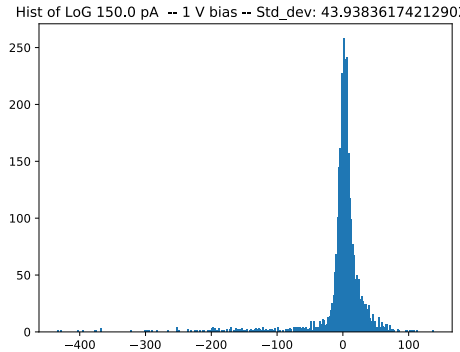
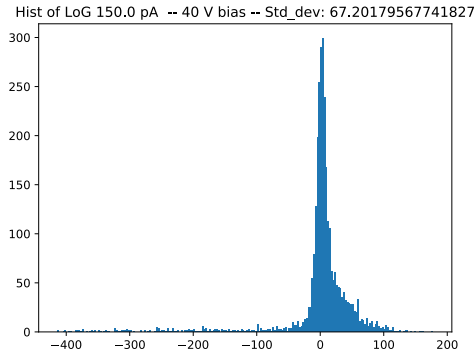
Even at low 150 pA current beam (294 e/pix/s roughly) there is already a difference. 40V counts more high-value pixels and a higher average overall due to greater collection

Laplacian of Gaussian histograms show higher negative values too

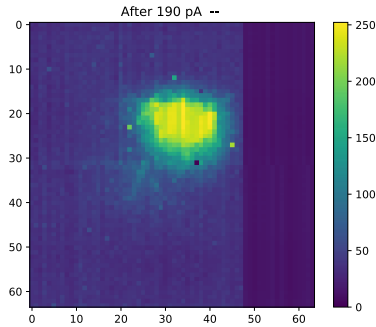
Average Dark Noise map after each beam current increase step
Chip is already compromised after 64 pA focused beam
