# UT CO2 cooling pipes contamination status

07.10.2019

# Cooling pipe contamination studies

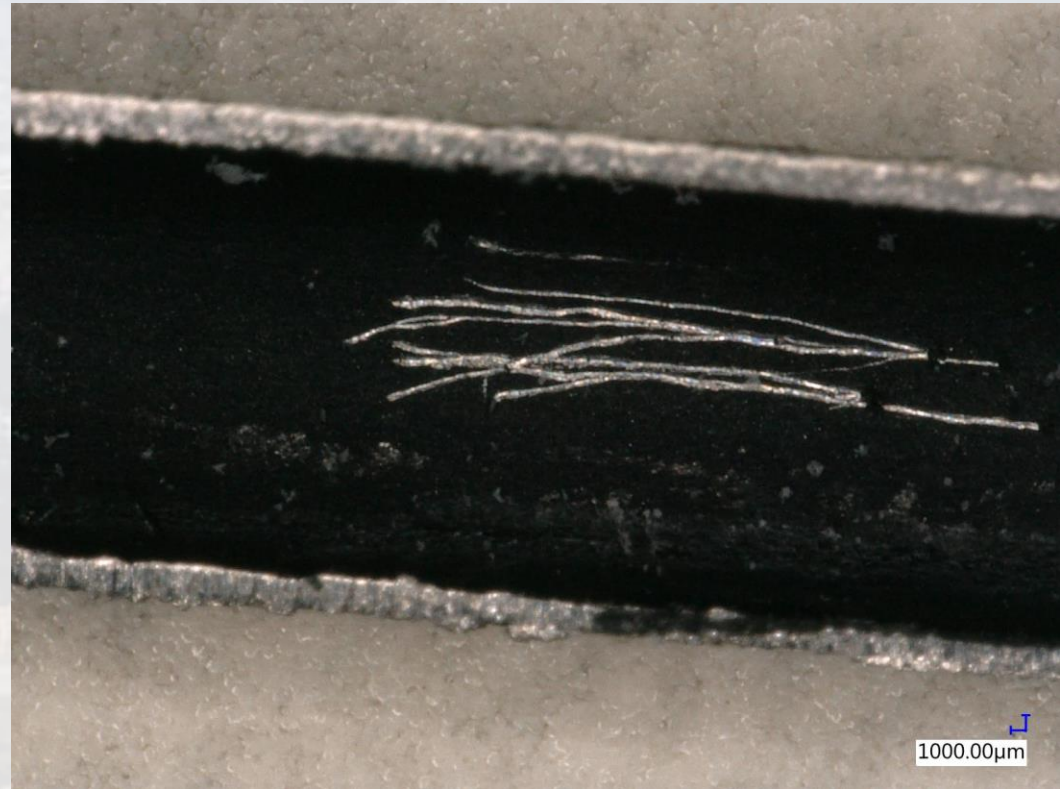
- Titanium snake cooling pipes have a layer of oxide on the inner surface
- Knife scratches can remove this layer as shown
- Investigation of the surface together with EN-MME (metallurgy/materials)

The pipes are already embedded into the bare staves. In case the oxide layer from the pipes inner surface detaches, it can be a danger (for UT and VELO).

- If these particles detach, they **can possibly clog the MAUVE filters** (10  $\mu\text{m}$  mesh) -> stop of cooling operation and/or **clog VELO (60x60  $\mu\text{m}$ ) microchannel inlets** (if in backup joint operation)
- Two possibilities of cleaning are being investigated:
  1. „Mechanical cleaning“ – running CO<sub>2</sub> through the staves (Slide 6)
  2. Chemical cleaning – running a special cleaning detergent through the staves (Slide 10)
- The cleaning method needs to be validated:
  1. A sufficient amount of spare pipes – the only way to establish a working cleaning procedure
  2. Chemical analysis of the spare pipe surface
  3. LUCASZ filter inspection – decreasing amount of trapped particles after CO<sub>2</sub> circulation inside a real stave
  4. Pipe inspection inside the stave seems impossible (?)

Safety of the chosen method for the pipes must be ensured!

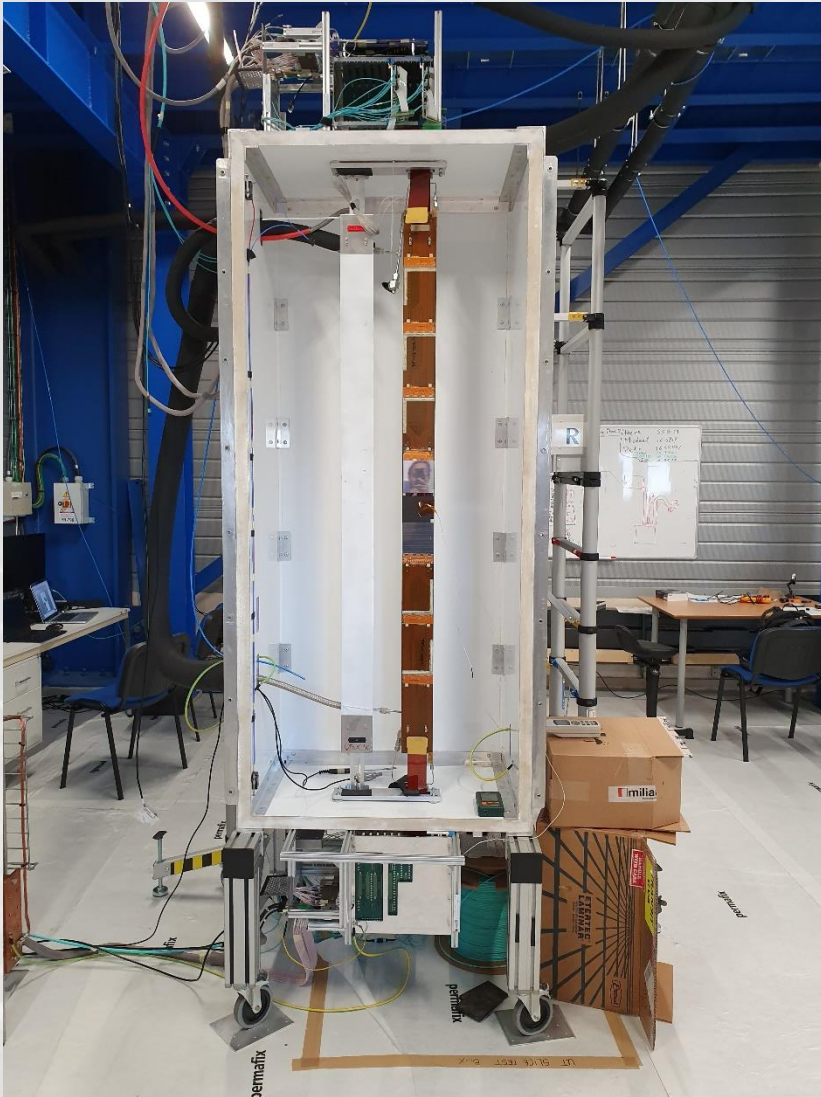
- LUCASZ: Plant has been running previously with „fresh“ Swagelok pipes and flexibles only – however, a filter contamination from them is still possible
- LUCASZ: Circulated CO2 through a test stave for 1 week with high flow ( $\sim 10$  g/s) whereby design flow is at  $\sim 0.5$  g/s per stave (The time scale needs to be validated as well)
- Two filters –  $90 \mu\text{m}$  for pump protection and  $15 \mu\text{m}$  for main supply line to stave extracted for analysis

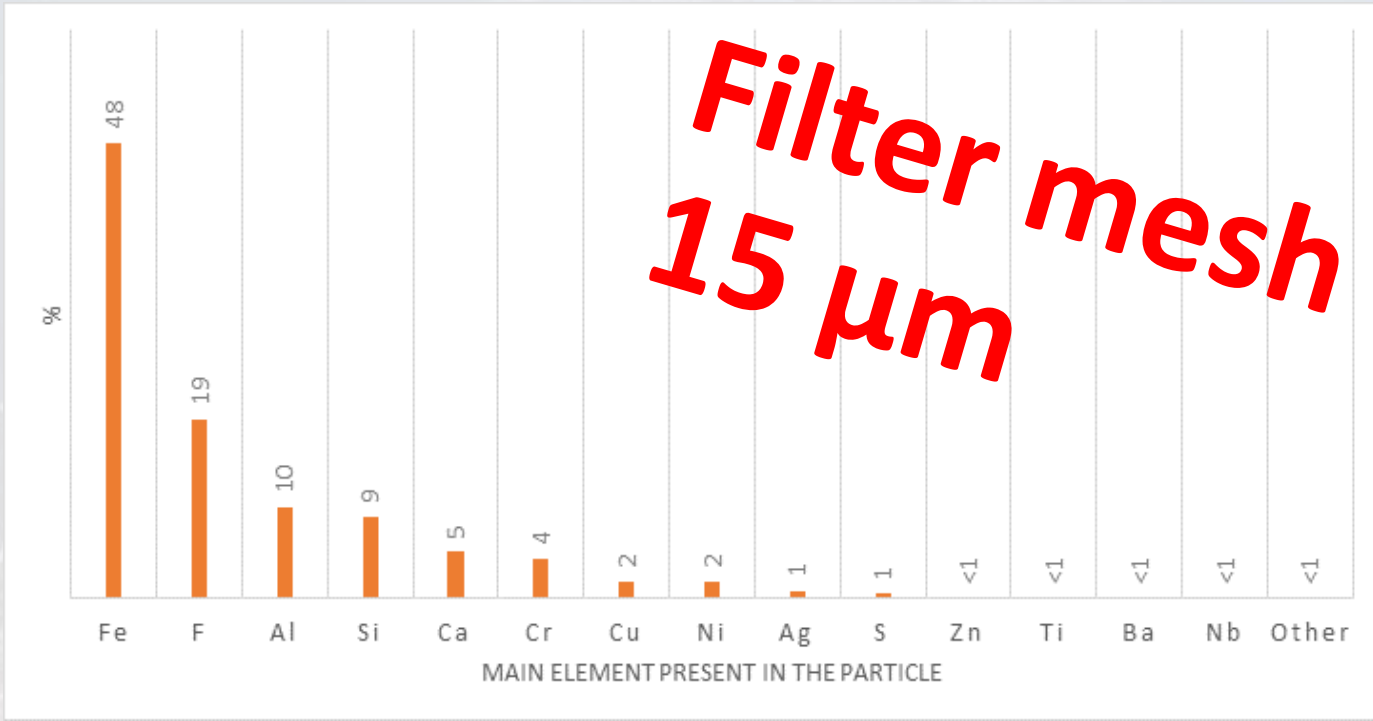
Particle identified by 51% of its content!

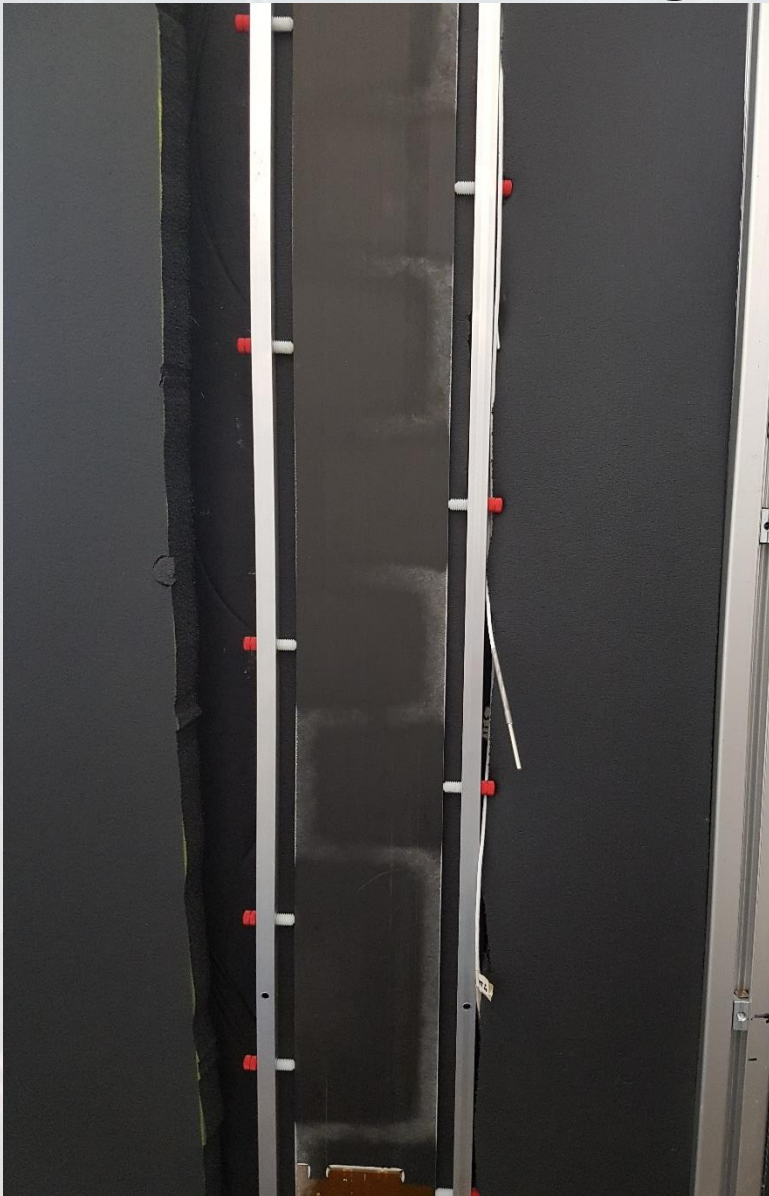
Received the bare stave for tests last week and met with the expert:

- Suggestion is to use Net Inox [Specs in backup] – a mix of nitric and fluorine acids
- Need a spare pipe pieces to test before applying to the bare stave (Simone is urgently shipping his pipes from Milano)
- Need to understand whether the remnants of Net Inox (or other?) would be a danger for the cooling system and the detectors:
  1. Running detergent (can be done in special lab) – time to be determined
  2. Cleaning with demineralized water
  3. Drying

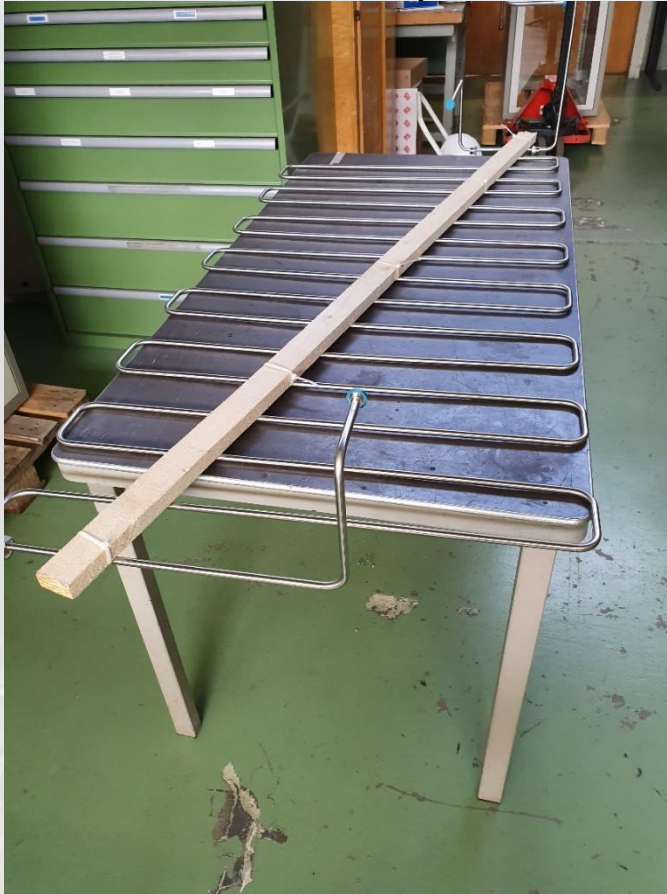
We need to study the DP behavior in normal operating conditions for the final geometry and power:

Up to two stave can be operated simulataneously, but we can only power up one of them. It would be interesting to circulate CO<sub>2</sub> through two fully powered staves (bricolage?)

Orifice tests for understanding the DP are first priority once this setup is installed (foreseen for upcoming week)!

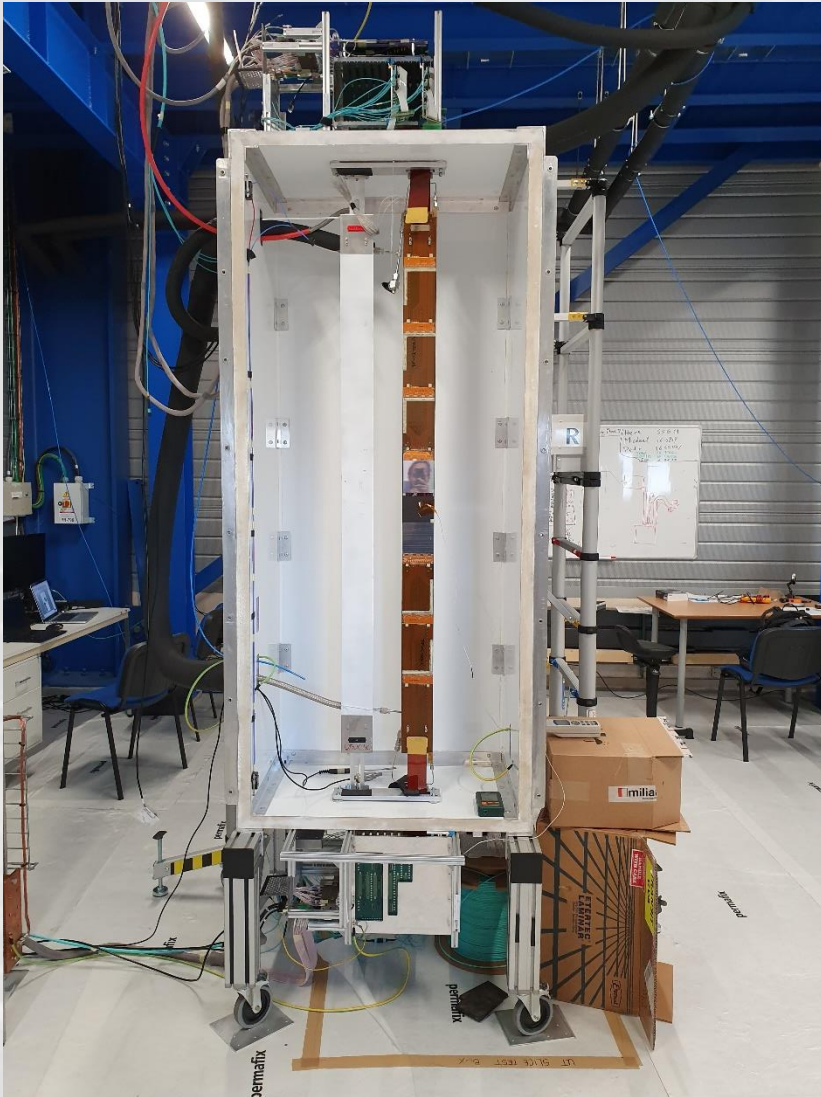
- Can house up to 2 staves, 14 hybrids can be powered at the moment (1 full non-central stave)
- Flowmeter, two PTs, two TTs will be installed, so the pressure difference over the stave can be studied (both with and without an orifice)
- One would need to bricolage in order to add an improvised heater on the second stave (only on a bare stave)

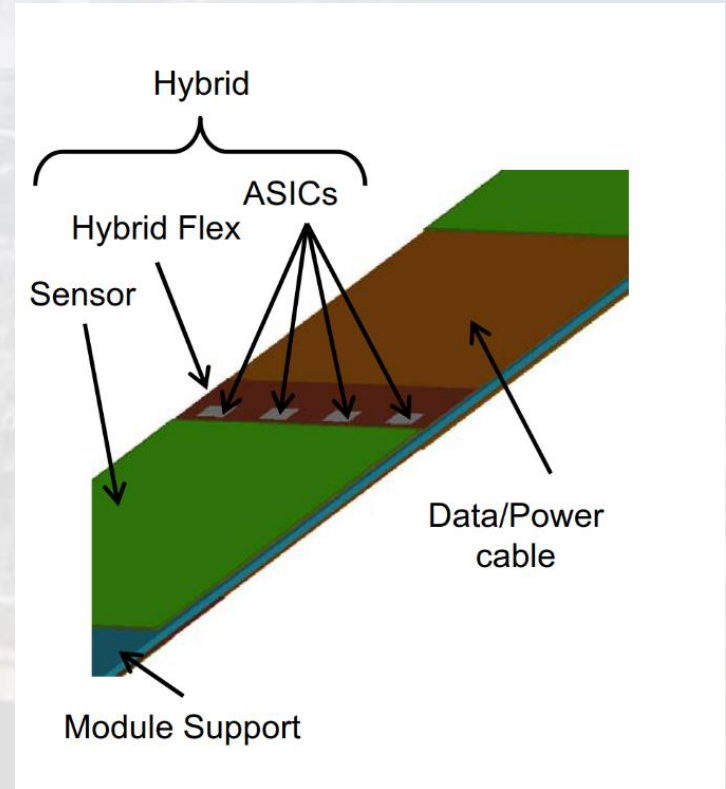
- ASiCs are the main heat producers with about ~2.4 Watt per 4ASiCs (preliminary; sensor contribution is negligible)

- Denser arrangement around the beam pipe due to higher particle flux

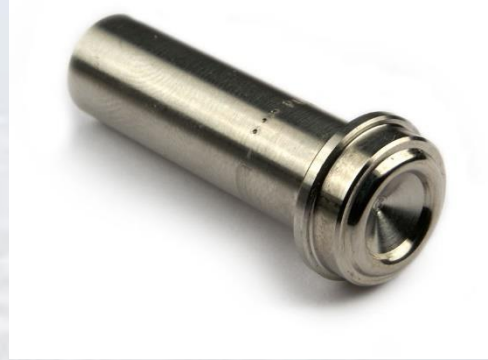
- VCR 1/8" glands drilling will be done by the **end of October**
- In the mean time, a manifold has been prepared as a pilot 2.4mm ID after brazing point for now  
-> will be 2.0mm as in final drawings for final brazing
- Will send this manifold to qualification pressure test
