TRB QUALIFICATION OF OFP PENETRATORS DOM & BASE

Ongoing Qualification Actions OFP base and DOM penetrators

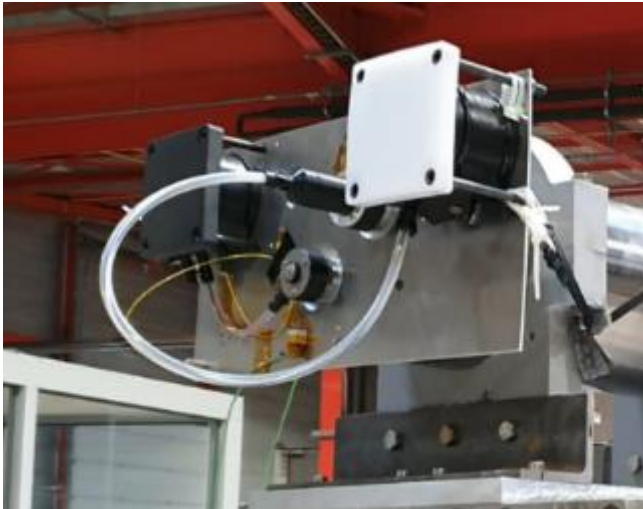
outside

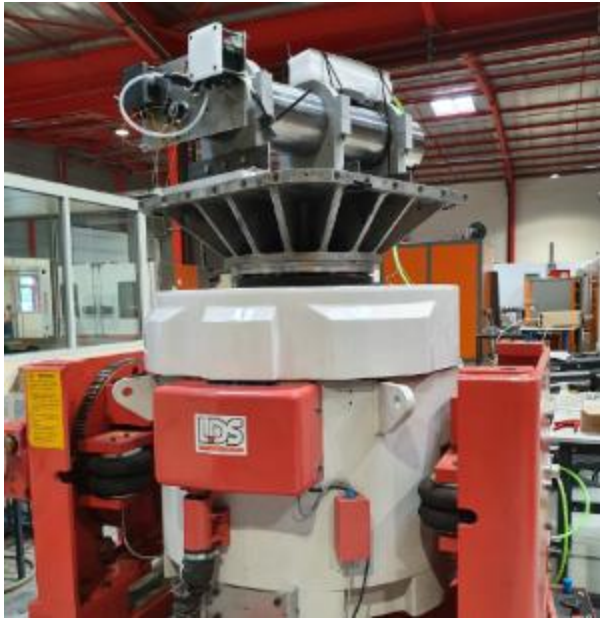
Vib. & shocks vertical axis

Vibration and
shock on the
vertical axis

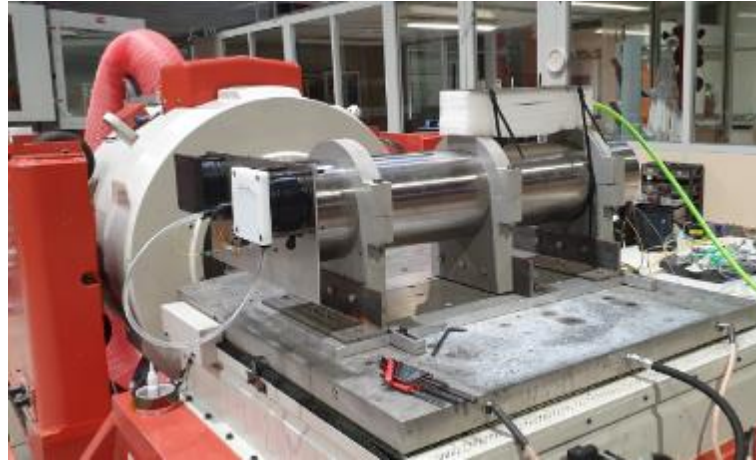
Vib. & shocks transversal axis

Vibration and
shock on the
transversal axis

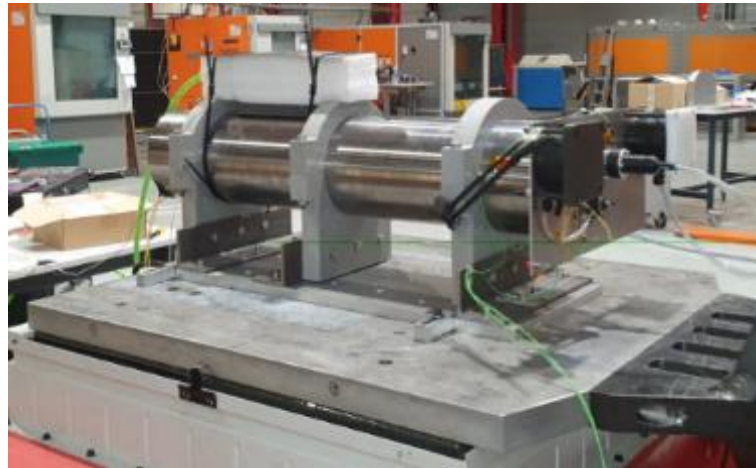
Vib. & shocks longitudinal axis

Vibration and
shock on the
longitudinal
axis

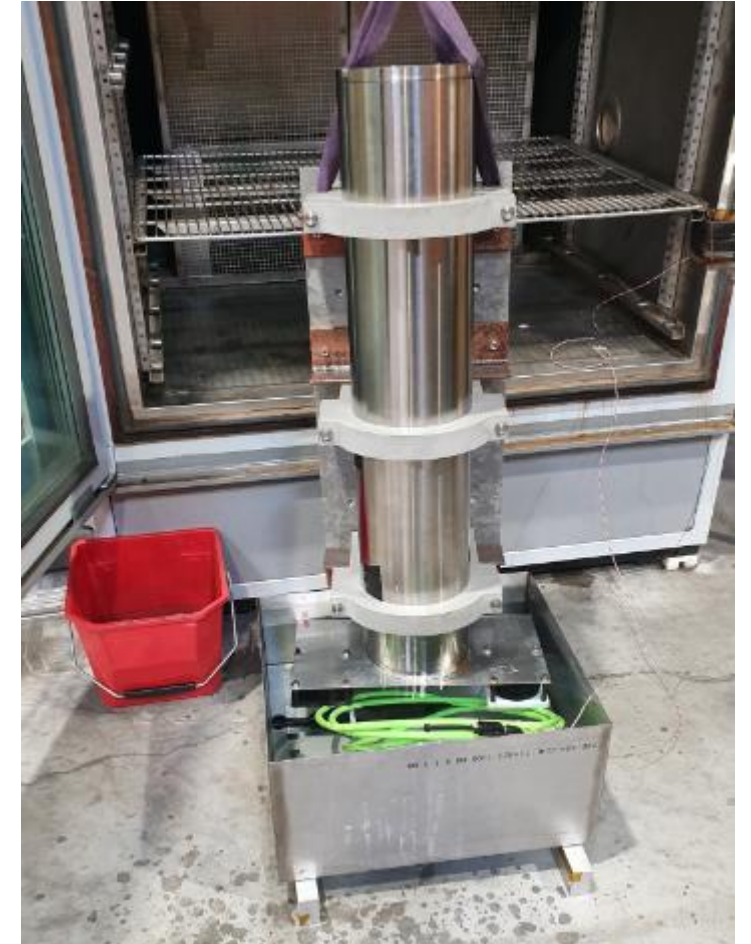
Thermal shock

Climatic &
thermal shock

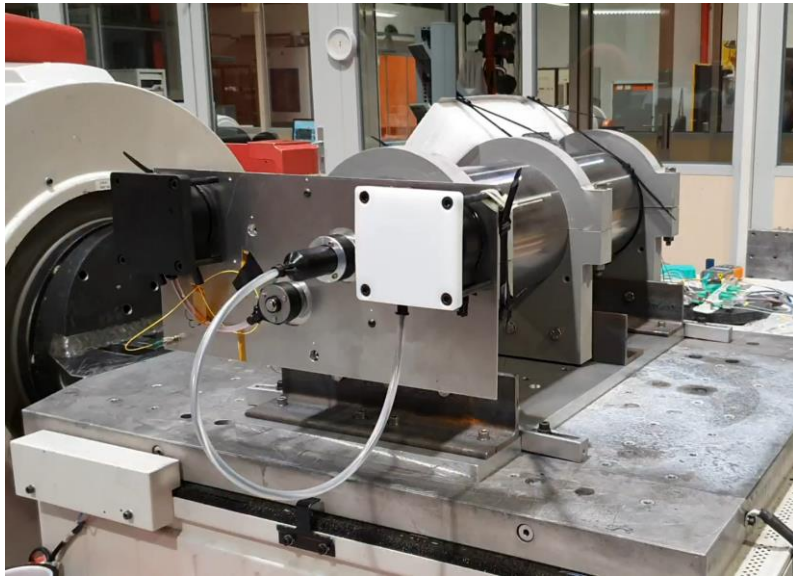
Ex: shocks transversal axis

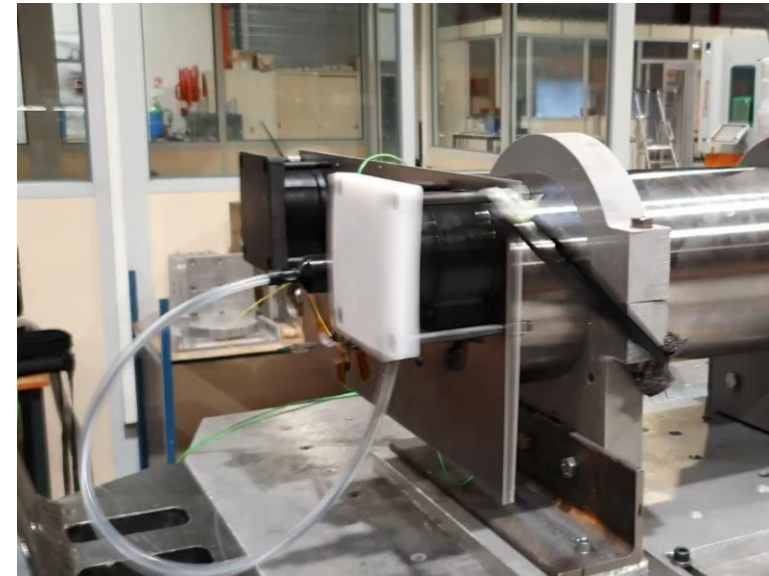
Ex: vibrations longitudinal axis
