Assembly, quality checks and installation of the scintillator detector modules for phase I upgrade of the Tile Calorimeter of the ATLAS experiment

HEPP WORKSHOP 29-31 January 2020 University of Venda

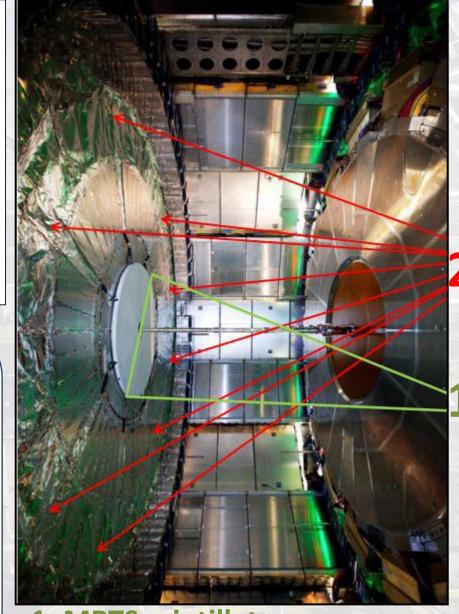
1: MBTS scintillators

2: Crack scintillators

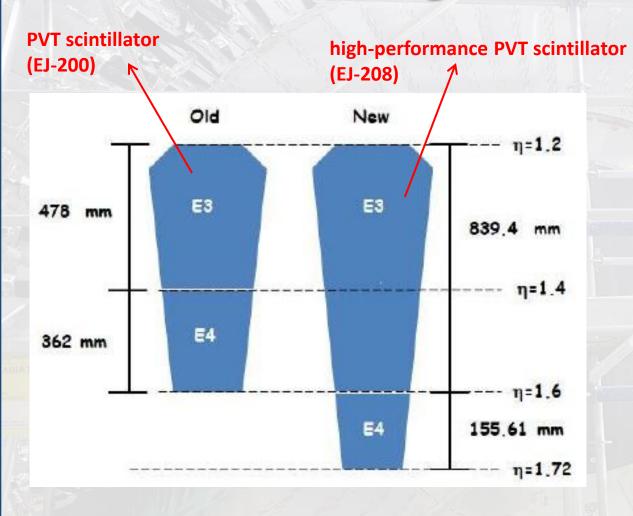
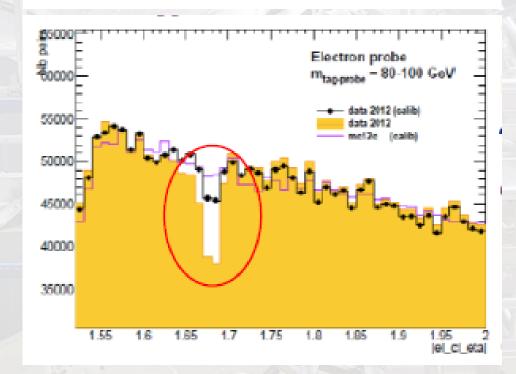
Counters geometry optimization

- The geometry of new counters extended up to 1.72 in pseudorapidity
- In the past there was a low electron reconstruction efficiency in the electromagnetic region (1.6<eta<1.72) -

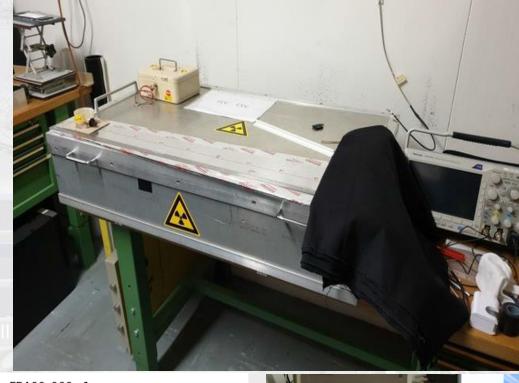
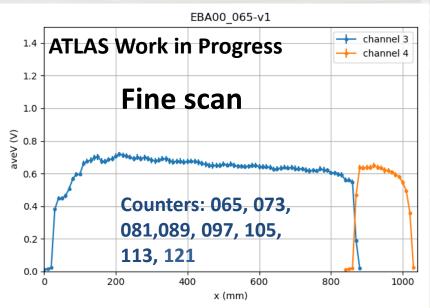
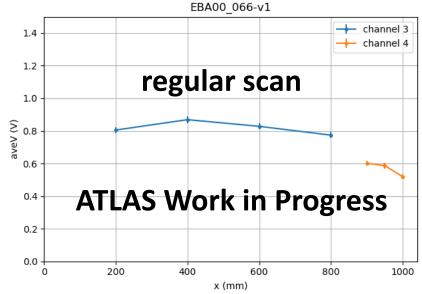
Sr90 scans

- PMT inside the light tight scan box
- High voltage source for the PMT and a digital multimeter for readout
- Counter is connected to the PMT with a clear optical fiber cable.
- Sr90- beta source (25MBq)
- Fine scans (steps of 10 mm) and regular scans (200, 400, 600, 800 & 900, 950, 1000mm) were conducted.
- One fine scan after every 7 regular scans
- All EBA and EBC counters were certified

Signal output after subtracting pedestal

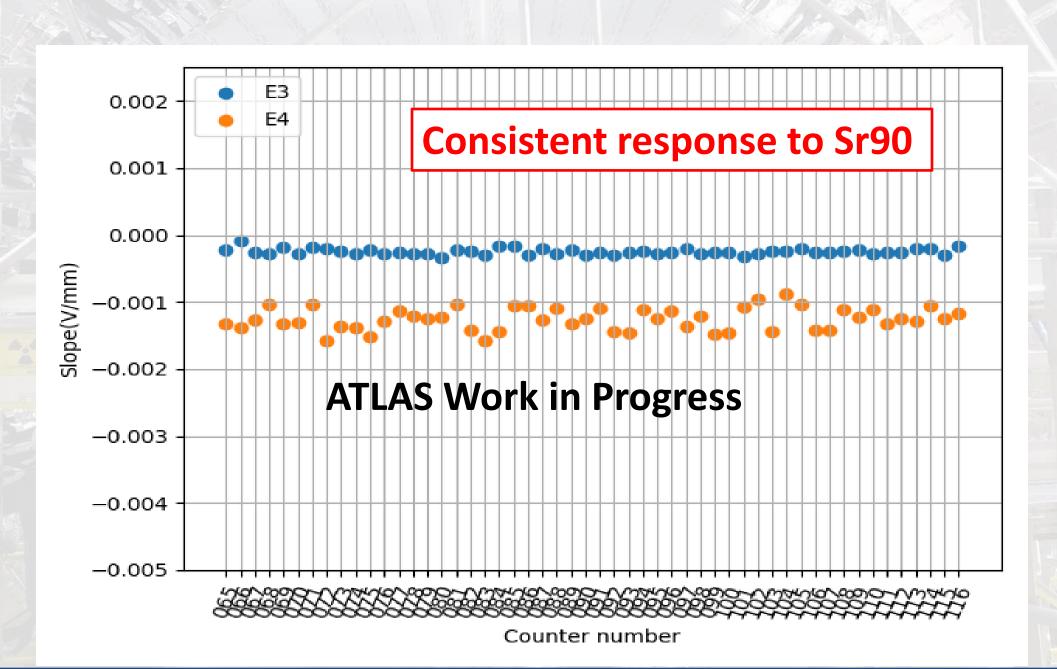
Summary of the slopes for each counter

The overall response of counters to Sr90 is consistent

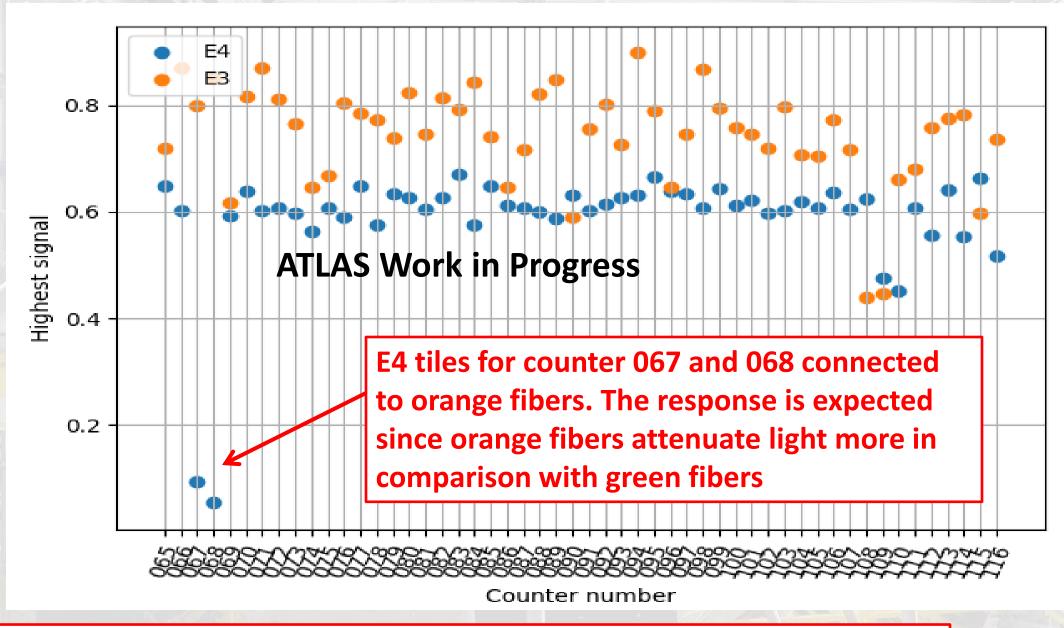
Highest voltage for each counter

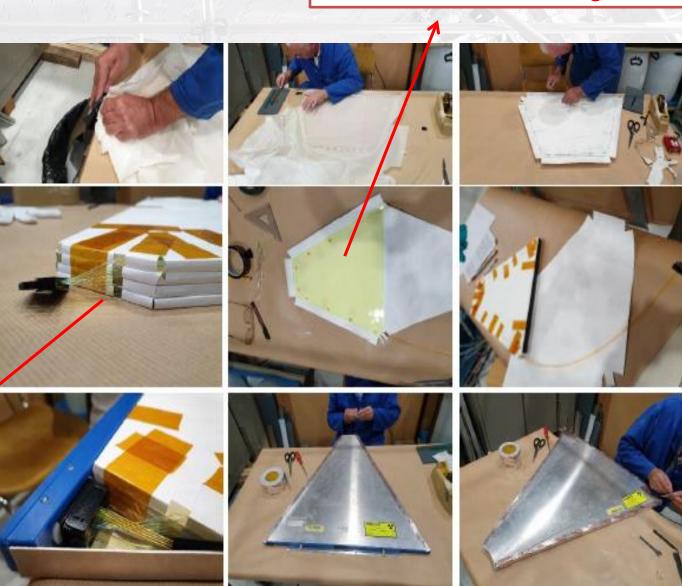
Green scintillator (inner counter) from IHEP Protvino + Orange fibers

- Open the can, remove old scintillator and fibers, clean
- Prepare the scintillators and Tyvek wrapping
- Put the fibers and wrap the plates in Tyvek one by one
- Put the wrapped plates in the can
- Seal the counter
- Total of 16 counters produced and tested with Cs137

PS scintillators (outer counter) and new green fibers

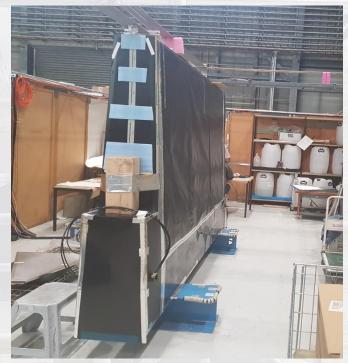
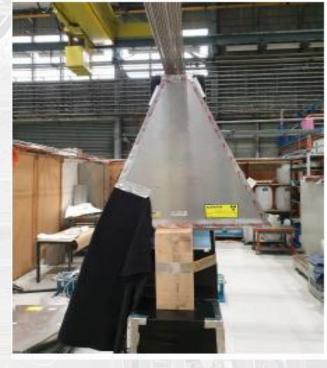
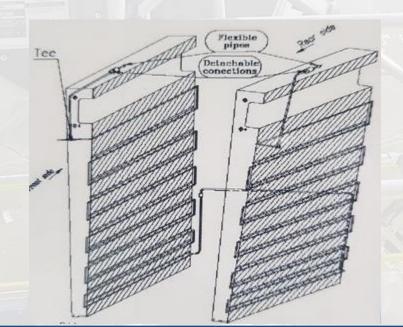
Cs137 scans: MBTS

- Each counter was tested with Cs137 system
- Counter is attached to the edge of the EB module, where the tubes are going out of the calorimeter module.
- The maximum amplitude with pedestal subtracted is used a metric.
- All EBA and EBC counters (16) were certified

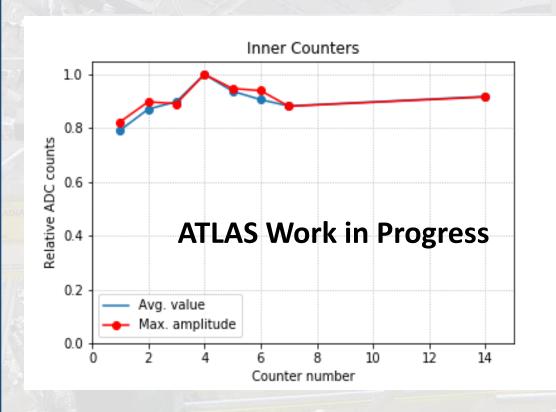
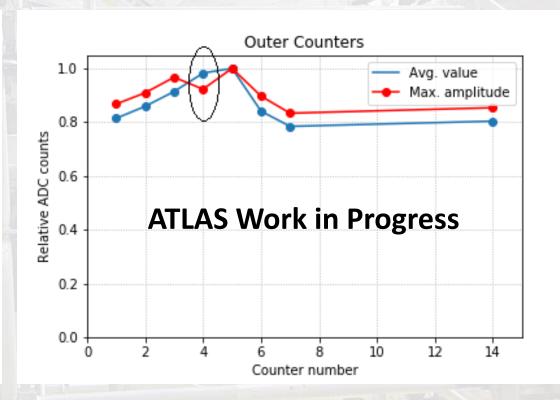
ADC ratio plots for inner and outer counters
