# Strength Measurement of Tracker Detector Composite and Titanium Structures

## ITk Global Mechanics Structural Prototypes

*Forum on Tracking Detector Mechanics 2022, INFN, Frascati, Italy*

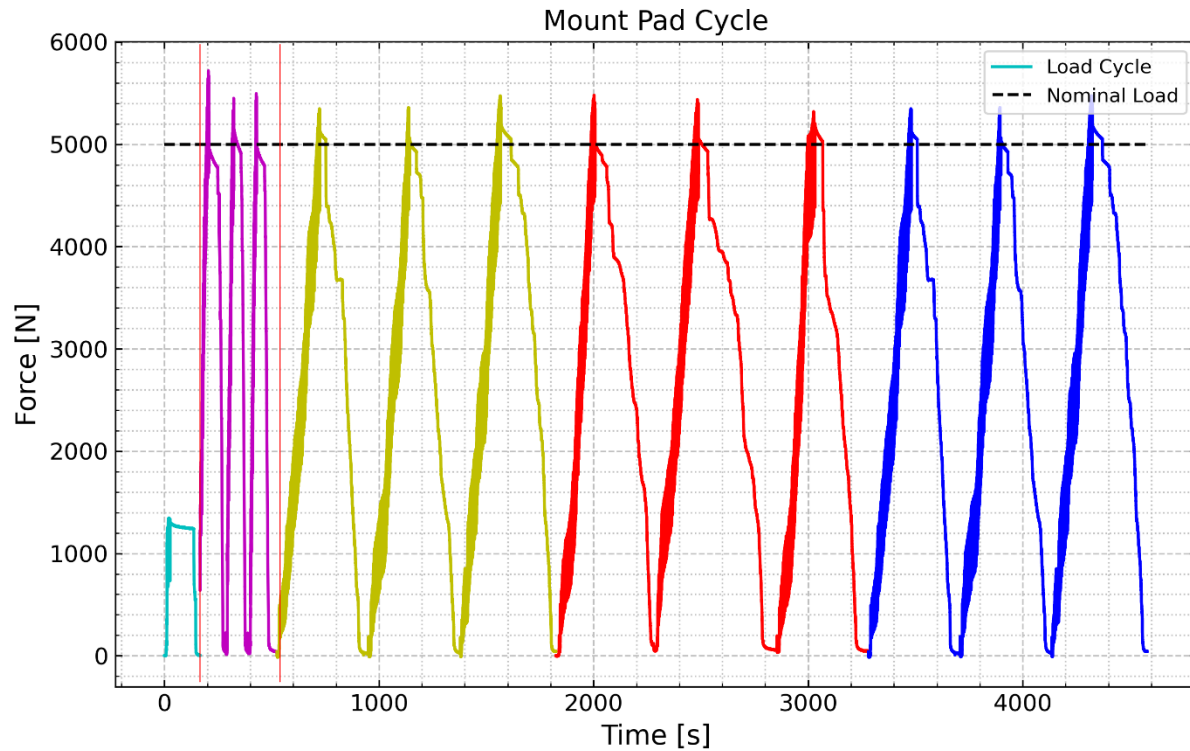
- Phase 1 – Load up to 1000N.
  - LVDT measuring stud displacement not zeroed.
- Phase 2 – Load up to 5000N. Visible motion of the stud during cycling.
  - LVDT measuring stud displacement not zeroed.
- Phase 3 – Cycling up to 5000N.

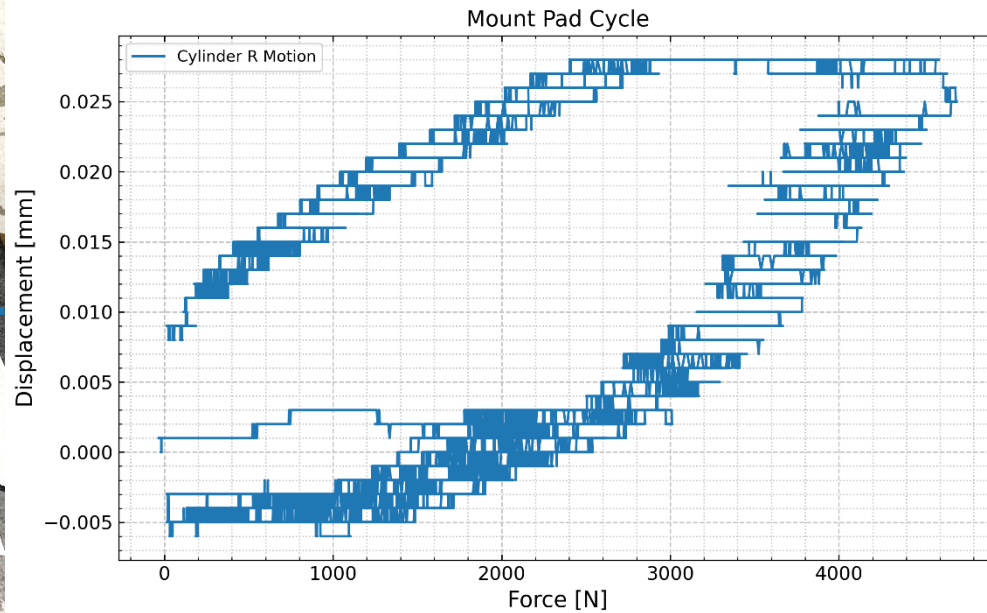
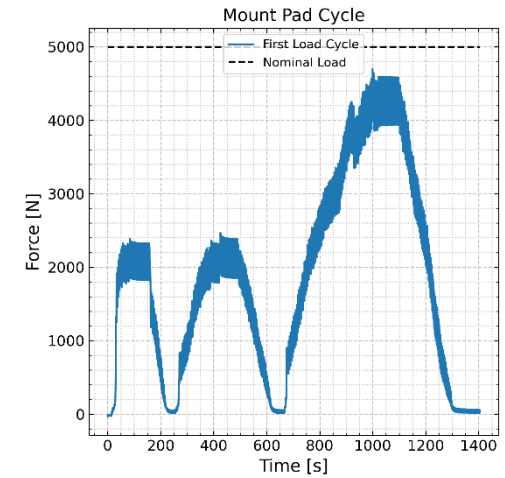
- Small motion of 0.015mm on the LVDT located radially on the cylinder
  - The displacement remains after the unloading.
  - -> slipping in cylinder fixture.
- Measurement done for one cycle only.

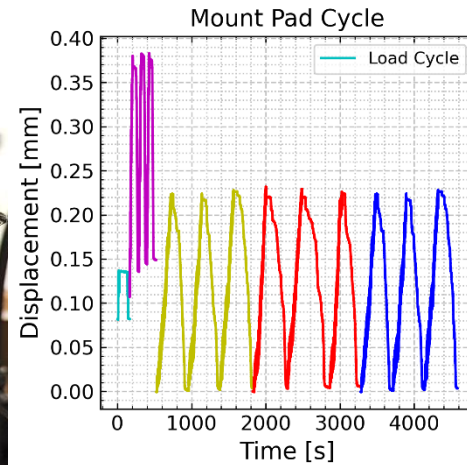
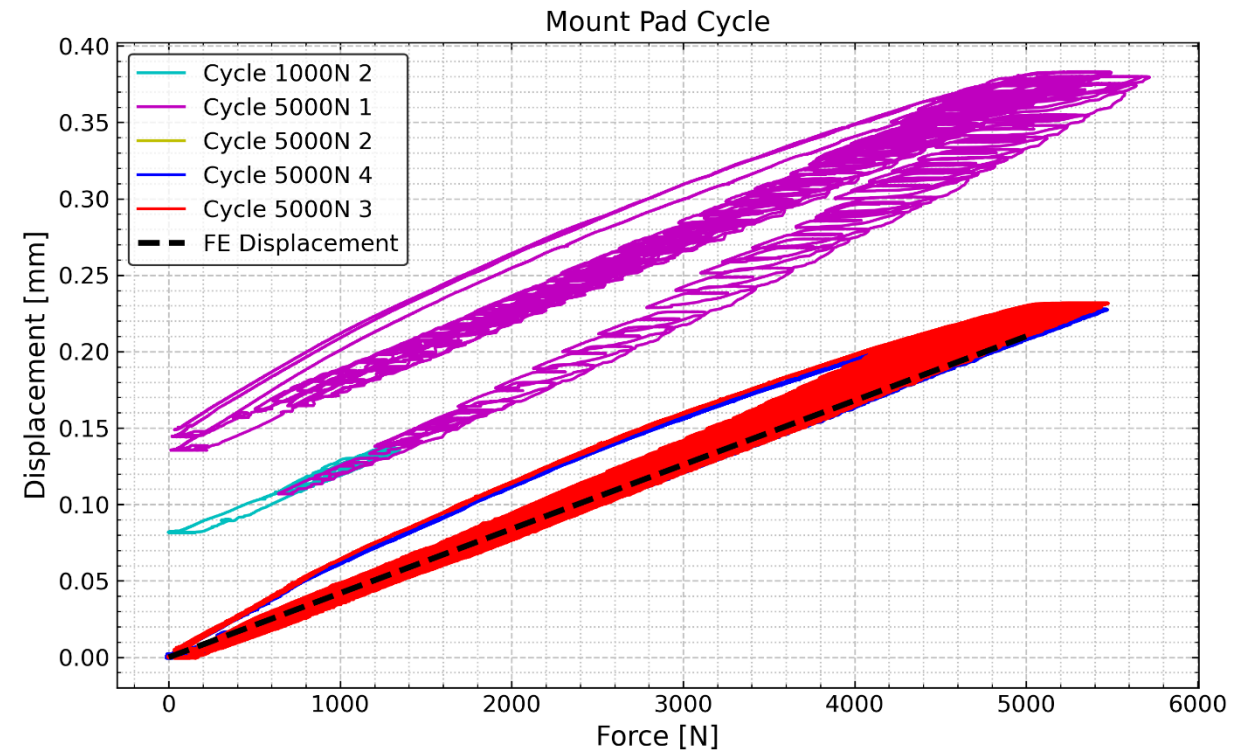
- Total displacement in the test set-up correspond to the displacement predicted by FE analysis – error up to 9%.
- Small hysteresis in the system caused by the pressure regulation.

- Tests were designed for critical ITk OC structure interfaces
- Mount Pad test set-up
  - Stiffness as expected – by 9% higher than predicted by FEA
  - Strain as expected
    - by 10% lower than predicted by FEA compared to non-linear behavior observed in measurement
    - less than 5% lower than predicted by FEA compared to linear fit obtained from measured data
  - Slippage in the fixture
  - Second load case and Failure load ongoing
- Bracket test set-up
  - Failure load ~12.5 kN ~1.5 ultimate (with stainless steel bolts)
  - Deflection higher than expected – probably bolt geometry.
  - Titanium bolts are being procured, the experiment will be repeated soon
- Structure Health Monitoring
  - Nominal load of 5kN for both interfaces
  - Mount Pad sensitivity: ~150 ( $\mu\text{m}/\text{m}$ )/kN
  - Bracket sensitivity: ~34 ( $\mu\text{m}/\text{m}$ )/kN

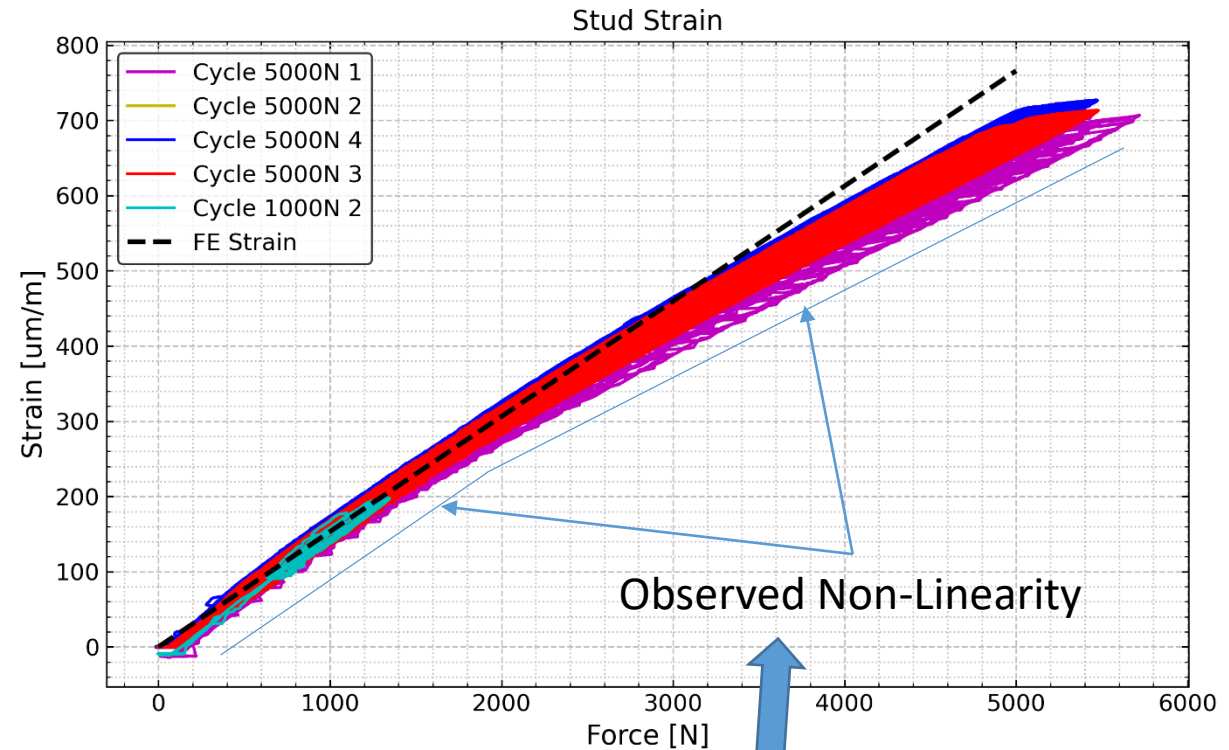
- Strain gauges half-bridge (bending) on the roller stud.
- Measured strain follow the slope of the FE strain up to  $\sim 1.7\text{kN}$  (error up to 5%).
- Possible source of the observed non-linearity could be change in the position of the force applied on the stud caused by the stud deflection.

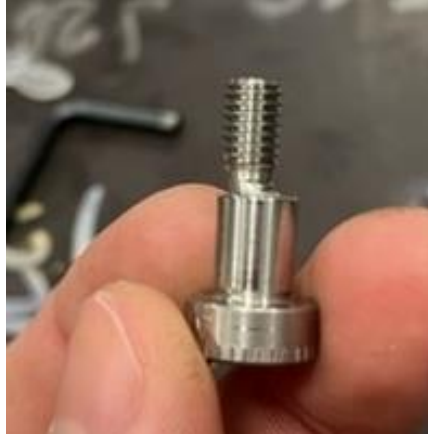
F: Full Load Procedure  
Equivalent Plastic Strain 2  
Type: Equivalent Plastic Strain - Top/Bottom - Layer 0  
Unit: mm/mm  
Time: 12  
5/11/2022 3:56 PM

- The system 'yielded' above 12.5 kN, but reached 20 kN (safety factor ~4)
- The failed component is the stud connecting the bracket to the bracket extension
  - Significant plastic deformation, but still carrying the load
  - Bushing was fine, as all the other components
  - This component is not in the correct material and geometry!
    - Titanium grade V yield is ~4 times higher
    - Design geometry has a larger cross-section

- Updated analysis performed with correct bolt material
- With conservative material properties model predicts significant plastic strain starting from 12 kN
  - Bolt eqv. stress ~200 MPa, but Titanium grade V has a yield strength of ~880 MPa
  - Still not 'failing' as the bolt hardens

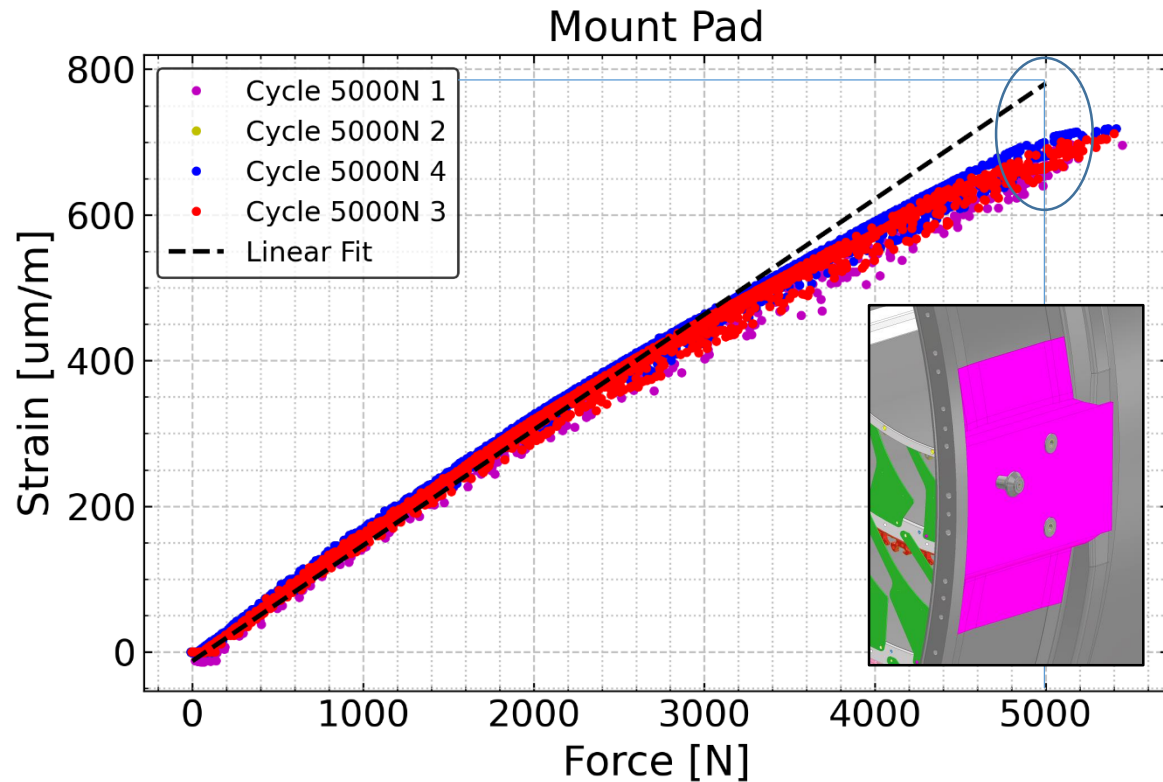
- Good sensitivity to applied load:  $\sim 150$  ( $\mu\text{m}/\text{m}$ )/kN
- We expect around  $750$   $\mu\text{m}/\text{m}$  at the nominal load

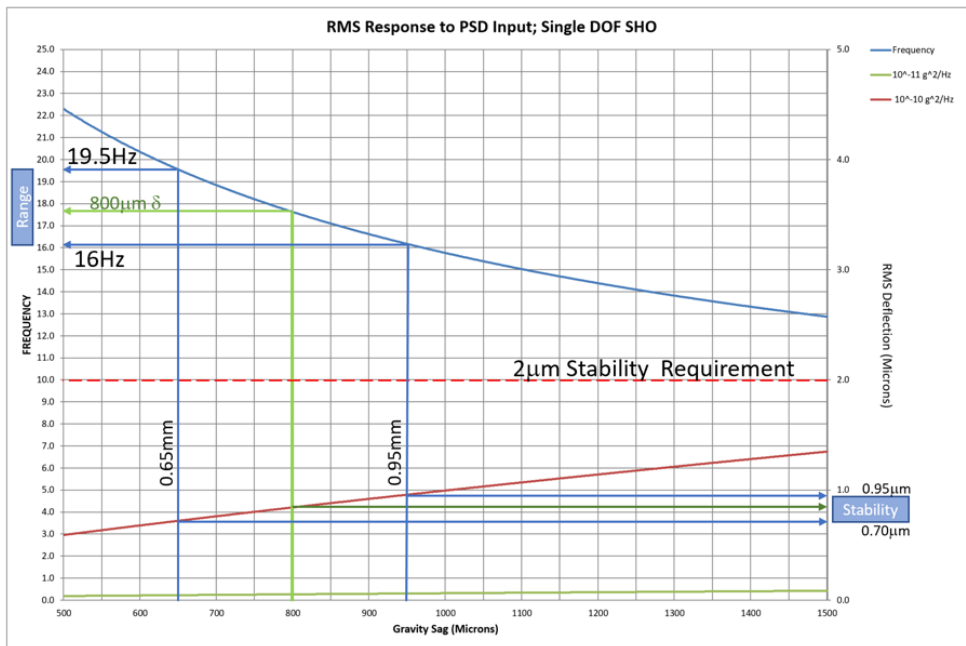
Requirement				
Type	R ( $\mu\text{m}$ )	Phi ( $\mu\text{m}$ )	Z ( $\mu\text{m}$ )	Other
Positioning	Assembly Tolerance			
Short Term Stability	20	2	20	
Medium Term Stability	50	5	50	
RMS Stability	20	2	20	
Gravity sag				2 mm
IRF				<0.5

- Requirements from: *ATU-SYS-ES-0027 - Alignment and positioning requirements (...)*
- **RMS stability** requirement (most stringent):
  - Azimuthal: 2  $\mu\text{m}$
  - Other directions: 20  $\mu\text{m}$
- Designs with a **vertical sag** lower than **1 mm** provide a margin factor of  $\sim 2$

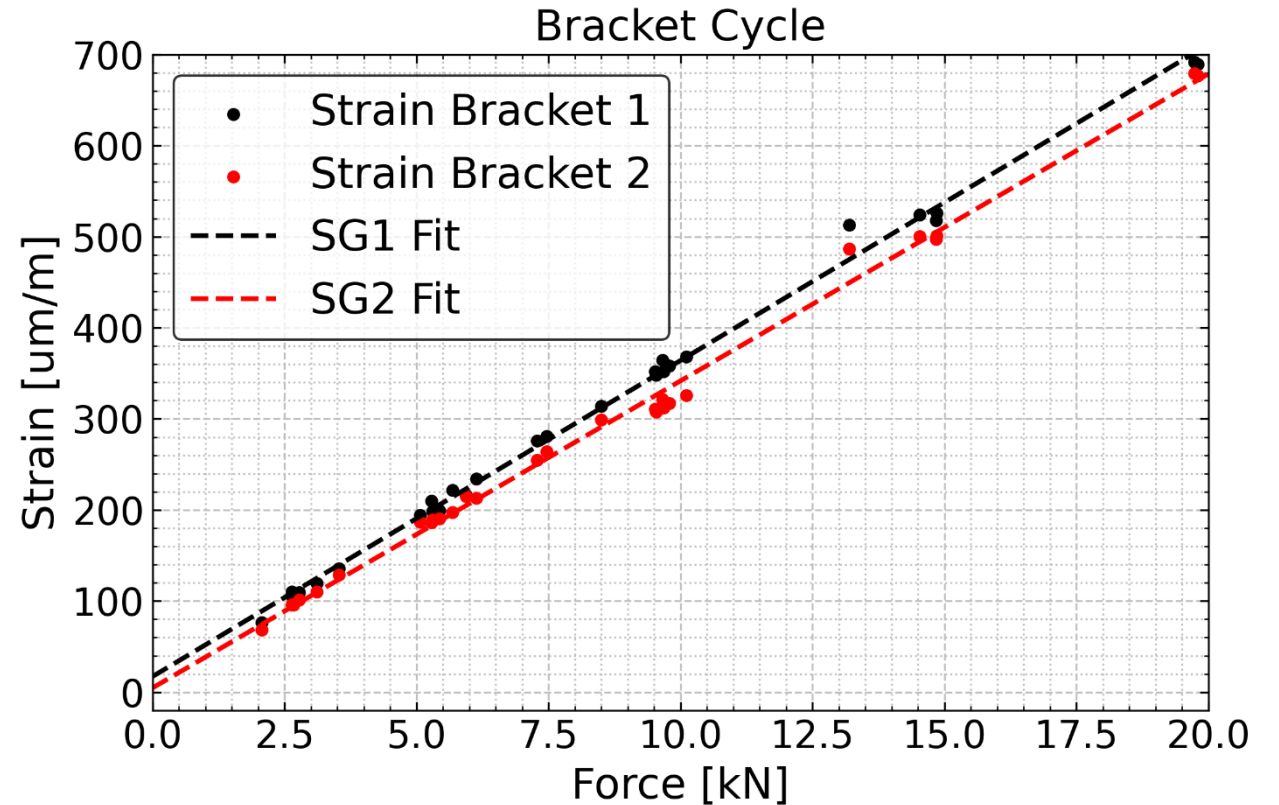
Strain gauges  
Half bridge

- Signals are linear with load
- Half bridge removes thermal effects
- Good sensitivity to applied load:  $\sim 34 \text{ } (\mu\text{m/m})/\text{kN}$ 
  - FE prediction was  $32 \text{ } (\mu\text{m/m})/\text{kN}$
  - Expected noise in the order of  $5 \text{ } \mu\text{m/m}$  (was  $\sim 1 \text{ } \mu\text{m/m}$  during measurements)
  - We expect around  $200 \text{ } \mu\text{m/m}$  at the nominal load
- Promising SHM tool

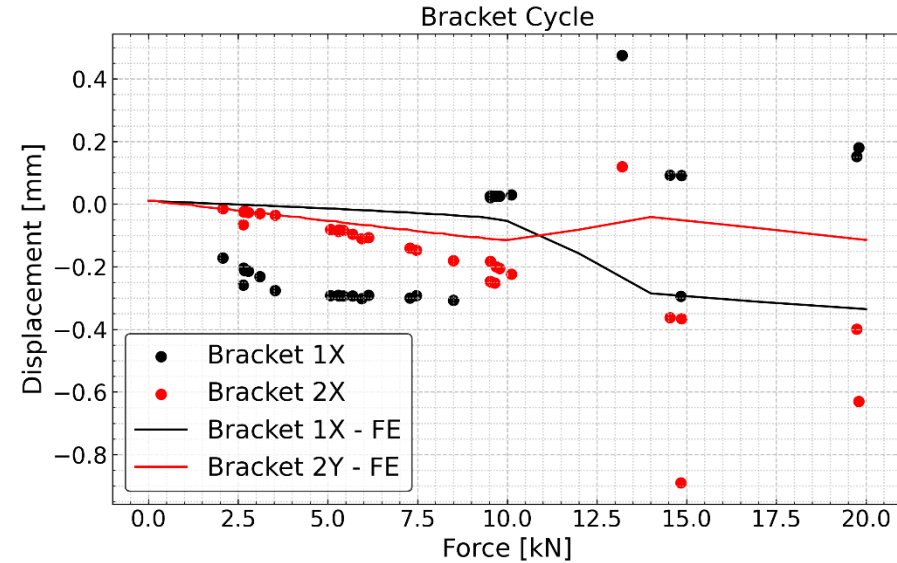
LVDT  
Horizontal

- Something strange in bracket 1 signal
  - Saturates at around 10 kN (in fact we moved it)
  - Then seems to provide random numbers
- Bracket 2 matched up to ~nominal load
- Not clear what happens after – more time needed to correctly post-process the data
  - Some measuring blocks unglued during testing
  - Need to check the history with test engineer

Debonding

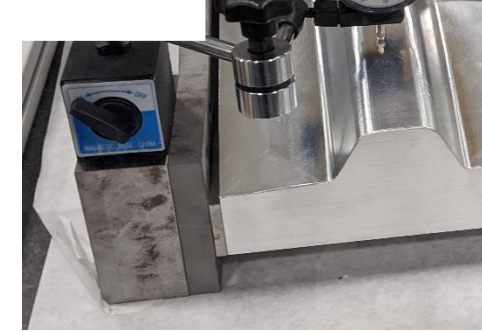
# Mount Pad Test Set-Up

## Status:

- Set-up is complete
- First load cycle performed
- Preliminary post-processing in progress, after sanity checks are passed we will apply the nominal load

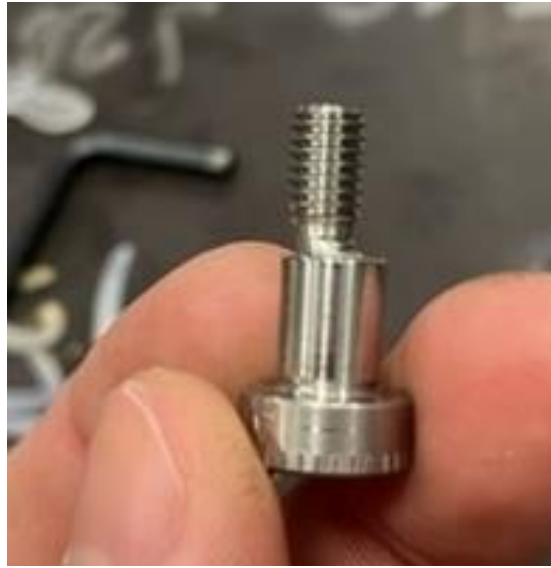
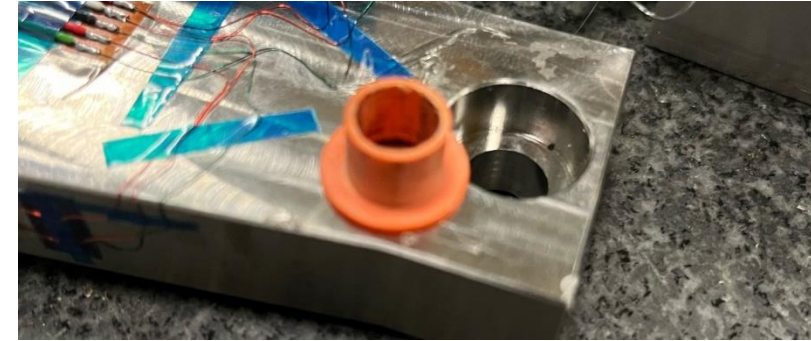
- The system ‘failed’ above 15 kN, but reached 20 kN (safety factor  $\sim 4$ )
- Not easy to see on the measurements – checks in progress
- The failed component is the stud connecting the bracket to the bracket extension
  - Significant plastic deformation, but still carrying the load
  - Bushing was fine, as all the other components
  - This component is not in the correct material!
    - Titanium grade V yield is  $\sim 4$  times higher

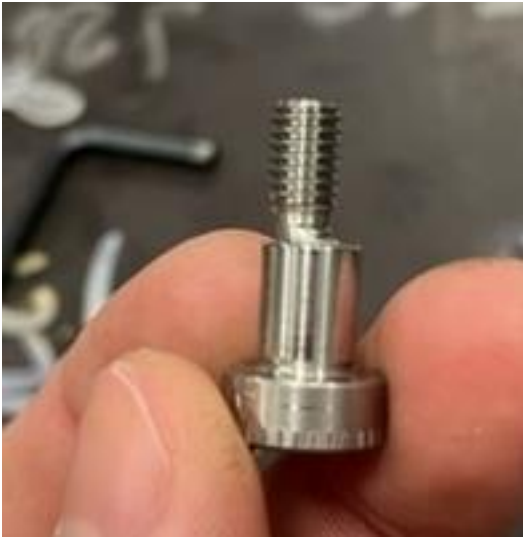
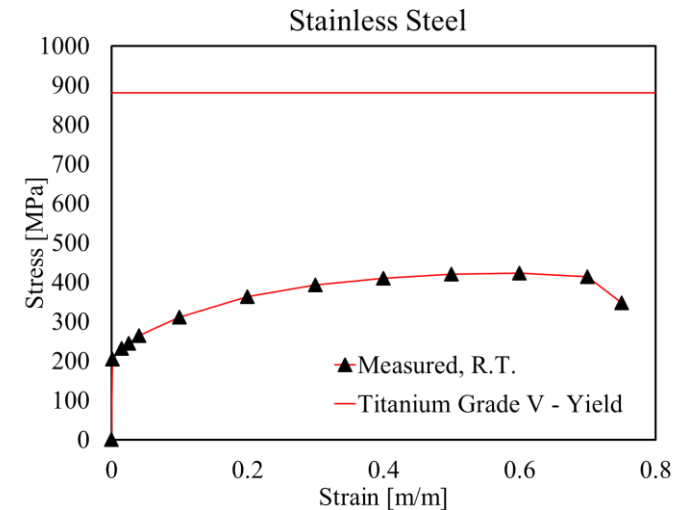
F: Full Load Procedure  
Equivalent Plastic Strain 2  
Type: Equivalent Plastic Strain - Top/Bottom - Layer 0  
Unit: mm/mm  
Time: 12  
5/11/2022 3:56 PM

- Updated analysis performed with correct bolt material
- Something strange in the geometry
  - Model one seem more optimal
- With conservative material properties model predicts significant plastic strain starting from 12 kN
  - Bolt eqv. stress  $\sim 200$  MPa, but Titanium grade V has a yield strength of  $\sim 880$  MPa
  - Still not 'failing' as the bolt hardens
