Titanium orbital welding: 3D printed parts to bulk

Cecilia Rossi^{*1}, Mickael Denis Crouvizier², Julien Debeux²,
Gilles Favre², Romain Gerard², Jerome Hebert³

Titanium welding test

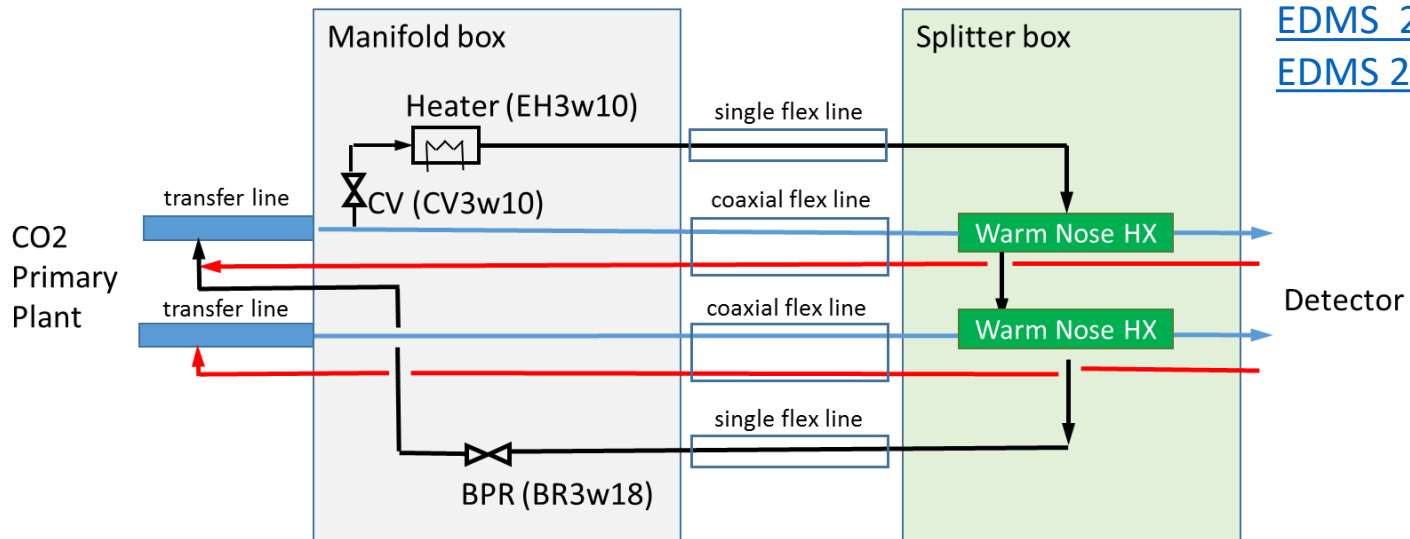
Warm nose working principle:

- avoid that instability, related to the Liquid Super Heating, occurs at the detector
- regulate detector temperature without technical intervention in its unreachable areas during runs.

- Part of liquid CO₂ is drawn from the main stream and processed to reach the 2-phase status, i.e. WN loop
- Temperature in WN loop is controlled by a Back-Pressure Regulator (BR3w18).
- WN HX → heat exchange between WN loop and subcooled liquid directed to the detector.
- Heater (EH3w10) to get WN loop in 2-phase and control the vapour quality of the loop
- Mass flow in the circuit is controlled by a carrel valve (CV3w10)

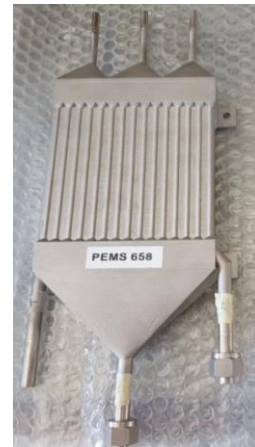
Due to the power required and limited space
→ **metal additive manufacturing.**

These heat exchanger will have to be welded to the plant (i.e. bulk material)
→ issues?

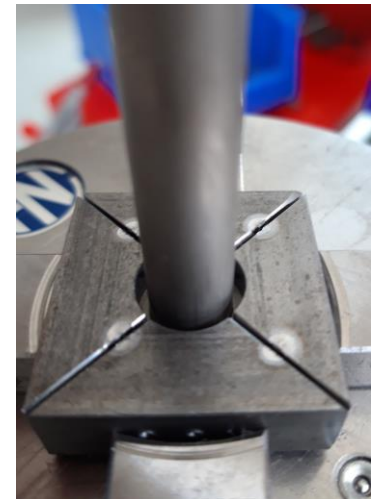
- Development of orbital TIG welding parameters
- Orbital welding of 4 samples:
 - n. 2) bulk Gr. 2 (pure Titanium) to Gr. 5 additive manufacturing
 - n. 2) bulk Gr. 2 (pure Titanium) to Gr. 23 additive manufacturing
- AM samples produced by two different companies
- Visual inspection
- Leak test
- Pressure test @162 bar
- Leak test
- Micro tomography

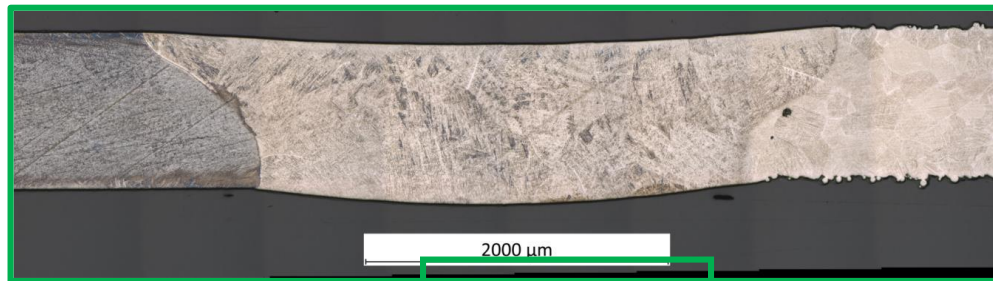
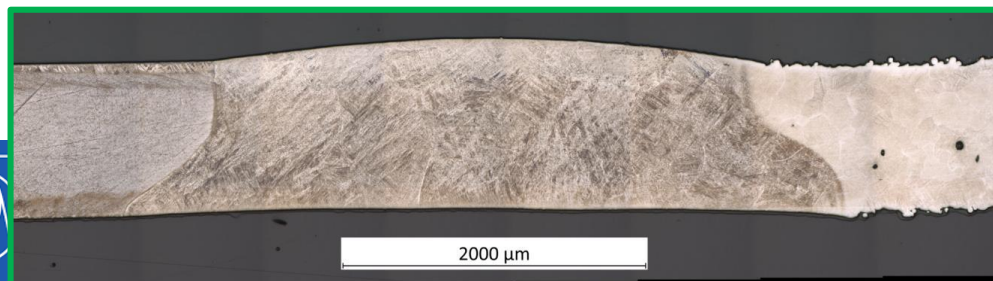
- Metallographic inspection (weld 2) according to ISO 5817 Level B:
 - Good quality butt weld joints
 - Joint free from imperfections

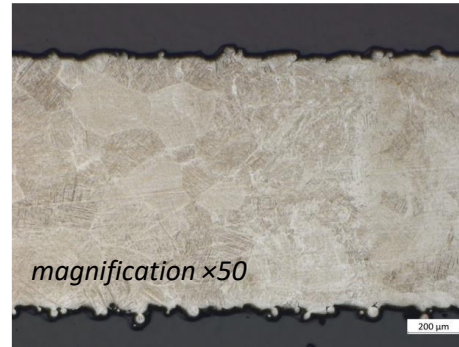
after etching – grain size can be appreciated

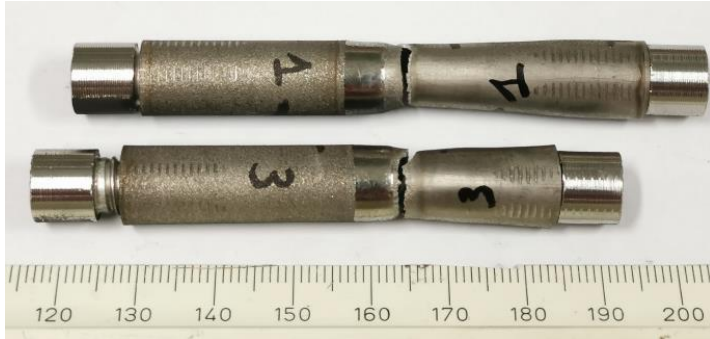
- Transverse tensile test (welds 1 and 3) according to ISO 6892-1 Method A2

Weld	Rp0.2 (MPa)	Rm (MPa)	A15mm (%)
n. 1	423.4	515.0	13.2
n. 3	435.8	542.7	9.2
Mean \pm std dev	429.6 \pm 6.2	528.9 \pm 19.6	11.2 \pm 2.0

min required strength = min strength of Ti Gr. 2 (345 MPa) \rightarrow ok

Breakdown occurred always at HAZ of titanium grade 2

- Keyence VHX-6000 \rightarrow confirm the ductile breakdown
- SEM Carl Zeiss Sigma with EDS detector \rightarrow identification of weld regions and analysis of fractured surface - smooth transition between the weld seam and both parent materials. Confirmation of oxides in Ti Gr. 2 "standard" pipe
