Investigation of  
**mechanical degradation mechanism**  
onto the quench heater insulation to Nb<sub>3</sub>Sn coil

TE-MS-C-LMF

11.12.2019

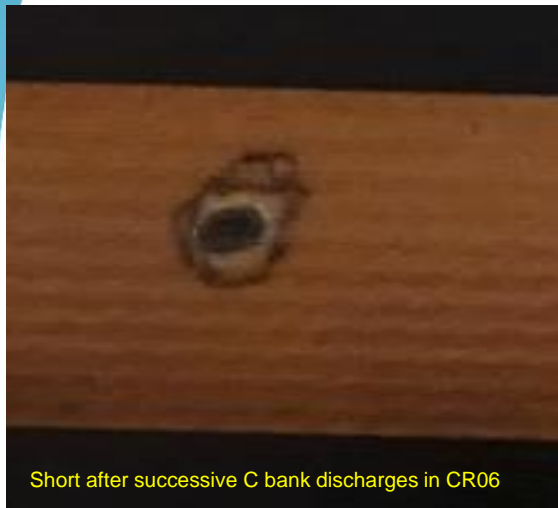
- Direct shorts provoked in collared coil state was found in same cross sections on paired coils, residual resistance of few Ohms.

Short after successive C bank discharges in CR06

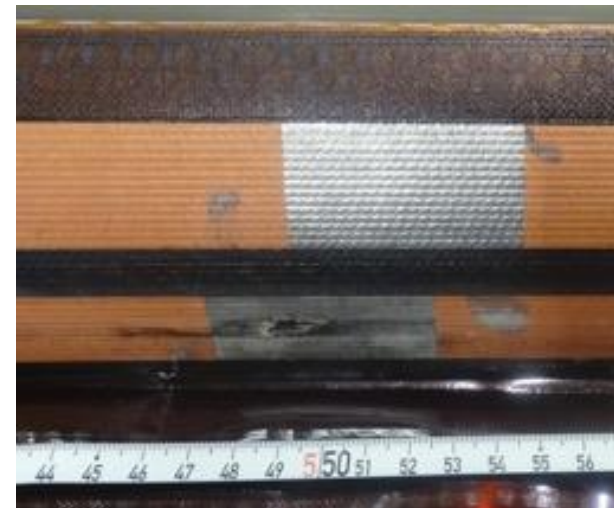
Type of direct short defect created in extended Hi-pot test on CR07, ( hole diam 2 mm, dumped E tot > 1kJ)

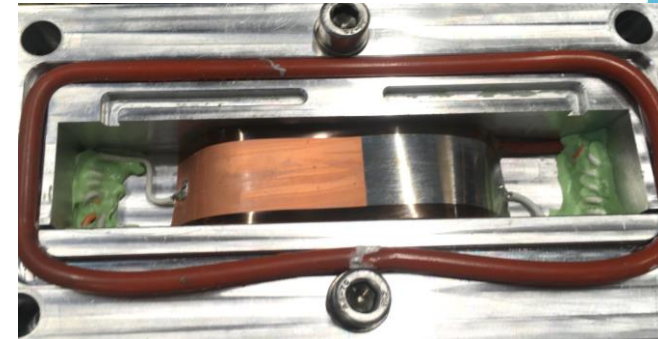
Prepared sample in the impregnation mould which enables radial and transversal compression

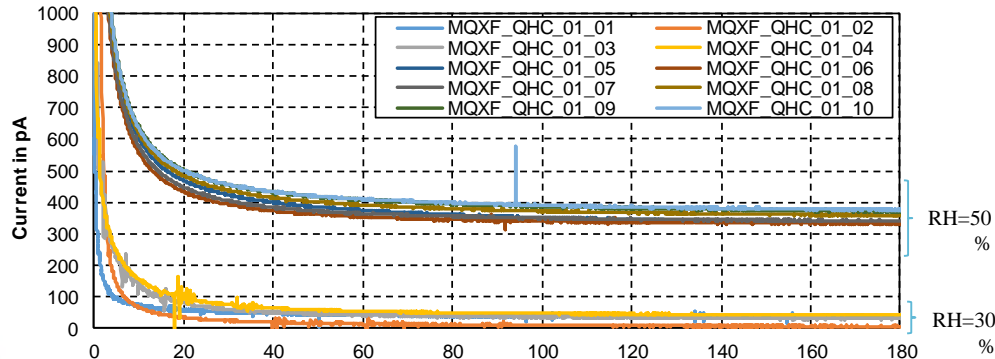
Leakage current measurement at **500V without load** of sample MQXF\_QHC01 (<150 $\mu$ m).

- Good repeatability of the leakage current measurements at stable ambient conditions
- Leakage current decreases towards an plateau value
- Leakage current is very sensitive to:
  - Ambient conditions
  - Time gap between measurements

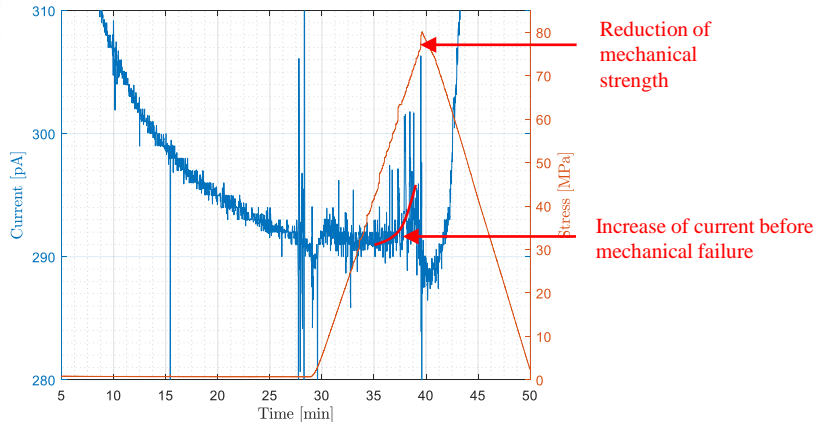
Leakage current measurement **at 500V** with load ramp rate 0.13MPa/s QHC07 (<150 $\mu$ m insulation thickness).

- Sample prepared with higher compression (extra 100 $\mu$ m polyimide shim).
- Leakage current increases with at load above 60 MPa.
- Time dependent leakage current increase, even at decreased load.
- Clear change of the leakage current behaviour without applied load after 80MPa loading.

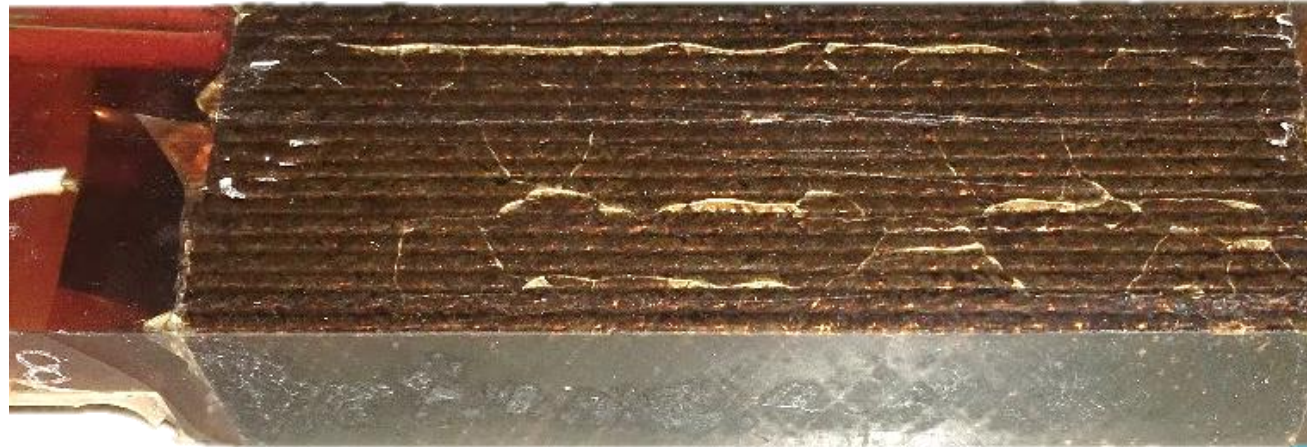
*Sample installed at the sample holder of the cryostat in Bldg. 163 for cool down to 1.9K.*

*Cracks in the insulation system (bottom surface of the sample) after cool down to 1.9 K.*

- Cryogenic cool down in a cryostat with liquid helium to 1.9 K
- cooling rate of about 75 K/h
- warm up rate about 100 - 150 K/h

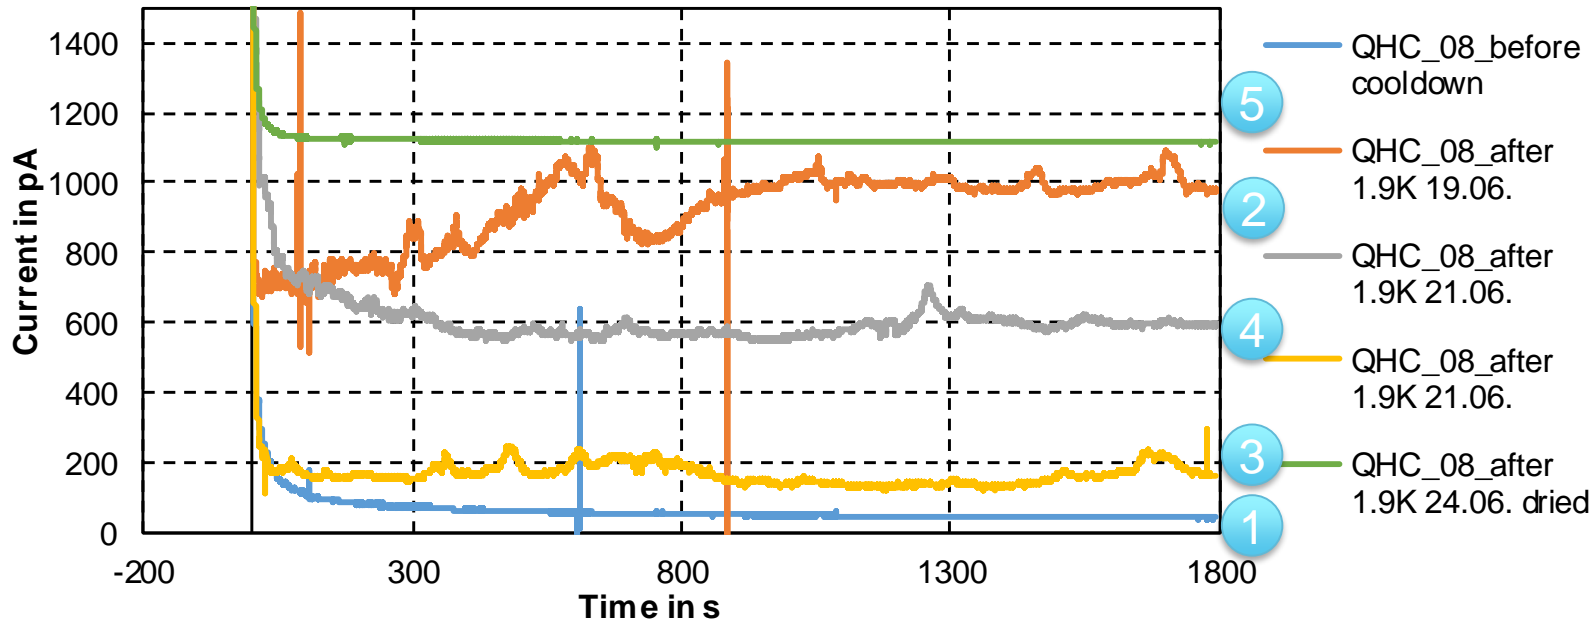
*Leakage current measurement at 500V without load.*

- No effect on the leakage current after sample drying
- Absolute value is influenced by the ambient conditions

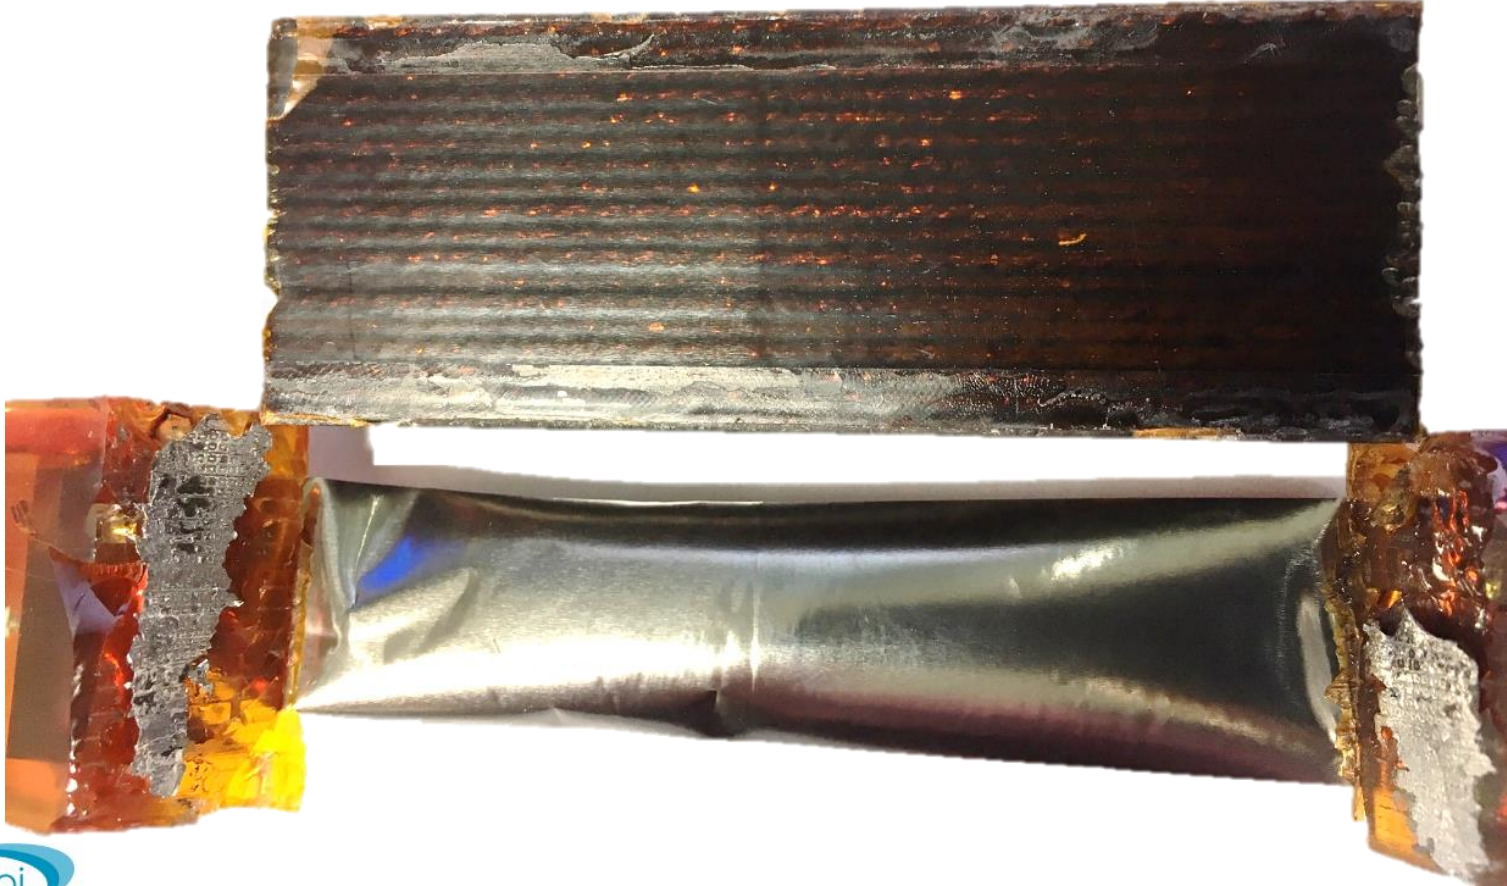
*Sample with peeled off quench heater after cryogenic cycle to 1.9 K.*

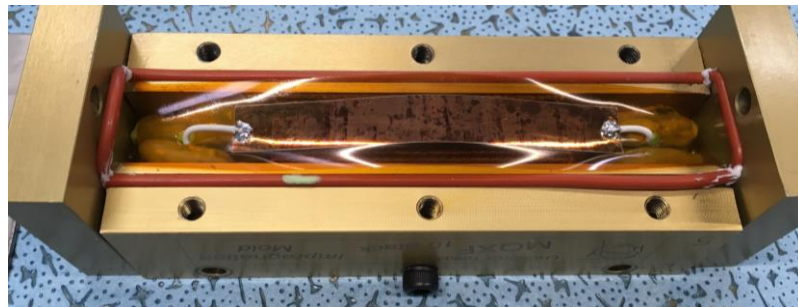
*Impregnation mould for the investigation of the MQXF impregnation system.*

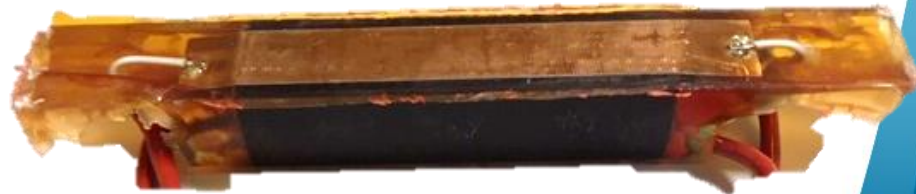
*Impregnated MQXF sample.*

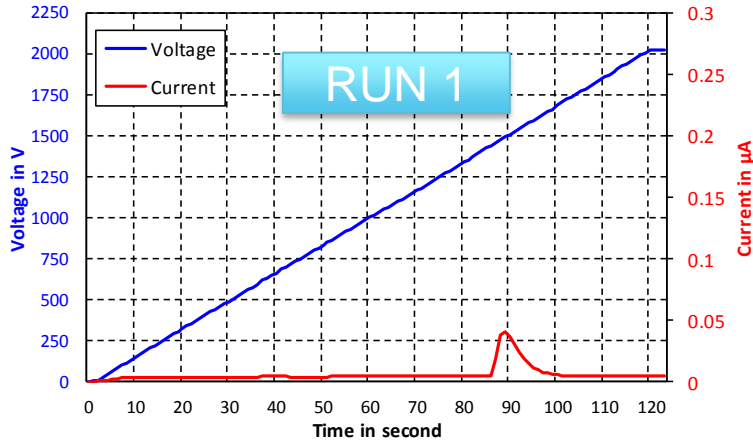
Leakage current activity can be observed before the break down.

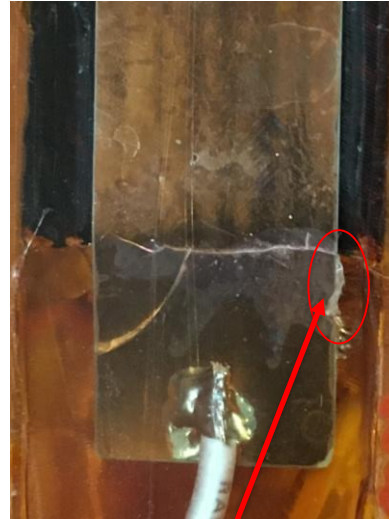
Break down location on the MQXF-01.
