# **LMBHA-001\_CR00001 manufacture electrical test history**

***2020, 15th January – 11T task force meeting***

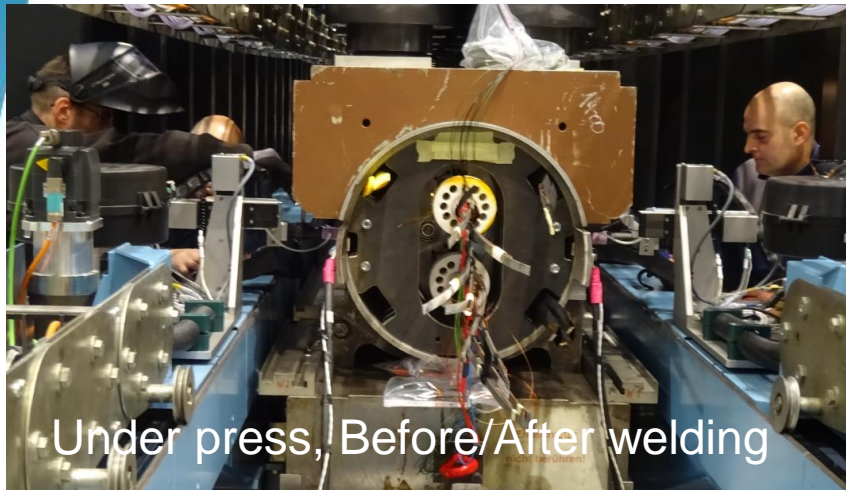
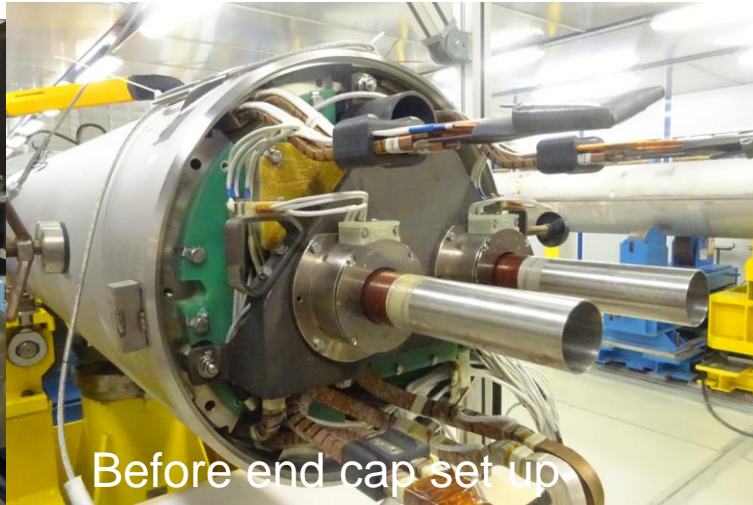
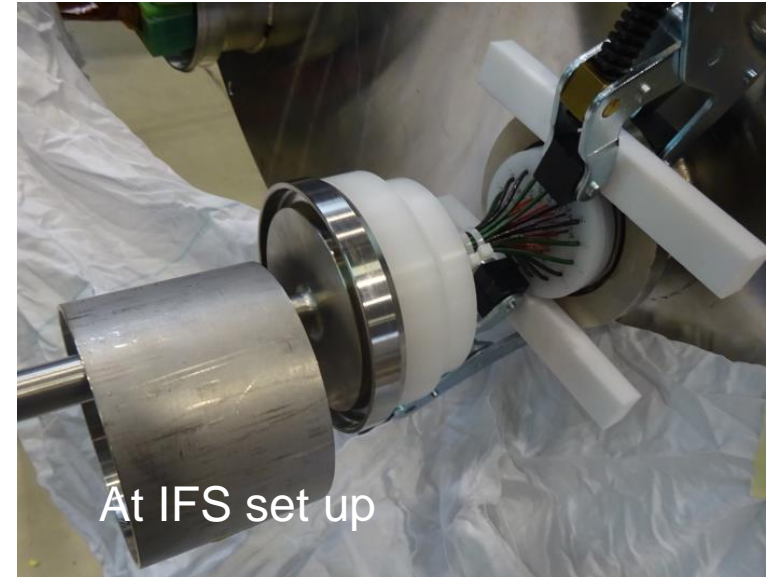
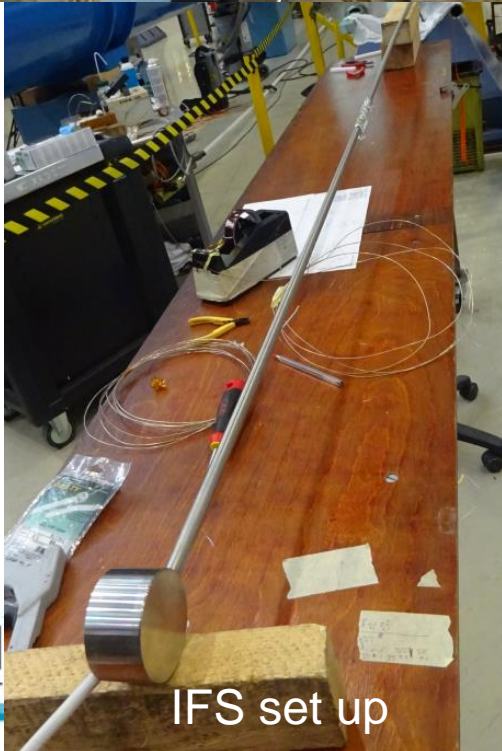
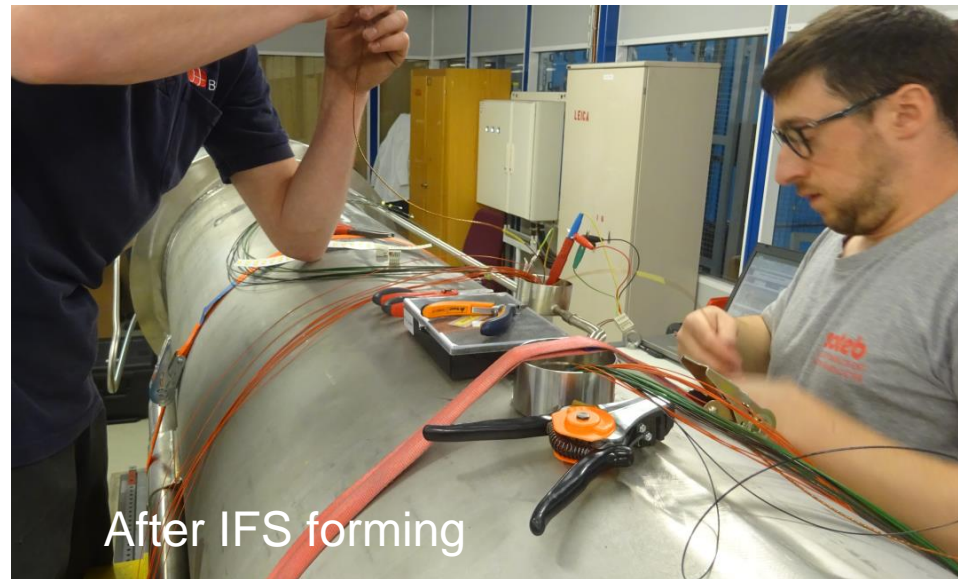
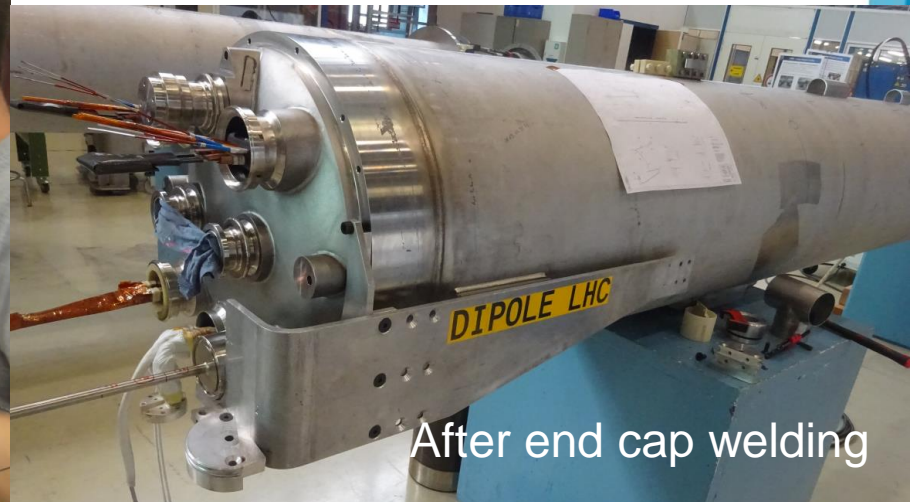
# Cold mass electrical test steps
