LMBHA-002 (S3)

Work plan for dismounting, including QC

2020-02-19, 11T Dipole TM #24, <https://indico.cern.ch/event/889468/>

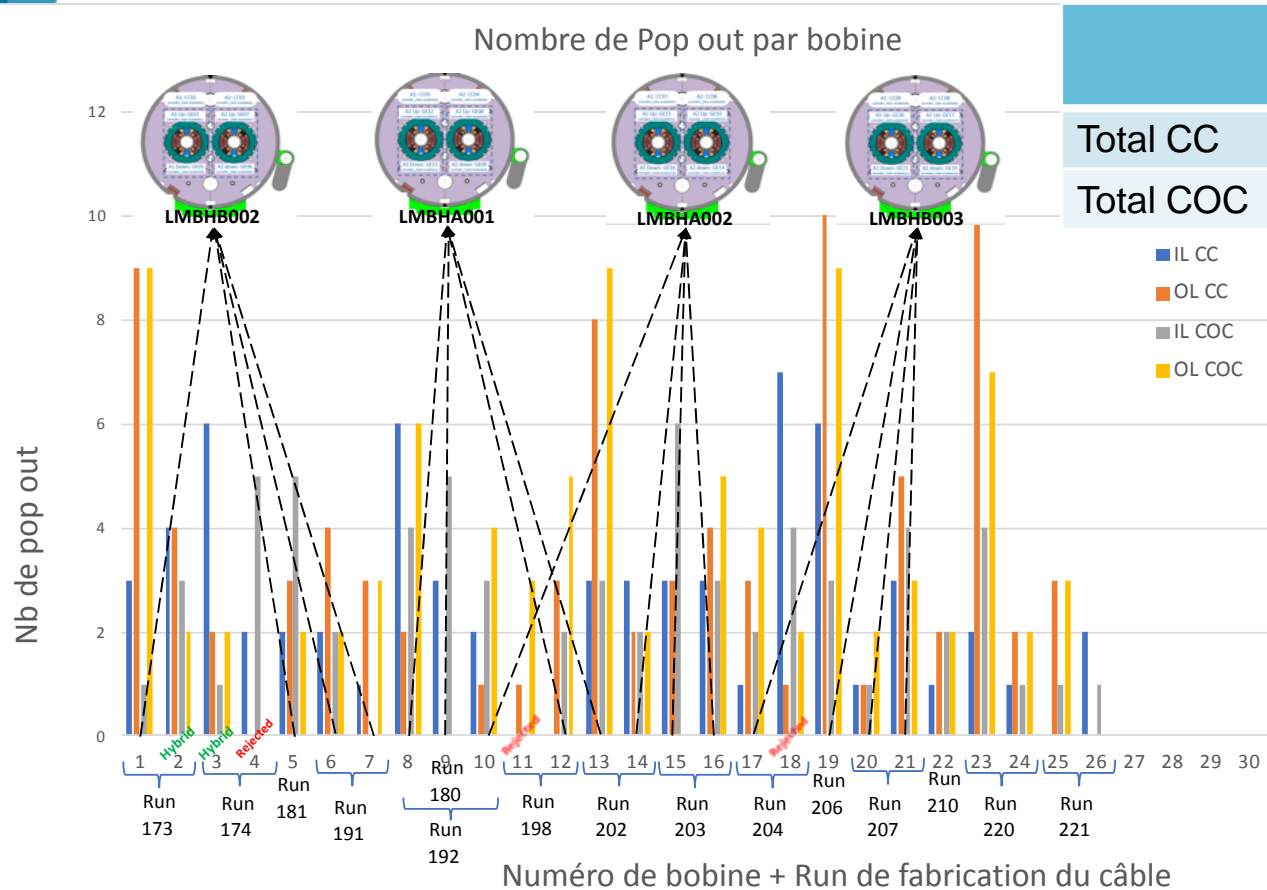
Winding and pop out – Nb events per coil

Total IL	Total OL	Total IL+OL
Total CC	61	82	143
Total COC	64	88	152

- All coils concerned
- More events on OL, goes with Nb turns (globally)
- However, more events on some turns (see next slides)
- Only IL for coil 26
- We could also indicate the billets

Summary on long coils from previous meeting			
	Total - IL	Total - OL	Total - IL+OL
Total CC	61	82	143
Total COC	64	88	152

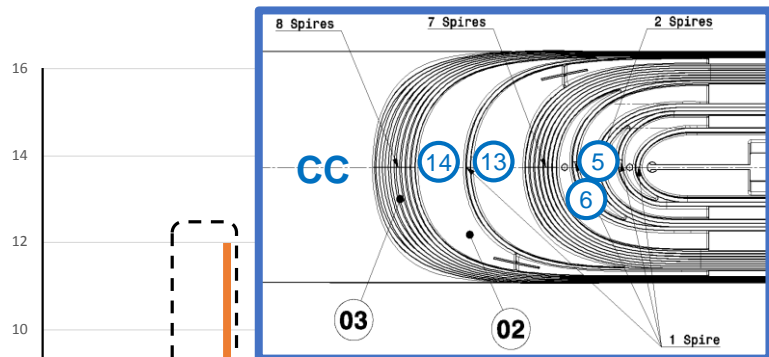
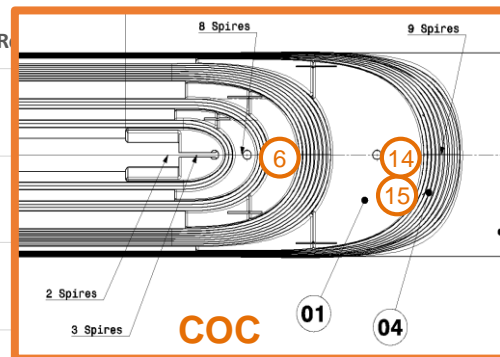
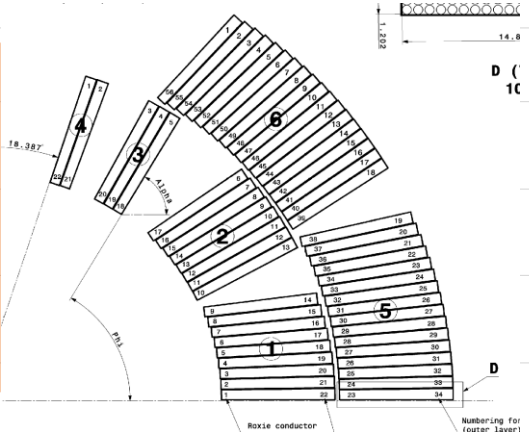
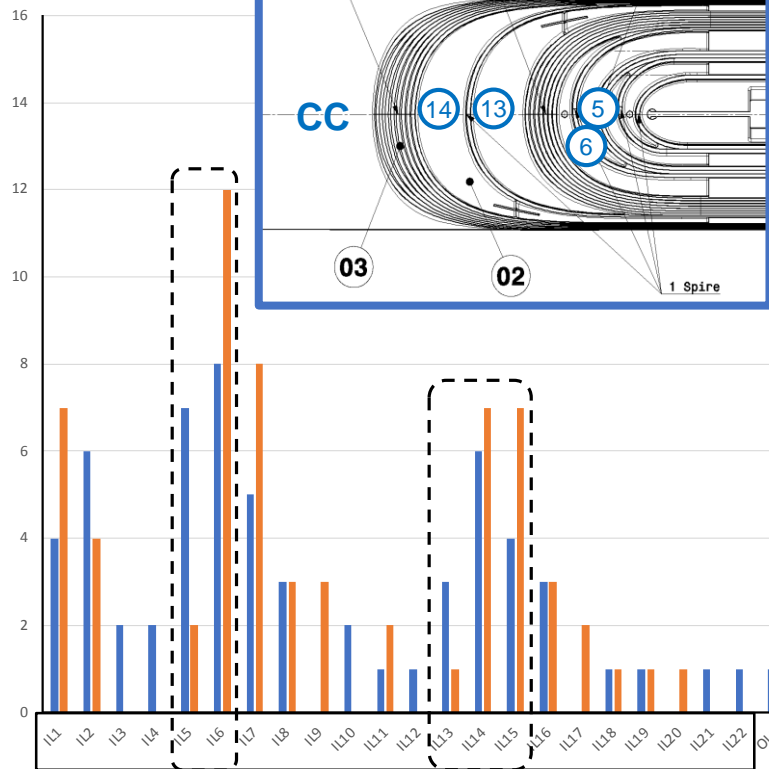
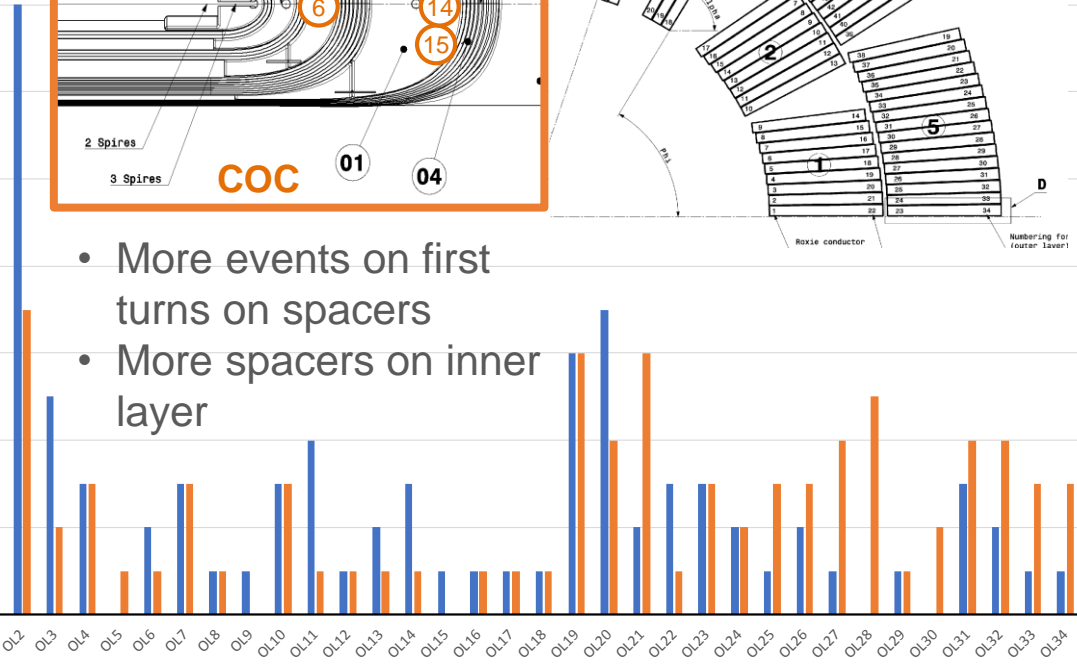
Winding and pop out – Inner layer (22 turns)

- More events on first turns on spacers
- More spacers on inner layer
