Status and Test Results of the 11T Magnets

10th HL-LHC Collaboration Meeting, CERN, <https://indico.cern.ch/event/937797/>, 2020-10-06

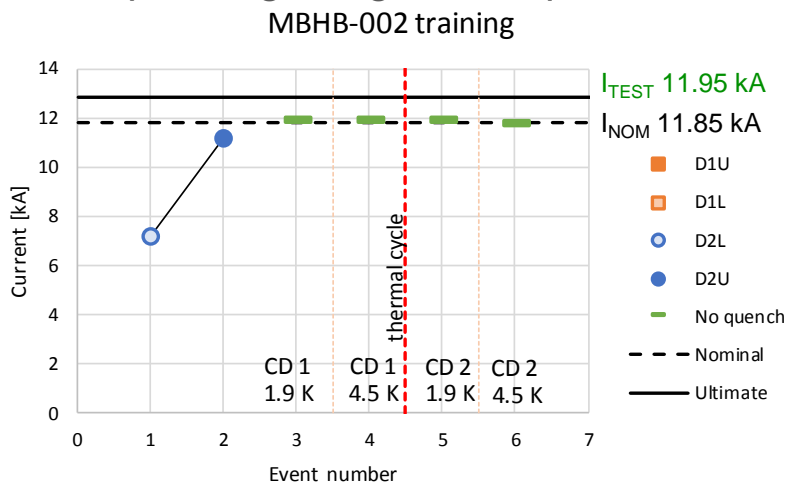
S1 (LMBHB002) – Powering tests results

- **Virgin training with only 2 quenches (in Ap2) to 11.95 kA**, one in each coil. The first one at rather low current (not uncommon in models too)
- After thermal cycle, no quench up to 11.95 kA, **good memory**
- After the two quenches at the initial training, **no additional quench** recorded throughout all subsequent powering tests, at all ramp rates, and temperatures (1.9 K and 4.5 K)
- The magnet reached nominal current at 4.5 K, indicating a temperature margin > 2.6 K
- The magnet has been subject to **330 electro-magnetic cycles**, and **4 holding current tests** for a total of 20.5 hours (of which one plateau of 12 hours)

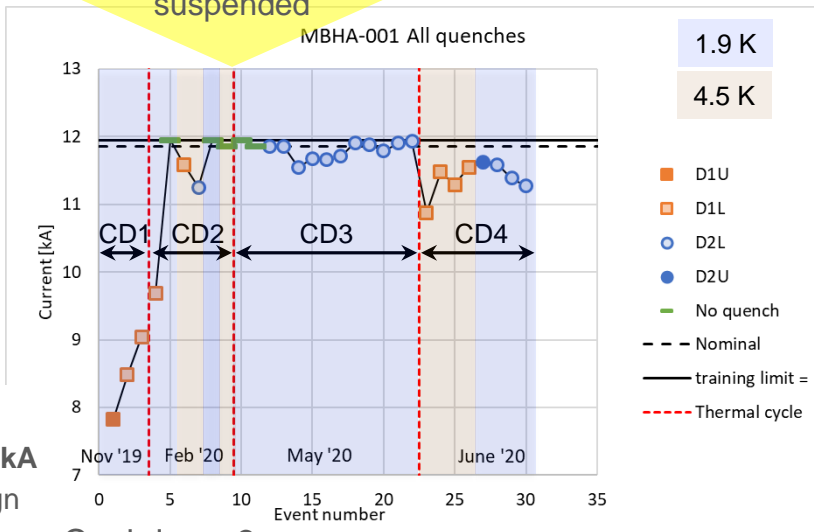
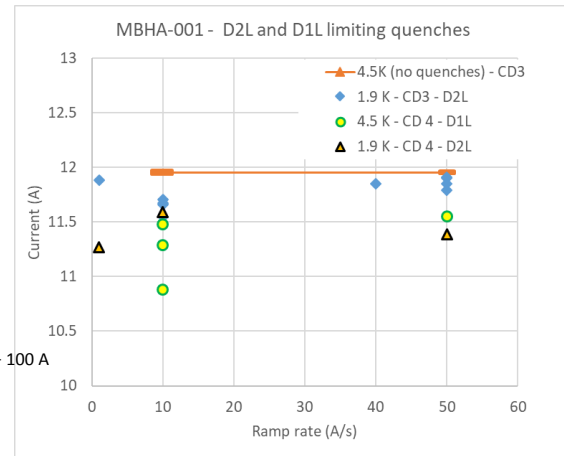
S2 (LMBHA-001) – Powering tests results

- ✓ Four quenches to 11.95 kA
- ✓ The magnet is OK, no sign of degradation
- ✓ 12-hour holding current test at 11.85 kA
- ✓ **Spikes on V-signals**, originally attributed to an intermittent short between D1 & D2 in the capillary tube

- ✓ No quench in the beginning up to 11.95 kA, then 4-hour holding current test at 11.85 kA w/o quench
- ✓ Instability as from 2nd week of testing in coil D2L @ 1.9 K
- ✓ V-I measurements show degradation in coil D2L
- ✓ 120 electromagnetic cycles (3 series of 10, 30, and 80) between 5 kA and 11.85 kA **without degradation** (checked on V-I measurements)
- ✓ No quench at 4.5 K

- ✓ At 4.5 K, quench limit in coil D1L
- ✓ At 1.9 K, quench limit in coil D2L, like during CD3
- ✓ V-I measurements show conductor degradation in both D1L and D2L

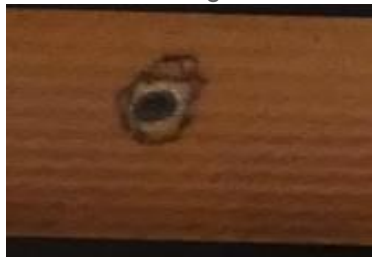
Last discharge before burn through

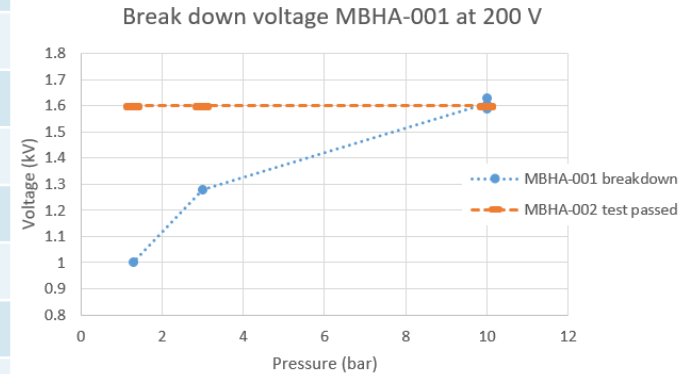
An overview of the HV tests at 200 K in GHe

Red box means breakdown

- Coils equipped with external QHs pass the test successfully, not those equipped with impregnated QHs
- It has also been shown recently (August 2020) on the last model MBHDP-201 (PIT conductor), equipped with external QHs, that the QH to coil insulation system can withstand the expected dielectric strength of 10kV, at RT, after the coils have been exposed to helium during cold tests

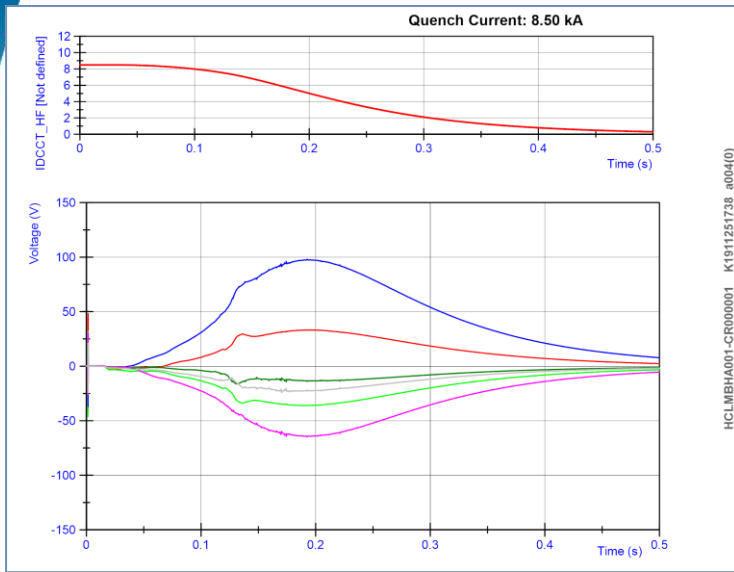
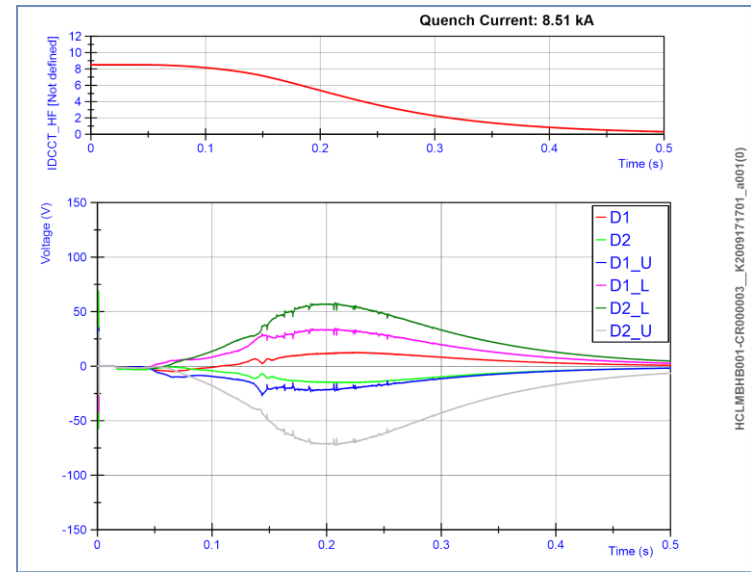
S2 – MBHA-001, quench at 8.5 kA

- Spikes appear on the voltage signals following a quench, during the current decay
- **S2 was subject to > 40 discharges** (provoked quenches) in different conditions in order to understand their origin. An **Electrical Conformity Assessment Panel** was put in place in the middle of April for the installation of the S2

- Spikes are **also present in S4 – MBHB-003**, and other 11T dipole magnets to a certain extent (also in some short models)
- The spikes are **most likely related to changes in magnetization, or differences in quench propagation velocity**. This feature still needs to be understood and explained!

- Given this, **we are convinced that we can rule out the idea of an intermittent short between the two apertures**, as originally thought, for which there was a demand to carry out electrical tests in specific conditions (“lifted voltage”). One shall review whether these special tests are still needed, as there isn’t any electrical weakness (tbc by ECAP)

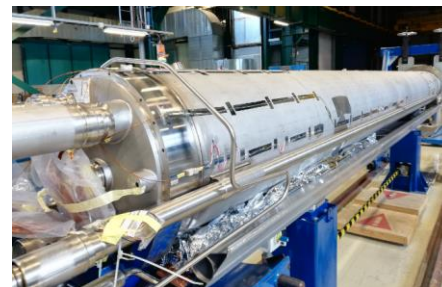
Installation of PT100 on outside surface of CM shells

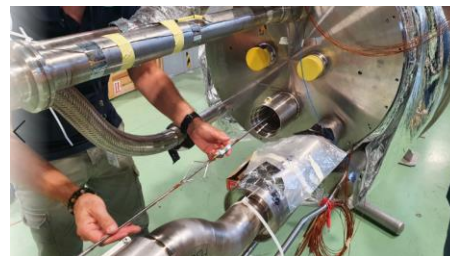
Insertion of TT00X in channel 1

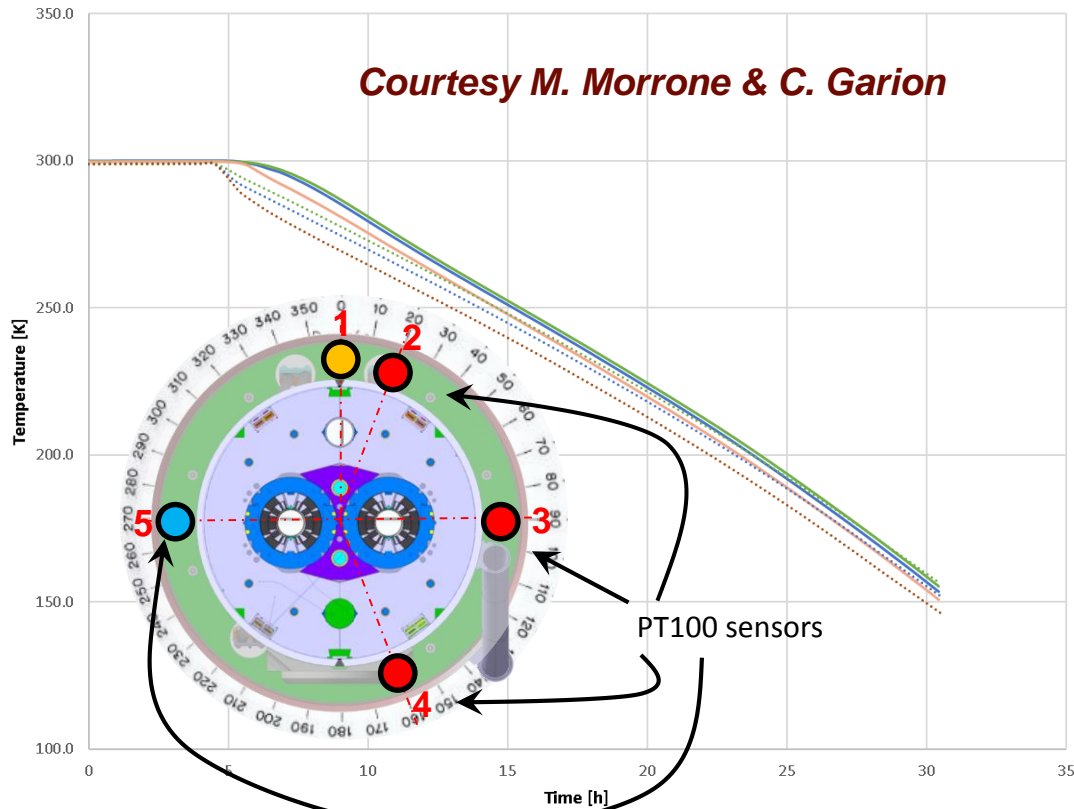
S2 Cooldown "Shell of the Magnet": Measurements vs Simulations

- QLFC2_S_TTB001.POSST
- QLFC2_S_TTB002.POSST
- QLFC2_S_TTB004.POSST
- ⋯ TTB001_sim
- ⋯ TTB002_sim
- ⋯ TTB004_sim

Same picture, i.e. good match between measurements and simulations for the other sections A and C

- The **maximum difference in temperature between the measurements and simulations is below 3% for the main cooling channel and 9 % for the other cooling channels**

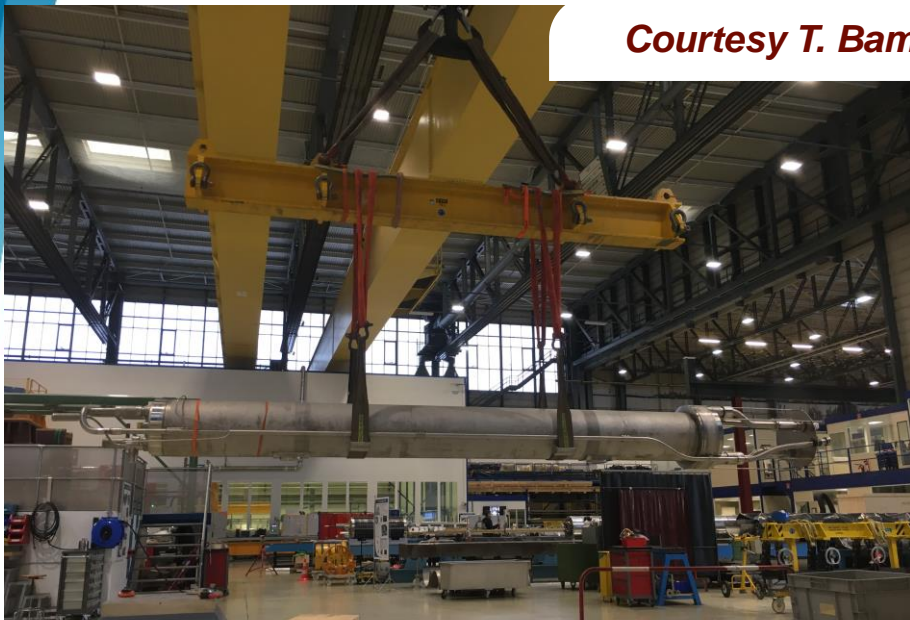
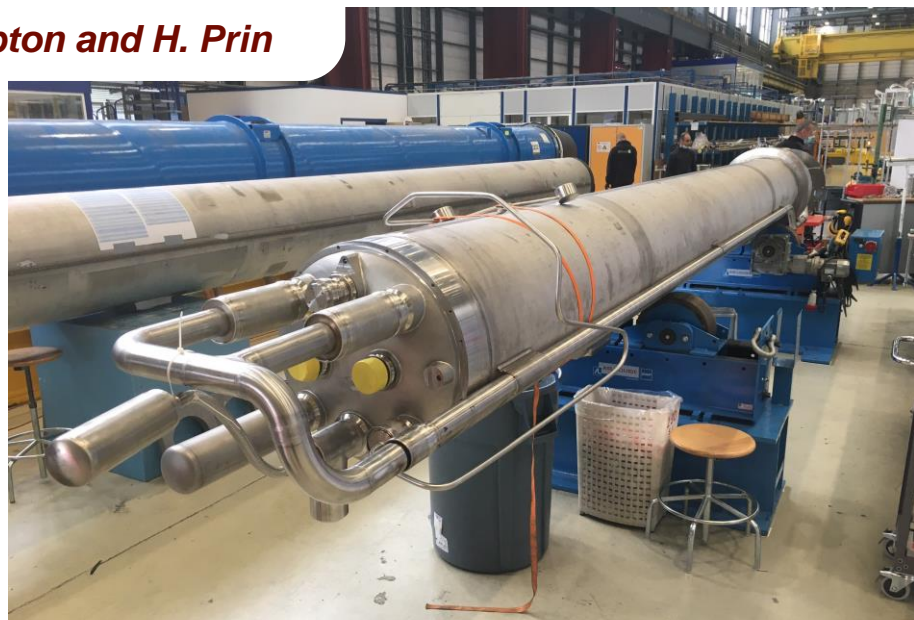
Cold mass of S5 shown in bldg. 180 on 2020-10-01 (left), and on 2020-09-28 (right)
