VNA measurements of the TCSPM05

N. Chitnis, S. Joly, C. Zannini

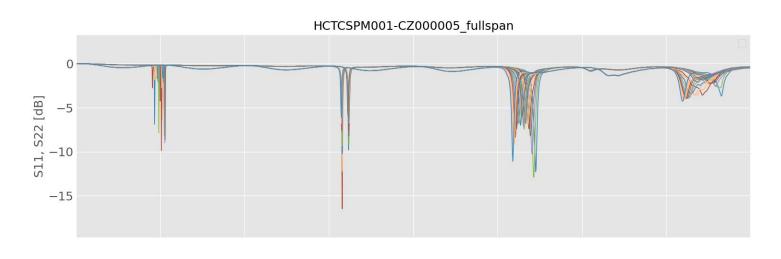
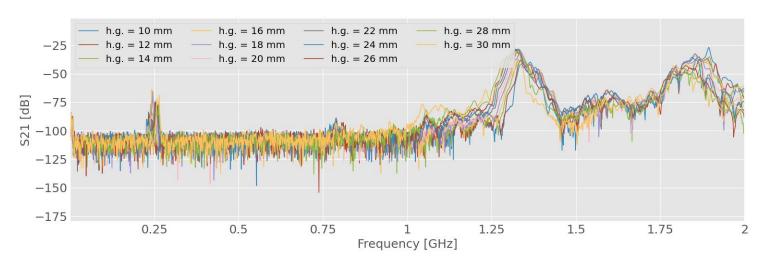
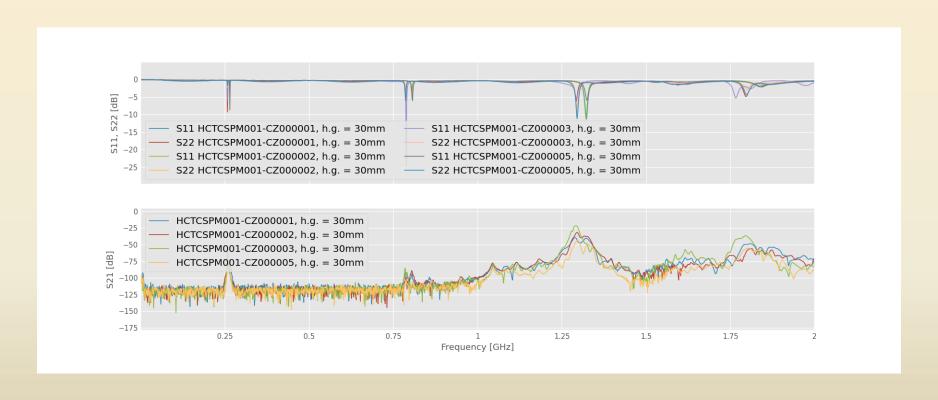
Measurements with on axis electric pickups

Behavior similar to the previous TCSPM. No anomalies in the frequency response with on axis electrical pickups

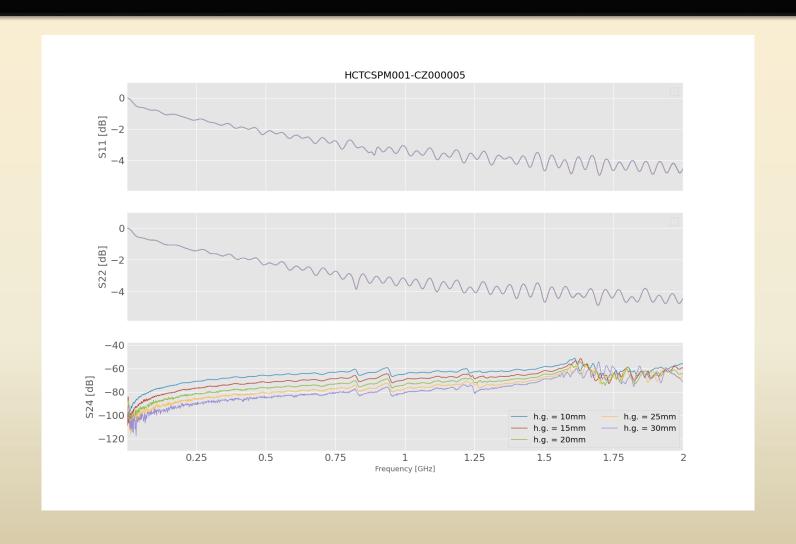
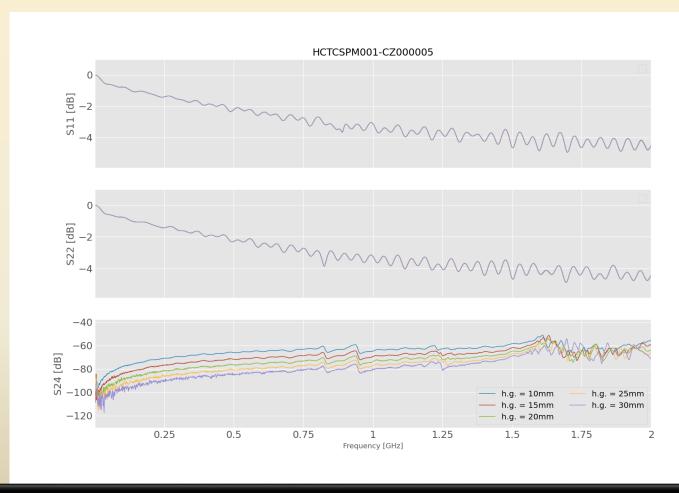
Measurements from the BPM SMA connectors

Behavior similar to the previous TCSPM. No anomalies in the frequency response from the BPM buttons

- Behavior similar to the previous TCSPM. No anomalies in the frequency response from the BPM buttons
 - Collimator impedance is considered to be acceptable

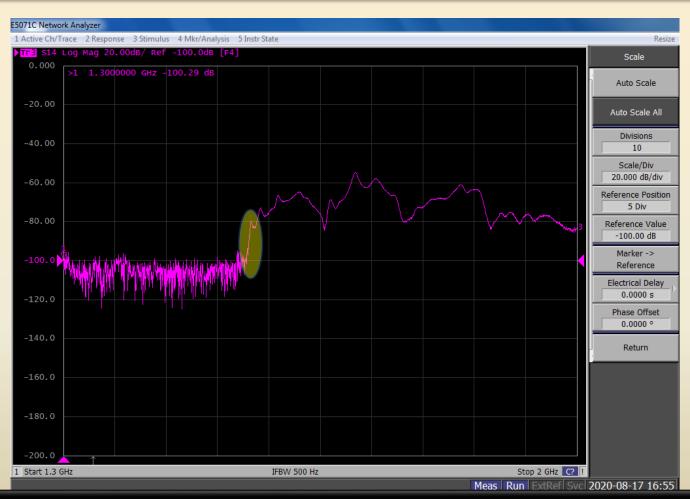
Cut-off measurements for the determination of the material properties

Half-Gap scan: 10, 15, 20, 22, 24, 26, 28, 30

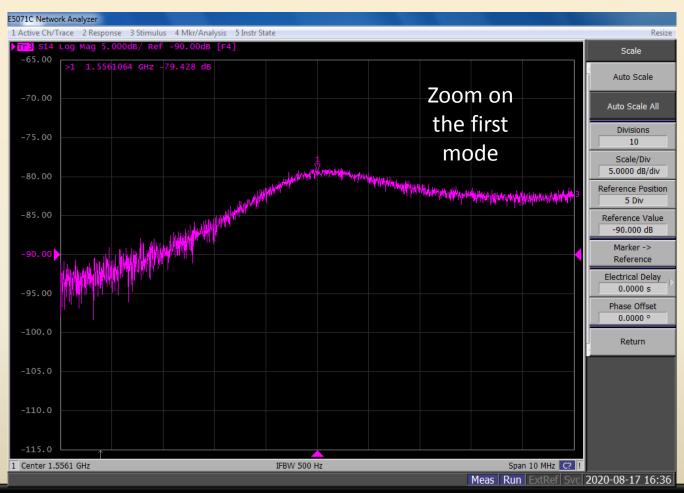
Cut-off measurements for the determination of the material properties

Half-Gap scan: 10, 15, 20, 22, 24, 26, 28, 30
