SMOG 2 WFS Discussion

24-Sept-2020

Motivation

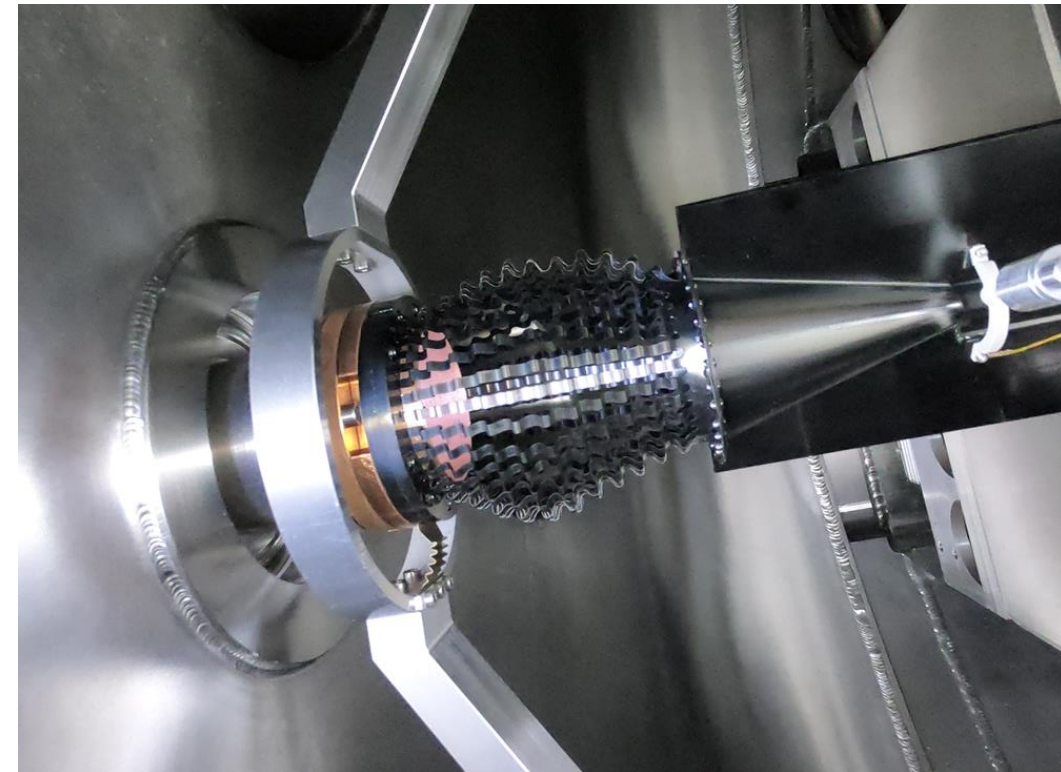
Buckling WFS (picture: P. Di Nezza)

SMOG2 wake field suppressor (WFS) installation is not as expected (fingers buckling and twisting as observed on pictures). We recommend that the nominal situation with a cylindrically shaped WFS is restored to start Run 3 in good conditions.

- If the 2-3 mm longitudinal oversize of the WFS is confirmed, this could be corrected by:
 - reducing of Cu flange would lead to recovery of the WFS length by about 1 mm (can be done without opening of the vessel).
 - “spacing flange” -> compensation flange installed additionally from outside, recovers up to 5-8 mm. Leads to a overcompression of the bellow on the upstream side (see picture).
 - re-doing the entire upstream transition chamber (est. costs ~15kCHF).
- Can the WFS status be checked while installed?
 - Endoscopy will be possible from the upstream side only before run and means venting the Velo (Josef).
- Could additional tests be done on a WFS outside the machine?
- Would an inspection of the WFS be possible by using the existing view ports, e.g. during TS. To be used for regular monitoring, if needed. View port needs to be modified to allow this method.

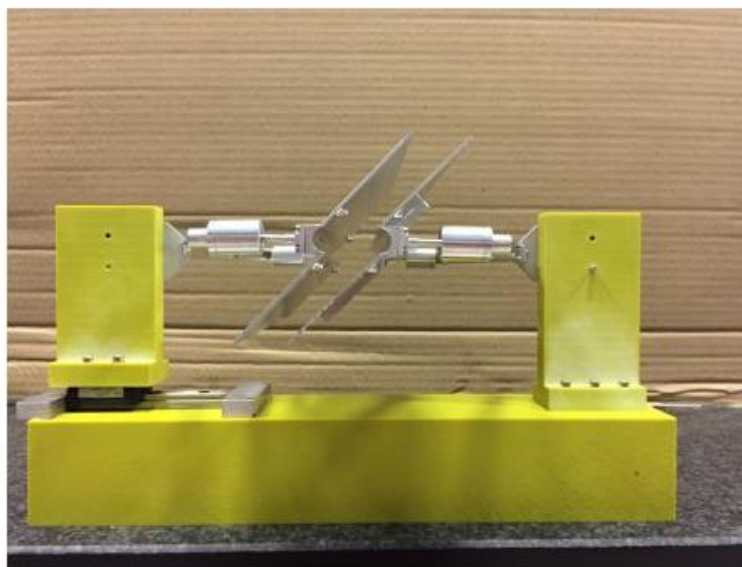
open

Closing mechanism of Smog 2 cell without WFS

One half of the cell (right) is fixed and used as reference, the other has limited 3D degrees of freedom in order to find always the nominal closed position

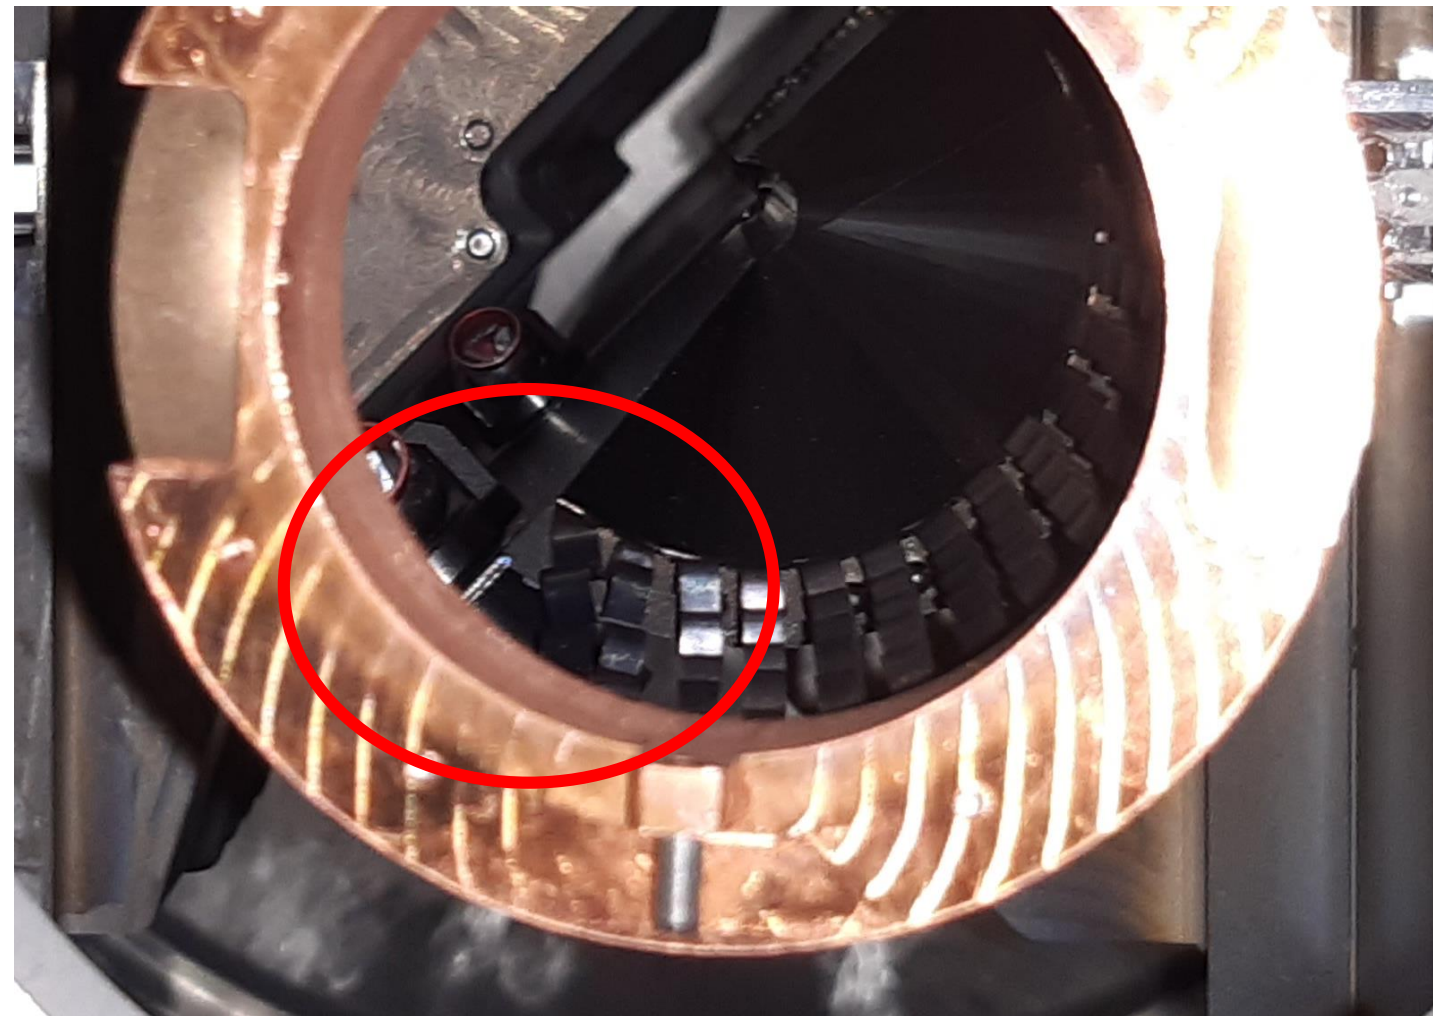
Pic 122052

WFS – additional pictures (1/2)

- What is the chance that the WFS keeps its shape and survives all movements during LHC run?
 - mechanical movement during each fill.
 - if fingers are ripped off, could they bend into the aperture?
- Is there a risk to LHCb or LHC run if the Smog 2 WFS fail?
 - Awareness of the problem to be given to LHCb (**inform Rolf or Massimiliano**).
- Was the twisting angle of the fingers observed during test installation already and has this been taken into account?
 - there was no full prototype which would have allowed us to identify these problems beforehand
 - but the cycling tests already included the sideways movement of the Smog 2 cell.
- It would be worth to see the calculated stress concentration in the WFS fingers. This in particular since no visual monitoring of the installation is possible, as far as we understand.
- The estimated longitudinal oversize of the WFS is about 2-3 mm.

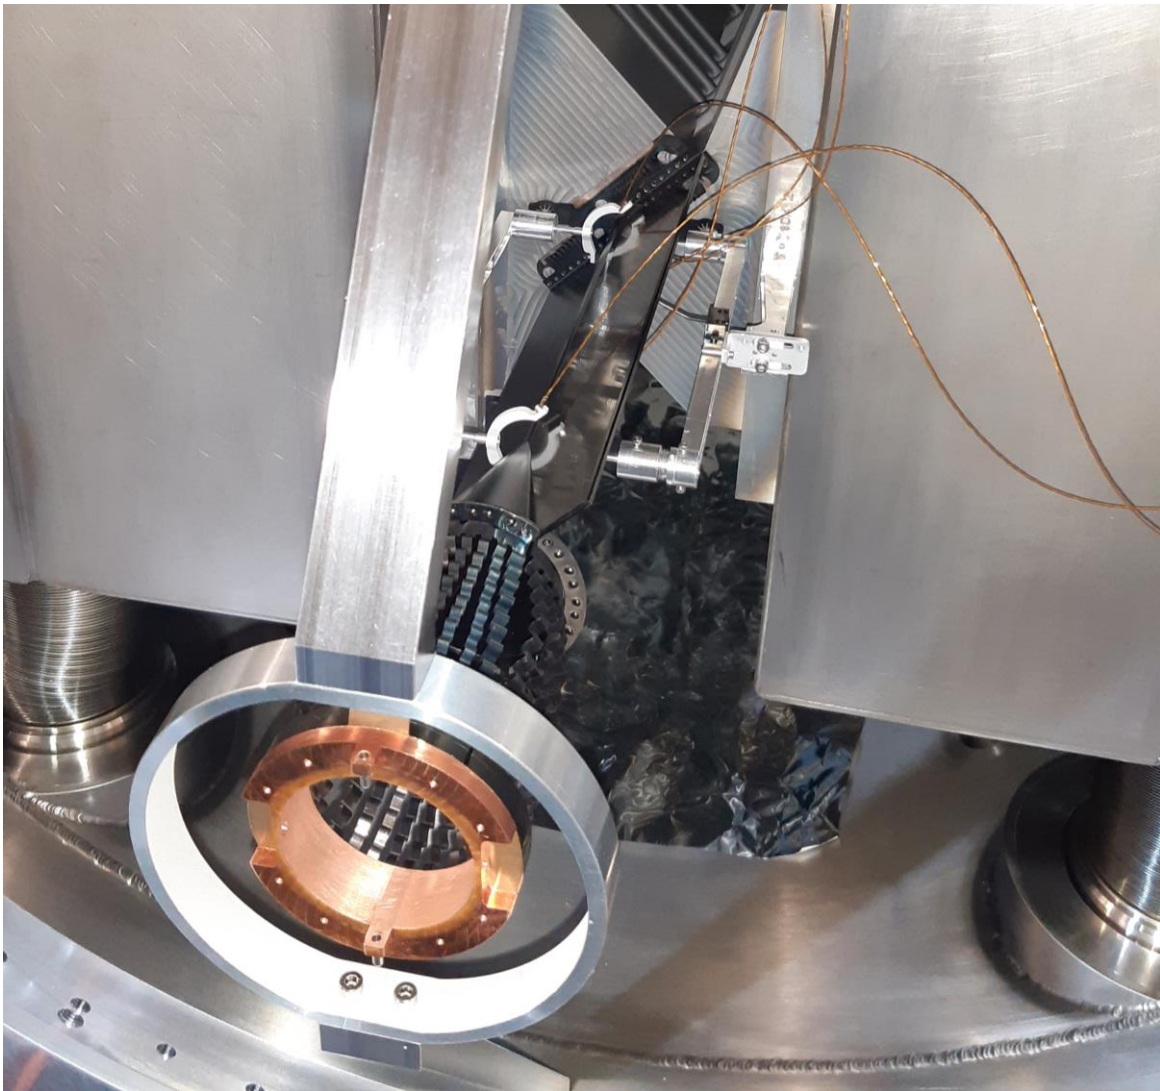
Pic 095924

WFS – additional pictures (2/2)

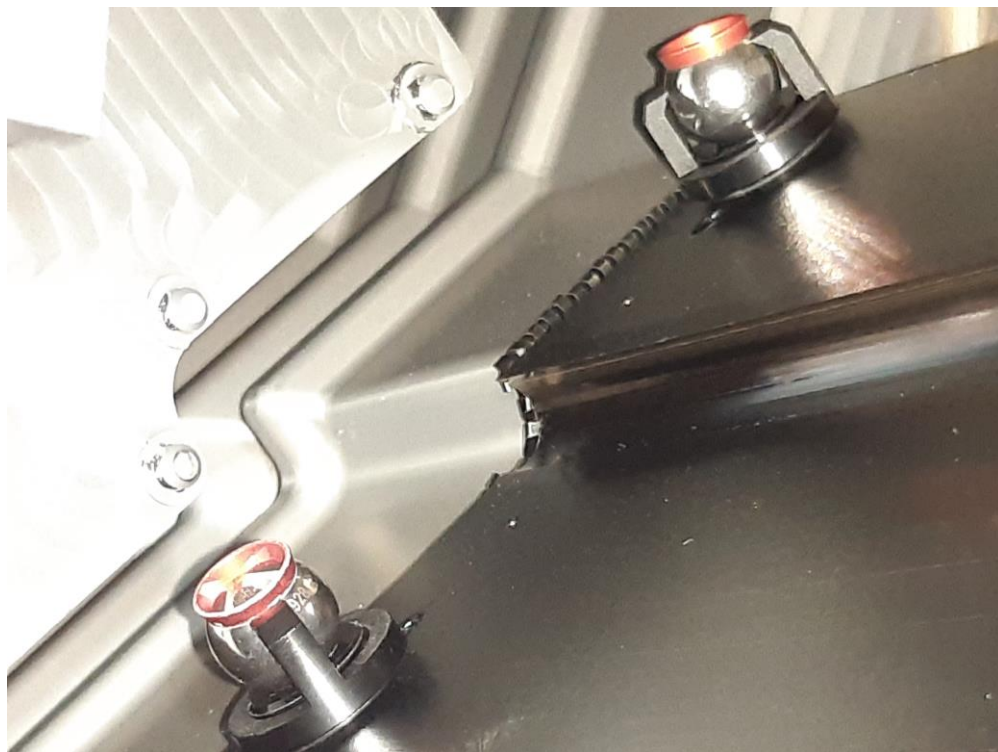
Pic 103527

Other RF fingers

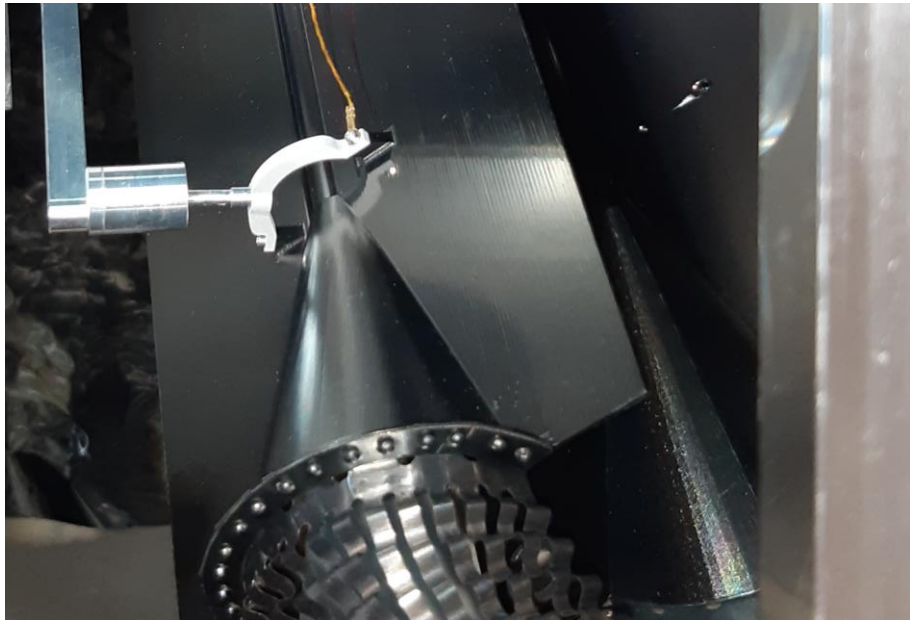
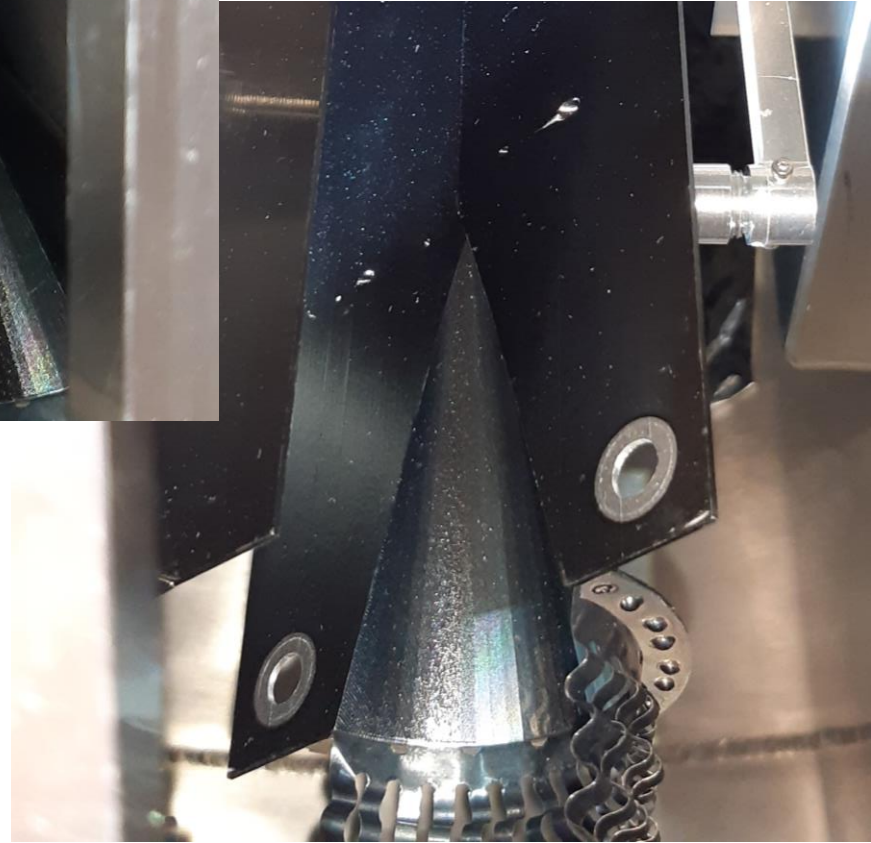
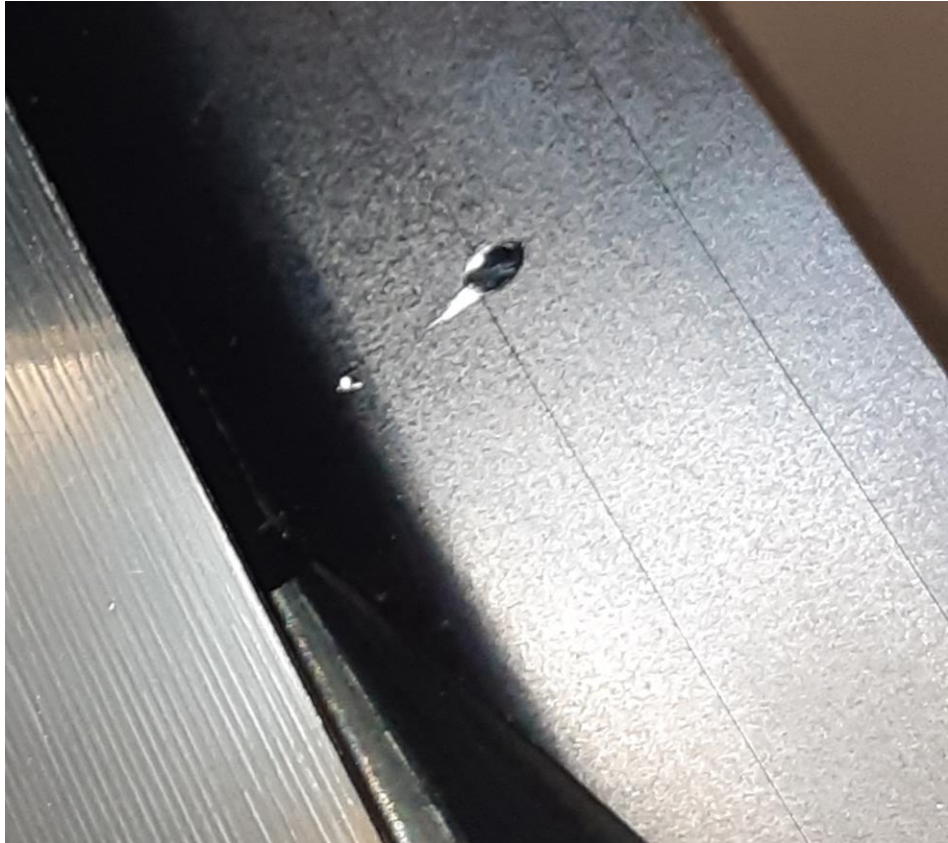
Pics 164955, 165008, 165035

Other concerns: Scratches on the Smog 2 surface
