Test-beam results of CLICpix2 planar sensor assemblies

Morag Williams

CLIC Detector and Physics Collaboration Meeting

01 / 10 / 2020

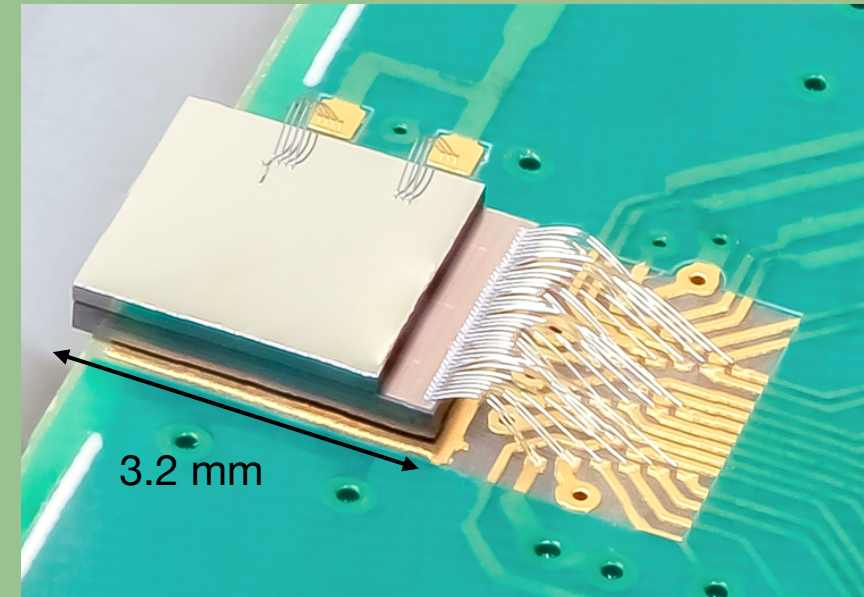
CLICpix2 readout ASIC bump-bonded to a planar silicon sensor

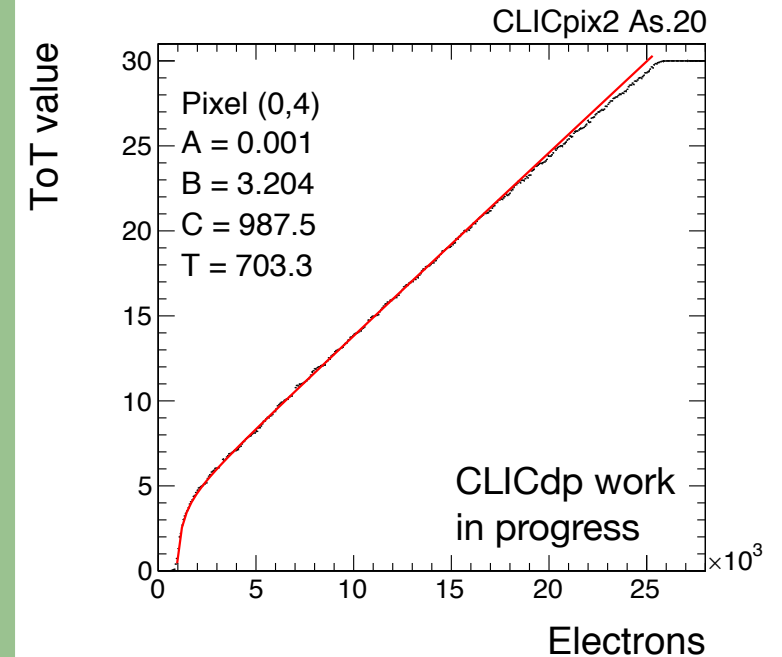
- Per-pixel Time-over-Threshold units calibration into electrons using test-pulse injection measurements.
- Each ToT calibration curve parameterised with surrogate function fit.

$$\text{surrogate function} \\ = Ax + B - \frac{C}{x - T}$$

*ToT calibration curve of pixel 0,4
of CLICpix2 planar assembly 20.*

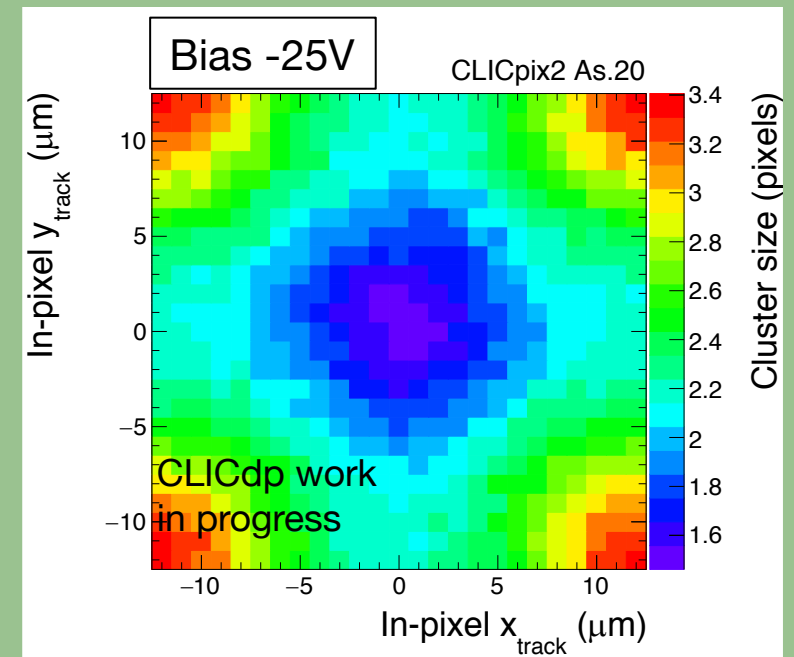
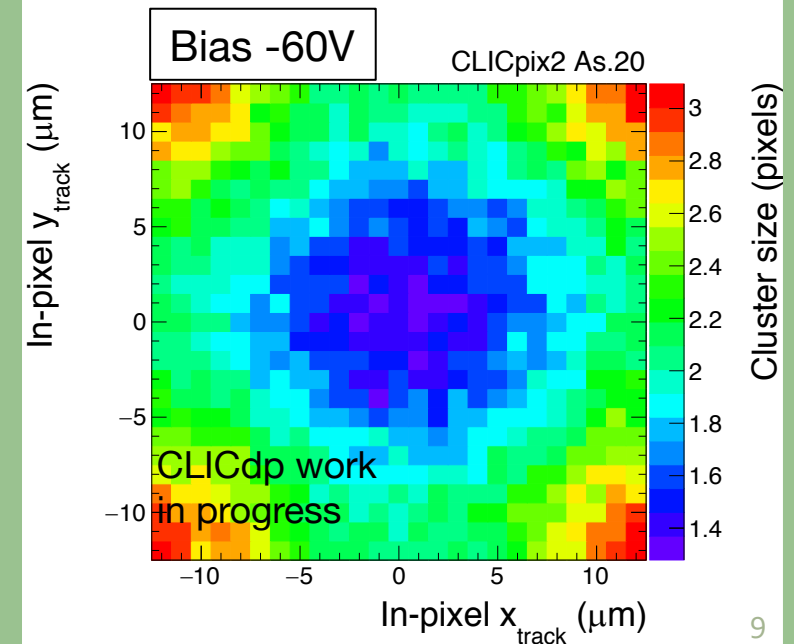
- Threshold (893 +/- 9) electrons
 - lowest noise-less operating threshold
- Applied bias voltage of -25V
 - found to be the optimal bias voltage for charge sharing

Top: In-pixel associated cluster charge, applied bias voltage of -25V.

Bottom: In-pixel associated cluster charge, applied bias voltage of -60V.

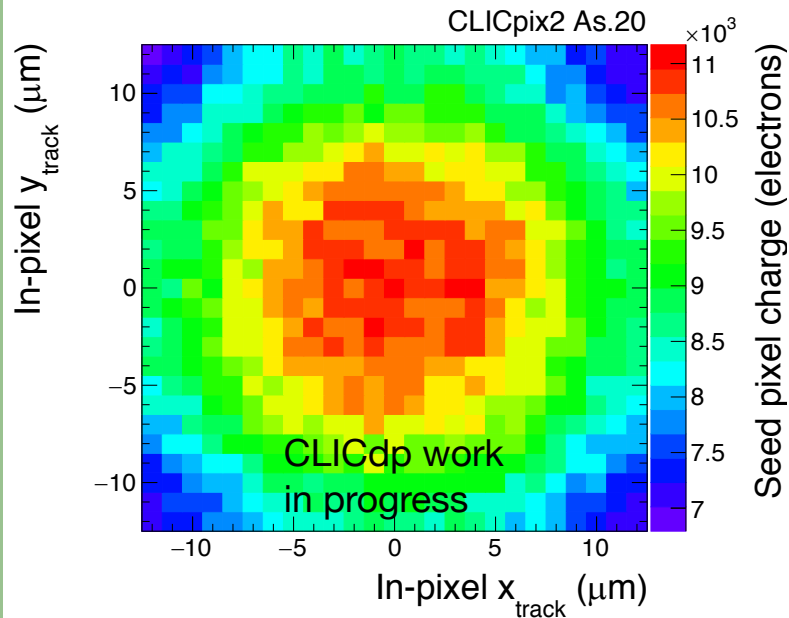
In-pixel charge of associated cluster seed pixel.

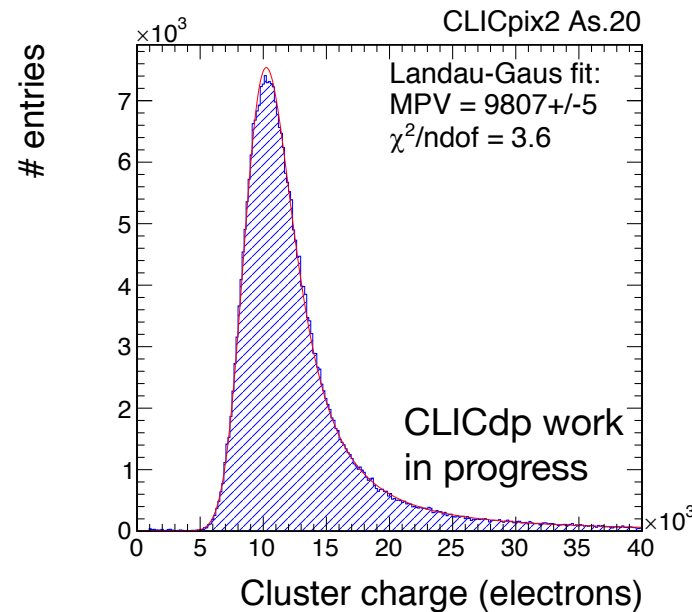
Associated cluster charge, with a Landau-Gaus fit function.

Cluster charge MPV occurs at 9807 electrons.

→ Measured value is within 2% of theoretical value.

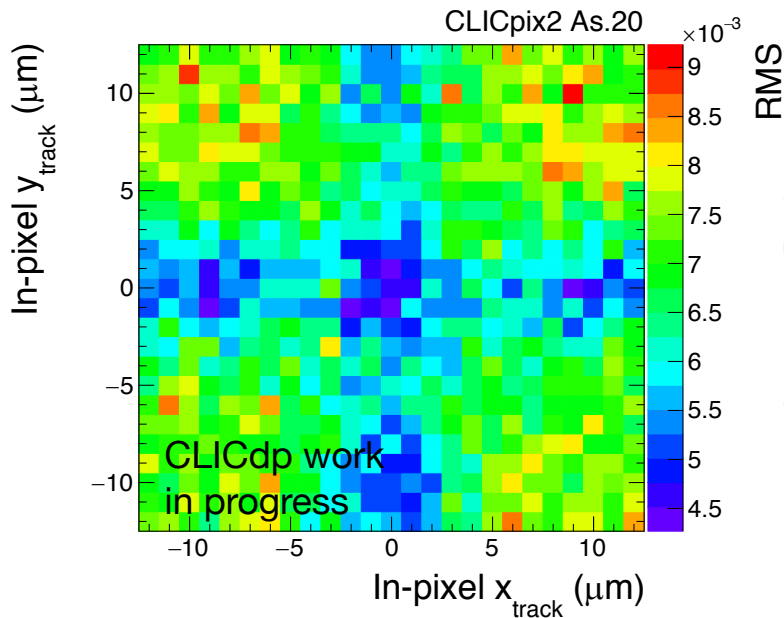
In-pixel combined resolution.

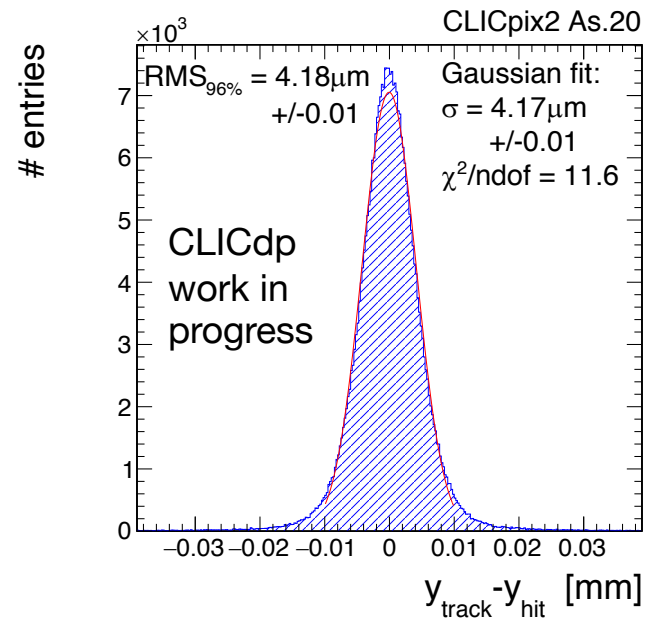
Spatial residual along the Y axis, with a Gaussian fit function.

Note: high χ^2 due to non-Gaussian tails from δ -electrons

Spatial residual width is $4.17\mu\text{m}$

$$\sigma_{\text{intrinsic}} = 3.2\mu\text{m}$$

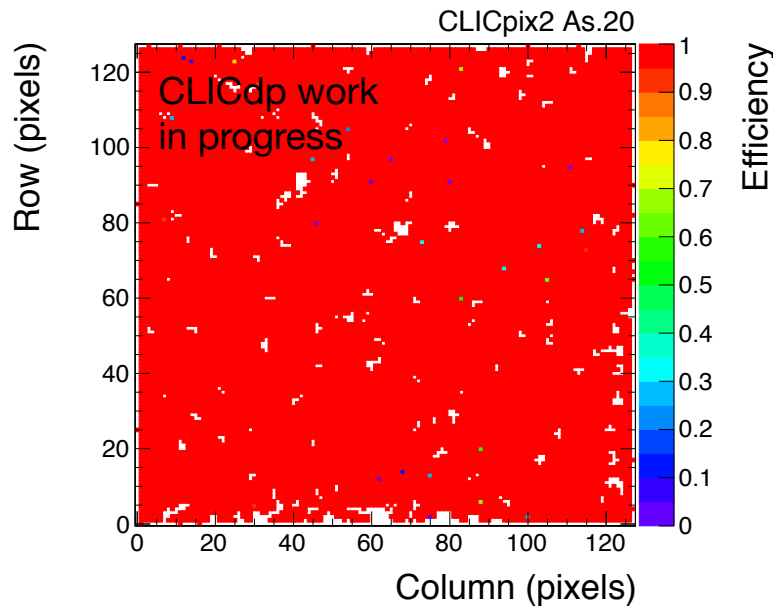
2D efficiency map

Total efficiency at nominal conditions of $(99.96 \pm 0.01 - 0.00)\%$

Note: efficiency value does not take masked or unresponsive pixels into account, which show as white areas on the pixel matrix

See efficiency across the matrix is even with random outliers

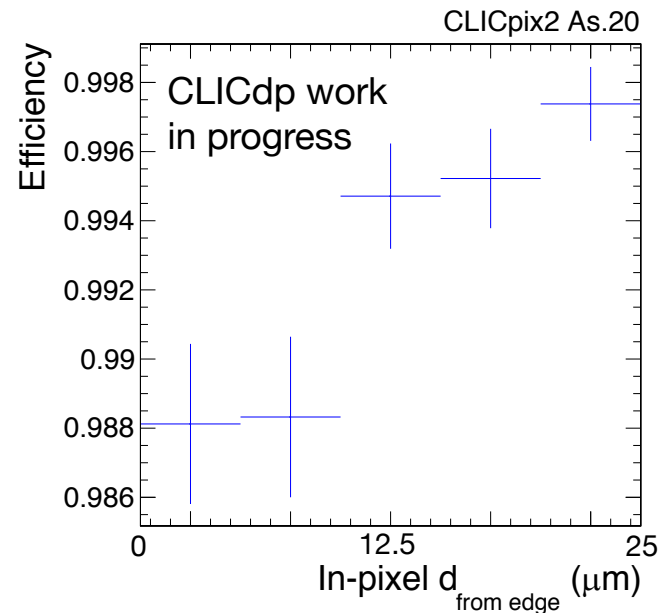
Efficiency as a function of distance from the edge

Right: histogram of efficiency as a function of distance from the matrix edge, spanning one pixel pitch.

Can see slight decrease in efficiency towards the matrix edge, but still at a high overall value.

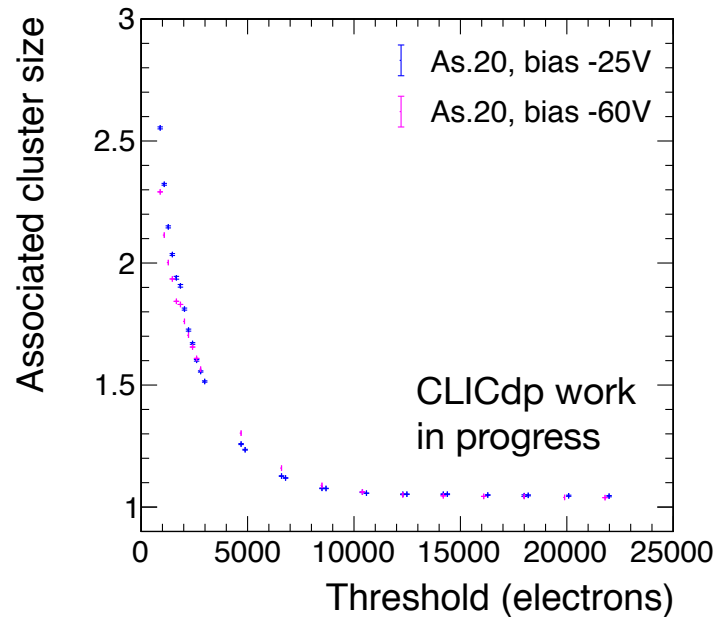
Associated cluster size as a function of threshold

Cluster size greatly reduces with threshold: approximately only have single pixel clusters after ~8.5ke

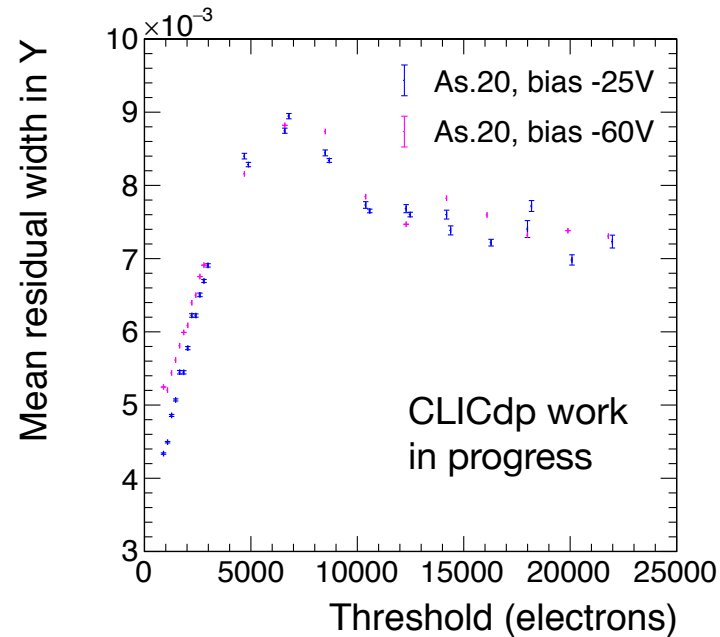
Mean residual width in Y as a function of threshold

Can see the effect in residual width. For threshold $< \sim 7\text{ke}$: increase in residual width as charge sharing reduces

For threshold $> \sim 7\text{ke}$: decrease in hit detection efficiency at pixel borders causes reduction in width.

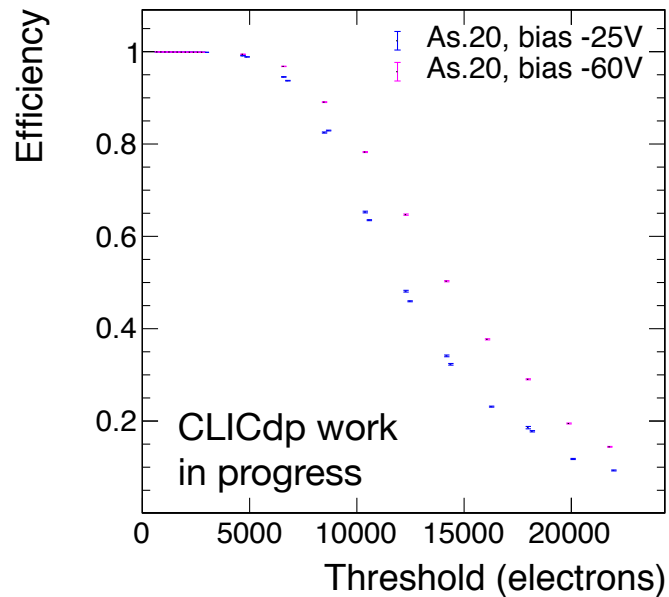
Efficiency as a function of threshold

Efficiency decreases faster for a bias voltage of -25V as there is more charge sharing at this bias.

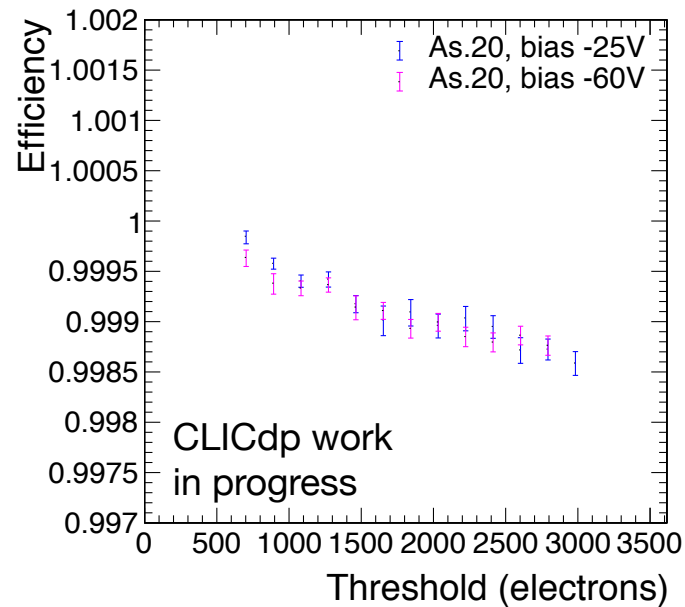
Efficiency as a function of threshold, zoomed into the low threshold region

High-efficiency plateau (>99.7%) at thresholds up to ~5ke.

→ large operational margin with high efficiency

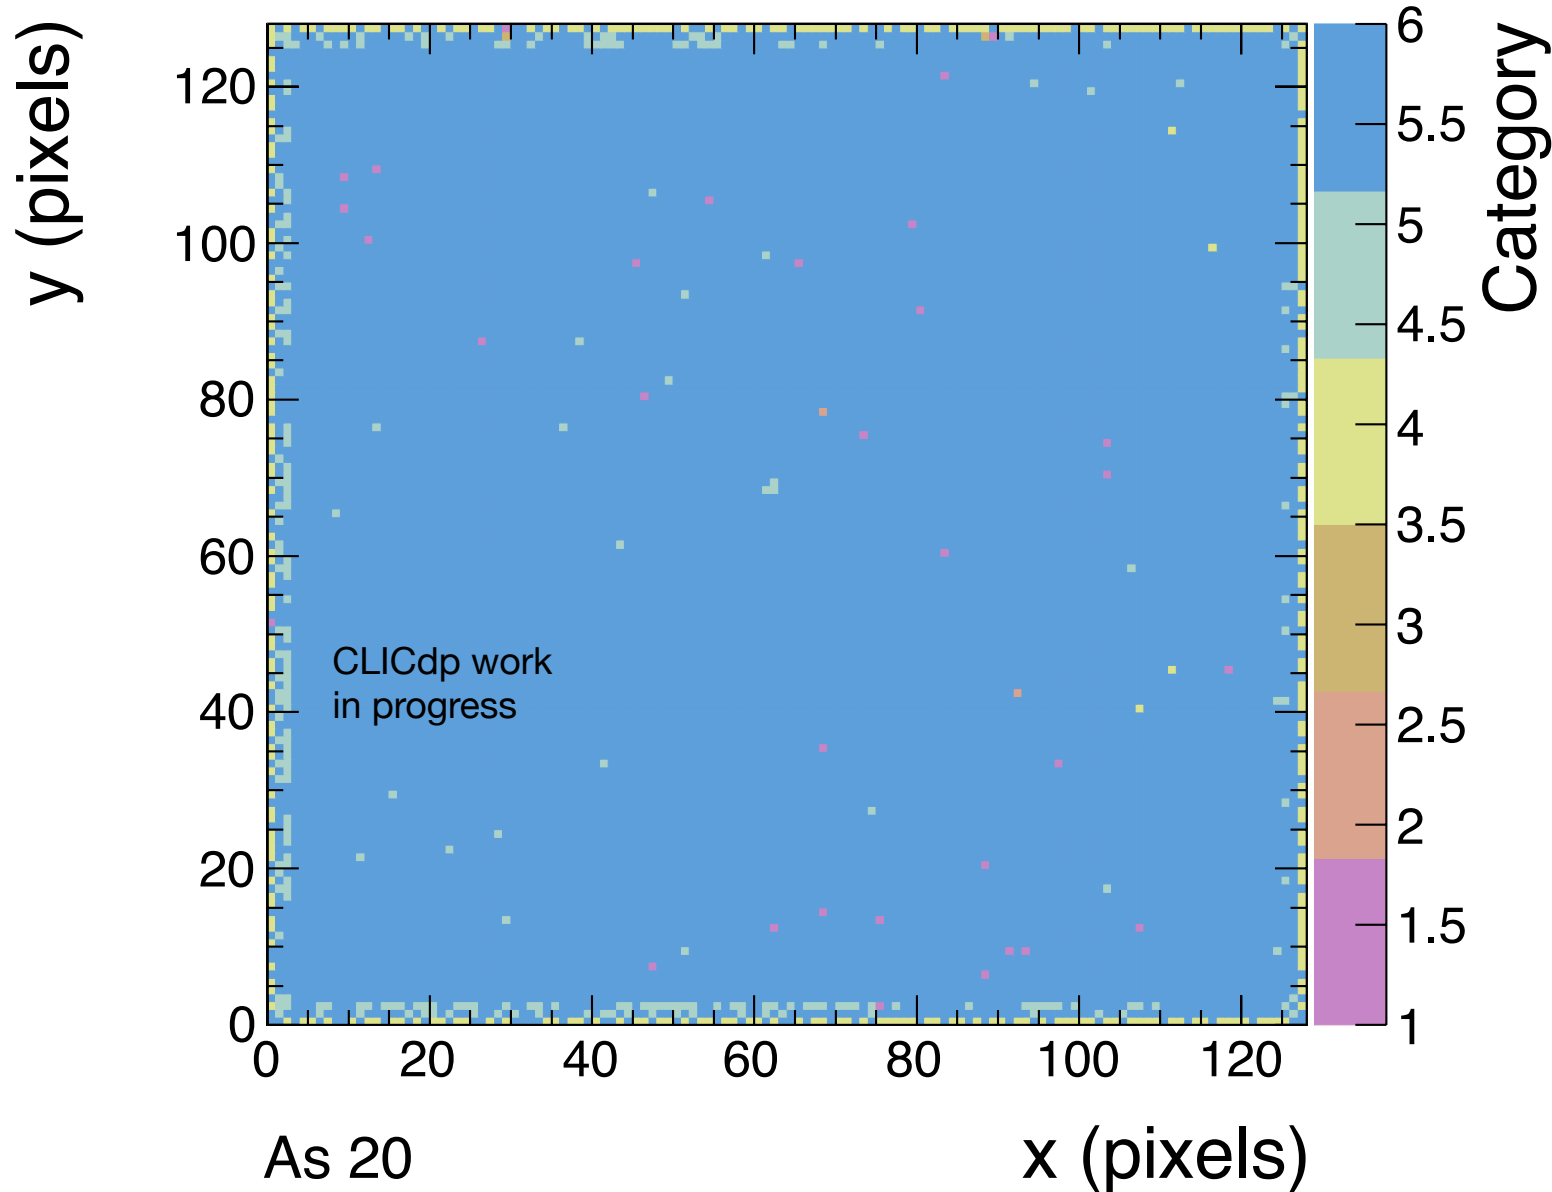
Pixel categorisation map
for assembly 20
(130um sensor, same as on slide 4)

1. Pixels masked due to noise
2. Unresponsive to test pulsing
3. Shorted pixels
4. Bonding/sensor issue
5. High rate pixels
6. Expected response

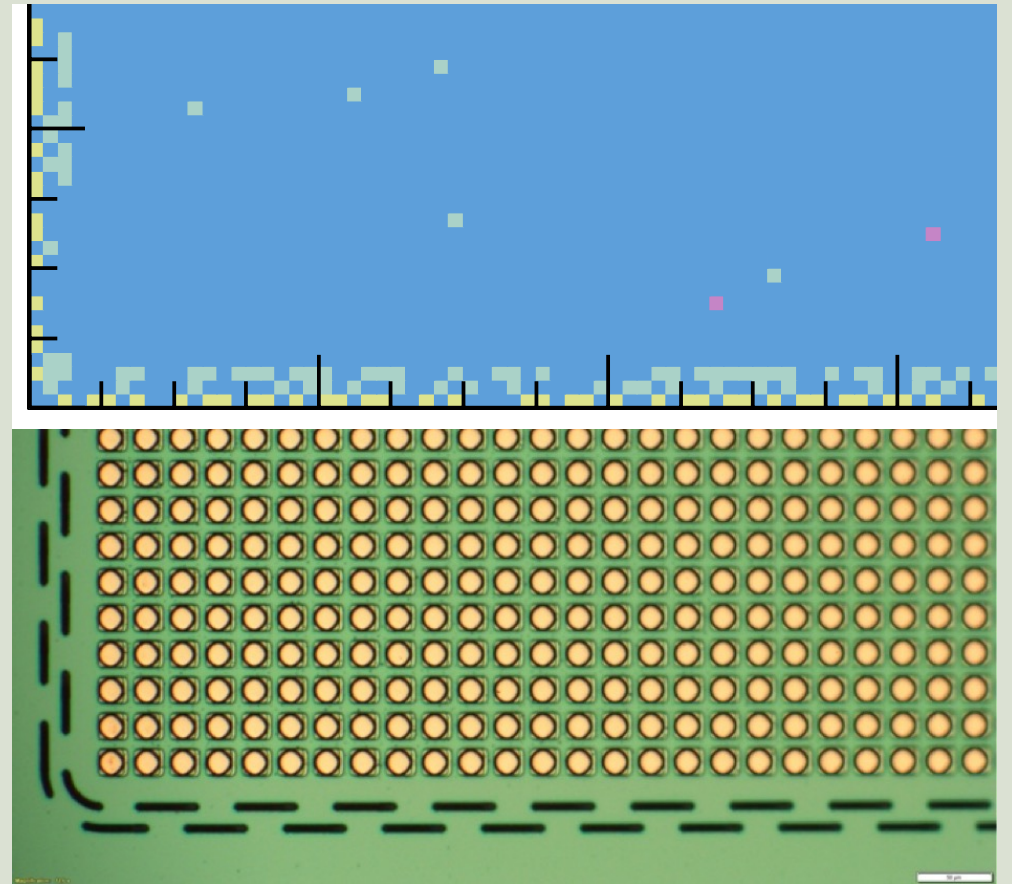
Top: Pixel categorisation results of CLICpix2 assembly 20, zoomed.

Bottom: Cropped image of staggered active-edge design of sensors from FBK.

- Up to 99.6 % interconnect yield achieved
- FBK active-edge sensors found to be of high quality
- Effect on edge pixels of staggered active-edge sensor design discovered
- Also able to identify smaller process issues, such as Z-misalignment of a sensor.
- 2/9 assemblies of very high quality

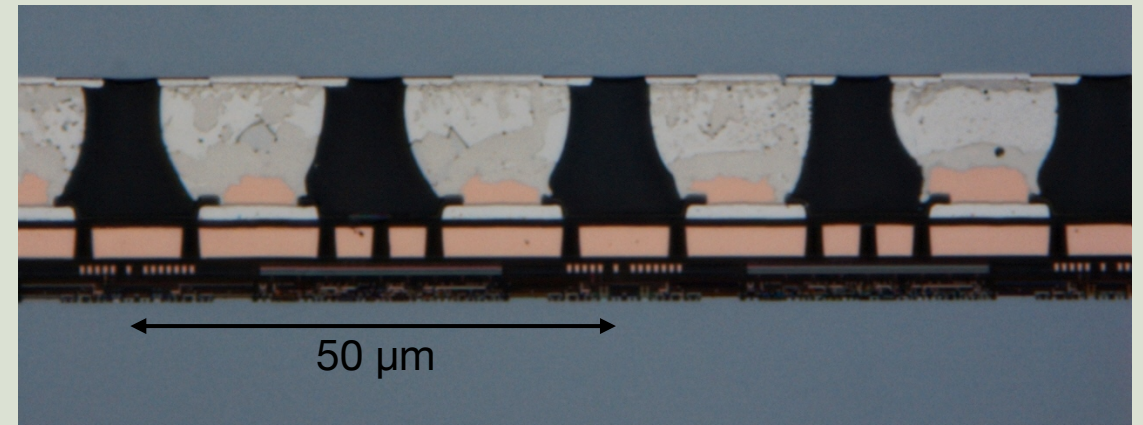
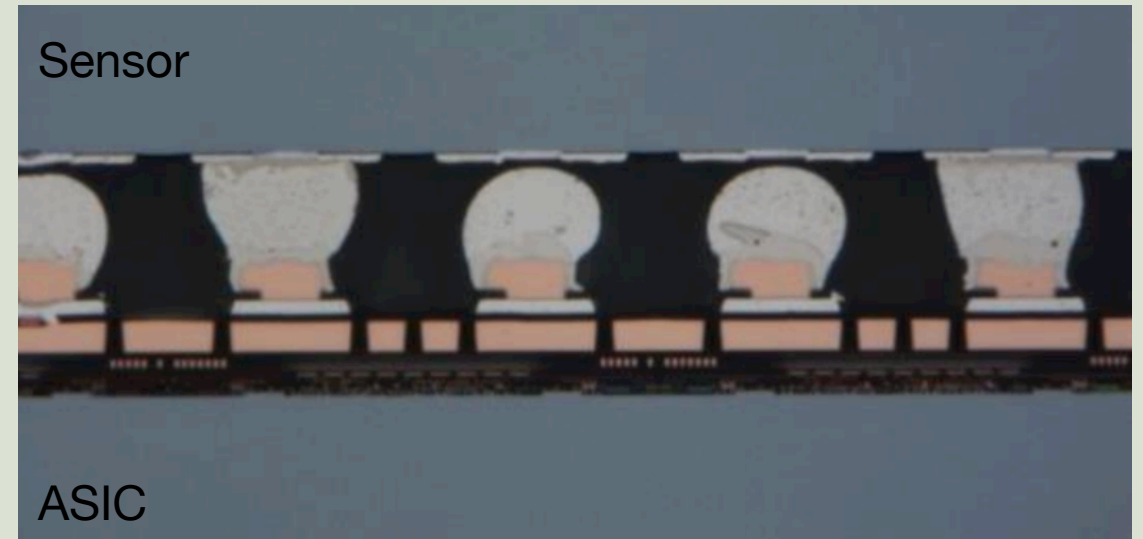
Discovered incompatibility between the thin-film Ni/Au UBM of the ADVACAM sensors and the IZM bump-bonding process.

Cross-section of bump bonds by IZM of CLICpix2 assembly 9

*Top: well connected region with pillar-like bumps
Bottom: poorly connected region with spherical bumps*

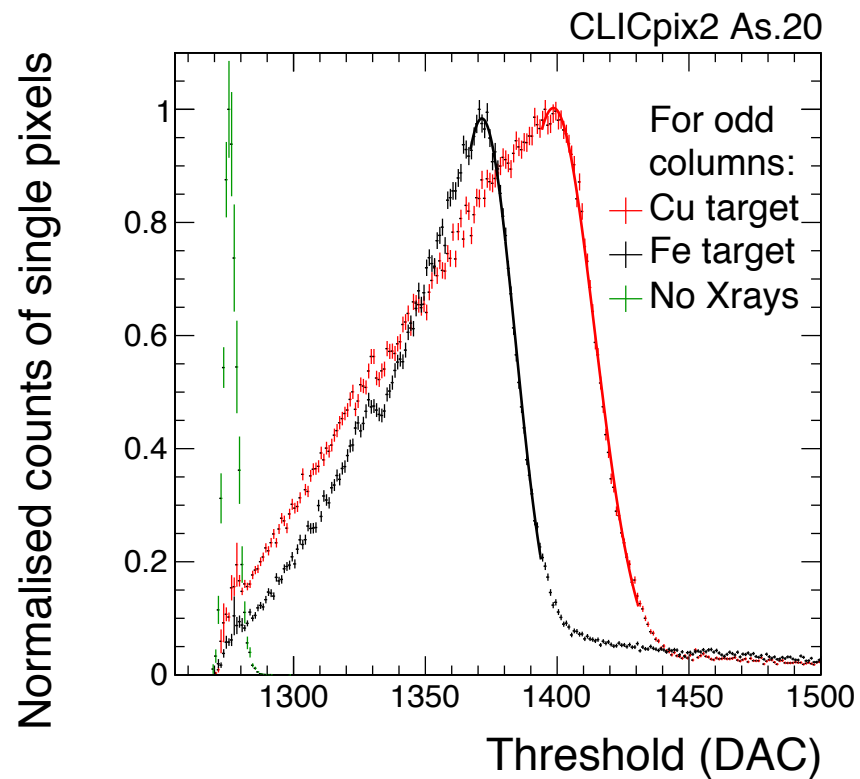
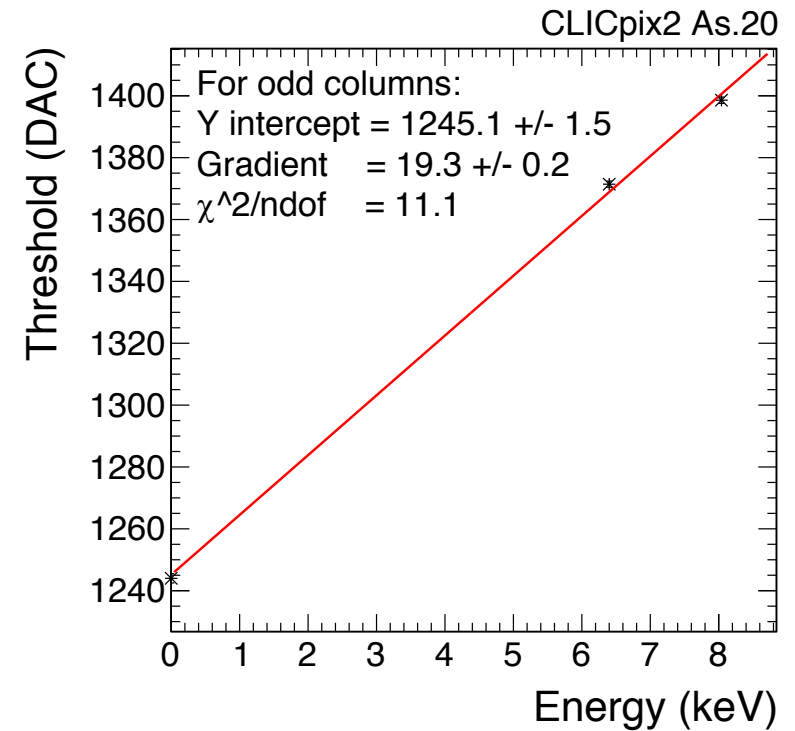
Threshold calibration

- Threshold DAC-to-electrons calibration carried out using X-ray fluorescence measurements.
- ASIC's mirrored column design causes differences in parasitic capacitance of odd and even columns, ∴ separate value.

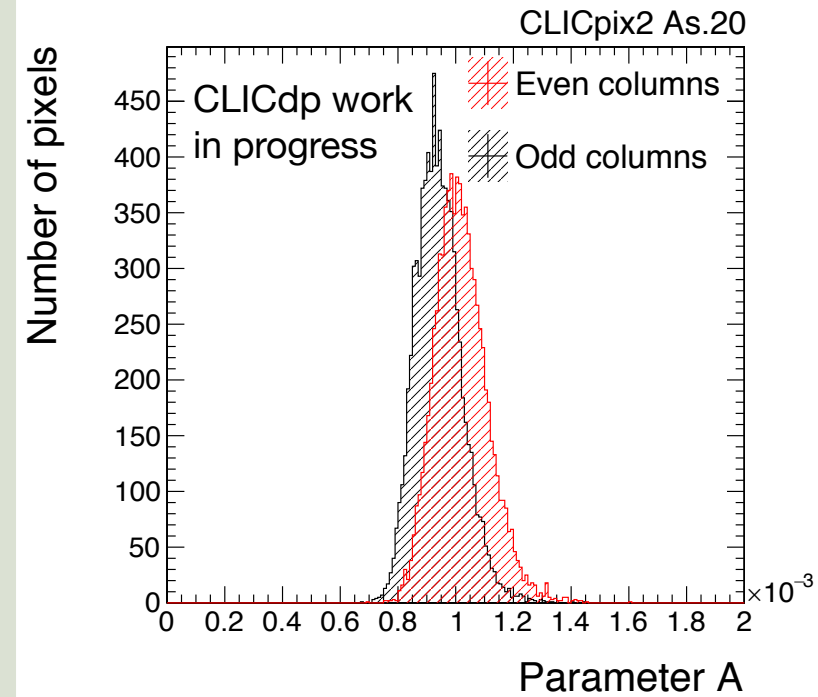
Discovered a small difference in gain between odd and even columns due to mirrored column design of the CLICpix2 ASIC.

Top: Difference in A parameter of surrogate function fit for odd and even columns.

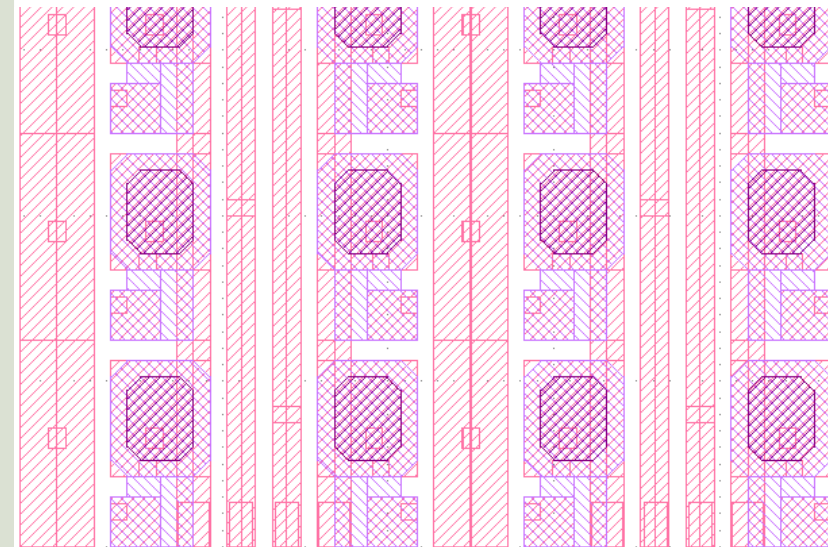
Bottom: top-metal layer design showing mirrored column design.

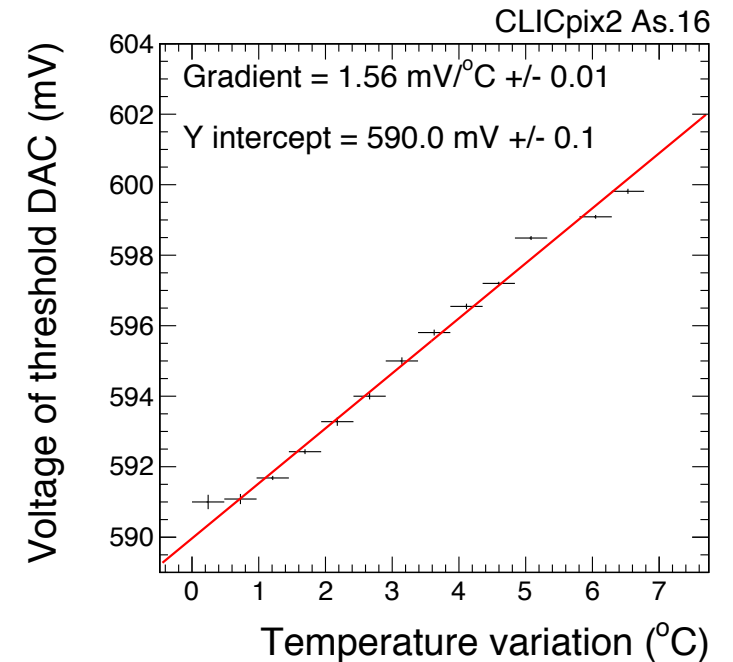
CLICpix2 temperature dependence

- Discovered that a resistor within the voltage DACs of the CLICpix2 ASIC had a low temperature coefficient that did not match those of the other resistors in the circuit.
- This causes the output of all voltage DACs to fluctuate with temperature.

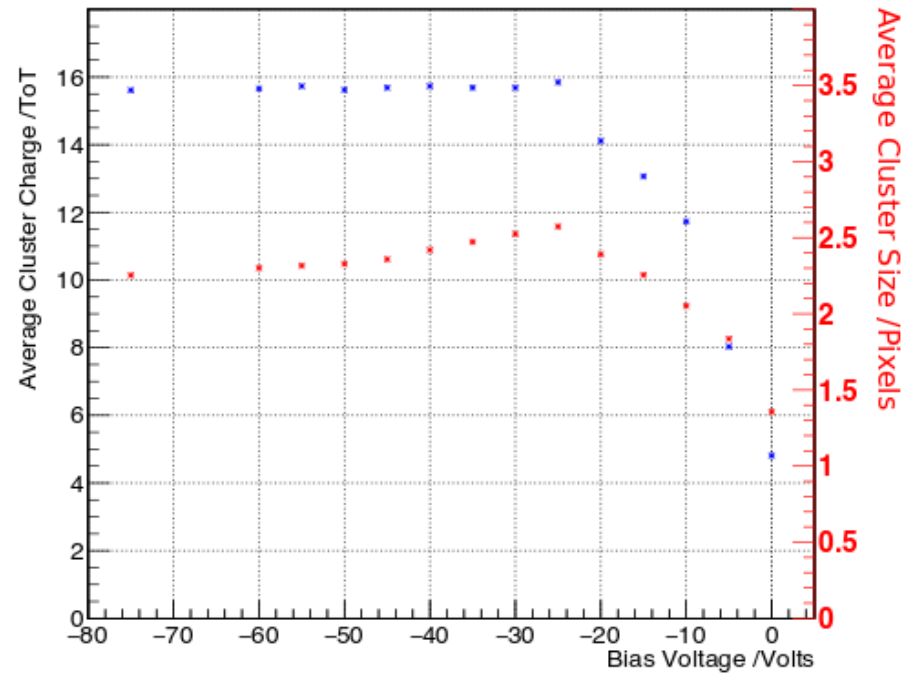
Graph of average cluster size and average cluster charge as a function of applied bias voltage

- Calculated depletion voltage = -24V

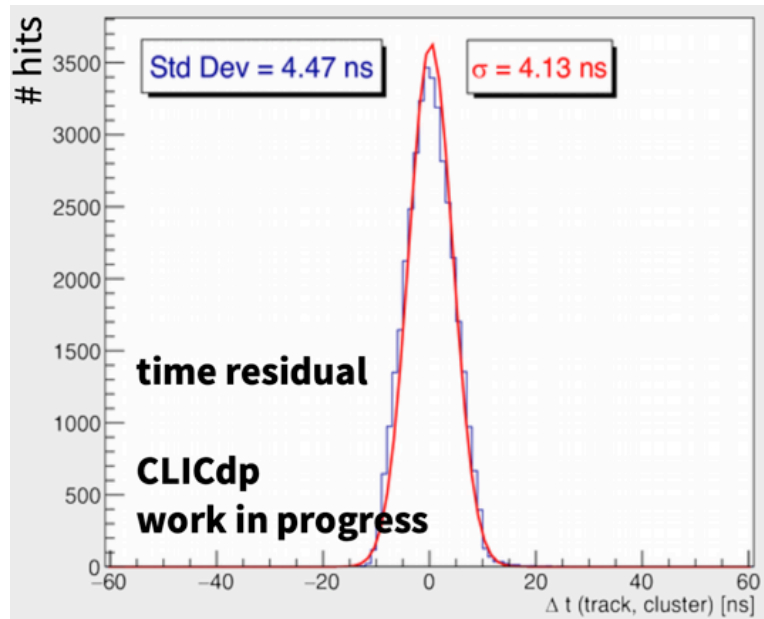
After time-walk correction, timing resolution around 4ns. Further studies envisaged to look at the effect of bias voltage and threshold on the timing residuals obtained.

Timing residual of CLICpix2 planar assembly 16 (Magdalena Munker).

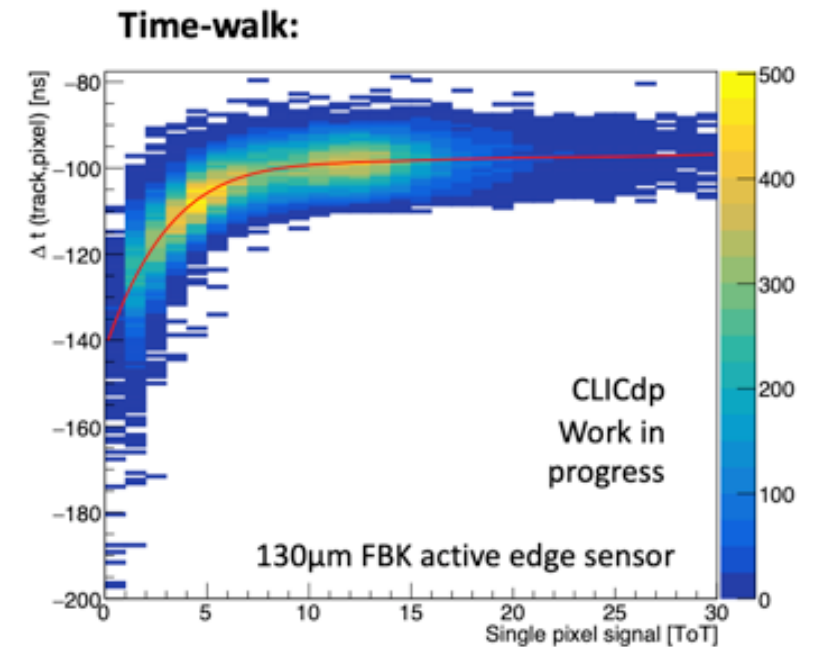
Time-walk correction applied to CLICpix2 planar assembly 16 (Magdalena Munker). 30
