Low-Z anode wires testing for particle accelerator electrostatic septa

B. Balhan, [J. Borburgh](#), L. Jorat, A. Prost

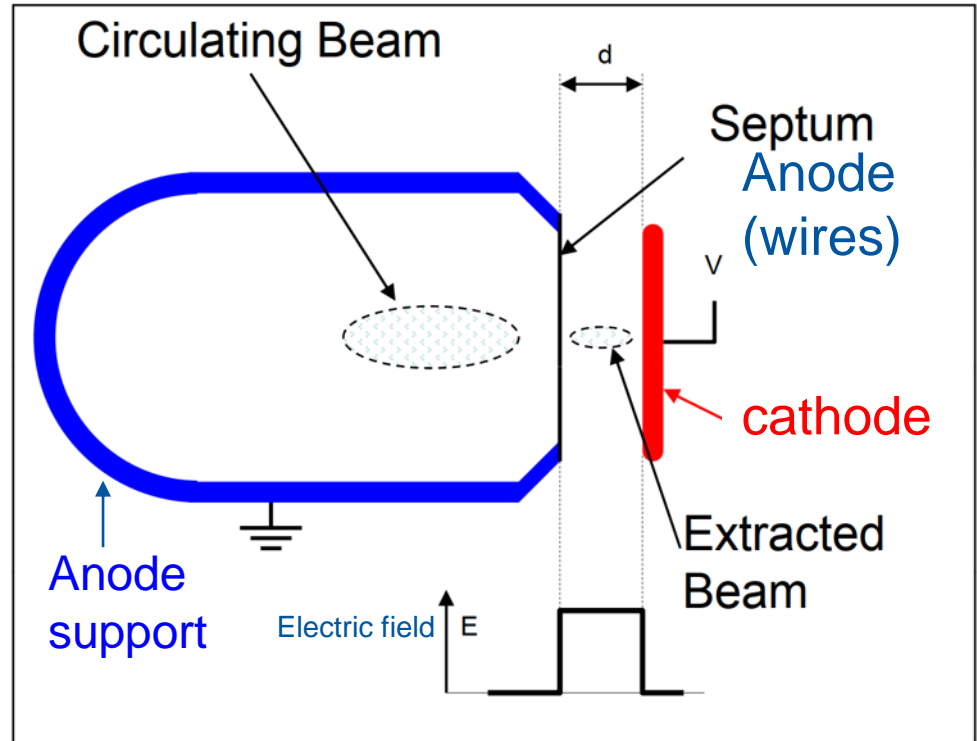
A laboratory test set-up was built, allowing the high voltage (HV) testing of anodes using wires made of different materials.

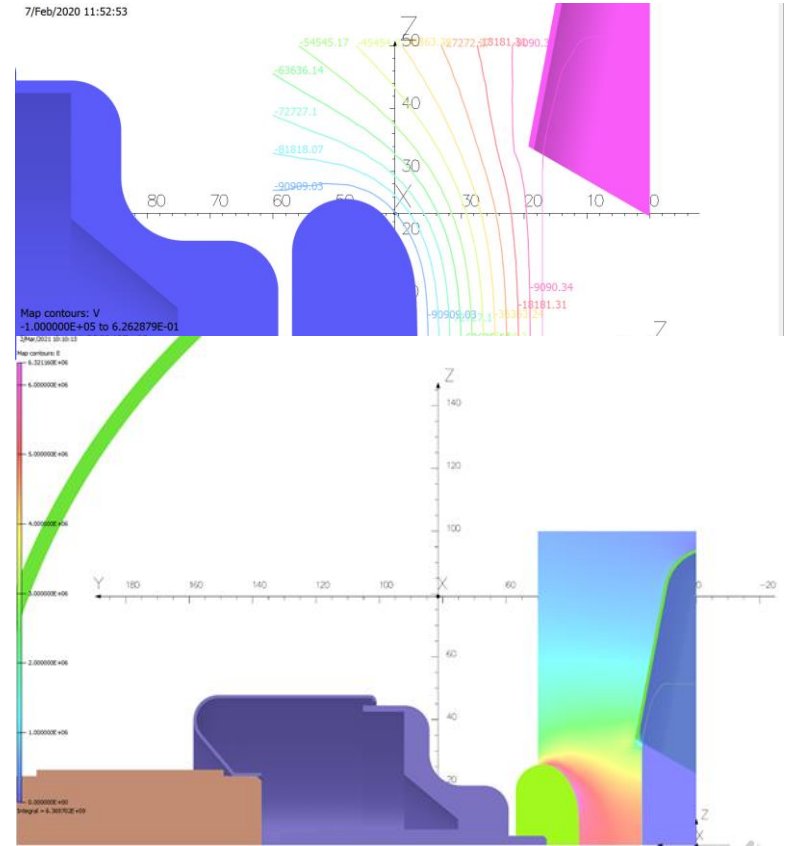
Cathode design

Cathode (60 x 80 mm) was designed to limit field amplification when placed opposite the existing anode. Several cathodes with the same profile were made, using stainless steel (304L) and titanium (grade 2).
