# Successes & Failures in Design Solutions During the 30 Year Life of ITER (and how we could have improved)

**Author:** N. Mitchell with contributions from IO, DA and industrial colleagues

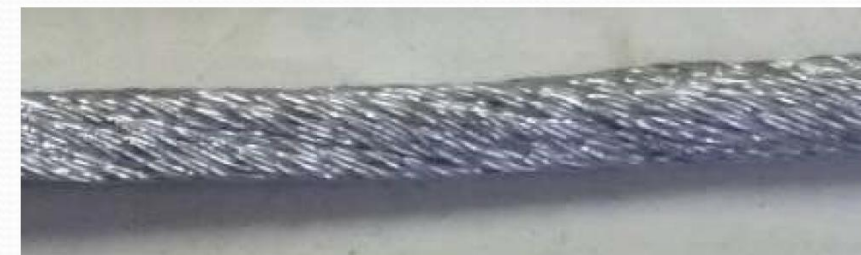
CS conductor (short twist pitch)

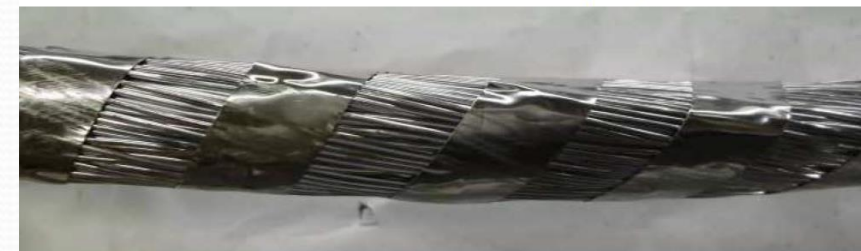
TF conductor (pseudo long twist pitch)

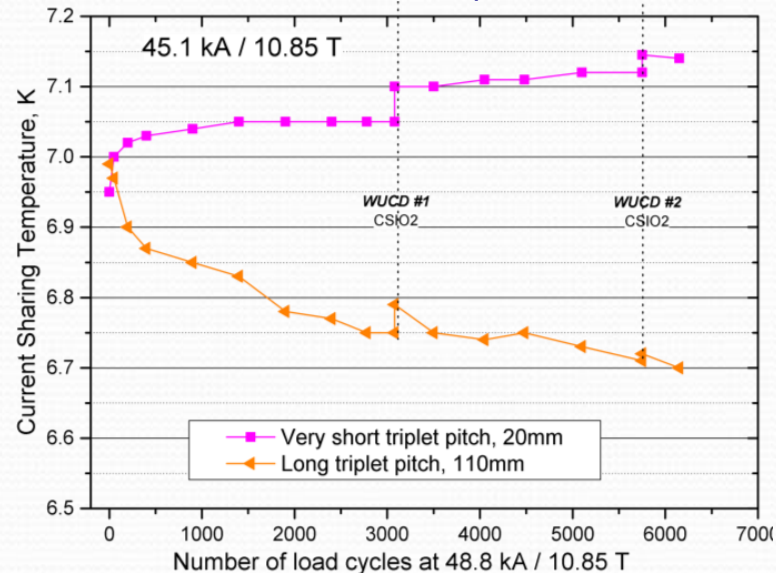
Conductor production ran well...but we discovered that there were undiscovered issues with the cables which we thought we had fixed in 2011

Stand twist pitch has strong impact on mechanical support in the cable. Long twist pitch allows extensive filament fracture to develop

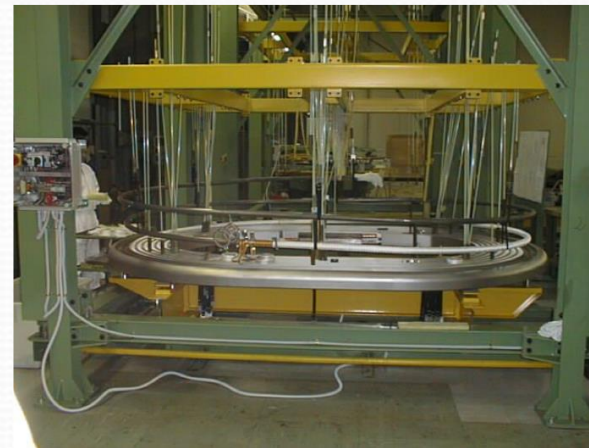
*Final selection of W&R&I from 1995*

Demonstrated on TF MC 1998

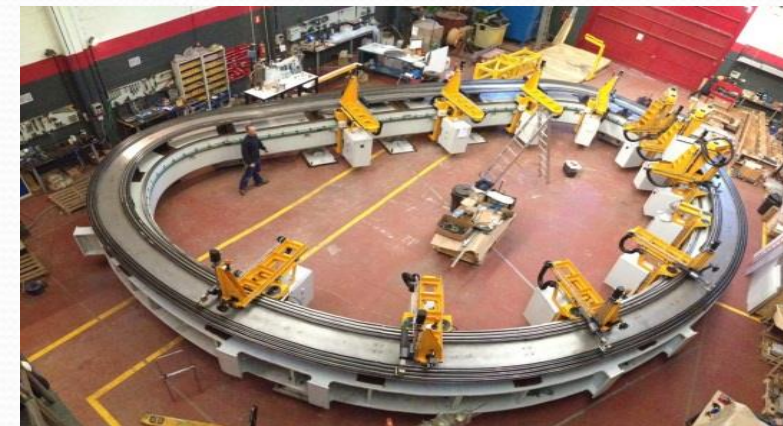
Implemented in ITER 2012=>  
Top: CS, Below: TF

Requires controlled handling of (delicate) Nb<sub>3</sub>Sn reacted conductor

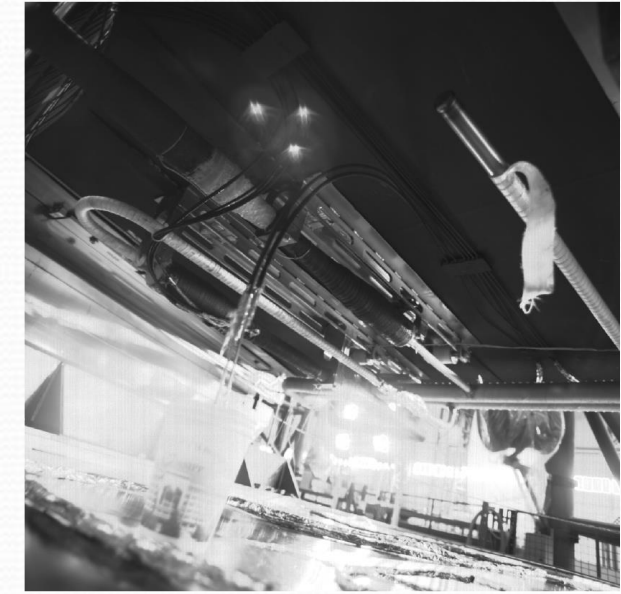
Paschen Test on PF6: HV wire exit failure

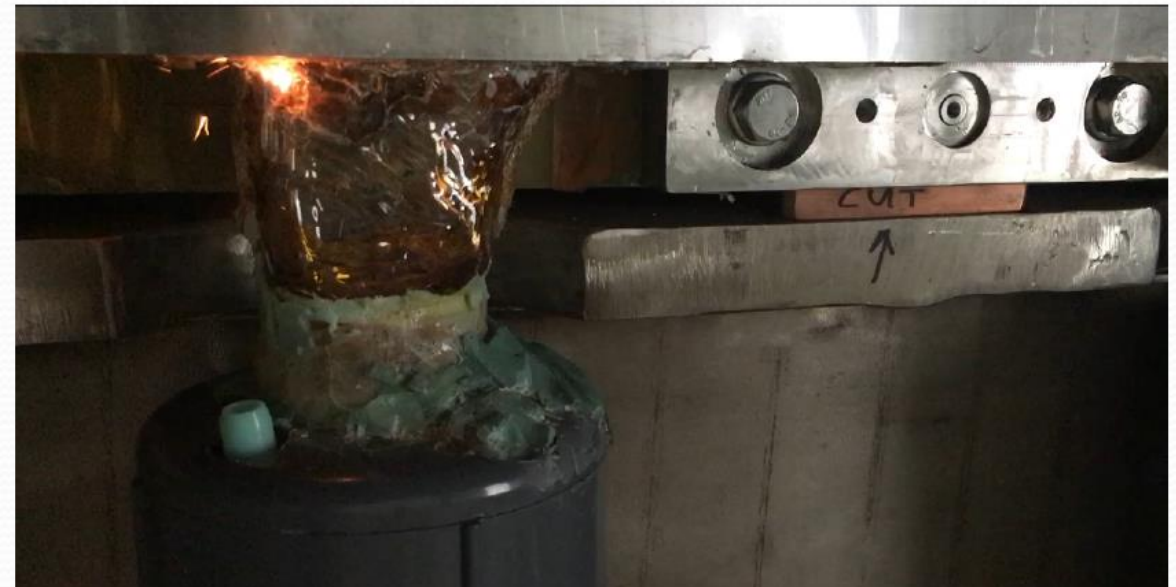
HiPot Test of CS Mock-Up: arcs between HV wires

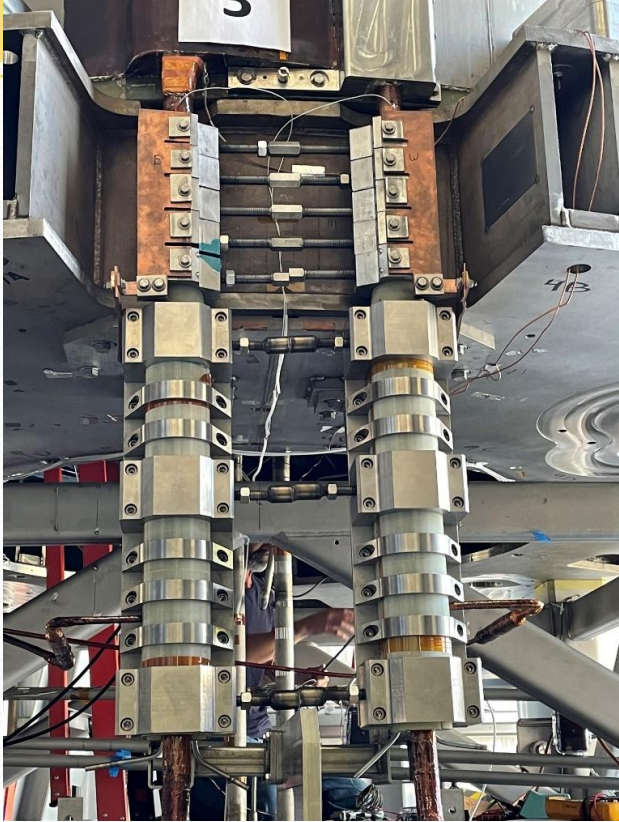
## CSM3 (& JT60) arc damage after Paschen failure of feeder in test facility

Top left: coil terminal and co-ax joint connection to busbars, as installed

For CS, root cause seems associated with insulation failure on a feeder, not coil

However for both CS3 test and JT60, extent of damage....and propagation of multiple arcs within feeders, structures and instrumentation gives a clear warning about potential hazards of high voltage operation in 'vacuum' and need for robust quality controls

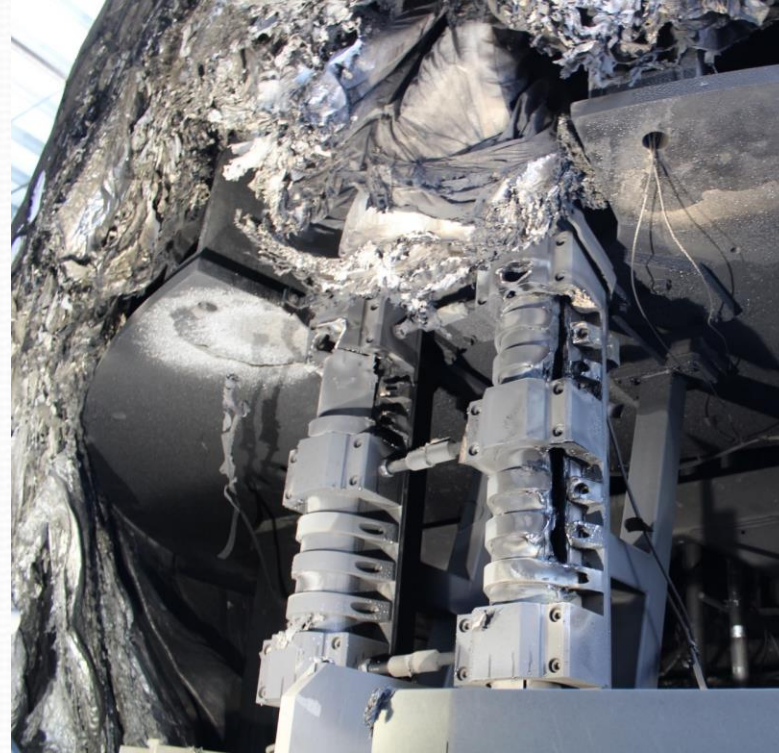
Top right, after arc. Steel clamps are clearly melted

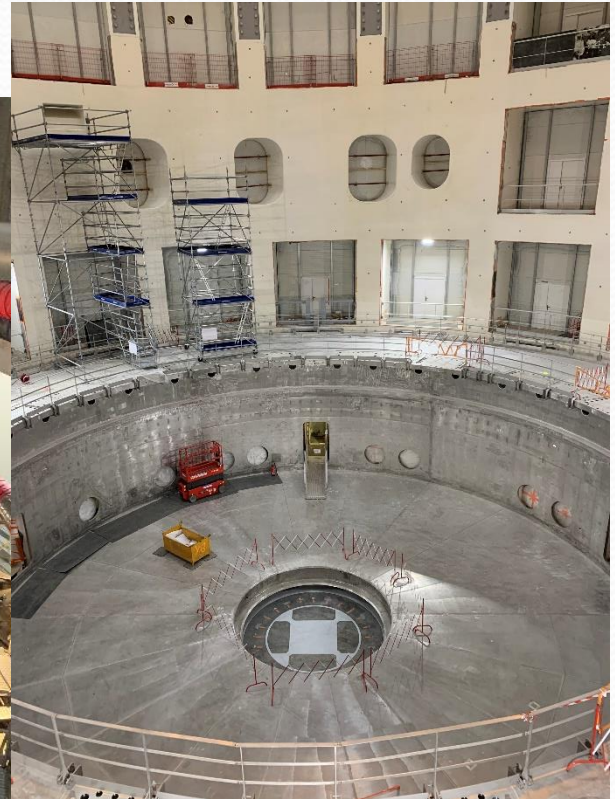
# Picture of in-cryostat and TF on SSAT as now

Components are in 'parked' position until TF installed but we can already see the congestion
