The industrial production and validation of Micromegas boards for the ATLAS upgrade

Filipp Dubinin on behalf the ATLAS Muon Collaboration

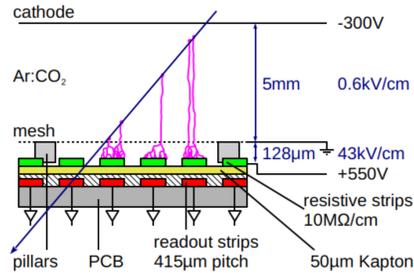
Micromegas is a micropattern gaseous detector consisting of a cathode, a mesh and an anode. The cathode-mesh gap forms a drift volume where drift field guides primary electrons and ions to the electrodes. Strong amplification field between the mesh and the anode drives the primary electrons to the thin amplification gap and accelerates them leading to ionizing collision with the gas molecules and formation of avalanches. When reaching the anode the avalanche is spread over the area of 1-2 mm diameter that leads to signal formation at several read-out strips.

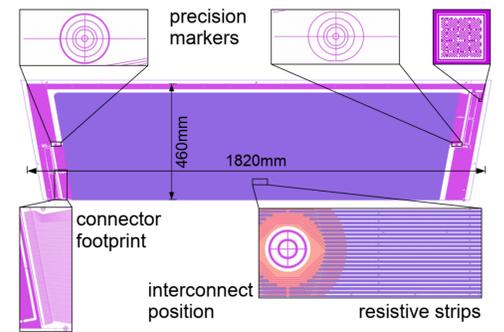
HV is distributed over the resistive strips using conductive silver paste plated on top of the resistive strips and connected to the HV copper strip through the via in the foil. The silver line is covered with insulating strip made with Pyralux®. The same material is used to create pillars supporting the mesh and determining the width of amplification gap.

In ATLAS Micromegas resistive anode is used. This technology consists in dividing the anode in high voltage and read-out parts and provides more stable operation and spark protection both the detector volume and the front-end electronics. High voltage (+500-600V) is applied to resistive strips disposed at insulative Kapton® film. The film is glued on the FR4 based PCB with the read-out copper strips.

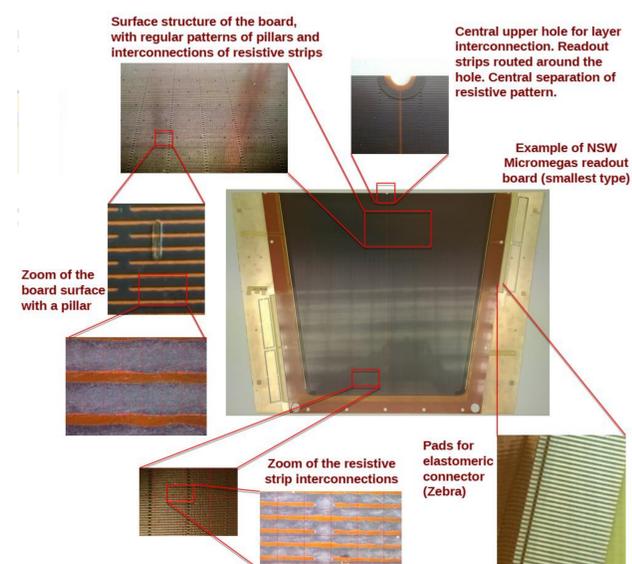
- ❖ ~ 3000 anode boards of 16 different types were produced in total
- ❖ A few hundred of the boards were reproduced due to major non-conformity that may lead to detector damage during operation
- ❖ 2000 boards meet the requirements and used to build the Micromegas modules
- ❖ A few hundred of the boards have issues that could be repaired and the boards could be potentially used

- Some of the listed defects can be repaired such as:
- ❖ bumps, scratches at the active area → insulated if possible
 - ❖ missing pillars → reglued
 - ❖ bubbles under Pyralux layer → filled with epoxy
