16th (Virtual) "Trento" Workshop on Advanced Silicon Radiation Detectors.
16-18 February 2021 FBK,

Femtosecond studies of single event effects in thin LGADs at ELI Beamline

Institute of Physics
of the Czech
Academy of Sciences

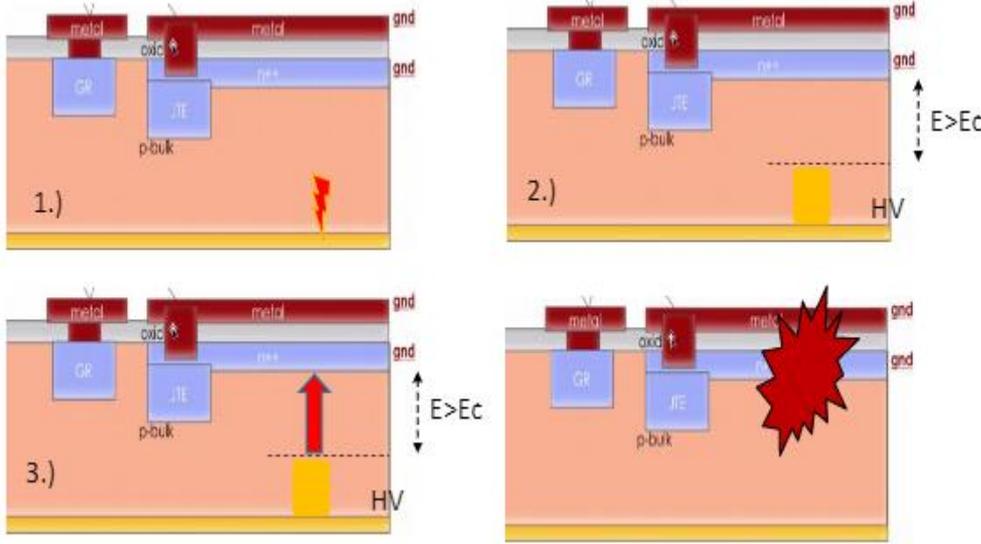
A possible explanation

1.) larger deposition of the charge (fragments producing deposition in few μm as large as 1000 mip- CMS tracker paper) in few μm (not possible with lab sources)

2.) larger density of carriers leading to collapse of the field (screening prevents the carriers from being swept away)

3.) once the field collapses the HV is brought closer to the pad which leads to very high field strength leading to avalanche breakdown and full discharge of sensors and bias capacitor

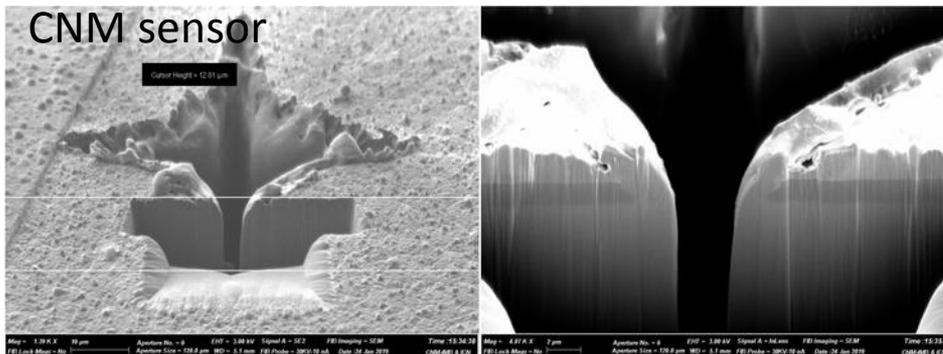
“courtesy of CNM (ATLAS TB sensor)”

Thanks to CNM for providing the photos of such fatality.

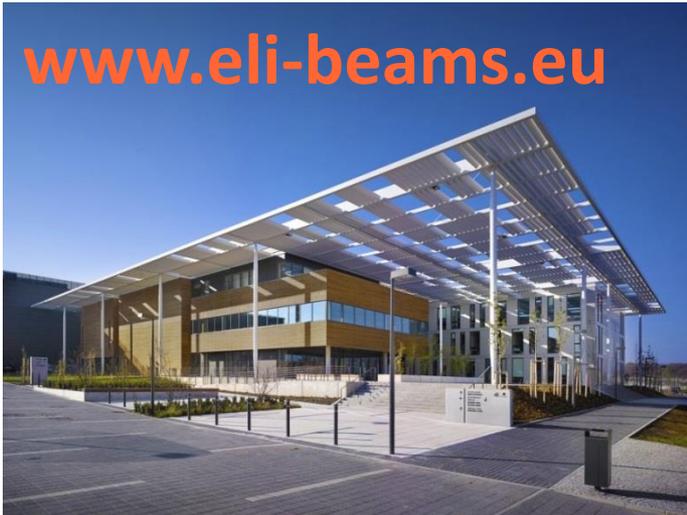
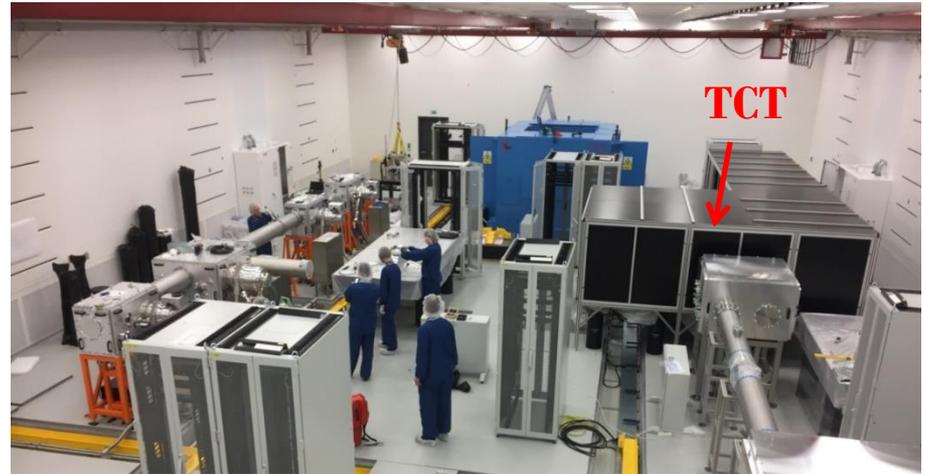
Experimental hall E1
Research program: Bio and Material Applications

Czech Republic
Dolní Břežany (on the outskirts of Prague)

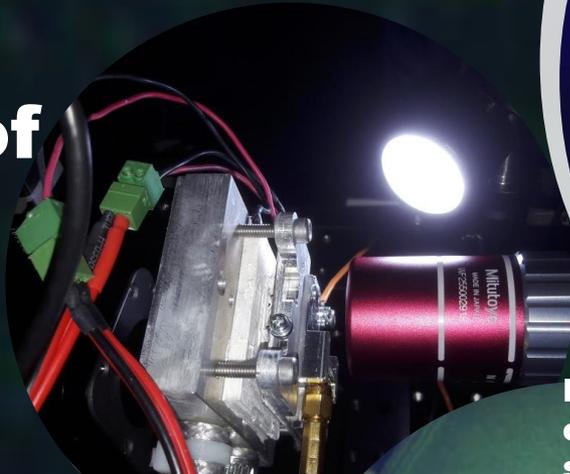
Pad of LGAD visible by imaging system

Beam focused to the center of the sensor

Image corresponds to the specified area (opening window) when 100X objective is used (during experiment)

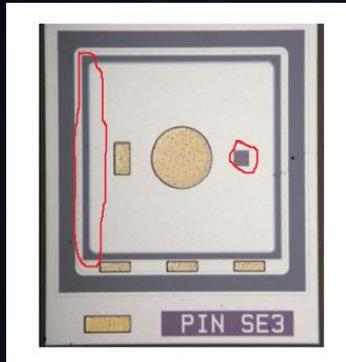
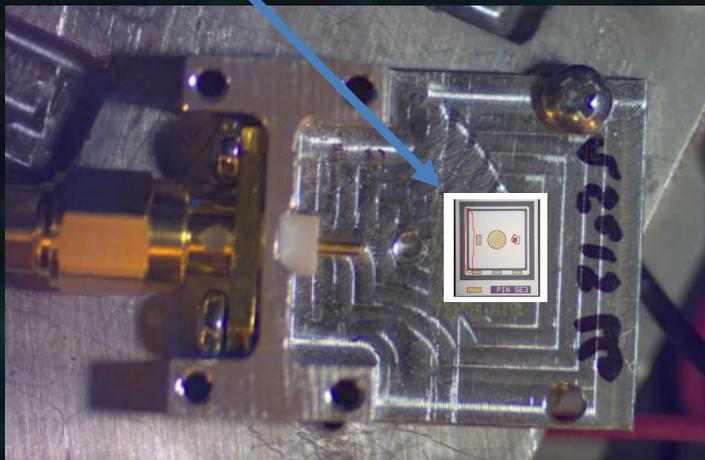
Pad of LGAD and laser printed in the center of the pad visible by imaging system

Image corresponds to the larger area of the sample if 25X objective is used instead of 100X (not used during experiment but used in pre-alignment of the sample position).

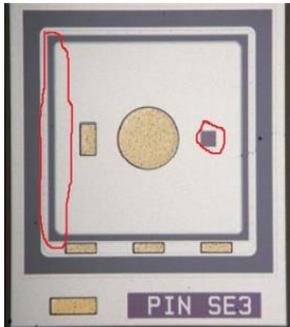
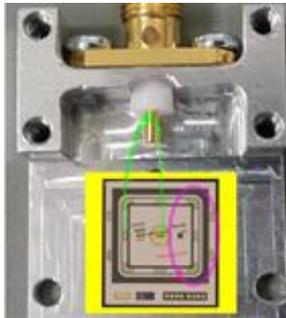
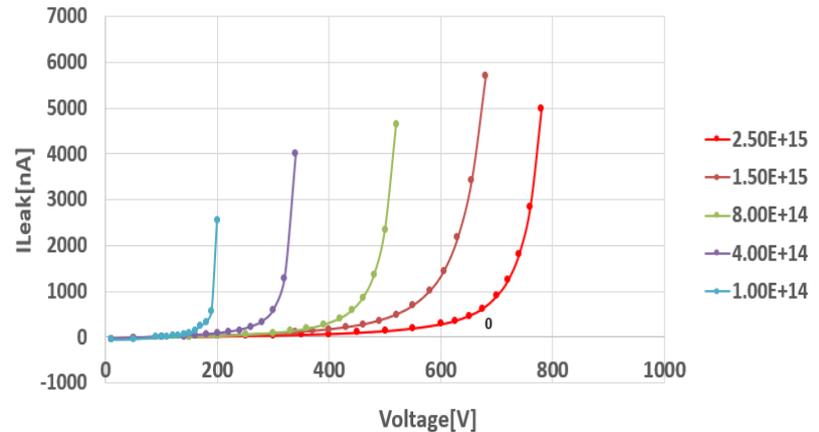
Samples and readout

- ❑ The samples are from HPK-P2 run, the latest ATLAS/CMS LGAD fabrication (shown in many talk in the workshop)
 - ❑ W36 ($V_{gl} \sim 51.5$ V, $V_{bd} \sim 220$ V)
 - ❑ fluences covered are the ones of interest for ATLAS and CMS: $4e14$, $8e14$, $1.5e15$, $2.5e15$ cm^{-2}
- ❑ For each sensor (4 sensor, 4 fluences) the bias was increased up to the maximal expected value (340, 520, 680, 780 V for respective samples) where the IV was measured

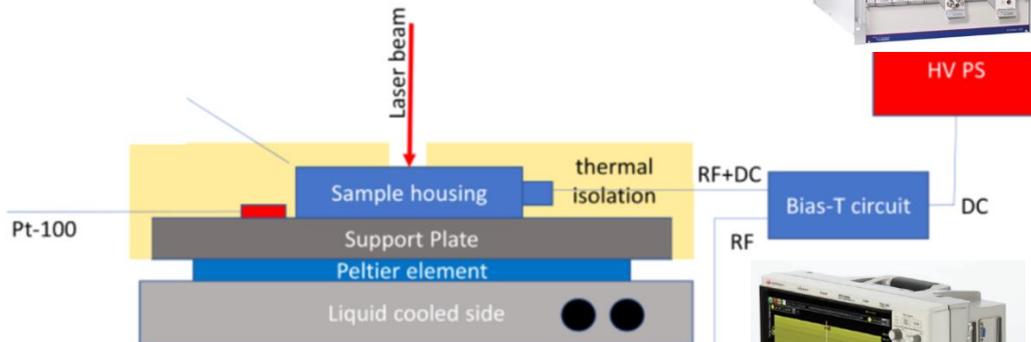
MORTALITY STUDIES

Oscilloscope
6 GHz (Keysight Infiniium)
DSOS604A

- Closed circuit chiller $T = -25$ C
- N2 flushed to avoid condensation.
- No active amplifier used—we want large signals.
- Bias-T used to prevent discharge into oscilloscope
- No other bias filtering used
- ✓ HV power supply: EB1200305040000200 (Iseg)

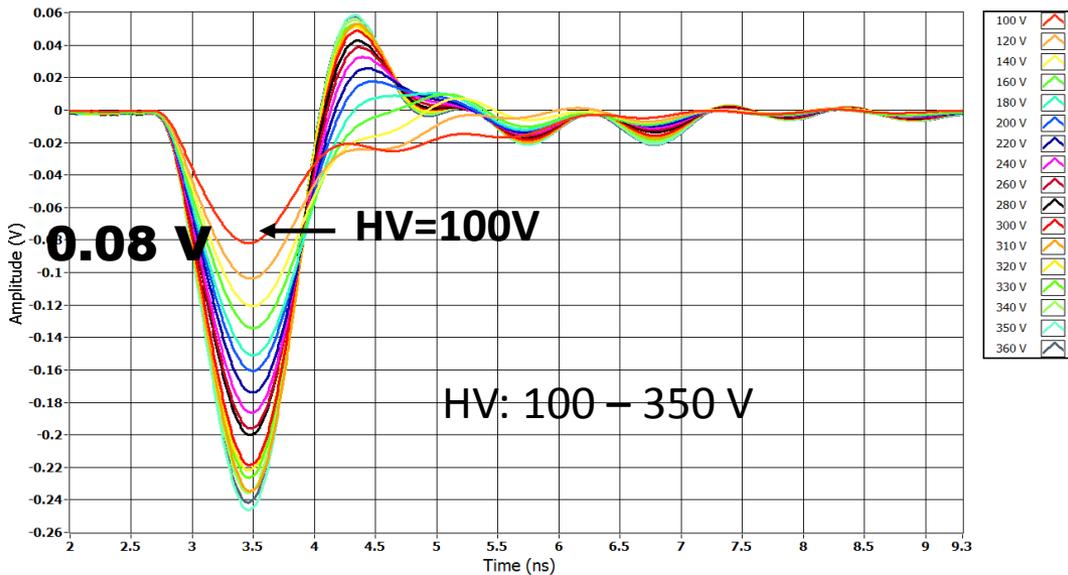
TCT signals

LGAD WF36, $4e^{14} n_{eq}/cm^2$
 $P_{laser}=10$ nW

3. A factor of 6 difference implies to large recombination possible. Recombination rate R is very much affected by the irradiation on. In order of both calculations to agree R has to be 1/6

4. The equivalent lost charge in the silicon to produce the same signal:

$$\Delta E = N_{e-h} 3.62eV = \sim 30 MeV$$

1. Calculation from signal recorded on the diode at 10 nW

$$N_{e-h} = \frac{1}{e_0 R} \int_0^{5 ns} V_{sig}(t) dt$$

$$N_{e-h} \sim \frac{1}{1.6e-19 As 50\Omega} 0.08 V \cdot 1ns \sim 10^7 e-h$$

2. Calculation from the beam parameters at 10 nW

$$E_{pulse} = \frac{P}{\nu}$$

$$N_{e-h} = \frac{E_{pulse}}{e_0} \cdot Q_E \cdot R_{e-h}$$

$$N_{e-h} = \frac{10nW}{1000s} \cdot 0.5 \cdot 1 \cdot \frac{R_{e-h}}{1.6e-19 As} = R_{e-h} \cdot 6.2 \cdot 10^7 e-h$$

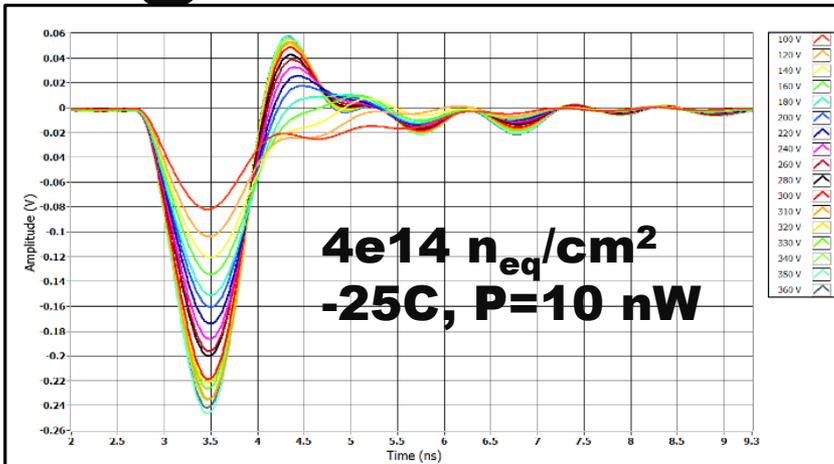
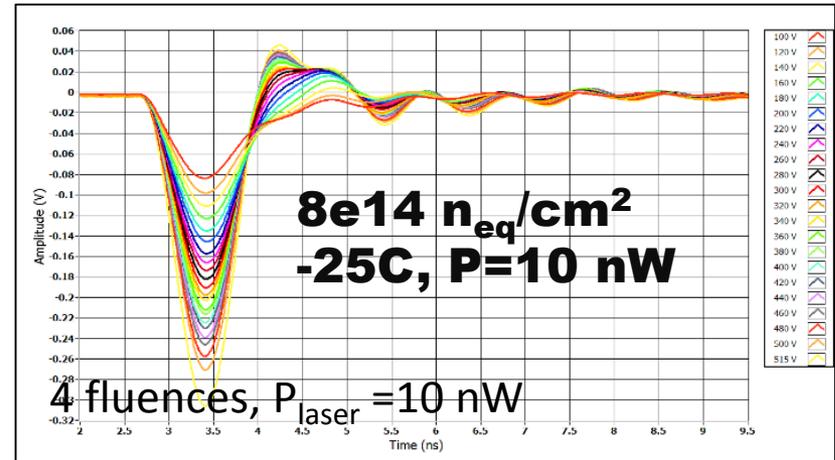
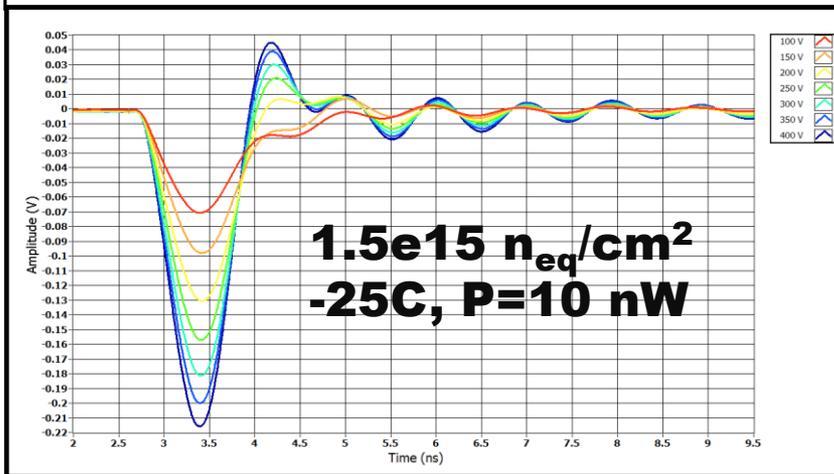
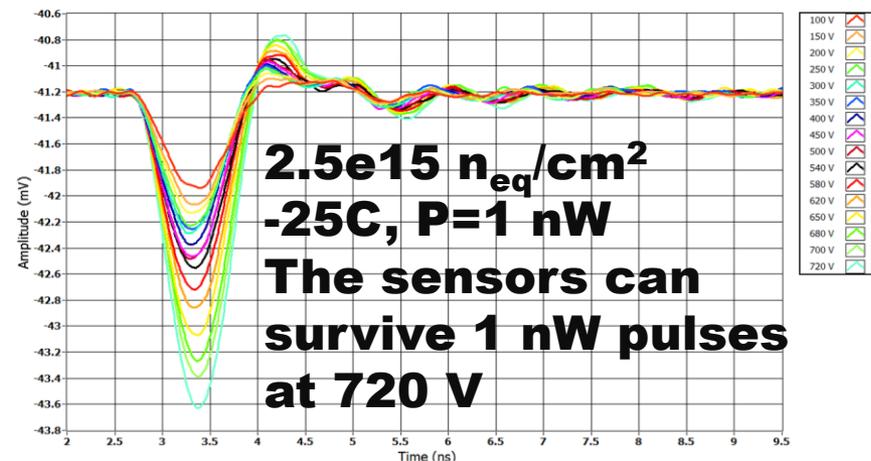
Signals at all fluences

- ✓ At $P_{laser} = 10 nW$ (that corresponds to pulse energy of 10pJ – repletion of the laser 1000 Hz) the same integrated charge is observed for all 4 fluences at HV=100 V where no gain is present due to high radiation;
- ✓ No visible plasma effects – rise time comparable also at low and high bias. Risetime comparable with RC constant.
- ✓ Recombination of e-h seems only moderately fluence dependant

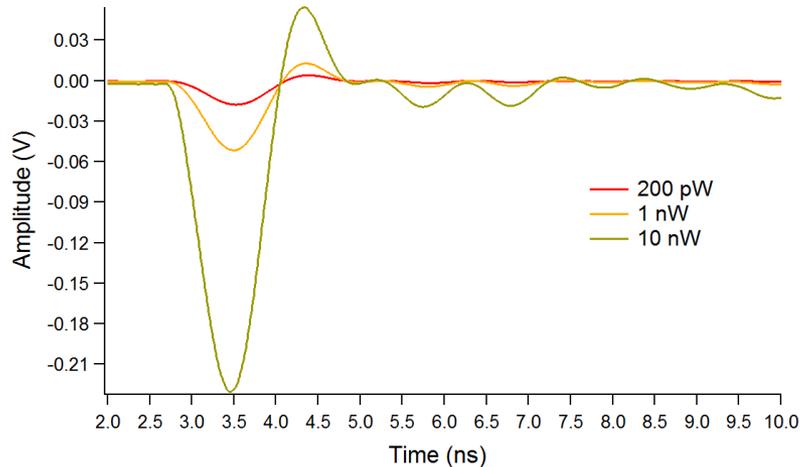
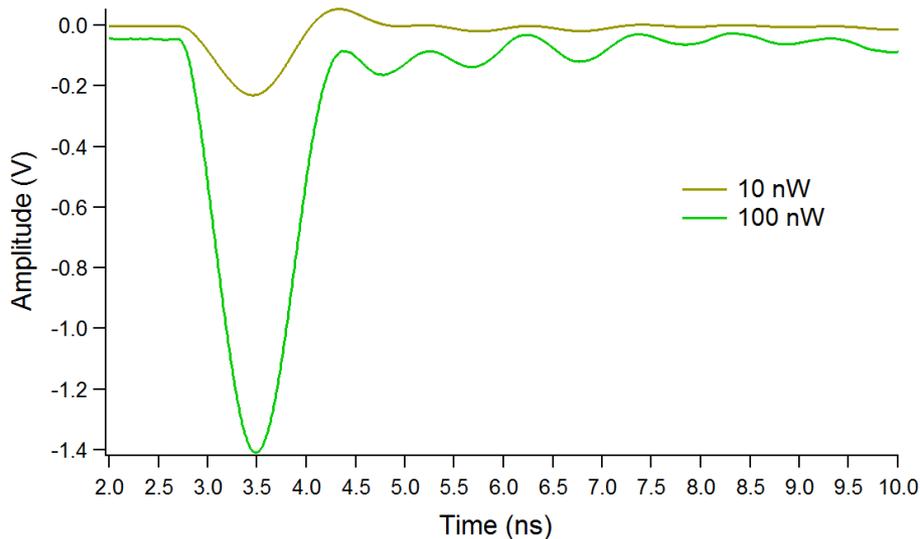
Exposure to extreme energies

- ✓ WF36,
- ✓ $4e14 \text{ n}_{\text{eq}}/\text{cm}^2$
- ✓ HV was set to maximal HV (HV=320 V)
- ✓ Laser power was increased until LGAD died
- ✓ Changes in the signal waveform were observed
- ✓ Laser power $L_{\text{power}} = 100 \mu\text{W}$ was critical point which completely destroyed the sensor
- ✓ $P_{\text{laser}} = 100 \mu\text{W}$ is extremely large power; LGAD will never worked under such extreme power.

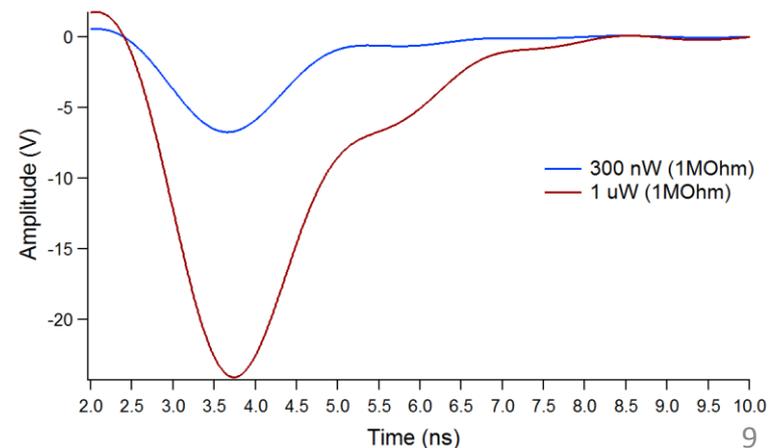
- ✓ **W36 LGAD, $4e14 \text{ cm}^{-2}$:**
- ✓ The HV was set to 340 V (breakdown bias measured by Sr-90 in lab)
- ✓ After reaching the laser power of **$100 \mu\text{W}$** at bias of **340 V** the sample partially broke down.

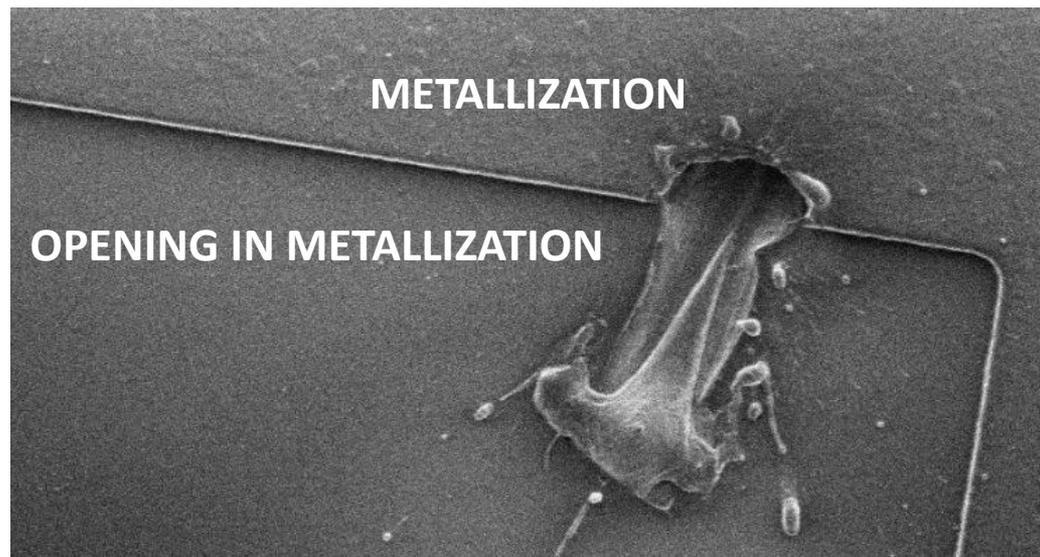
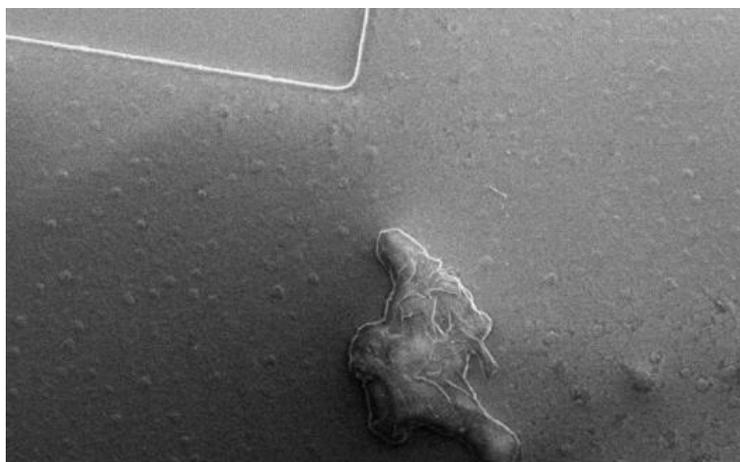
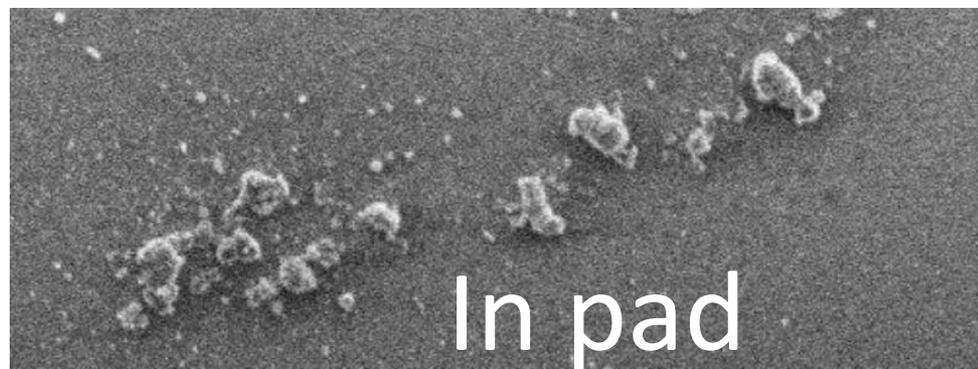
- ✓ **W36 LGAD, $8e14 \text{ cm}^{-2}$:**
- ✓ The HV was set to 500 V (breakdown bias measured by Sr-90 in lab)
- ✓ After reaching the laser power of **$10 \mu\text{W}$** at **500 V** the sample broke down.
- ✓ Damage can happen anywhere as demonstrated in the image below; laser was focused to the center of sensor opening, $d=1.7 \mu\text{m}$.

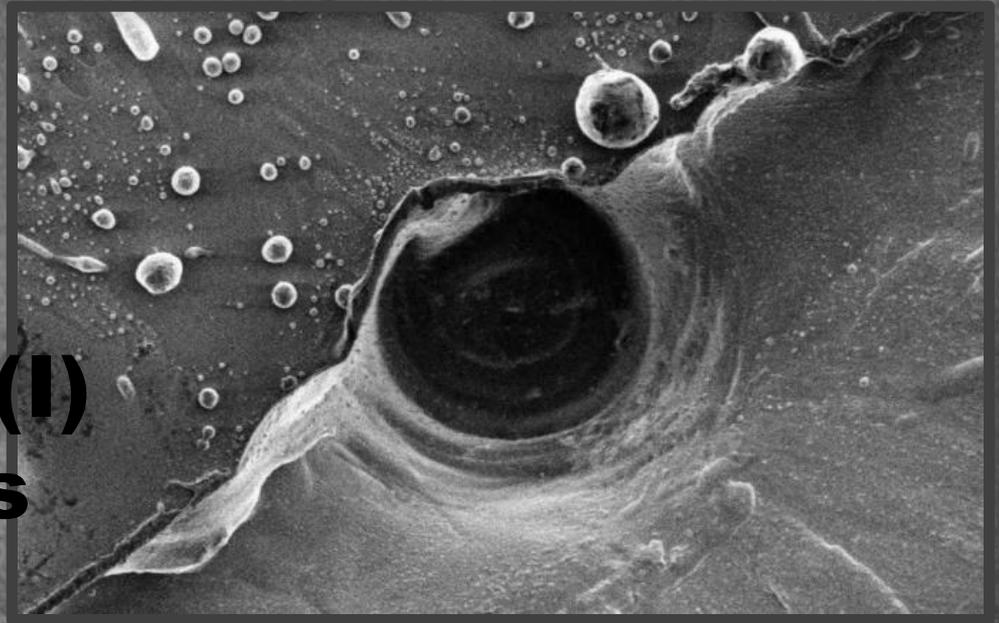
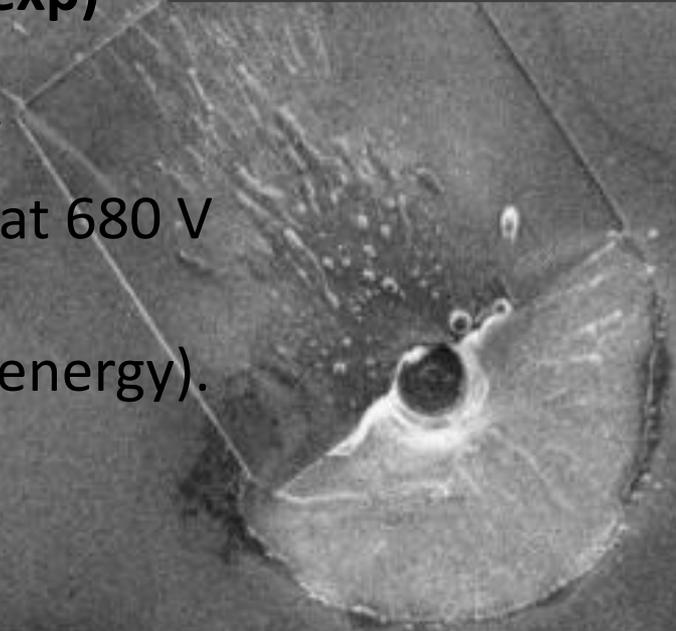
W36 LGAD $1.5e15 \text{ cm}^{-2}$ (I exp)

- ✓ The HV was set to 680 V
- ✓ After 3 nW illumination at 680 V the sample broke down (~10 MeV od deposited energy).

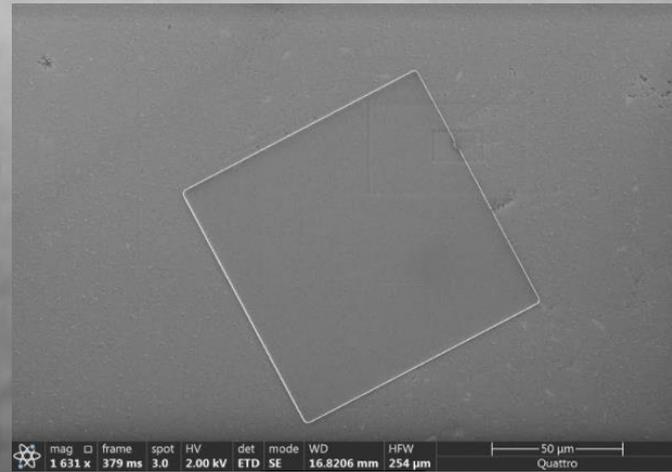
$1.5e15 \text{ cm}^{-2}$ (II exp)

- ✓ The HV was increased in steps, and survival of sensor was scanned in the way that at each chosen HV bias the fatality/survival was tested by increasing the laser power until LGAD brake down.
- ✓ The sample broke down at 400 V when illuminated by $6 \mu\text{W}$.
- ✓ Sample was still operational at lower bias HV=230 V.

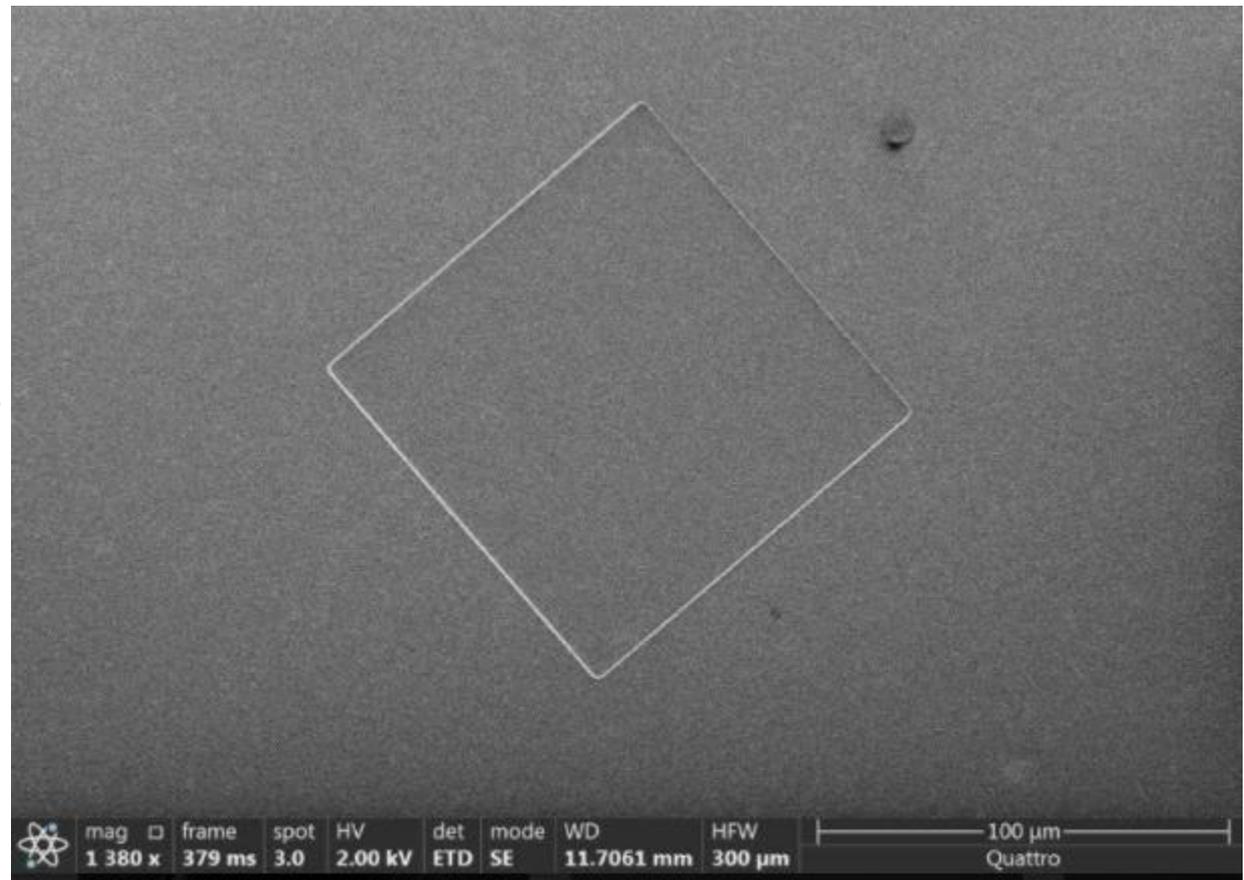
WF36 LGAD $2.5e15 n_{eq}/cm^2$ (I exp)

- ✓ The HV was set to 780 V
- ✓ Laser power was increased until sensor brake down.
- ✓ At $1\mu W$ of laser power the LGAD broke down.

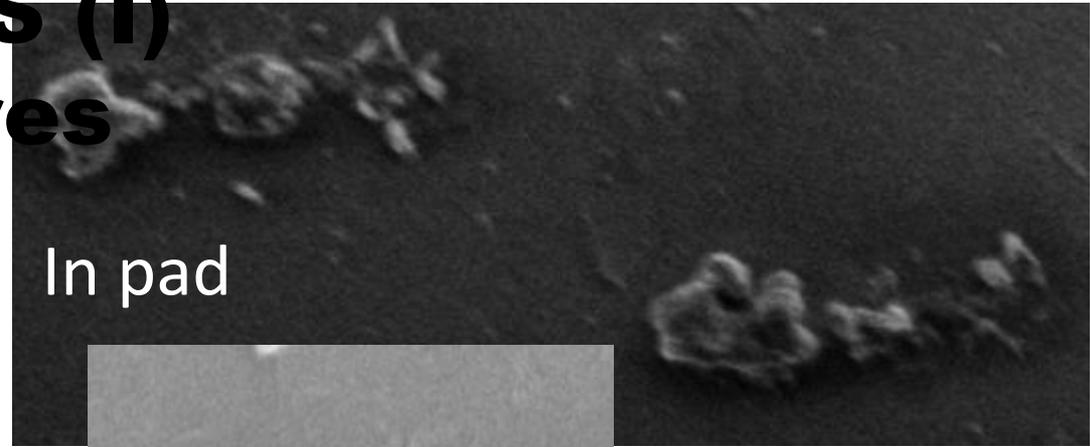
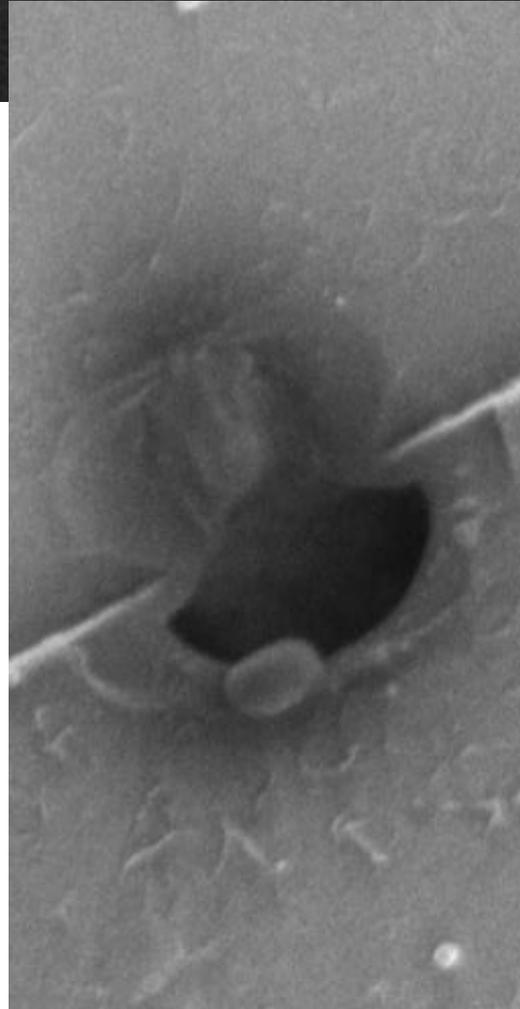
$2.5e15 \text{ cm}^{-2}$

- ✓ The HV was increased in steps, and survival of sensor at each step (chosen HV) was tested by increase of laser power till sensor brake down.
- ✓ In this case the LGAD broke down at bias of 450 V at 6 μW .
- ✓ Sample was still operational at lower bias HV=230 V

- Damage areas on the pad are clearly visible.
- Damage spots are also observed on the border of pad. It seems that this border region is especially sensitive to the damage.

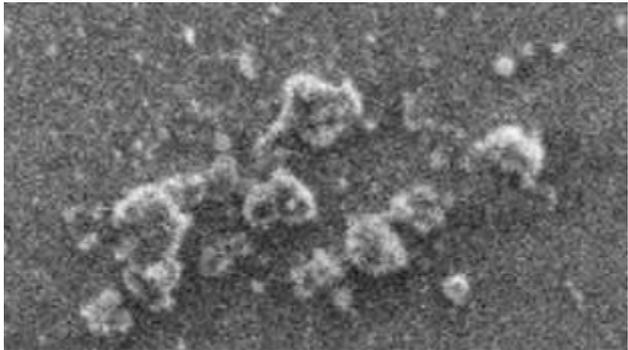
W36 PIN; $4e14 \text{ cm}^{-2}$

- ✓ PIN survived $10 \mu\text{W}$ at HV bias of 330 V ;
- ✓ Worked well after this test.
- ✓ Some laser induced spots appeared on the pad (aside from some other small spots which were there before experiment).

This allows us to perform additional tests at GR region with laser power of $10 \mu\text{W}$

- ✓ The sensor worked normally giving the same signal like for pad.

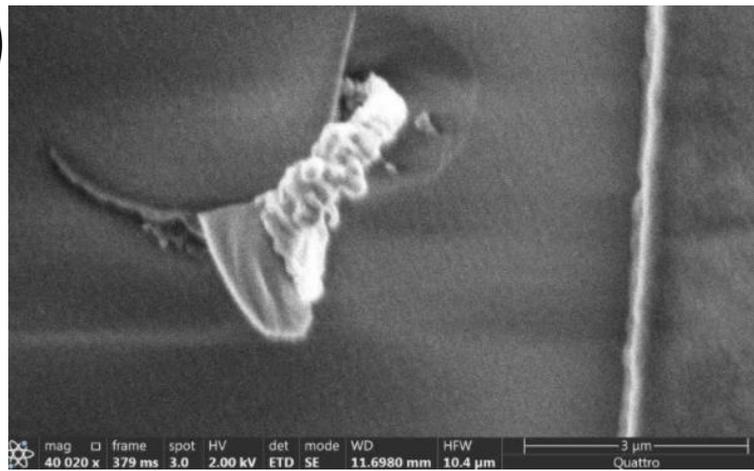
W36 PIN
 $8e14 \text{ cm}^{-2}$

- ✓ This sensor broke down at 450 V under $10 \mu\text{W}$. Some damage spot appears on the border area even though the laser was focused in the center of pad.

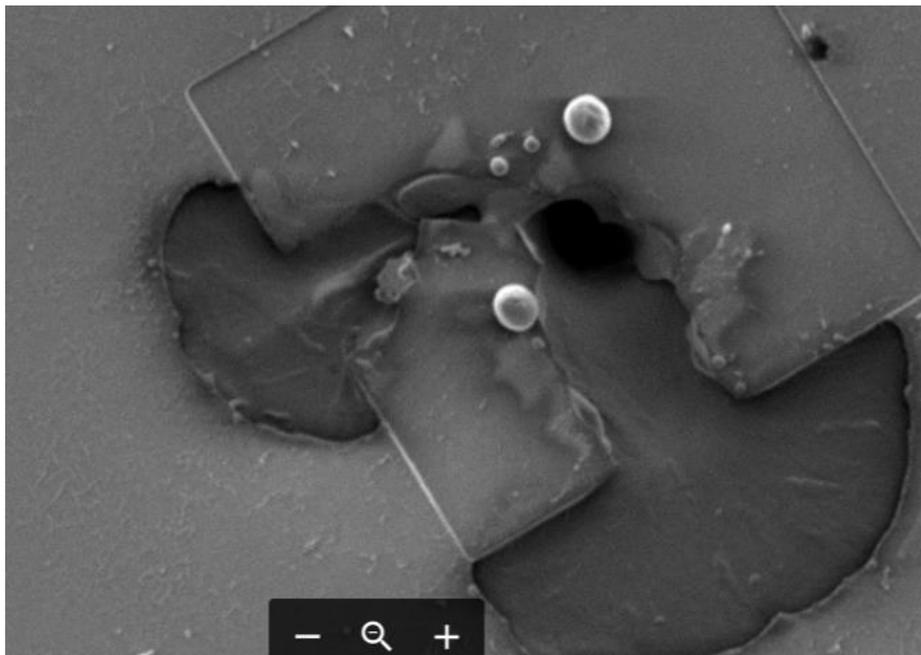
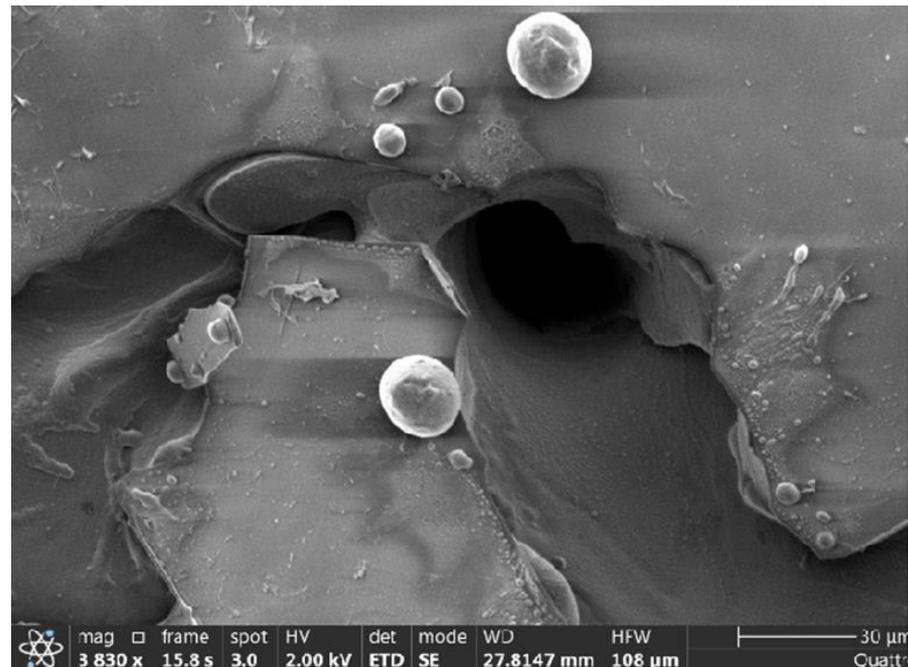
W36 PIN
 $2.5e15 \text{ cm}^{-2}$

- ✓ We achieved to bias of 600 V (after coming to 10 μW at lower bias).
- ✓ However, then PIN broke down completely under 100 nW.
- ✓ Massive damage is clearly visible on pad after that.

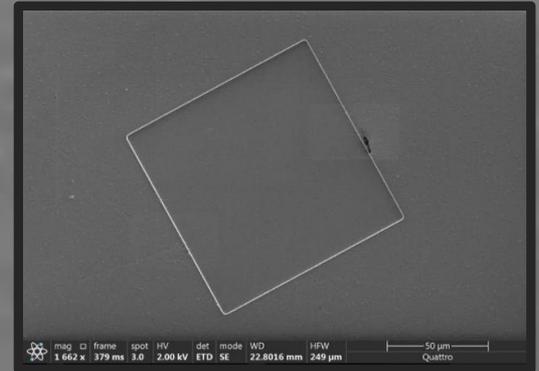
$1.5 \times 10^{15} \text{ cm}^{-2}$

Sensor was
broken at:

$HV = 400 \text{ V}$

$P_{\text{laser}} = 6 \mu\text{W}$

mag	□	frame	spot	HV	det	mode	WD	HFW
10 000 x		15.8 s	3.0	2.00 kV	ETD	SE	38.5397 mm	41.4 μm

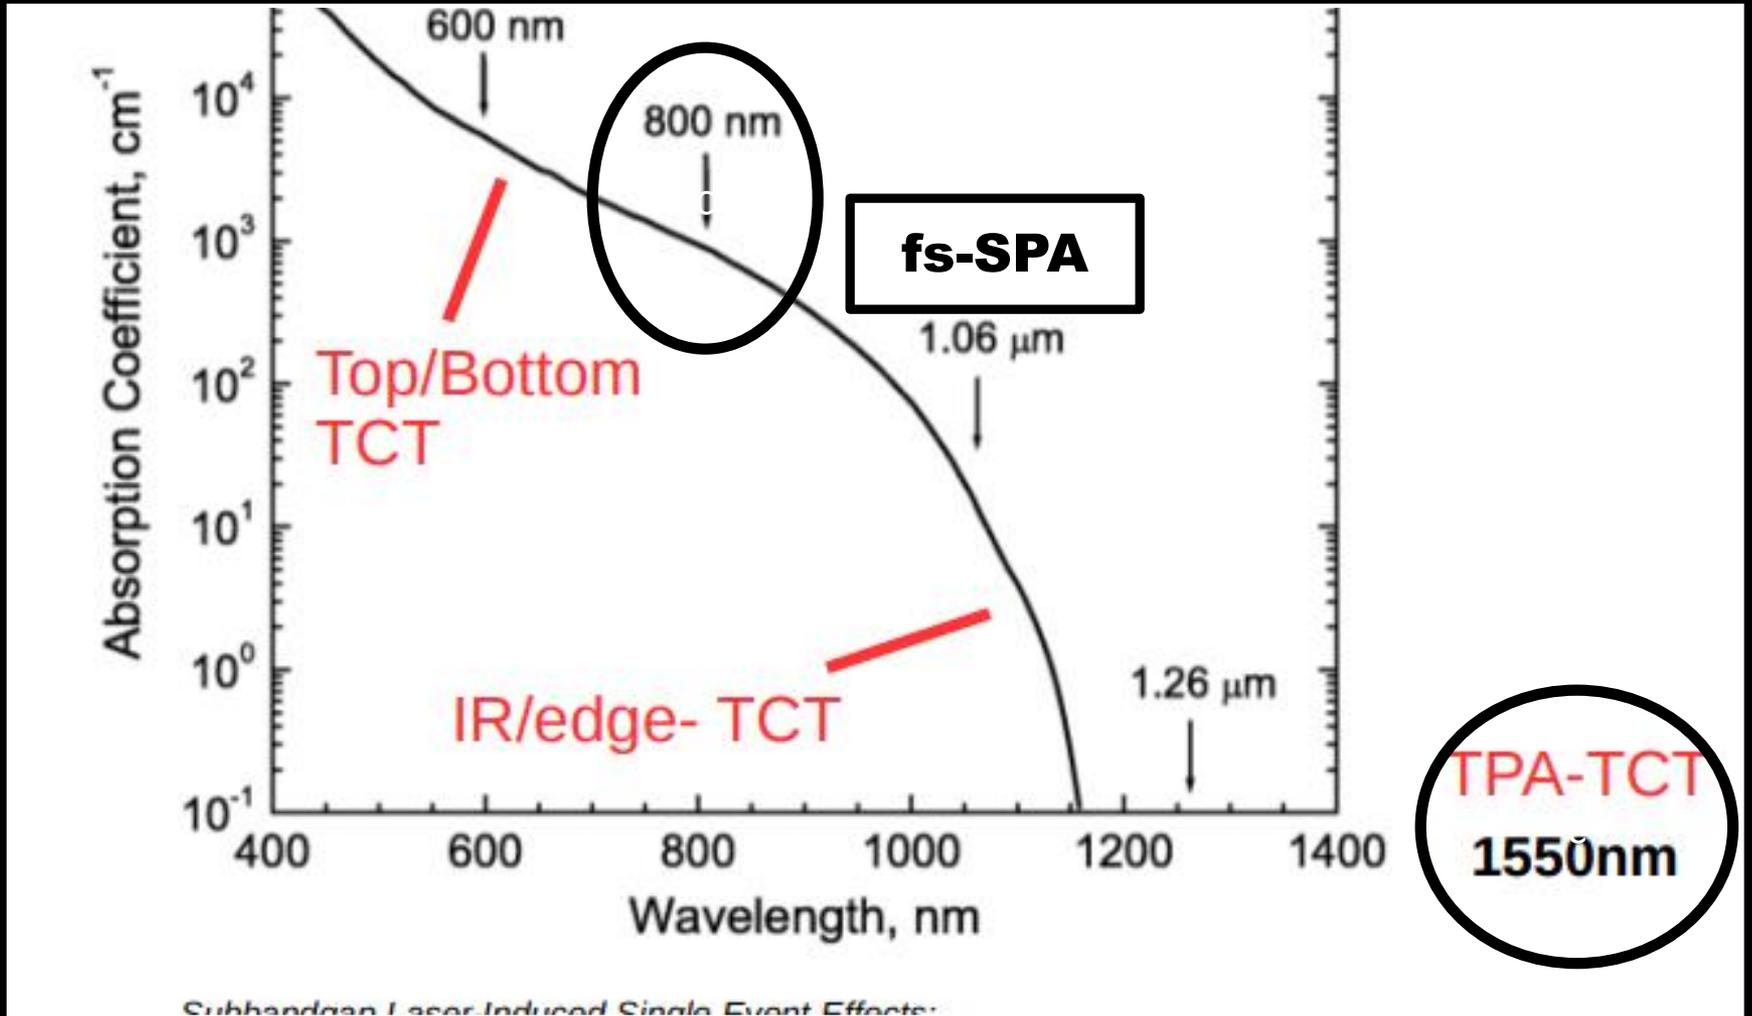
Fs-TCT Set up : Motivation

To build unique fs-TCT with both lines, Single Photon Absorption at 800 nm the and Two Photon Absorption at the 1550 nm of fs-laser

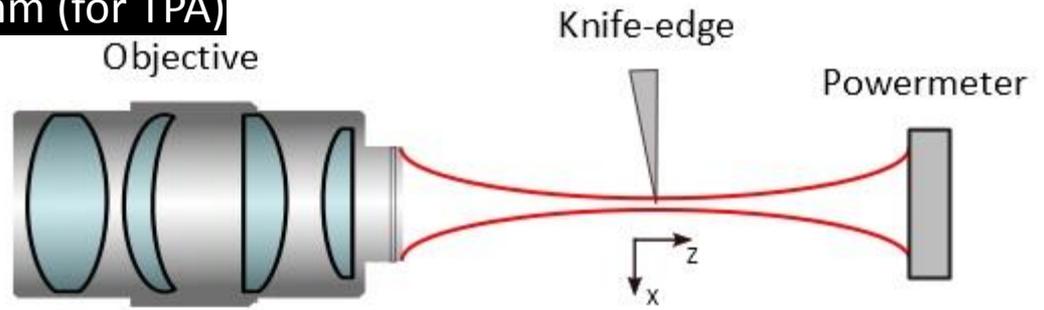
Beam profile and parameters at 1550 nm (for TPA)

$$P_{measured} = \frac{P}{2} \left[1 - \operatorname{erf} \left(\frac{\sqrt{2}(x - x_0)}{w} \right) \right]$$

$w - 1/e^2$ radius Gaussian beam

100X Mitutoyo Plan Apo NIR HR
Infinity Corrected Objective
 $\lambda = 1550 \text{ nm}$

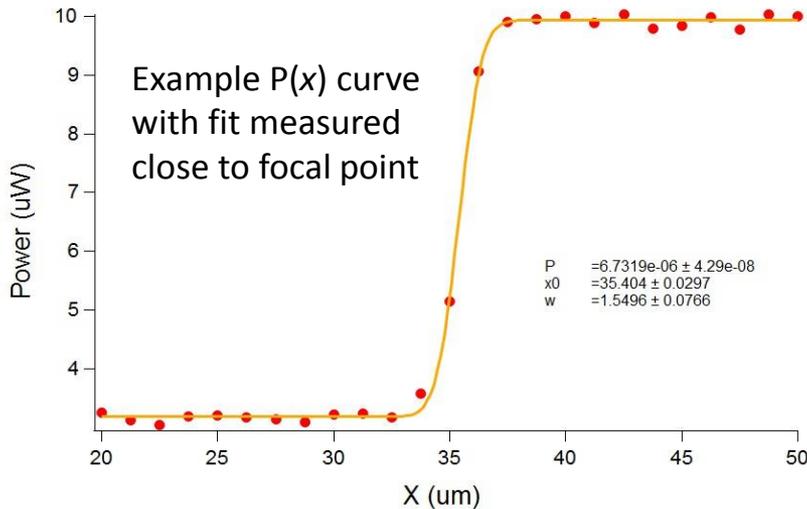
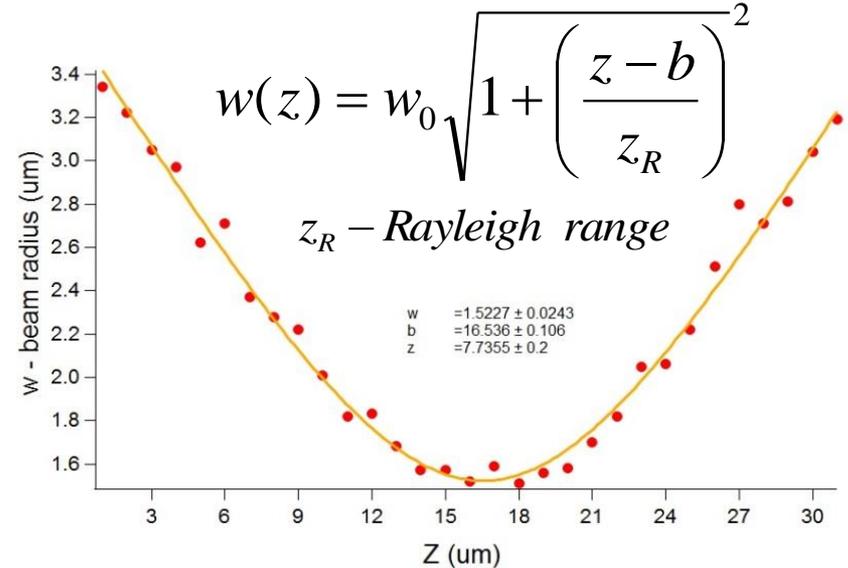
1. $P(x)$ measured for series of Z points around focal point
2. $w(Z)$ obtained by fitting for every Z
3. w_0 and Z_R obtained by fitting $w(Z)$ curve

Final parameters (in air):

$$w_0 = 1.52 \mu\text{m}$$

$$Z_R = 7.74 \mu\text{m}$$

In Si : refractive index correction needed

$$n = 3.48 \text{ at } 1550 \text{ nm}$$

$NA = 0.31$ (nominal $NA=0.7$ but probably not valid for focal point)

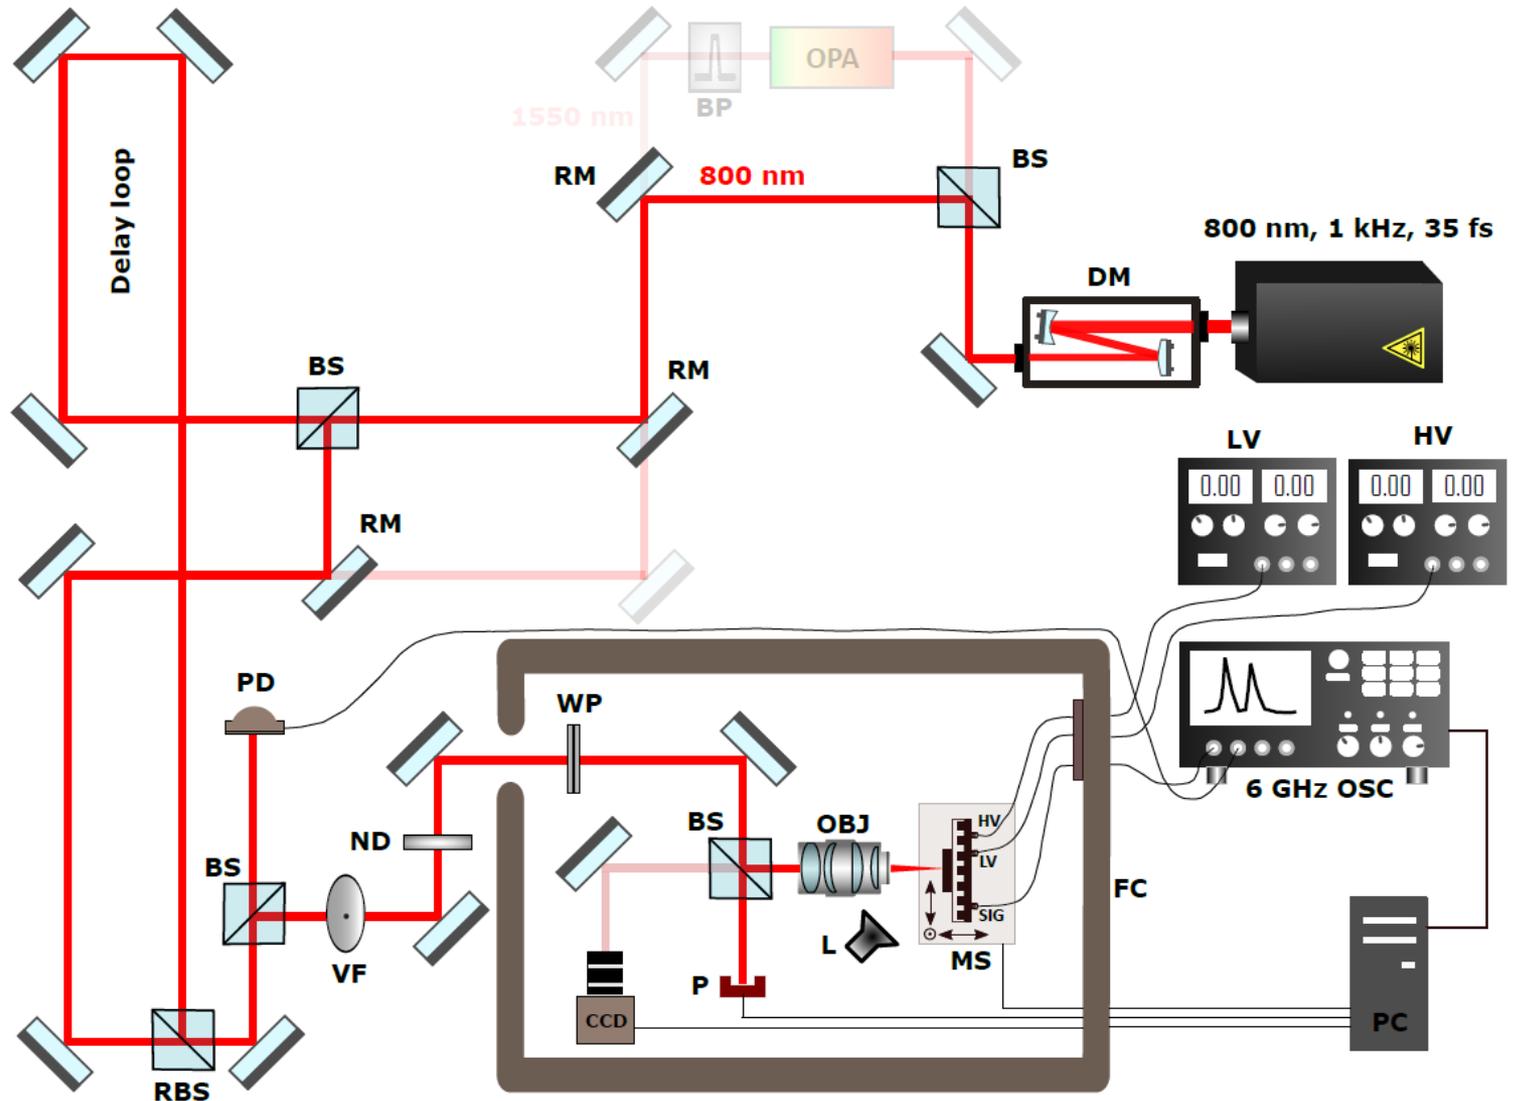
Schema for Experimental setup: SPA configuration

DM – demagnifier, **BS** – beamsplitter, **OPA** - optical parametric amplifier, **BP** - bandpass filter, **RM** - removable mirror, **RBS** - removable beamsplitter, **PD** - reference photodiode, **VF** - variable gradient ND filter, **ND** - fixed neutral density filter, **WP** - half waveplate, **P** – powermeter, **OBJ** - 100X objective L-lens, **MS** - motorized XYZ stages, **LV** - low voltage power supply, **HV** - high voltage power supply, **FC** - Faraday cage

- setup contains a few removable elements on magnetic mounts to quickly change between 800 nm and 1550 nm beam
- for 800 nm optional half wave plate is used to flip polarization (the same S-polarization (vertical) is kept for all measurements)

- beam splitter in the front of objective is exchangeable, different ones are used for 800 and 1550 nm to give 50/50 split in both cases
- power is measured after the beam splitter (it enables constant monitoring of power during measurements)

- at 1550 nm power is measured by S132C Thorlabs power meter
- at 800 nm power is measured by PD300 Thorlabs power meter (much more sensitive at this wavelength)

- if the most sensitive power meter is not enough in SPA (that was the case in mortality study where pW power gives already high signal) the additional ND filter OD=1 is insert in the front of objective (the actual power is attenuated by factor 10 in comparison to measured value)

- InGaAs reference diode is used to correct the laser fluctuations (it's important especially for long measurements: for xy scans for example) and to trigger the scope

- CCD camera with imaging lens (plus illuminating lamp) monitor when exactly we shoot. This system is used to precisely align position of detector and then is off (in principle illuminating lamp is off) during measurements

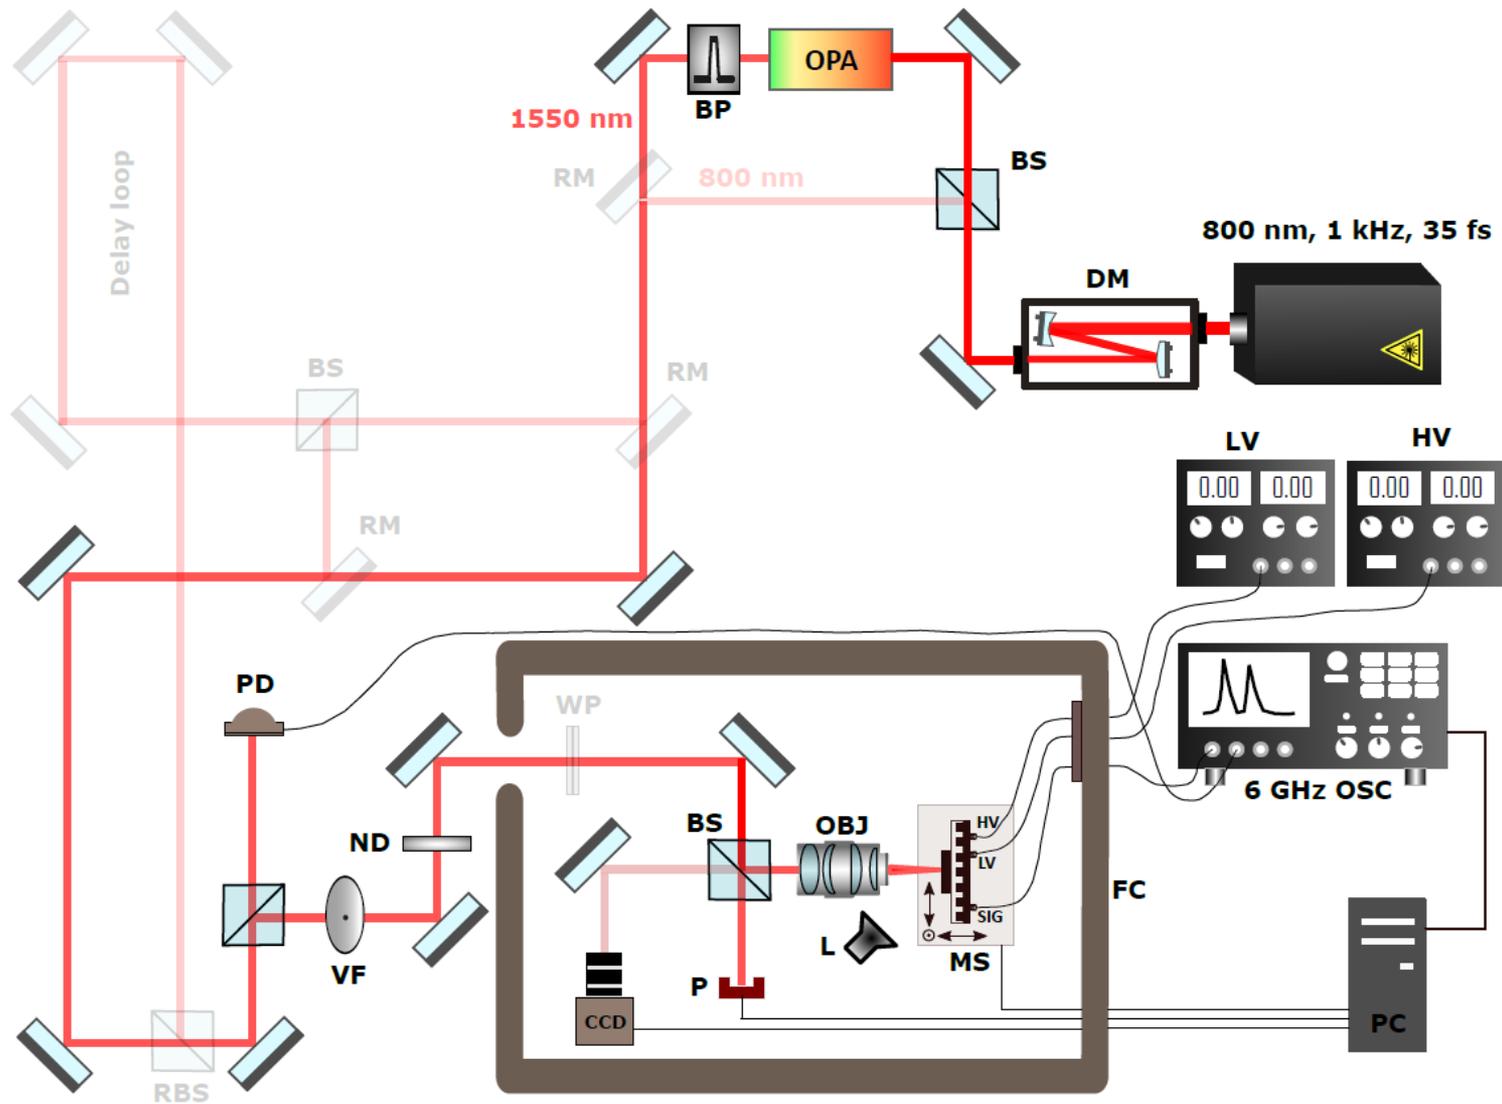
A NEW Experimental setup: TPA configuration

DM – demagnifier, **BS** – beamsplitter, **OPA** - optical parametric amplifier, **BP** - bandpass filter, **RM** - removable mirror, **RBS** - removable beamsplitter, **PD** - reference photodiode, **VF** - variable gradient ND filter, **ND** - fixed neutral density filter, **WP** - half waveplate, **P** – powermeter, **OBJ** - 100X objective L-lens, **MS** - motorized XYZ stages, **LV** - low voltage power supply, **HV** - high voltage power supply, **FC** - Faraday cage

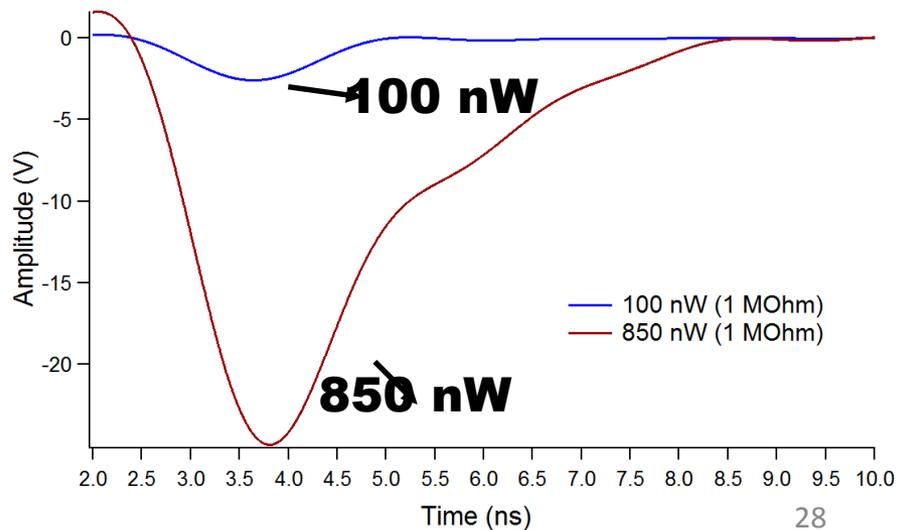
Signal for different laser powers at 450 V
