16th (Virtual) "Trento" Workshop on Advanced Silicon Radiation Detectors.
16-18 February 2021 FBK,

Femtosecond studies of single event effects in thin LGADs at ELI Beamline

Institute of Physics
of the Czech
Academy of Sciences

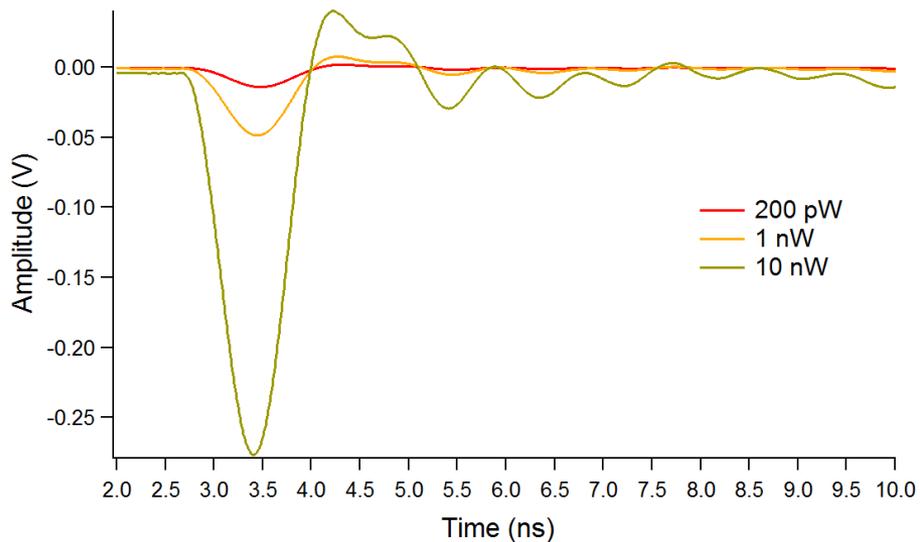
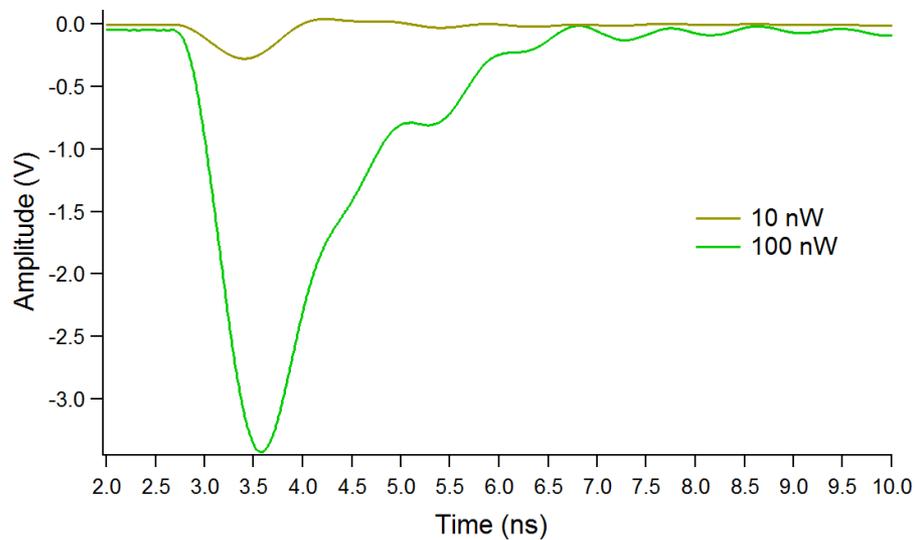
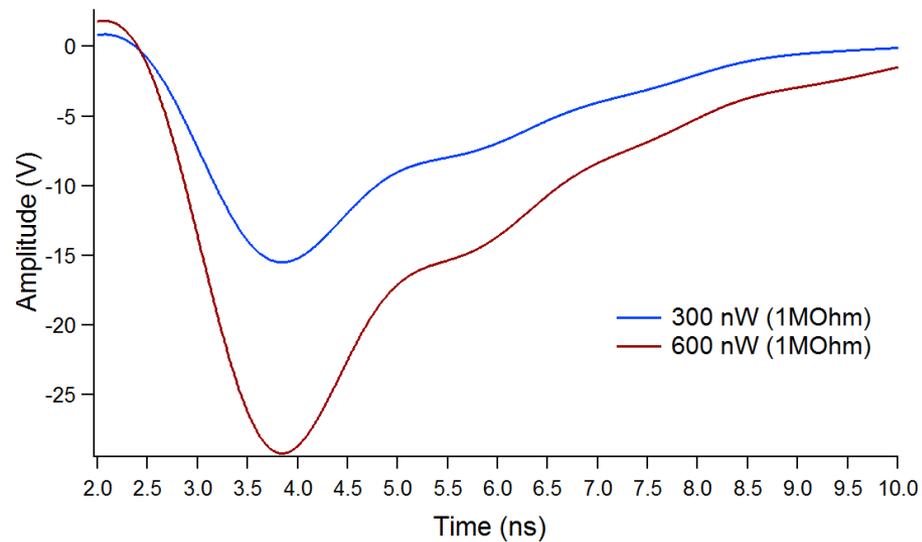
W36 LGAD ; $8e14 \text{ cm}^{-2}$; HV=500 V

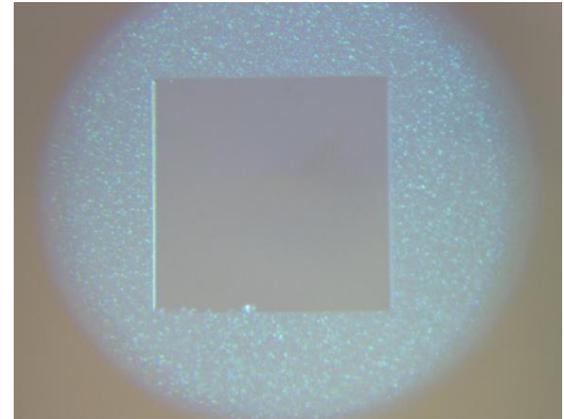
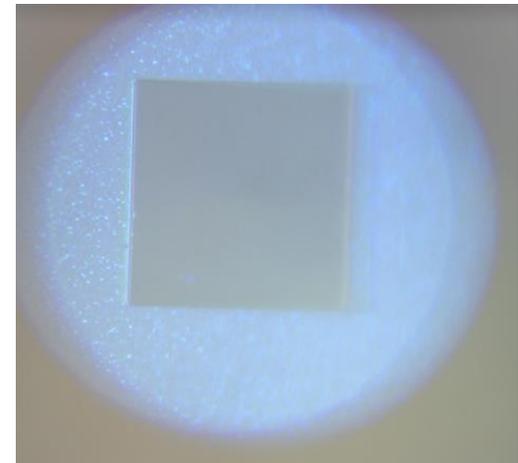
The beam-detector alignment procedure

Imaging system is based on the same objective we use for the focusing the beam. It means that we can see only very small area (100X magnification).

It fits perfectly to the size of pad which is our target. Moreover we know that sharp image of the pad means that we are in the focal plane of the objective.

More precisely the surface of pad is in the focal plane and also our beam is maximally focused on the surface. Finding this position is starting point of alignment.

This is very precise method because just a few micrometres off the focal plane we lose sharp image what is clearly visible. It also helps to align the tilt of the sample.

In the first picture (at the top) we can see sharp image of whole area. In the second picture the right side is blurry what means that the sample is tilted.
