DOM Assembly SUBATECH status

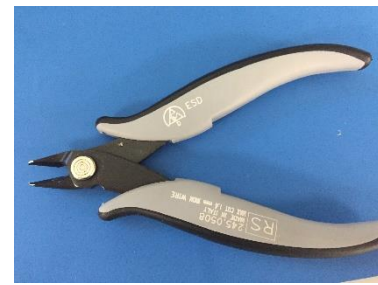
Due to a bad tightening on a maintenance bar the bottom structure was too high in the hemisphere so we had to cut the upper part of the structure with a cutting clamp.

This problem has taught us that the tools were not completely adapted, no clearance between the structures.

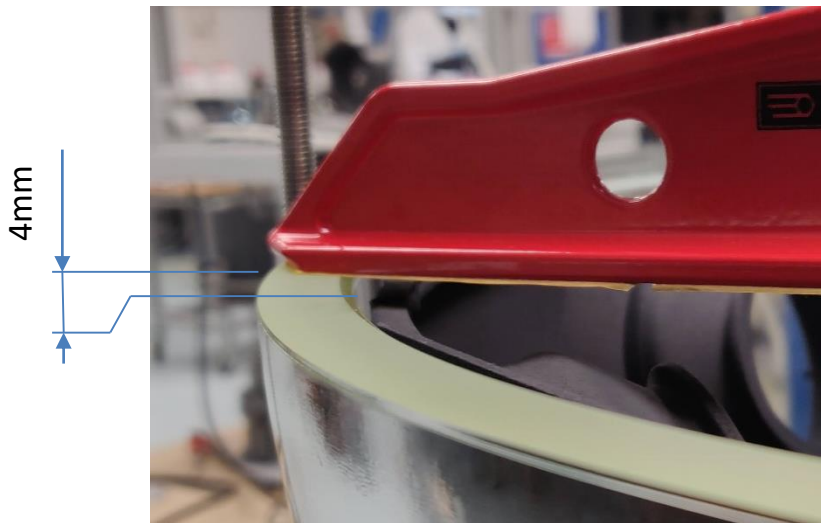
Bottom

To verify what it's possible to correct I made some measurement with new support structure just posed in their hemisphere.

- Conclusion:
- On the top it's difficult to increase the clearance because it's posed on the mushroom.
 - On the bottom it's possible to change the position of the structure in the hemisphere.

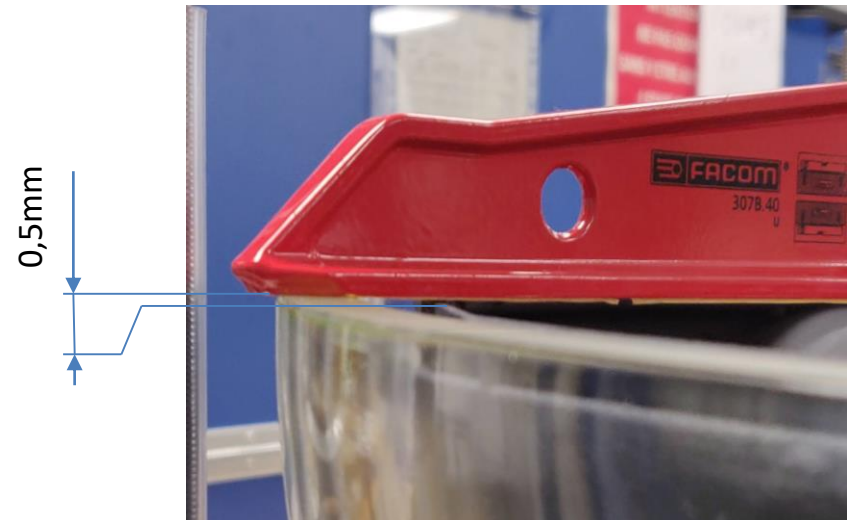
Top structure in a hemisphere with mushroom glued

Top: - I keep the tool like before, no change.

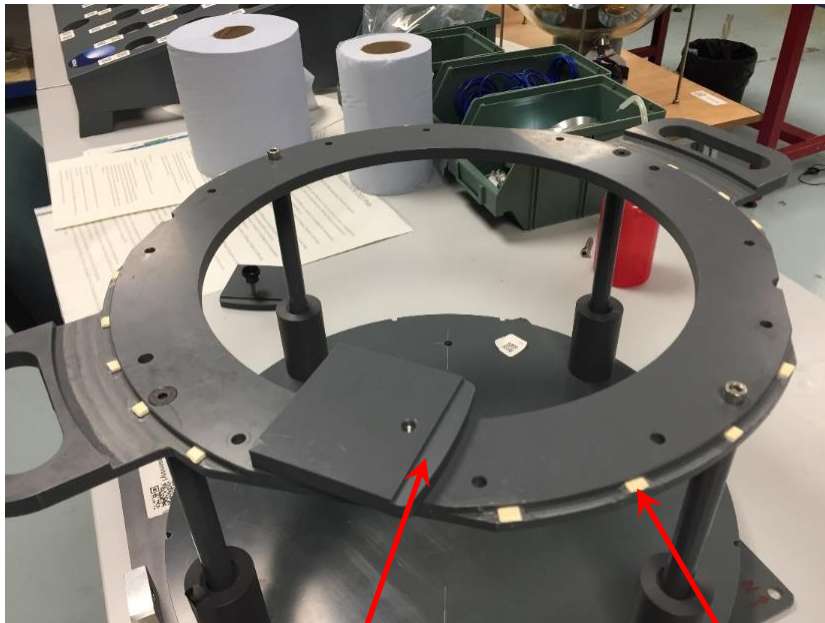
Tightening
Plates machined

PVC parts
glued

Bottom: - The goal is to win 2mm to lower the structure.

- 2 solutions - Machine the tool
- Glued wedges on the tool

Due to the workshop busy this month I decide to take the 2nd way.

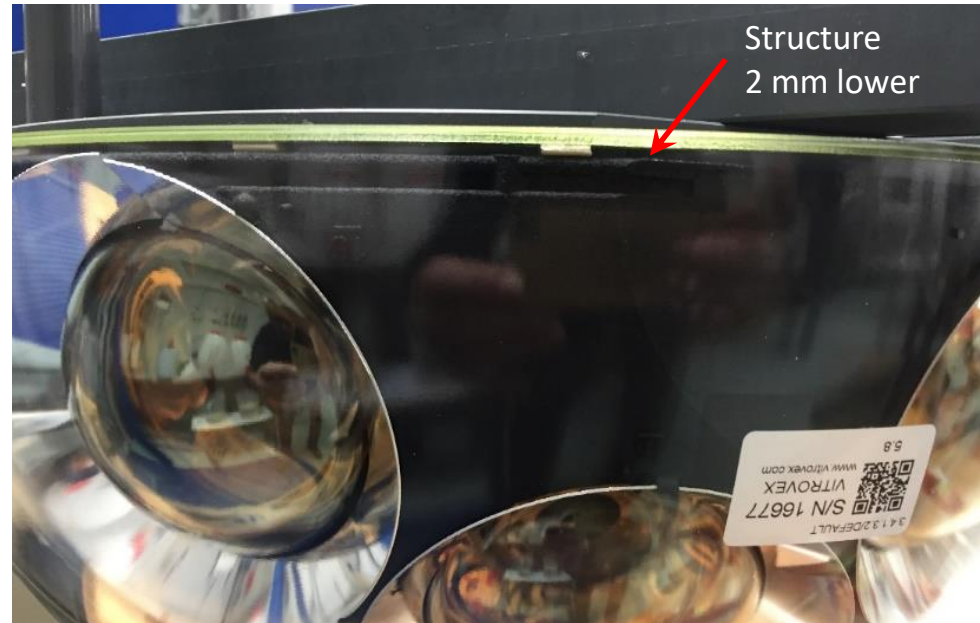
Structure
2 mm lower

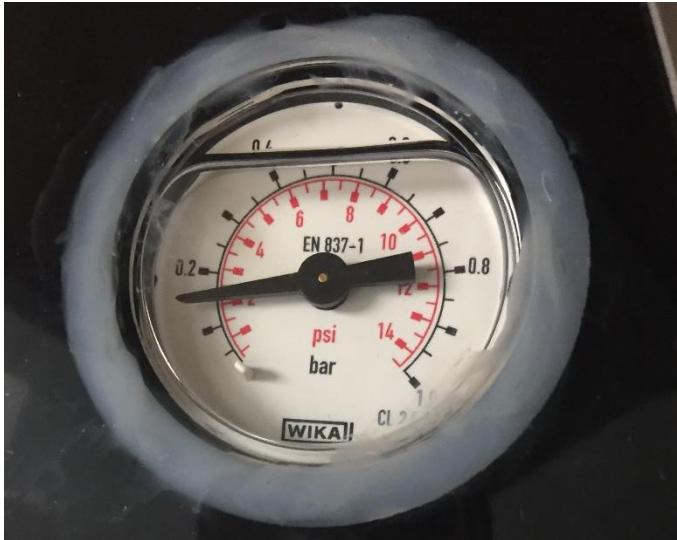
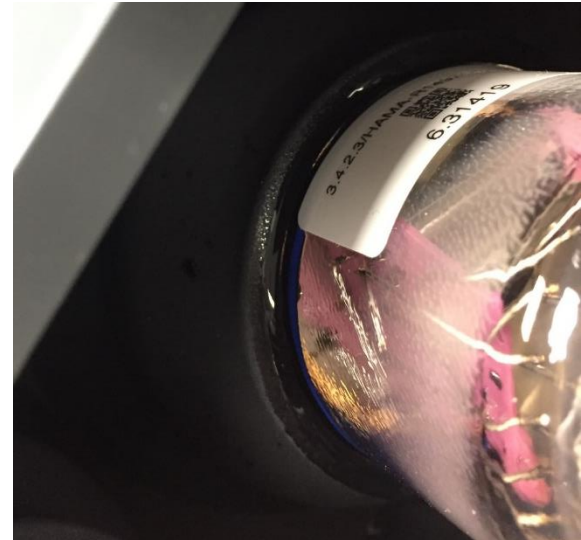
DOM 693

DOM 693: - Pouring Friday, gel in the pressure gauge and leak trough O-rings.

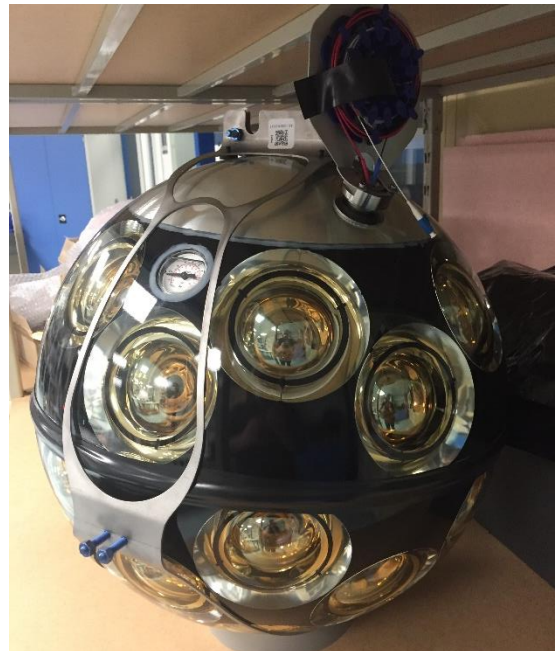
- Closed Monday
No problem to fit the 2
hemispheres.
